OVERHILLS STREAM AND WETLAND
RESTORATION MONITORING REPORT (YEAR 6)

Harnett County, North Carolina

EEP Project No. 199

Status of Plan: FINAL
Submission Date: November 2012

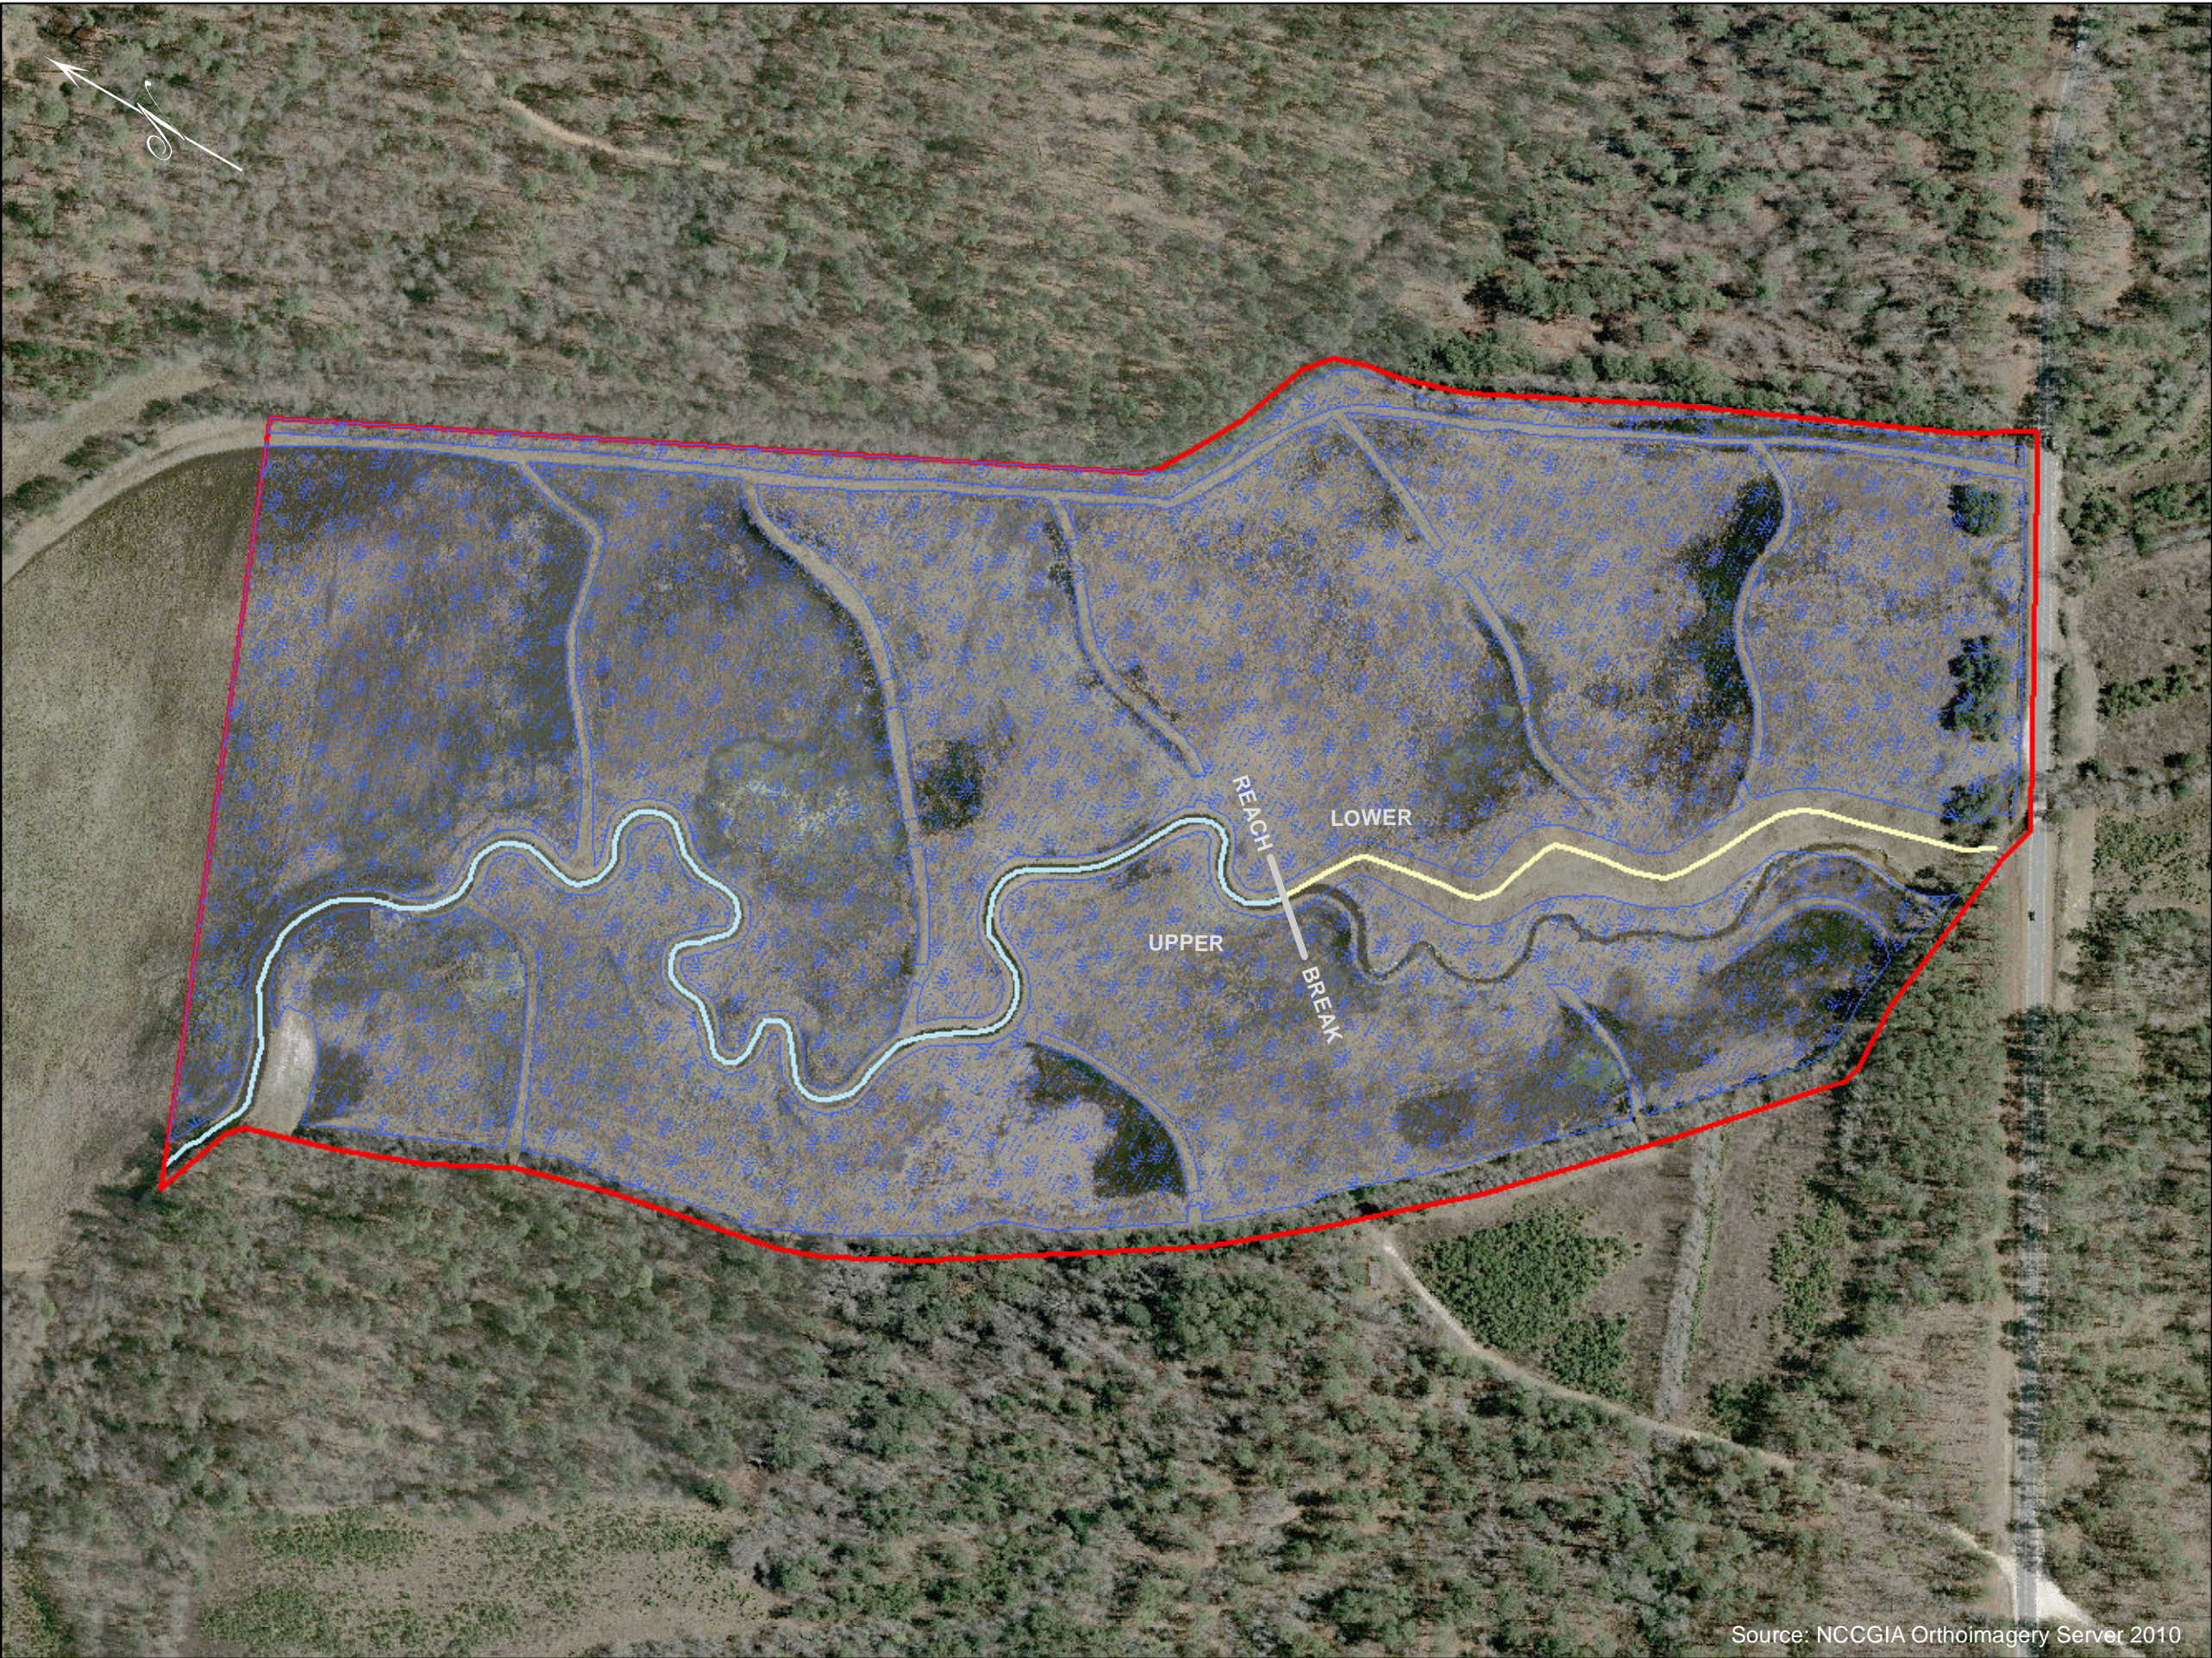
THIS MAP DEPICTS MY6 CONDITIONS AS OF 10/2012

and is not a cause for concern at this moment. Some minor beaver foraging was observed in VPA 22. The beaver are attempting to dam a section of the berm that has been removed.

The lower end of the repair reach is exhibiting weak herbaceous vegetation growth on both the banks and floodplain (VPA-21). However, numerous viable bare root trees were found on the floodplain. Possible causes for the stunted herbaceous growth may include topsoil replacement or compaction during construction. This may be assisting in maintaining low populations of *Lespedeza*.

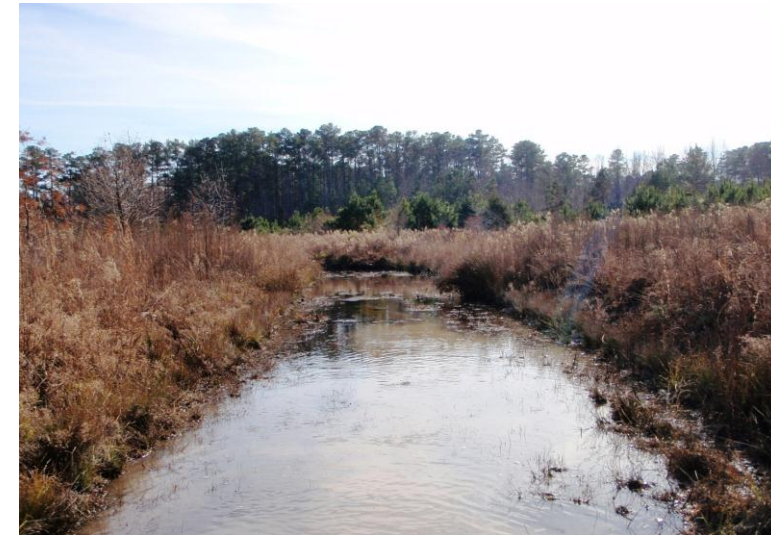
Photo of Cross-Section R1 - Looking Downstream @ STA 32+82

Asbuilt - 2011	Year 5 - 2011	Year 6 - 2012			
BKF Area		44.50	44.43			
BKF Width		26.62	24.25			
BKF Mean Depth		1.67	1.83			
BKF Max Depth		2.65	2.69			
W/D		15.94	13.25

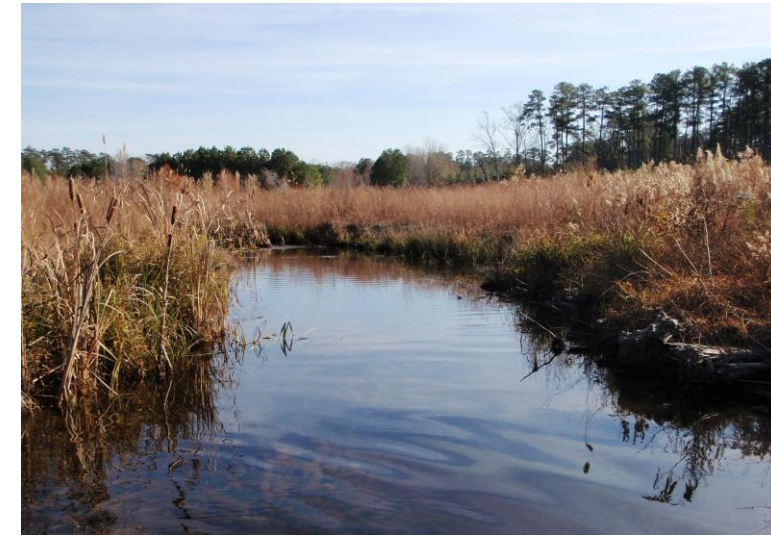
Photo of Cross-Section R2 - Looking Downstream @ STA 34+09

Baseline	0	0			
BKF Area		43.02	46.62			
BKF Width		30.69	31.38			
BKF Mean Depth		1.40	1.49			
BKF Max Depth		2.90	3.27			
W/D		21.92	21.06

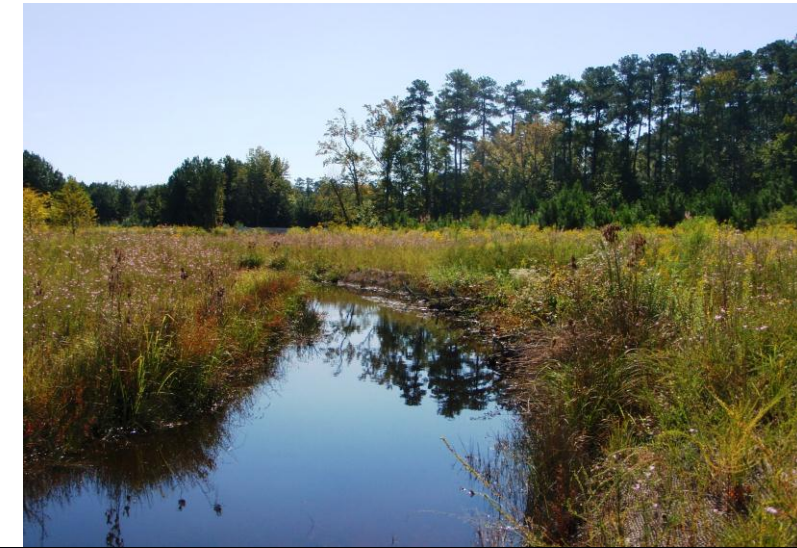
Photo of Cross-Section R3 - Looking Downstream @ STA 37+28

0	0	0		
BKF Area	63.05	66.57	70.23		
BKF Width	31.87	34.41	35.05		
BKF Mean Depth	1.98	1.93	2		
BKF Max Depth	3.85	3.95	3.94		
W/D	16.10	17.83	17.52

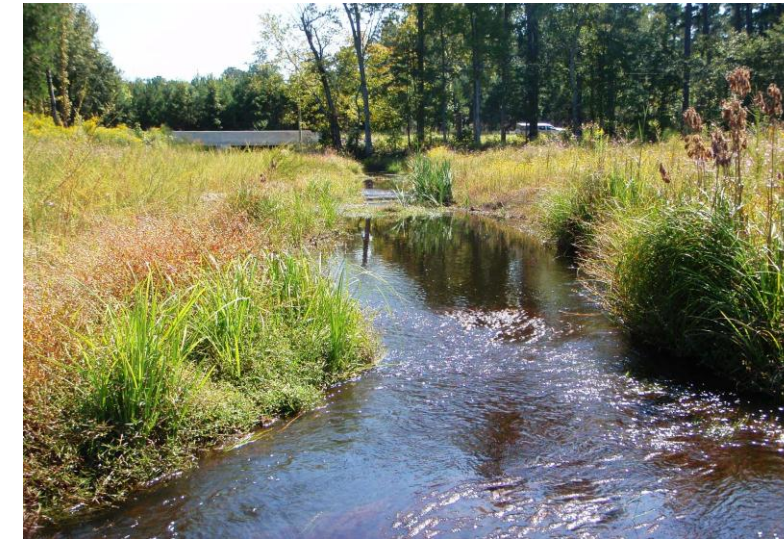
Photo of Cross-Section R4 - Looking Downstream @ STA 39+93

0	0	0			
BKF Area	33.29	29.90	29.08			
BKF Width	19.24	18.65	19.28			
BKF Mean Depth	1.73	1.60	1.51			
BKF Max Depth	2.59	2.48	2.32			
W/D	11.12	11.66	12.77
