OVERHILLS STREAM AND WETLAND RESTORATION MONITORING REPORT (YEAR 7)

Harnett County, North Carolina

EEP Project No. 199

Monitoring Year 7
November 2013

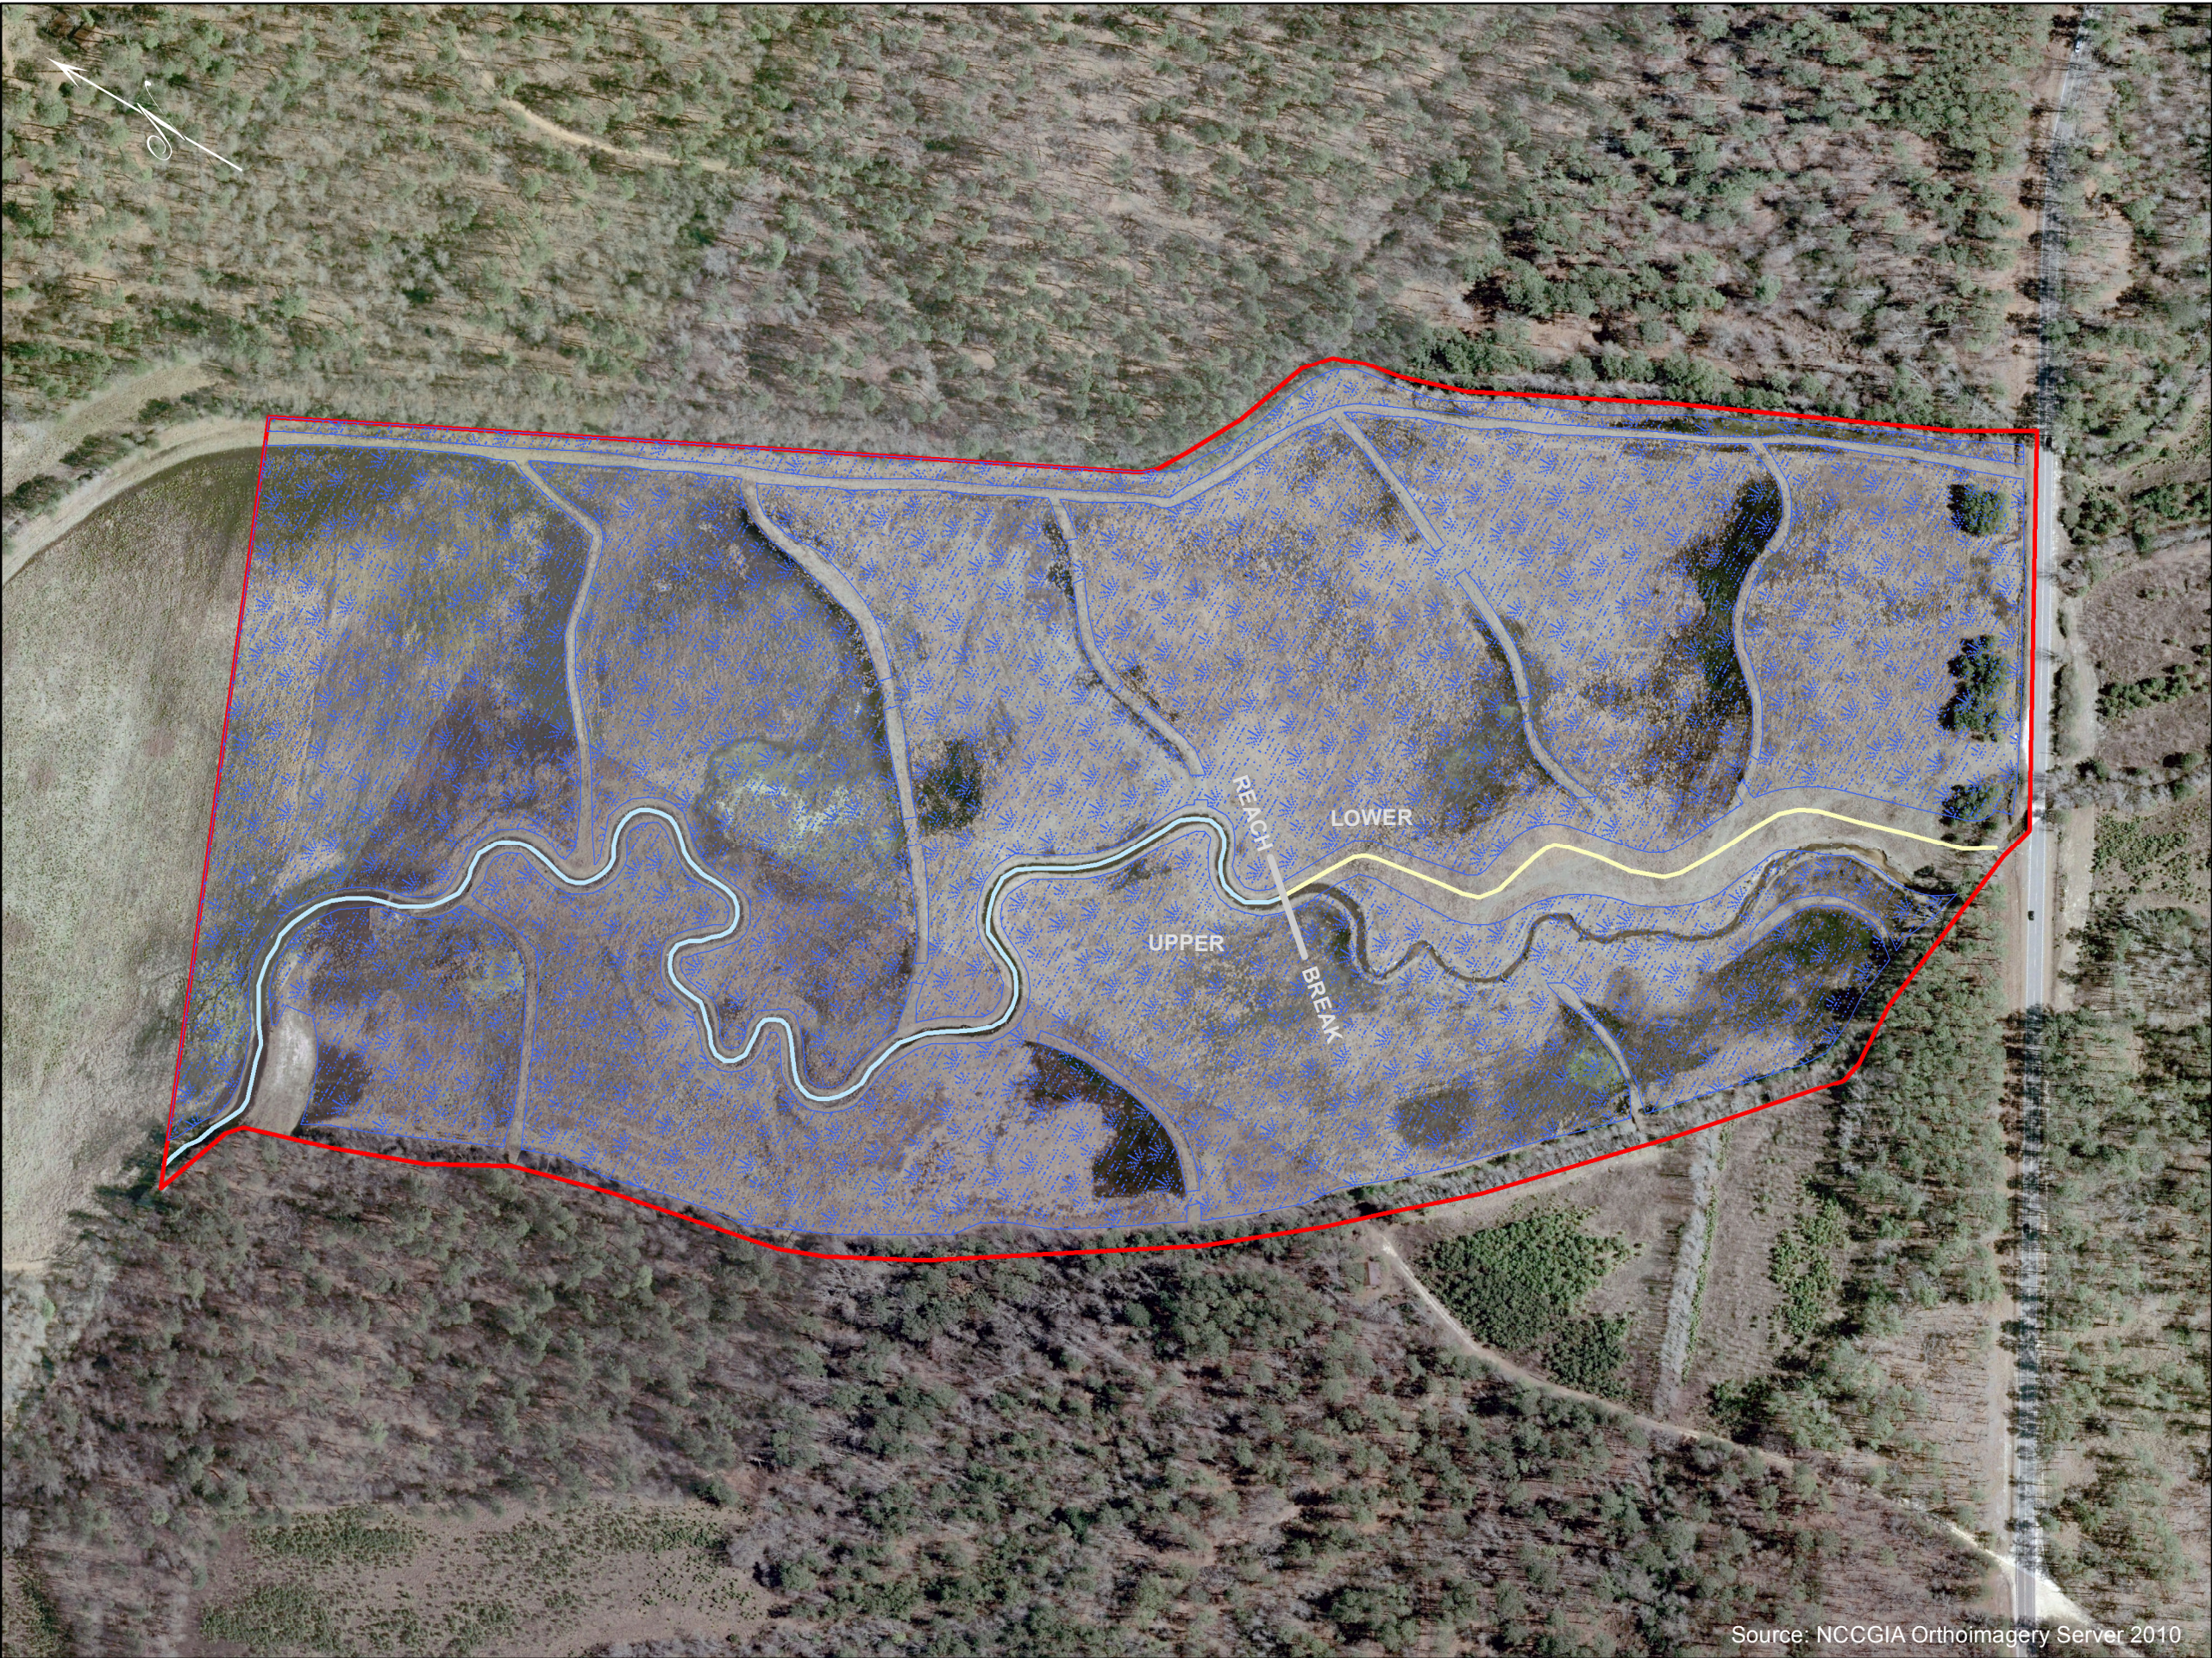
CURRENT CONDITION PLAN VIEW

Lespedeza is still present in some drier areas onsite, and has reestablished along the right bank and lower left bank in the newly repaired floodplain and has grown in area enough to be added to the CCPV as VPA 23 and 24. A few areas of *Typha* have also been observed onsite and are growing in size from previous assessments. Areas of *Typha* were observed near the wetter areas and are shown on the map as VPA 10, 15 and 20. VPA-10 and VPA-20 (*Typha*) have expanded. As previously noted, the remainder of the wetland is exhibiting excellent vegetation growth, particularly in the cypress trees.

The lower end of the repair reach continues to exhibit weak herbaceous vegetation growth on both the banks and lower floodplain (VPA-21). However, numerous viable bare root trees were found on the floodplain. Possible causes for the stunted herbaceous growth may include topsoil replacement or compaction during construction. This may be assisting in maintaining populations of *Lespedeza* in this area.

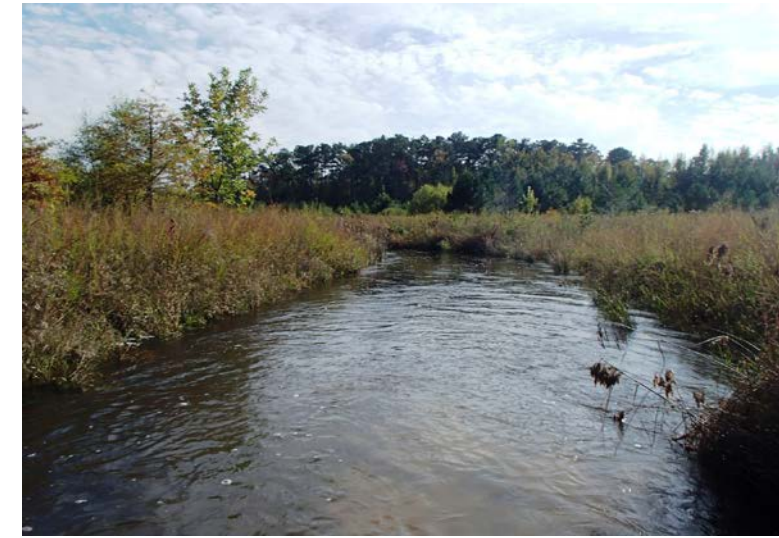
Overhills Cross Section #R1

Photo of Cross-Section R1 - Looking Downstream @ STA 32+82

Asbuilt - 2011	Year 5 - 2011	Year 6 - 2012	Year 7 - 2013
BKF Area		44.50	44.43	40.40
BKF Width		26.62	24.25	23.10
BKF Mean Depth		1.67	1.83	1.75
BKF Max Depth		2.65	2.69	2.75
W/D		15.94	13.25	13.20

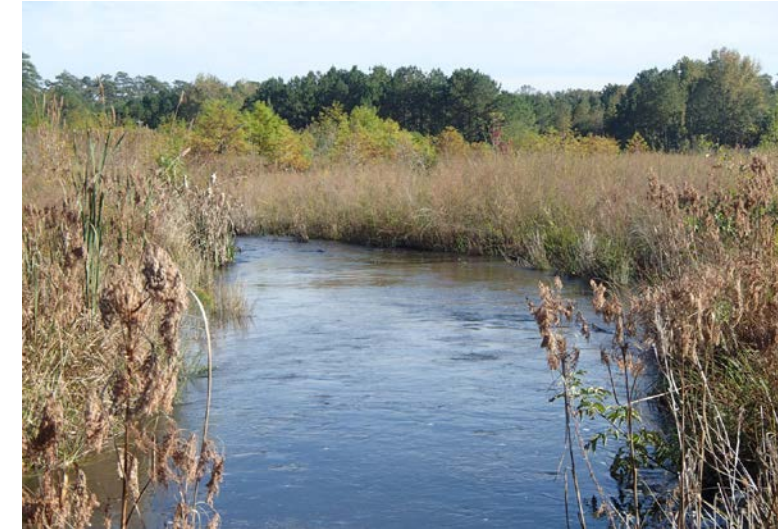
Overhills Cross Section #R2

Photo of Cross-Section R2 - Looking Downstream @ STA 34+09

Baseline	Year 5 - 2011	Year 6 - 2012	Year 7 - 2013
BKF Area		43.02	46.62	47.00
BKF Width		30.69	31.38	30.30
BKF Mean Depth		1.40	1.49	1.55
BKF Max Depth		2.90	3.27	3.14
W/D		21.92	21.06	19.55

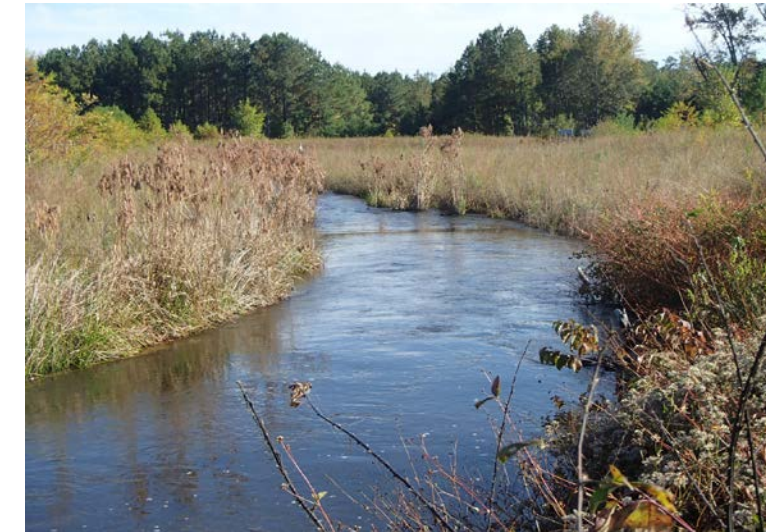
Overhills Cross Section #R3

Photo of Cross-Section R3 - Looking Downstream @ STA 37+28

Baseline - 2011	Year 5 - 2011	Year 6 - 2012	Year 7 - 2013
BKF Area	63.05	66.57	70.23	61.40
BKF Width	31.87	34.41	35.05	32.80
BKF Mean Depth	1.98	1.93	2	1.87
BKF Max Depth	3.85	3.95	3.94	3.84
W/D	16.10	17.83	17.52	17.54

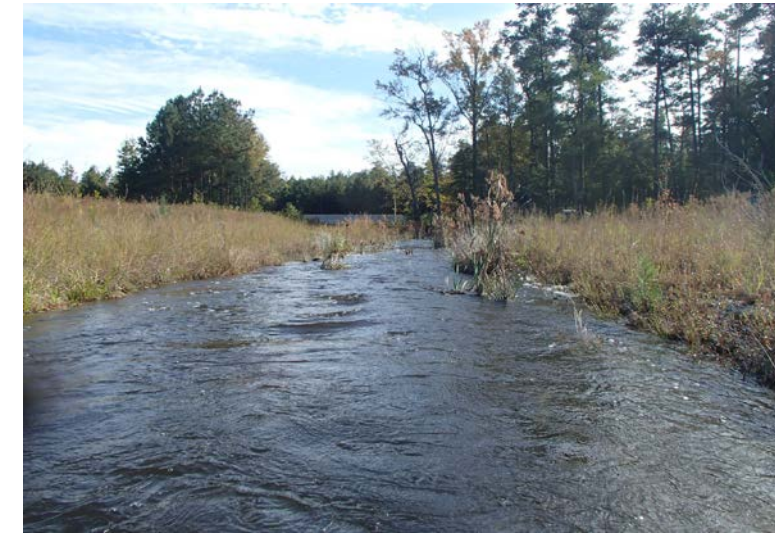
Overhills Cross Section #R4

Photo of Cross-Section R4 - Looking Downstream @ STA 39+93

Baseline - 2011	Year 5 - 2011	Year 6 - 2012	Year 7 - 2013		
BKF Area	33.29	29.90	29.08	29.12		
BKF Width	19.24	18.65	19.28	19.30		
BKF Mean Depth	1.73	1.60	1.51	1.51		
BKF Max Depth	2.59	2.48	2.32	2.36		
W/D	11.12	11.66	12.77	12.78
