Annual Monitoring Report

Monitoring Year 3 of 5

Project Name: Junes Branch Stream Restoration

NCDMS Project No.: 95027

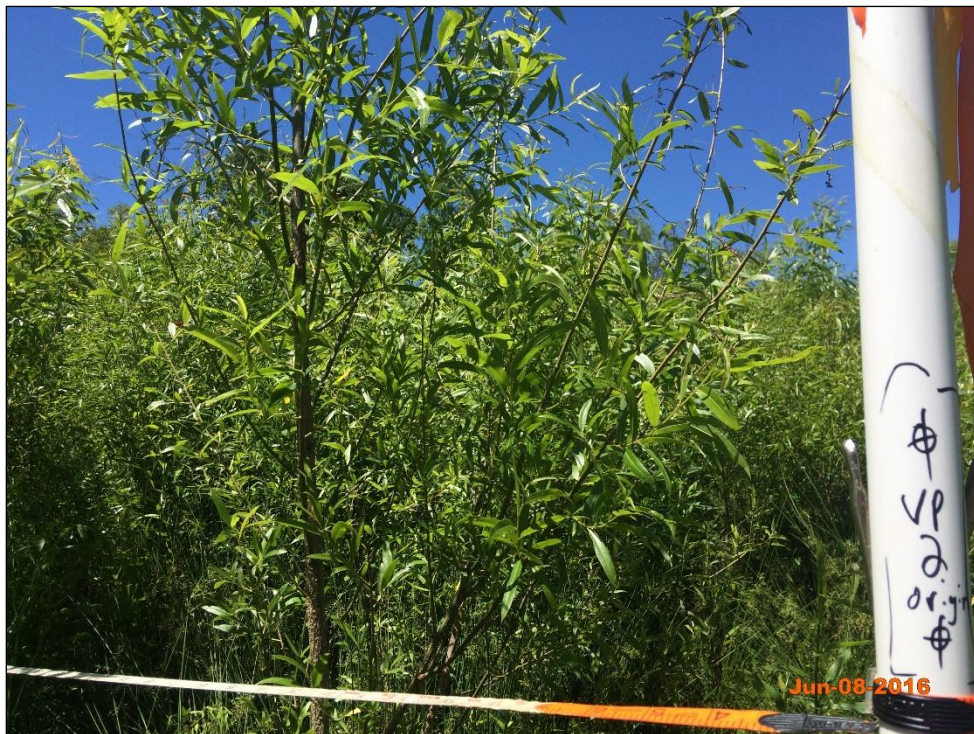
Junes Branch - Vegetation Monitoring Plot 2
June 8, 2016

Table 7. Vegetation Plot Criteria Attainment		
Junes Branch / Project No. 95027		
Vegetation Plot ID	Vegetation Survival Threshold Met?	Tract Mean
1	Yes	88%
2	No	
3	Yes	
4	Yes	
5	Yes	
6	Yes	
7	Yes	
8	Yes

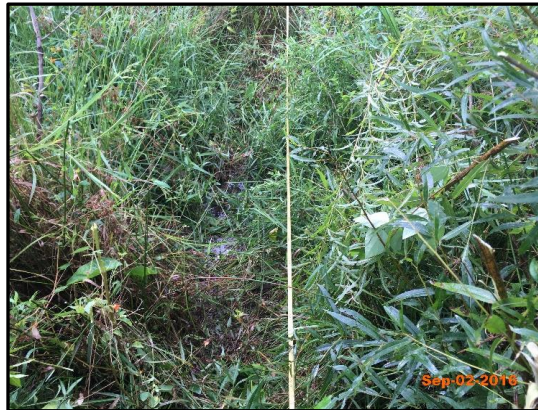
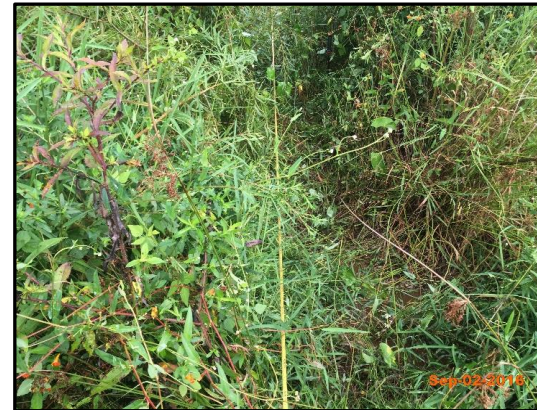
XS Number: 7
XS Type: Pool

Geomorphic data for MY3 was collected from August through December 2016. Summary tables, cross-section plots, and longitudinal profiles related to stream morphology are located in Appendix D. Significant changes in the cross-section data between MY2 and MY3 were limited to cross-sections 3, 6, 7, and 13 (Appendix B, Table 11a). Riffle cross-section 3, where downcutting of the channel was evident in MY1 has begun to stabilize, however the maximum water depth still increased by 0.2 feet from MY2 to MY3. Deposits of fine material and increased vegetation caused the formation of an inner berm on the left descending bank of cross-section 6, decreasing bankfull width, maximum depth and cross-sectional area by 1.7 feet, 0.2 foot, and 1.3 feet, respectively. Deposits of finer material in pools led to a significant decrease in maximum pool depth at cross-sections 7 and 13 over the last two monitoring years.

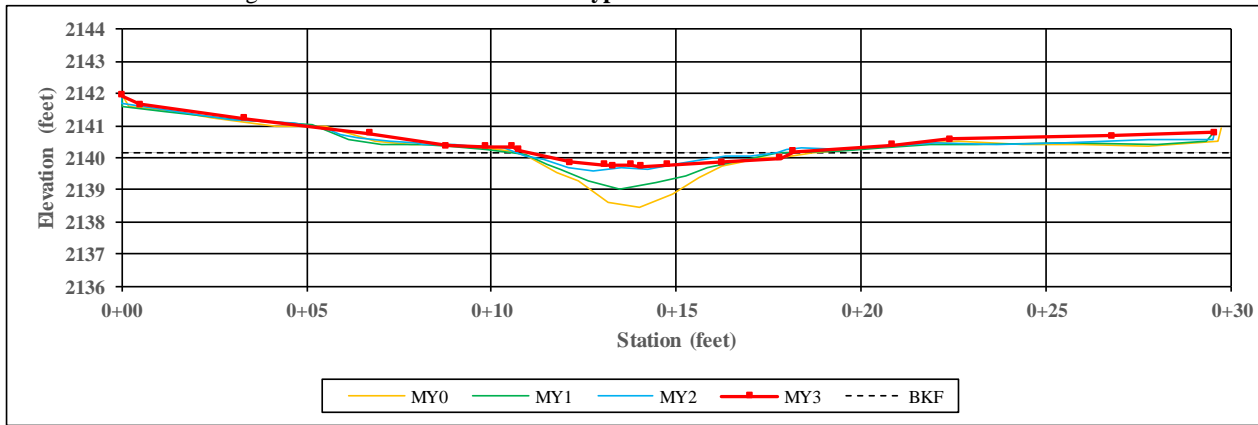
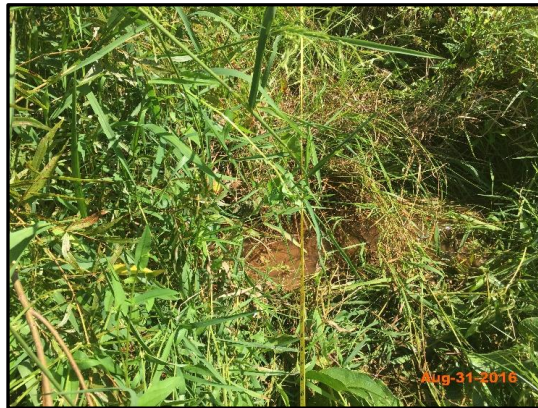
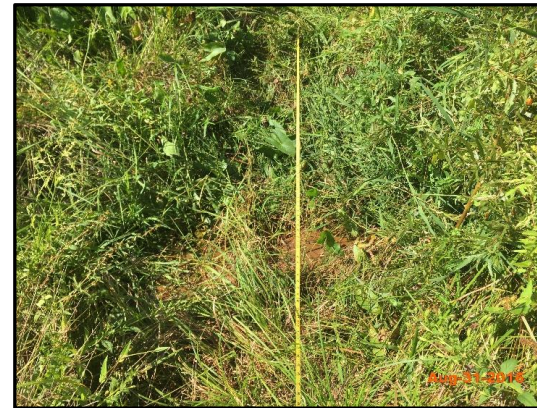
XS Number: 13
XS Type: Pool

changes were noted in the Junes Branch profile. Increased vegetation and drought conditions at the Site has led to deposition of fine sediment within Higdon Branch. Pool maximum depths have decreased from 1.4 feet to 1.0 foot between MY2 and MY3. This influx of sediment also caused a flattening of the water surface slope from 0.0184 (ft/ft) to 0.0162 (ft/ft). Aggradation within the upper portion of Higdon Branch has transitioned approximately the first 100 feet of stream to a linear wetland. This area still maintains hydrologic function, but riffle/ pool features have become difficult to decipher. Considering the drought conditions this year, RES will monitor this area during MY4 site visits to determine if any remedial work is warranted. Doris Branch also displayed a decrease in pool maximum depth from 1.2 feet to 0.9 foot between MY2 and MY3. As with Higdon Branch, aggradation can be seen throughout the Doris Branch reach, especially in pools. RES will also monitor this area during MY4 to determine if any remedial work is warranted. Assessment of recent aerial imagery within the watershed does not identify any off-site sediment sources affecting Junes Branch, Higdon Branch, or Doris Branch. However, it is expected that the unstable streams located upstream of the Site are contributing a considerable amount of sediment to the project. Considering the easements' close proximity to the road, runoff from the Fairview Road is another expected cause of sedimentation within the reaches. Especially the upper portions of Junes Branch and Higdon Branch.

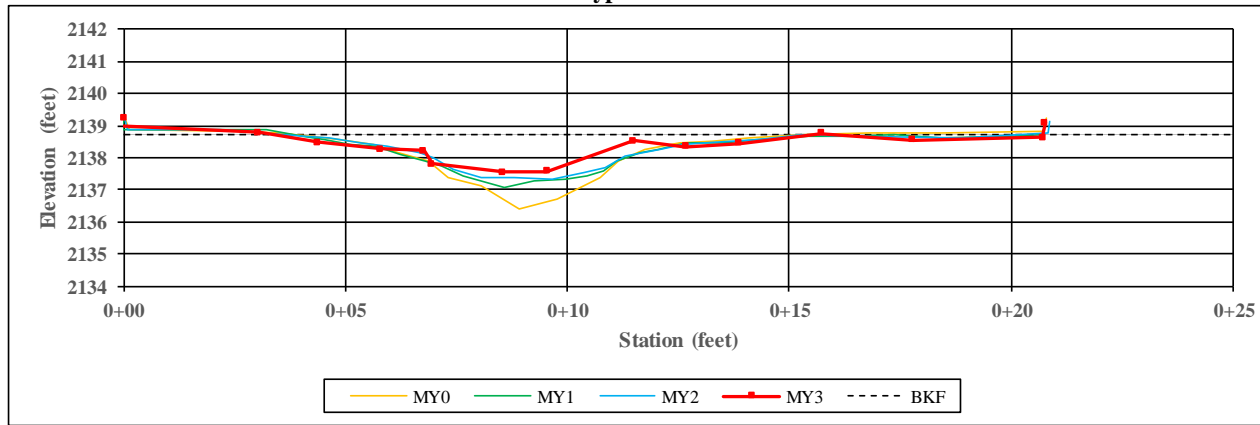
XS Number: 15
XS Type: Pool

CHANNEL DIMENSIONS SUMMARY	MY0	MY1	MY2	MY3	MY4	MY5		
Bankful Width (ft)	11.6	11.7	11.9	12.4	-	-	-	-
Floodprone Width (ft)	21.0	21.0	21.0	21.0	-	-	-	-
Bankfull Mean Depth (ft)	0.8	0.7	0.6	0.5	-	-	-	-
Bankfull Max Depth (ft)	2.3	1.7	1.4	1.2	-	-	-	-
Bankfull Cross-Sectional Area (ft ²)	9.4	8.3	7.4	6.5	-	-	-	-
Width/Depth Ratio	14.3	16.5	19.1	23.6	-	-	-	-
Entrenchment Ratio	1.8	1.8	1.8	1.7	-	-	-	-
Bank Height Ratio	1.0	1.0	1.0	1.0	-	-	-	-

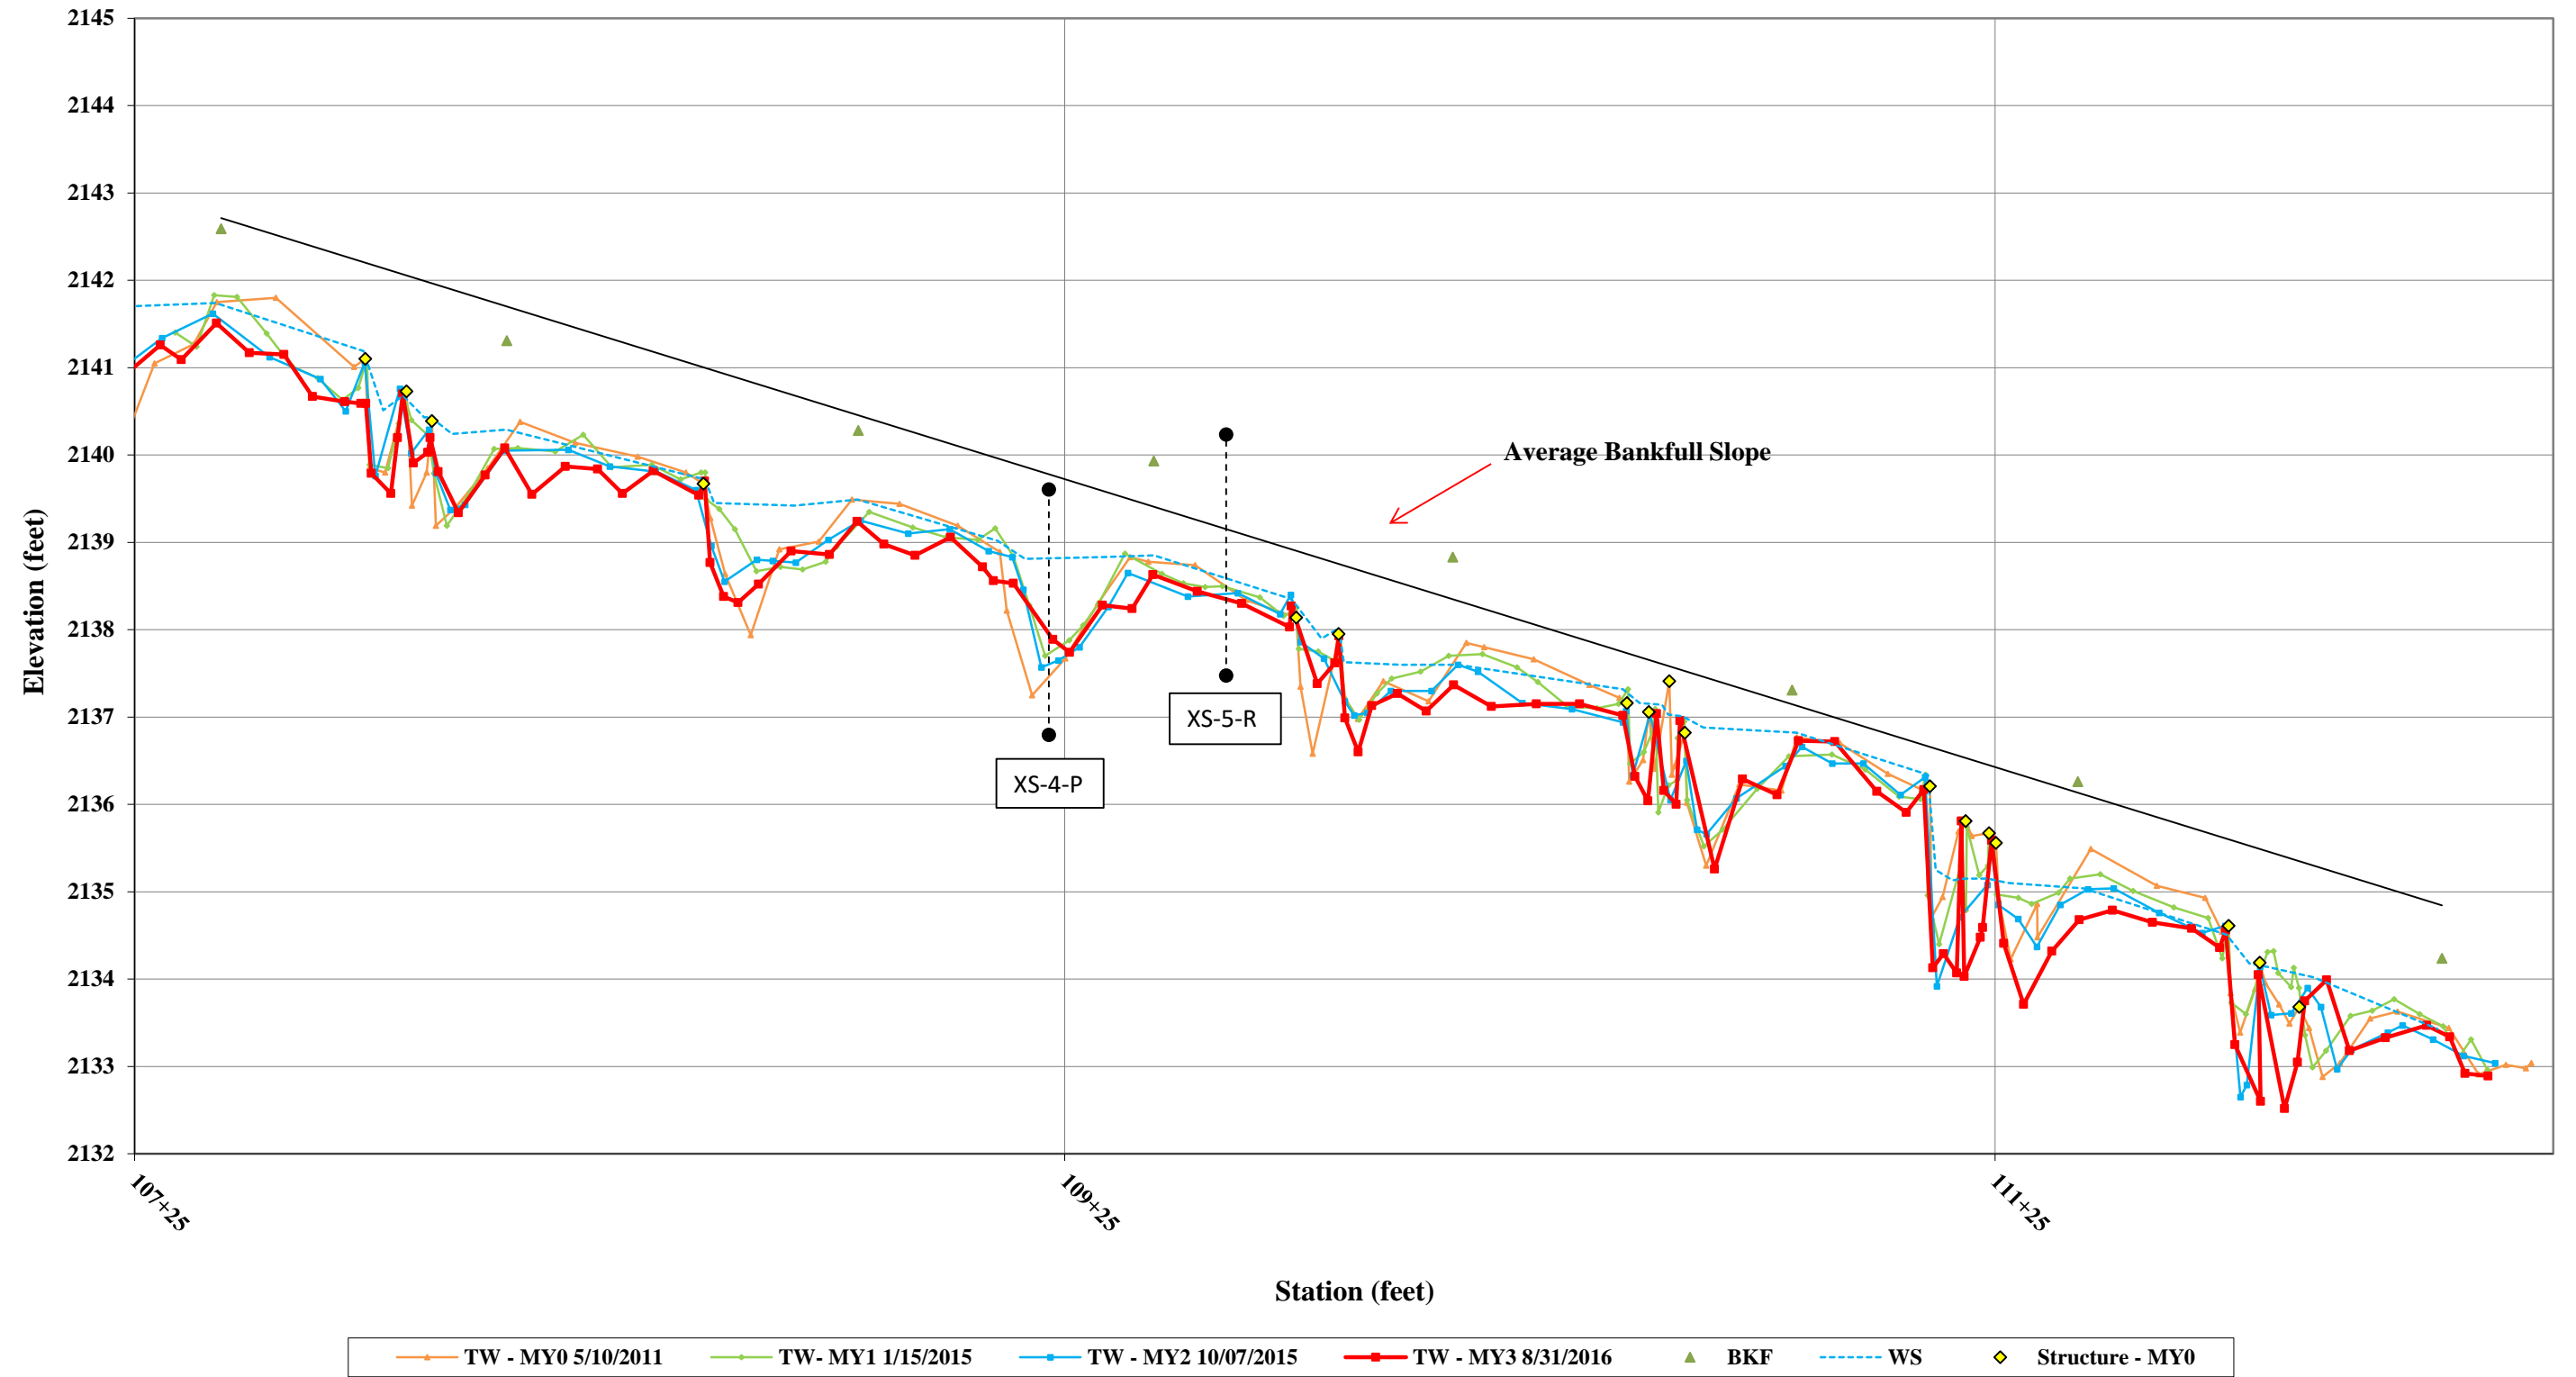
**Bumgarner Branch II
Longitudinal Profile
Staioning 107+27 to 112+35**

Generally, longitudinal profile data (Appendix B, Table 11b) indicated relatively little change in riffle and pool dimensions between MY2 and MY3. Bumgarner Branch I showed a decrease in riffle length of 2.0 feet, from 17.5 feet to 15.5 feet, and a decrease in pool maximum depth of 0.4 foot to 1.9 feet. An increase in sediment deposition has caused a slight flattening of the riffle slope from 0.028 (ft/ft) to 0.022 (ft/ft). Bumgarner Branch II dimensions remained relatively similar to the MY2 dimensions; however, pool maximum depths have decreased by 0.3 foot to 2.2 feet. The upper end of Junes Branch saw an influx of fine sediment flattening the riffle profiles and filling in some of the pools. No other major

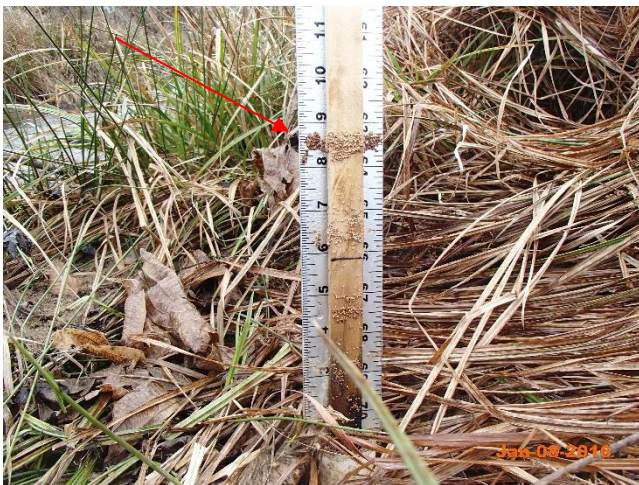
Photo 1: Bumgarner I Bankfull Event 1/11/2016

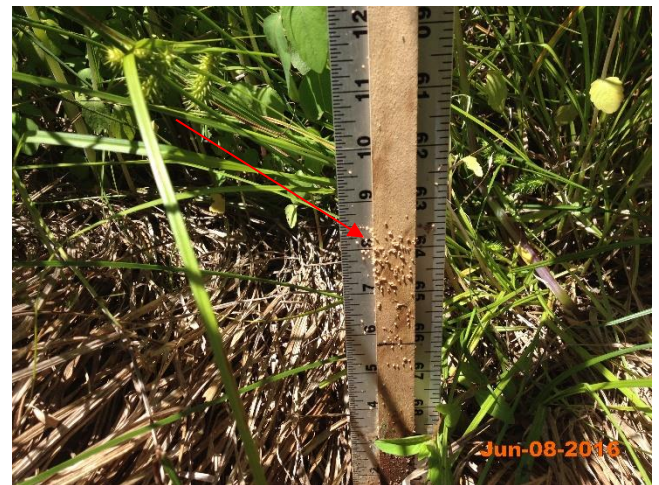
Photo 2: Bumgarner I Bankfull Event 6/23/2016

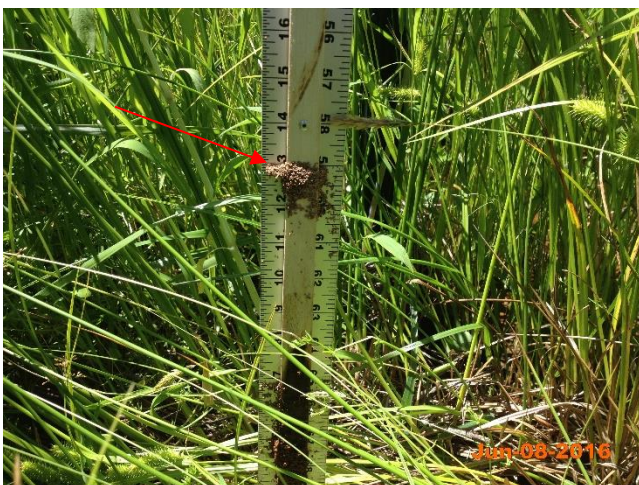
Photo 3: Junes Branch Bankfull Event 6/23/2016
