Annual Monitoring Report

Monitoring Year 4 of 5

Project Name: Junes Branch Stream Restoration

NCDMS Project No.: 95027

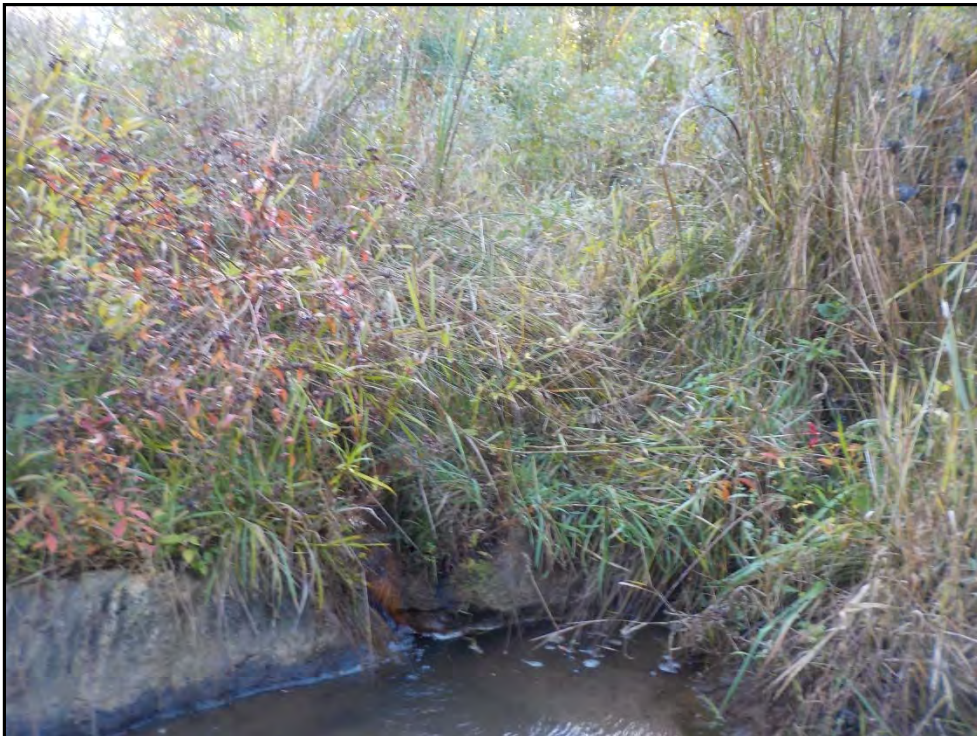
Higdon Branch – Permanent Photo Station 11
Looking Upstream from Confluence with Bumgarner Branch II
October 5, 2017

In April of 2017, RES and the IRT met to discuss the sediment aggradation noted on Doris Branch and Higdon Branch. On Higdon Branch, the IRT agreed there was sediment aggradation but a defined channel was present. No maintenance, remedial actions or credit deductions were requested. On Doris Branch, however, the sedimentation had diminished the distinct channel features. The IRT requested no specific maintenance and recommended a final decision on crediting be made after additional monitoring. The IRT also noticed that overall Junes Branch has a high sediment load but concluded that it appeared to be maintaining appropriate geomorphology. The meeting summary is documented in **Appendix F**.

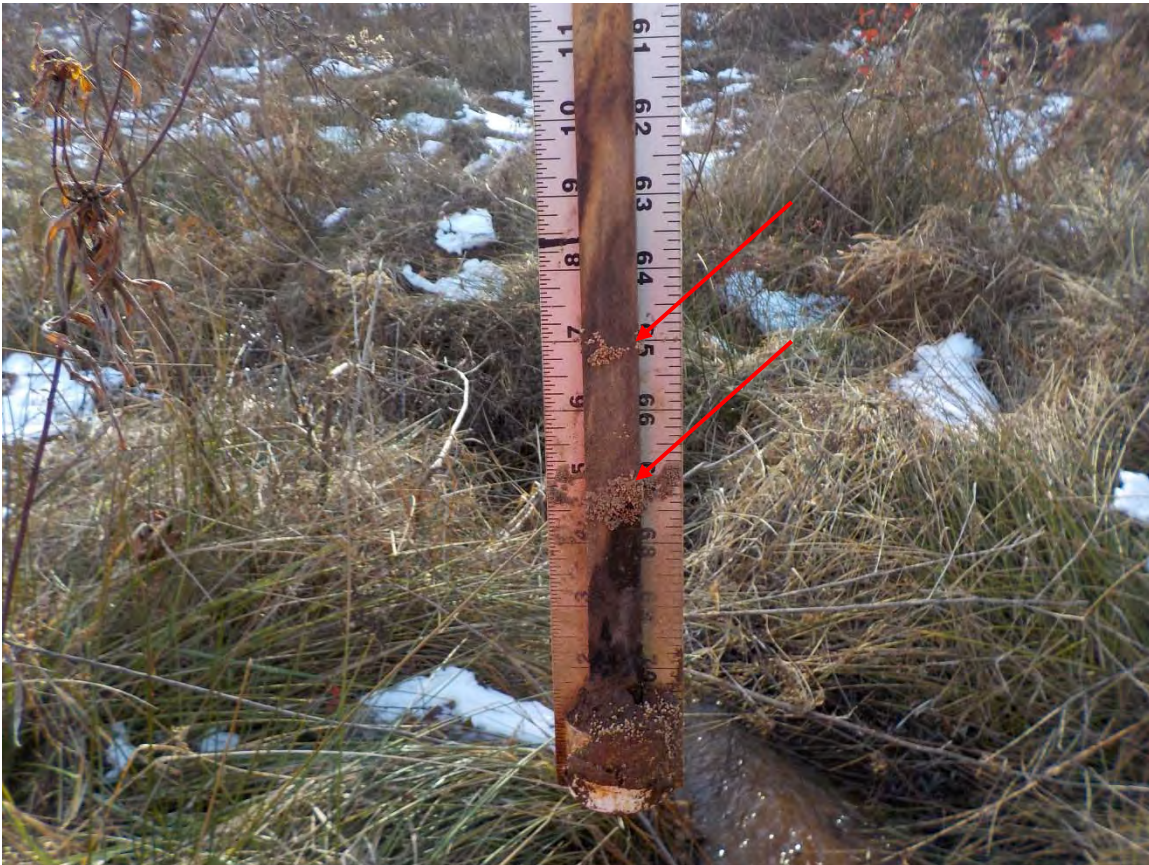
**Photo 1: Crest Gauge 1 - Junes Branch**

Crest Gauge	Stream Reach	Number of Bankfull Events	Date of Highest Bankfull Event	Maximum Bankfull Height (ft.)	Photo Number
Crest Gauge 1	Junes	2	October 2017	0.6	1
Crest Gauge 2	Bum II	0	NA	NA	NA

Data collected on 12/12/2017
