Annual Monitoring Report

Monitoring Year 5 of 5

Project Name: Junes Branch Stream Restoration

Jackson County, NC

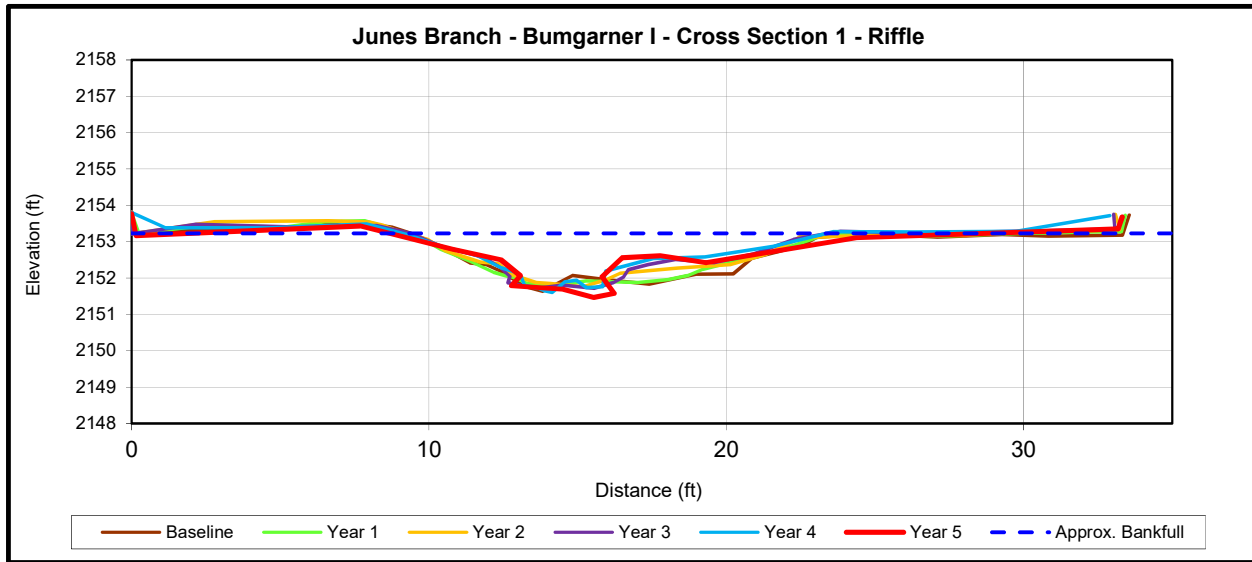
Cross Section 1 (Riffle)					
Based on fixed baseline bankfull elevation	Base	MY1	MY2	MY3	MY4	MY5
Record elevation (datum) used	2153.1	2153.1	2153.1	2153.1	2153.1	2153.2
Bankfull Width (ft)	13.3	13.4	12.7	12.9	13.2	20.0
Floodprone Width (ft)	>79	>79	>79	>79	>33	>33
Bankfull Mean Depth (ft)	0.9	0.8	0.8	0.7	0.7	0.6
Bankfull Max Depth (ft)	1.5	1.3	1.3	1.4	1.5	1.8
Bankfull Cross Sectional Area (ft²)	11.7	11.3	10.2	9.6	8.6	11.7
Bankfull Width/Depth Ratio	15.2	15.8	15.8	17.2	20.2	34.3
Bankfull Entrenchment Ratio	>5.9	>5.9	>6.2	6.1	>2.5	>1.7
Bankfull Bank Height Ratio	1.0	1.0	1.0	1.1	1.1	0.9

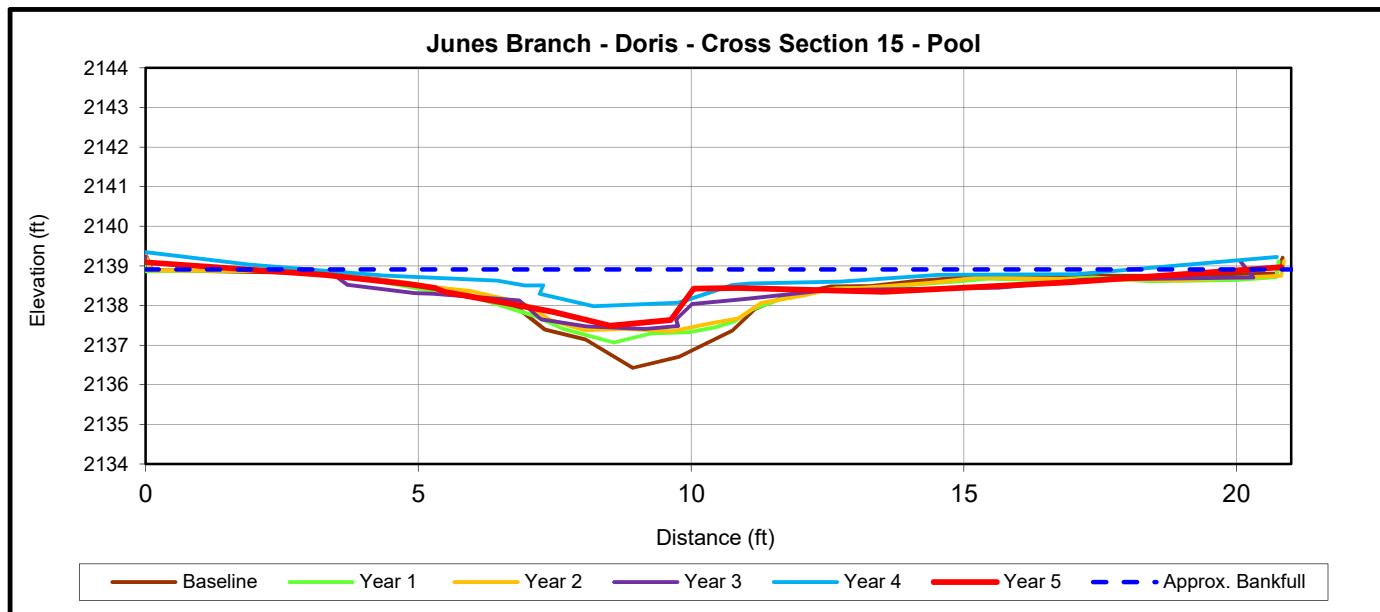
Cross Section 15 (Pool)					
Based on fixed baseline bankfull elevation	Base	MY1	MY2	MY3	MY4	MY5
Record elevation (datum) used	2138.7	2138.7	2138.7	2138.7	2138.7	2138.9
Bankfull Width (ft)	11.6	11.7	11.9	12.4	9.5	18.4
Floodprone Width (ft)	>21	>21	>21	>21	>21	>21
Bankfull Mean Depth (ft)	0.8	0.7	0.6	0.5	0.3	0.5
Bankfull Max Depth (ft)	2.3	1.7	1.4	1.2	0.8	1.4
Bankfull Cross Sectional Area (ft²)	9.4	8.3	7.4	6.5	2.8	9.4
Bankfull Width/Depth Ratio	14.3	16.5	19.1	23.6	32.1	36.0
Bankfull Entrenchment Ratio	>1.8	>1.8	>1.8	>1.7	N/A	N/A
Bankfull Bank Height Ratio	1.0	1.0	1.0	1.0	N/A	N/A

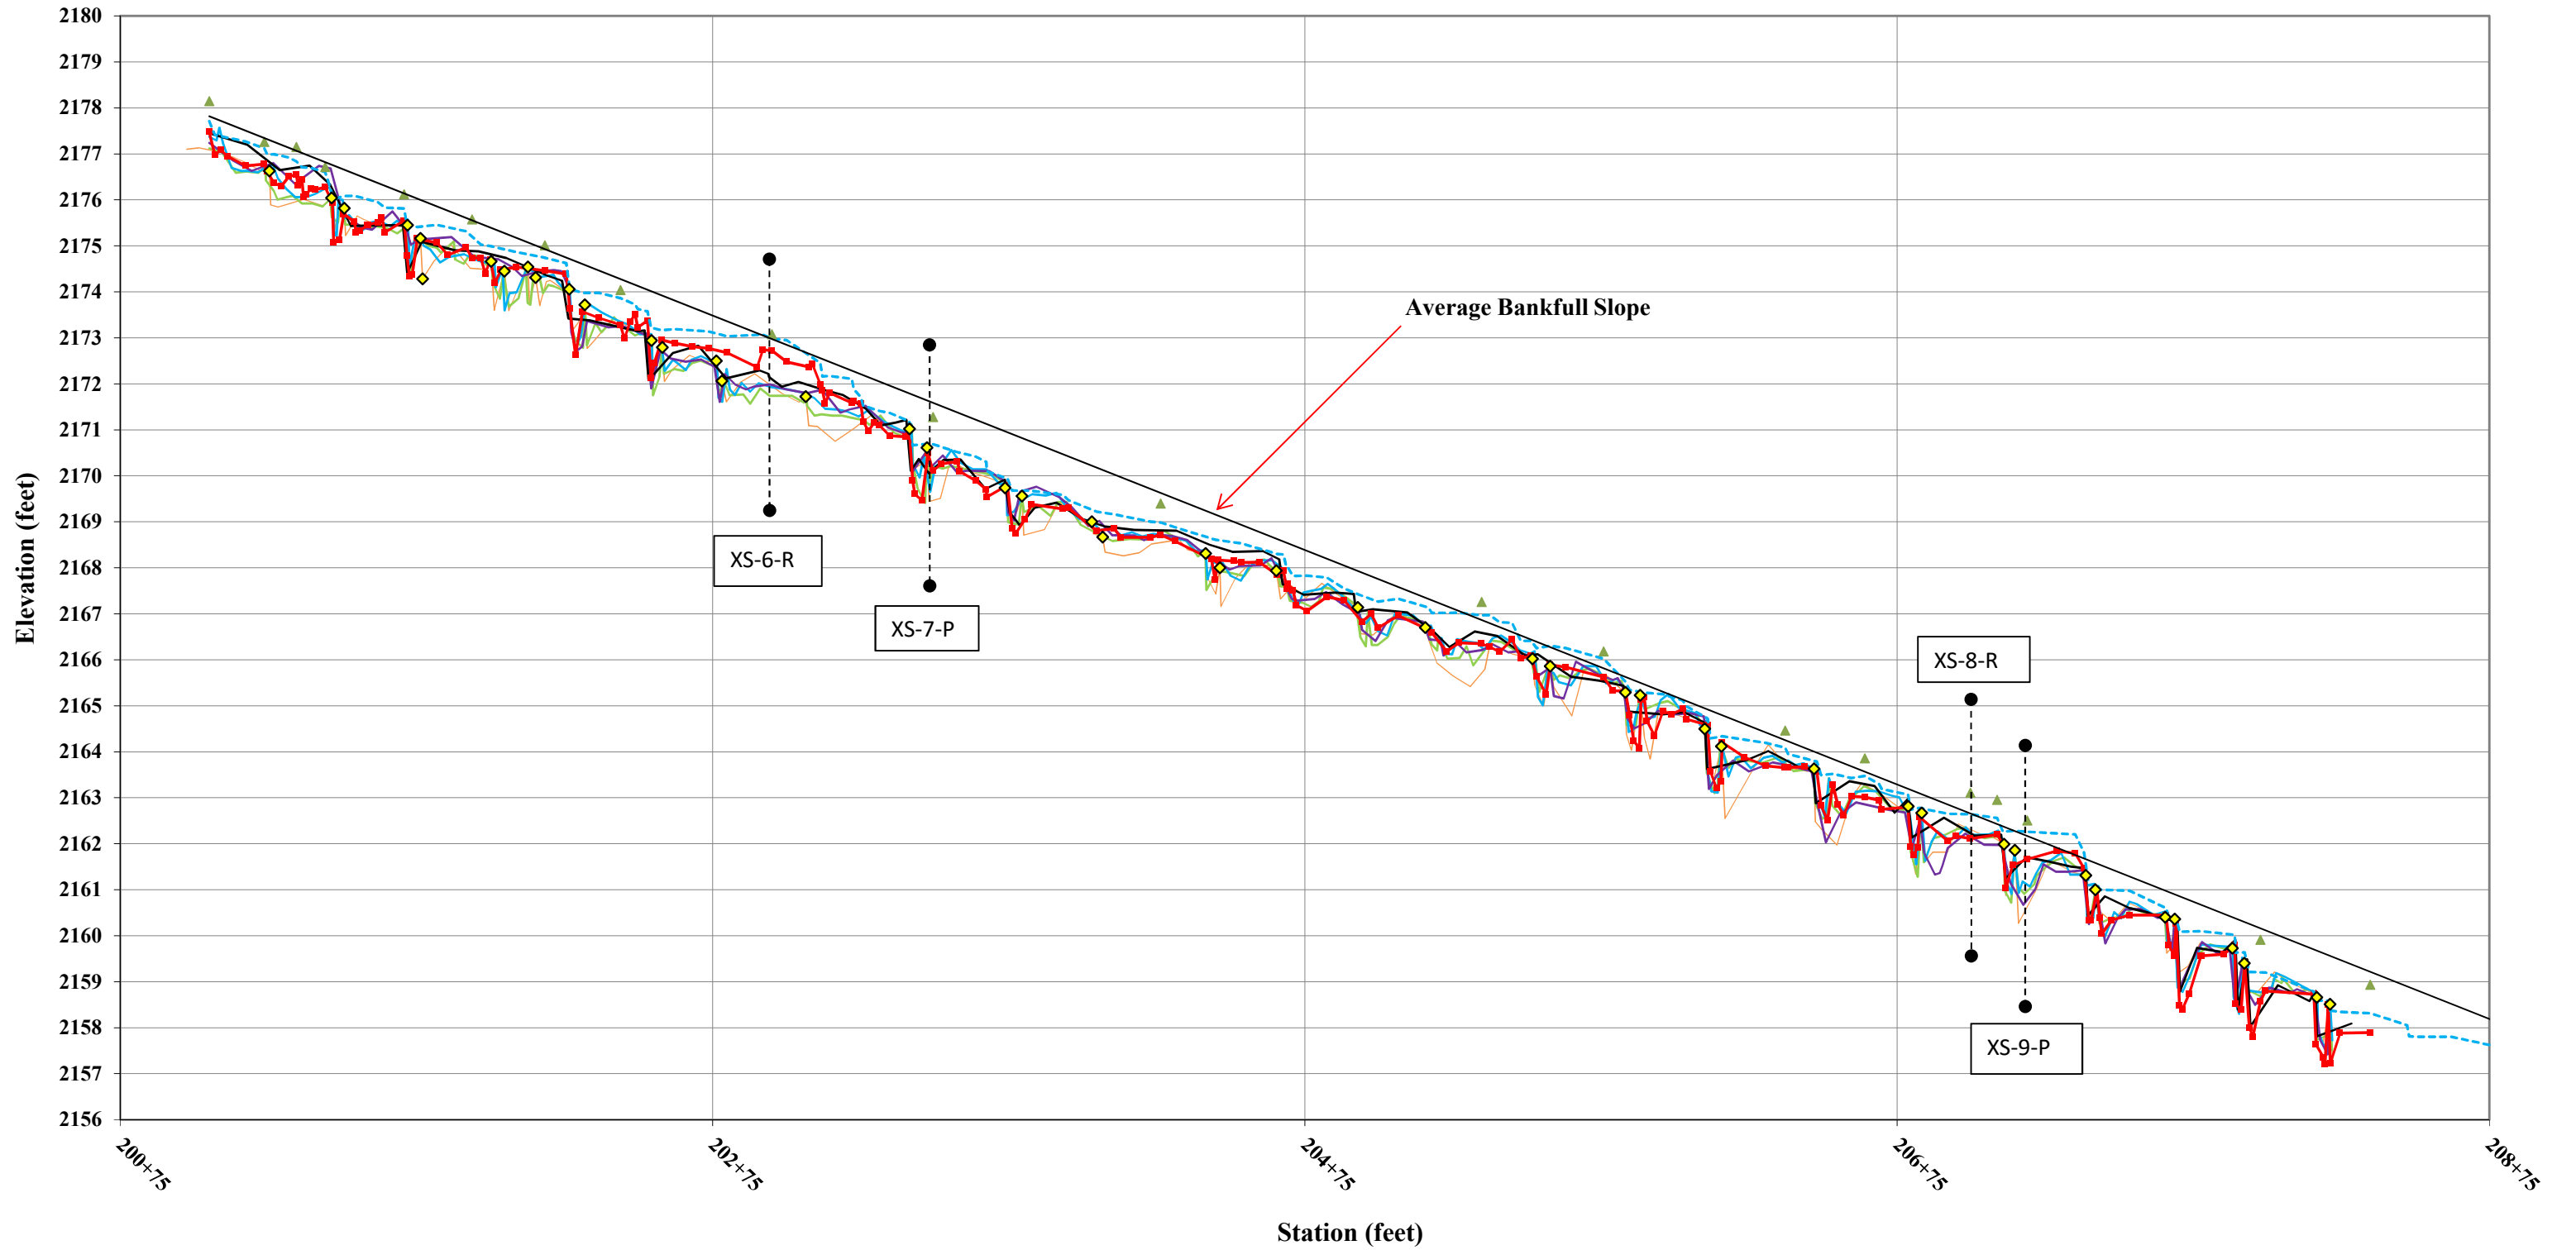
**Junes Branch - Sheet 1
Longitudinal Profile
Staioning 200+97 to 215+15**

- No specific problem areas or concerns were noted on Junes Branch.
- Overall the system has a high sediment load but appears to be maintaining appropriate geomorphology.

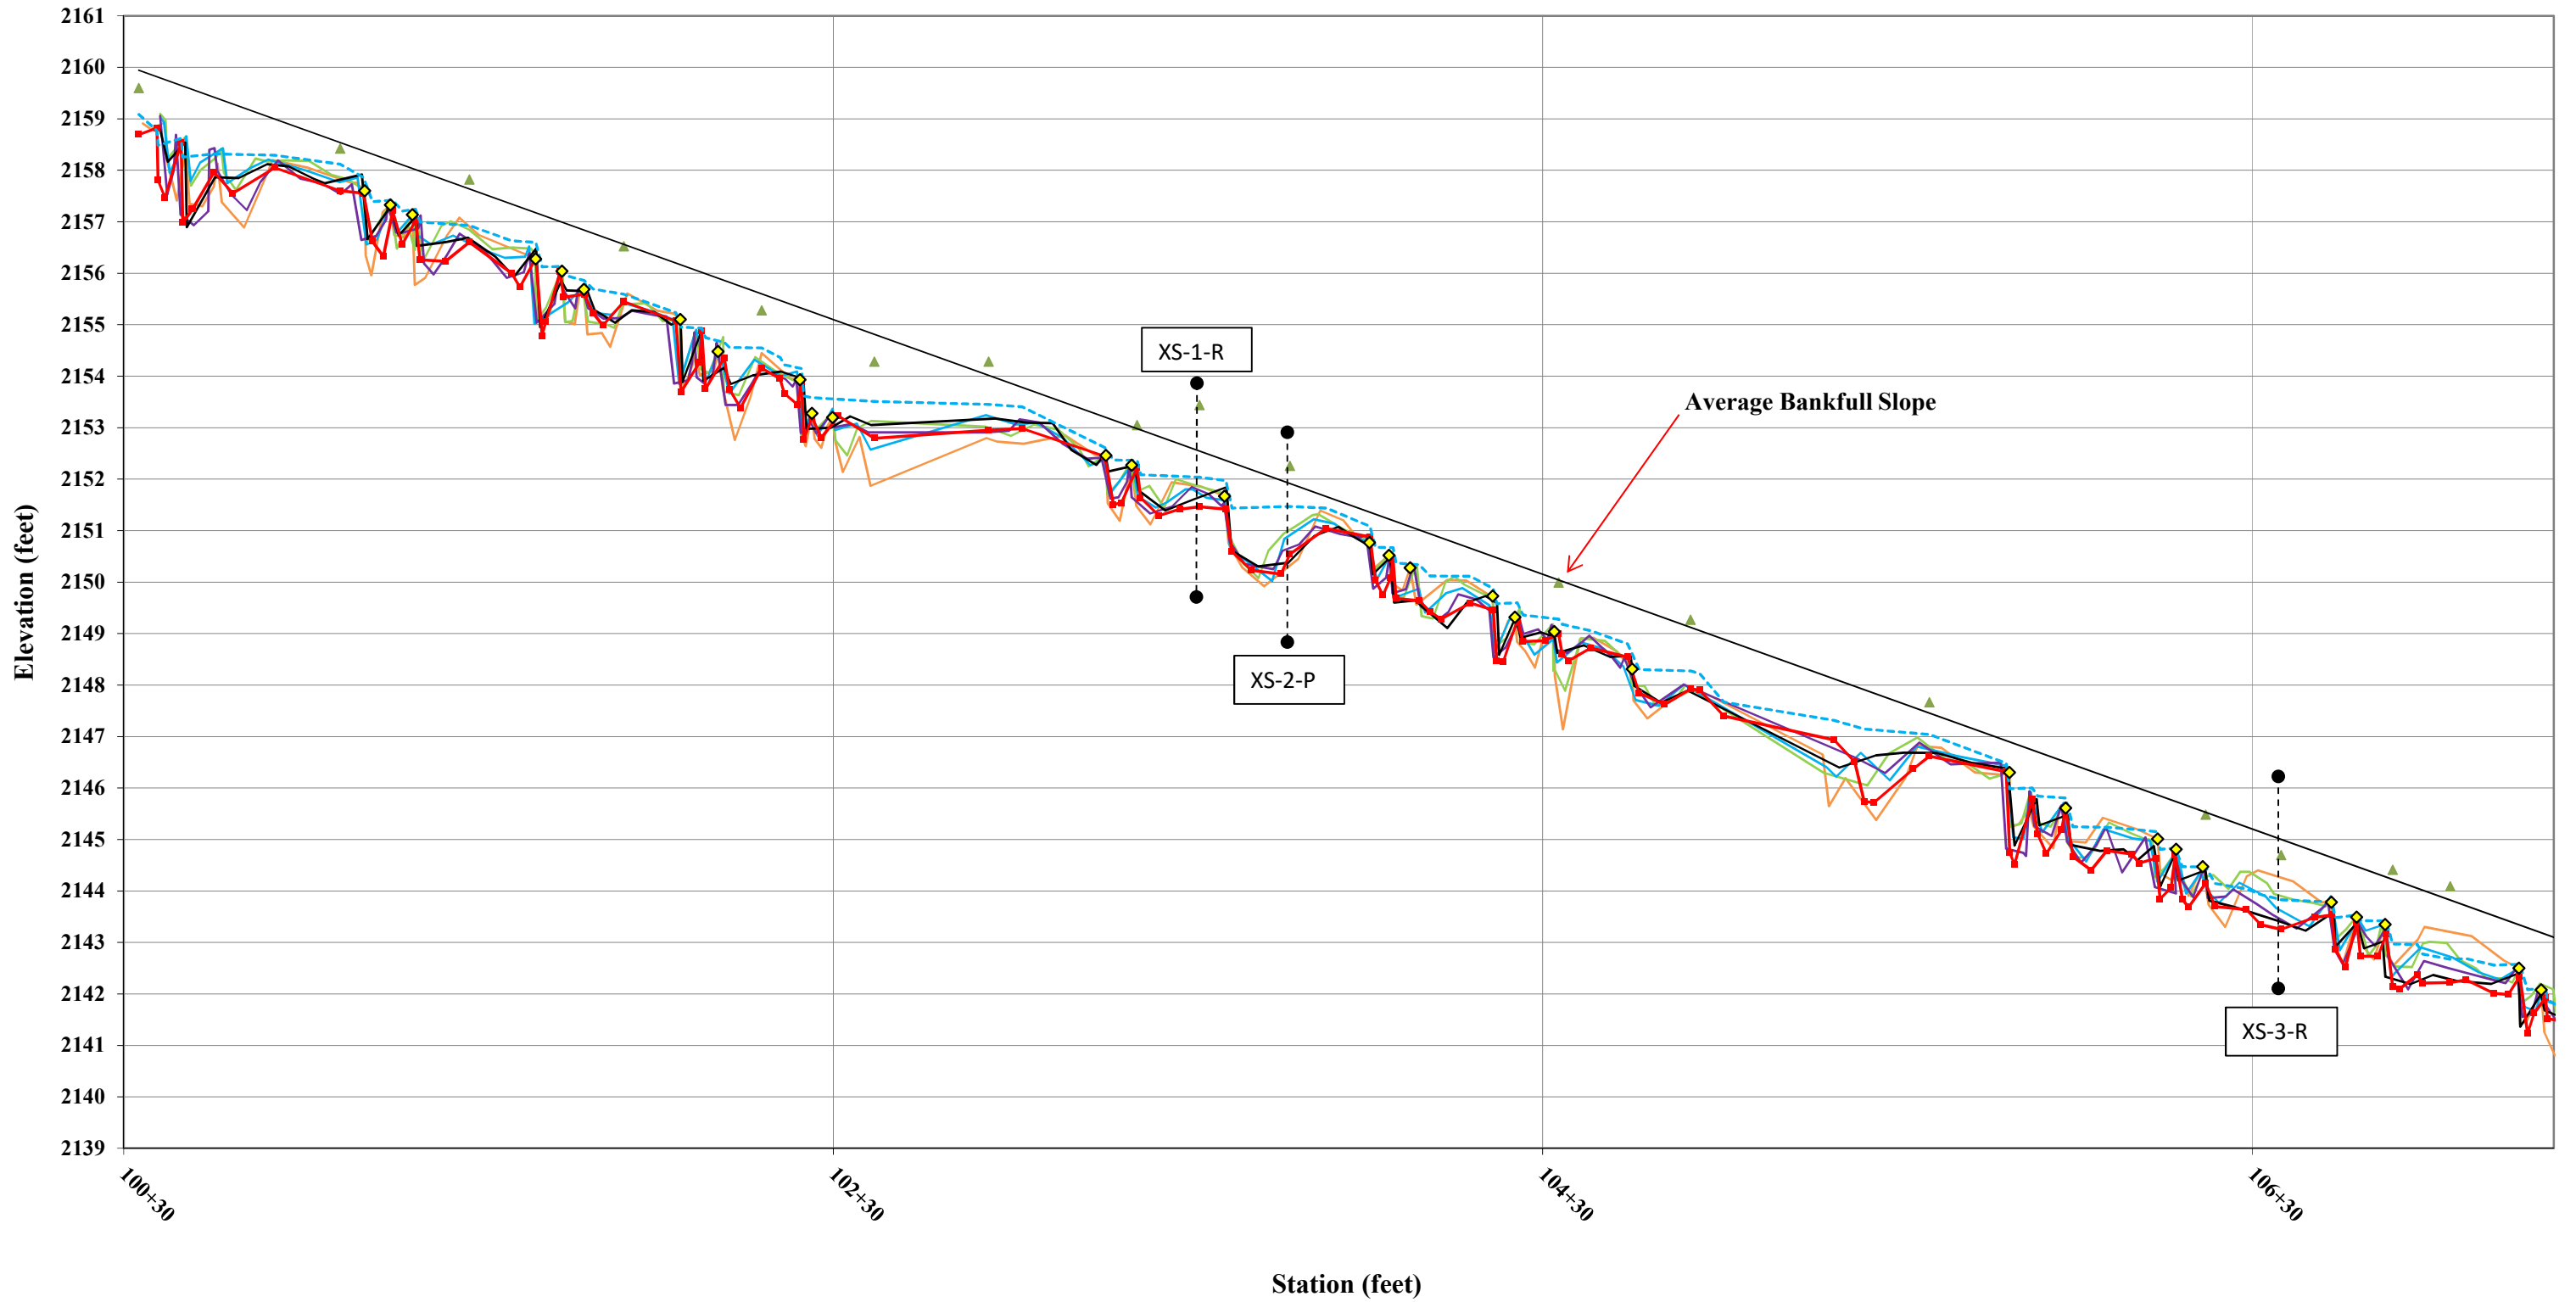
**Bumgarner Branch I
Longitudinal Profile
Staioning 100+37 to 107+27**

- No problems or concerns were noted on Bumgarner I and II.
