**Juniper Bay Wetland Mitigation Site
Robeson County, NC**

**2007 Annual Monitoring Report
Year 2 of 5**

NCEEP Project Number 201

Date: February 2008

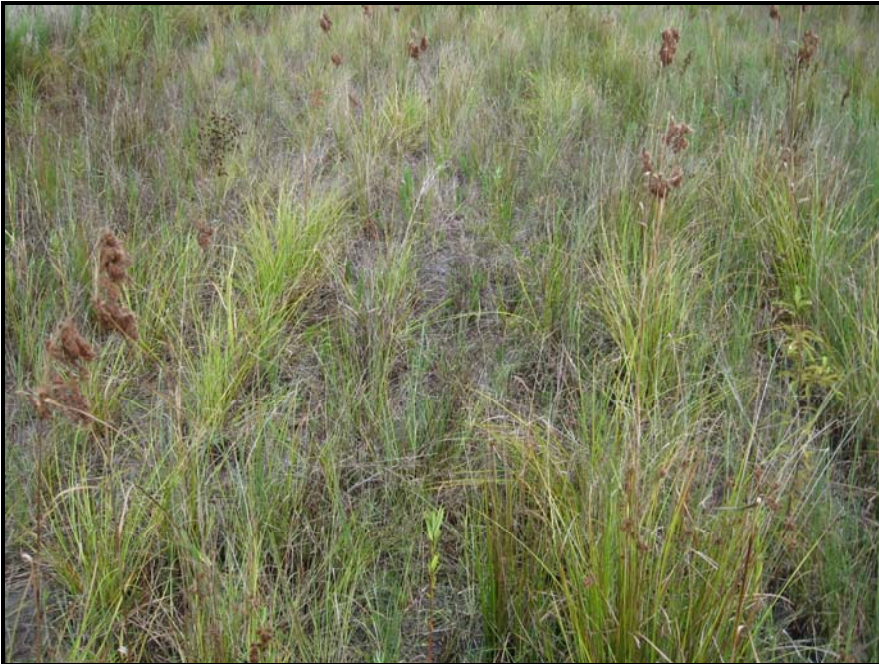
VPA-2
Plot 5

Plot 5, although successful in meeting the 320 stems/acre criterion, experienced significant loss of stems. Twenty of the 42 stems were recorded as missing during the 2007 monitoring event. The bald cypress stems were the only species which survived. All swamp tupelo (8), overcup oak (5), and swamp red bay (7) stems were missing from the plot. Plot 5 is located on the edge of one of the graded southwest to northeast ditches. It appears that low water levels due to drought conditions late in the growing season have enabled all-terrain vehicular (ATV) traffic to travel through this area causing the high stem missing rate. The vehicular traffic through this plot has been resolved by flagging the perimeter and instructing others on-site to avoid this area.

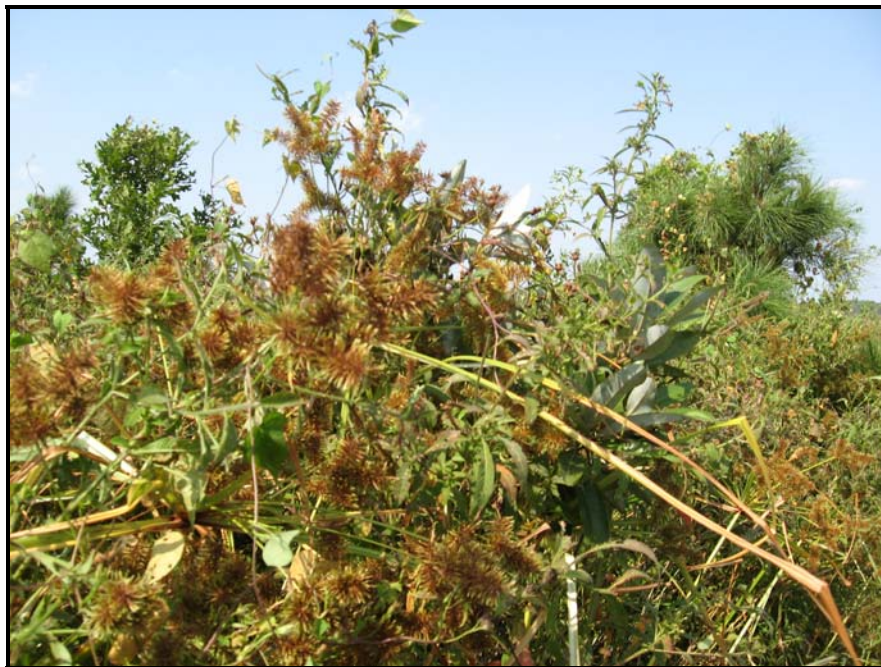
VPA-3
Plot-15

Plots 7, 9, 13, 14, 15, 16, and 19 did not meet the Year 3 success criterion of 320 stems/acre although these plots had 100 percent survival rates. The baseline stem counts for these plots during the 2006 monitoring event indicate these plots cannot meet the success criteria for monitoring years three and four even with a 100 percent stem survival rate. This is potentially due to the lack of uniform planting rates lower than the success criterion as evidenced by the lack of damaged or dead stems. Plots 9, 15, and 19 cannot meet the Year 5 survival criterion of 260 stems/acres with 100 percent stem survival rates.

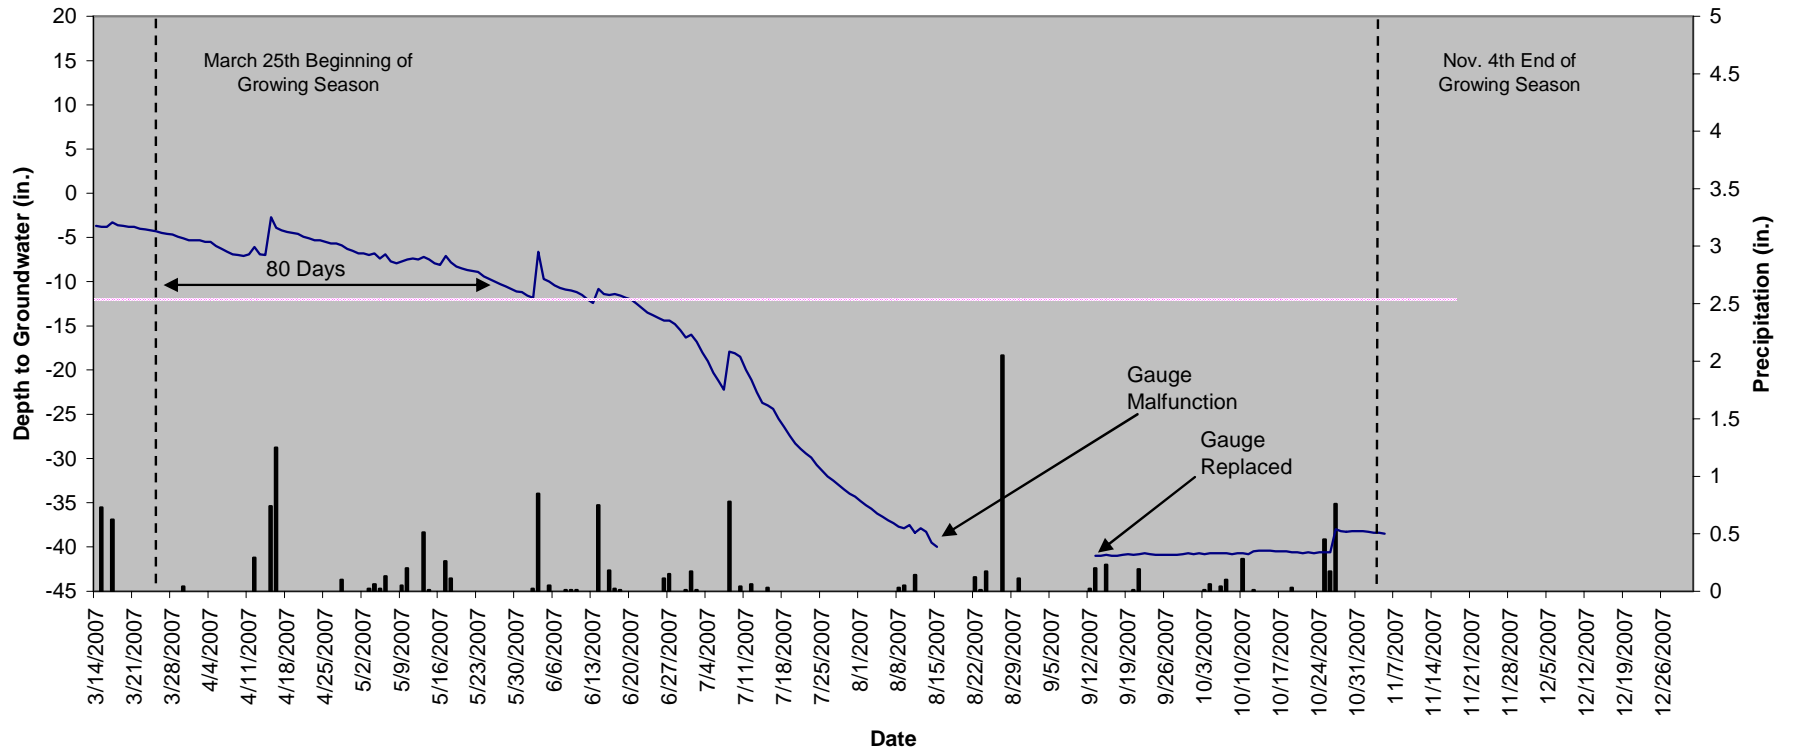
**Juniper Bay
1
40" Groundwater**

Gauges GW-1, GW-20, and GW-43 malfunctioned for short periods of the growing season and were replaced. These three gauges met the hydrologic success criterion regardless of the periods of missing data. The missing data for Gauges GW-1 and GW-20 does not affect the longest consecutive hydroperiod. Gauge GW-43 recorded 60 consecutive days of jurisdictional hydrology with one data gap. Using adjacent data points to extrapolate missing data, it can be assumed that Gauge GW-43 would have made jurisdictional hydrology for 57.3% of the growing season.

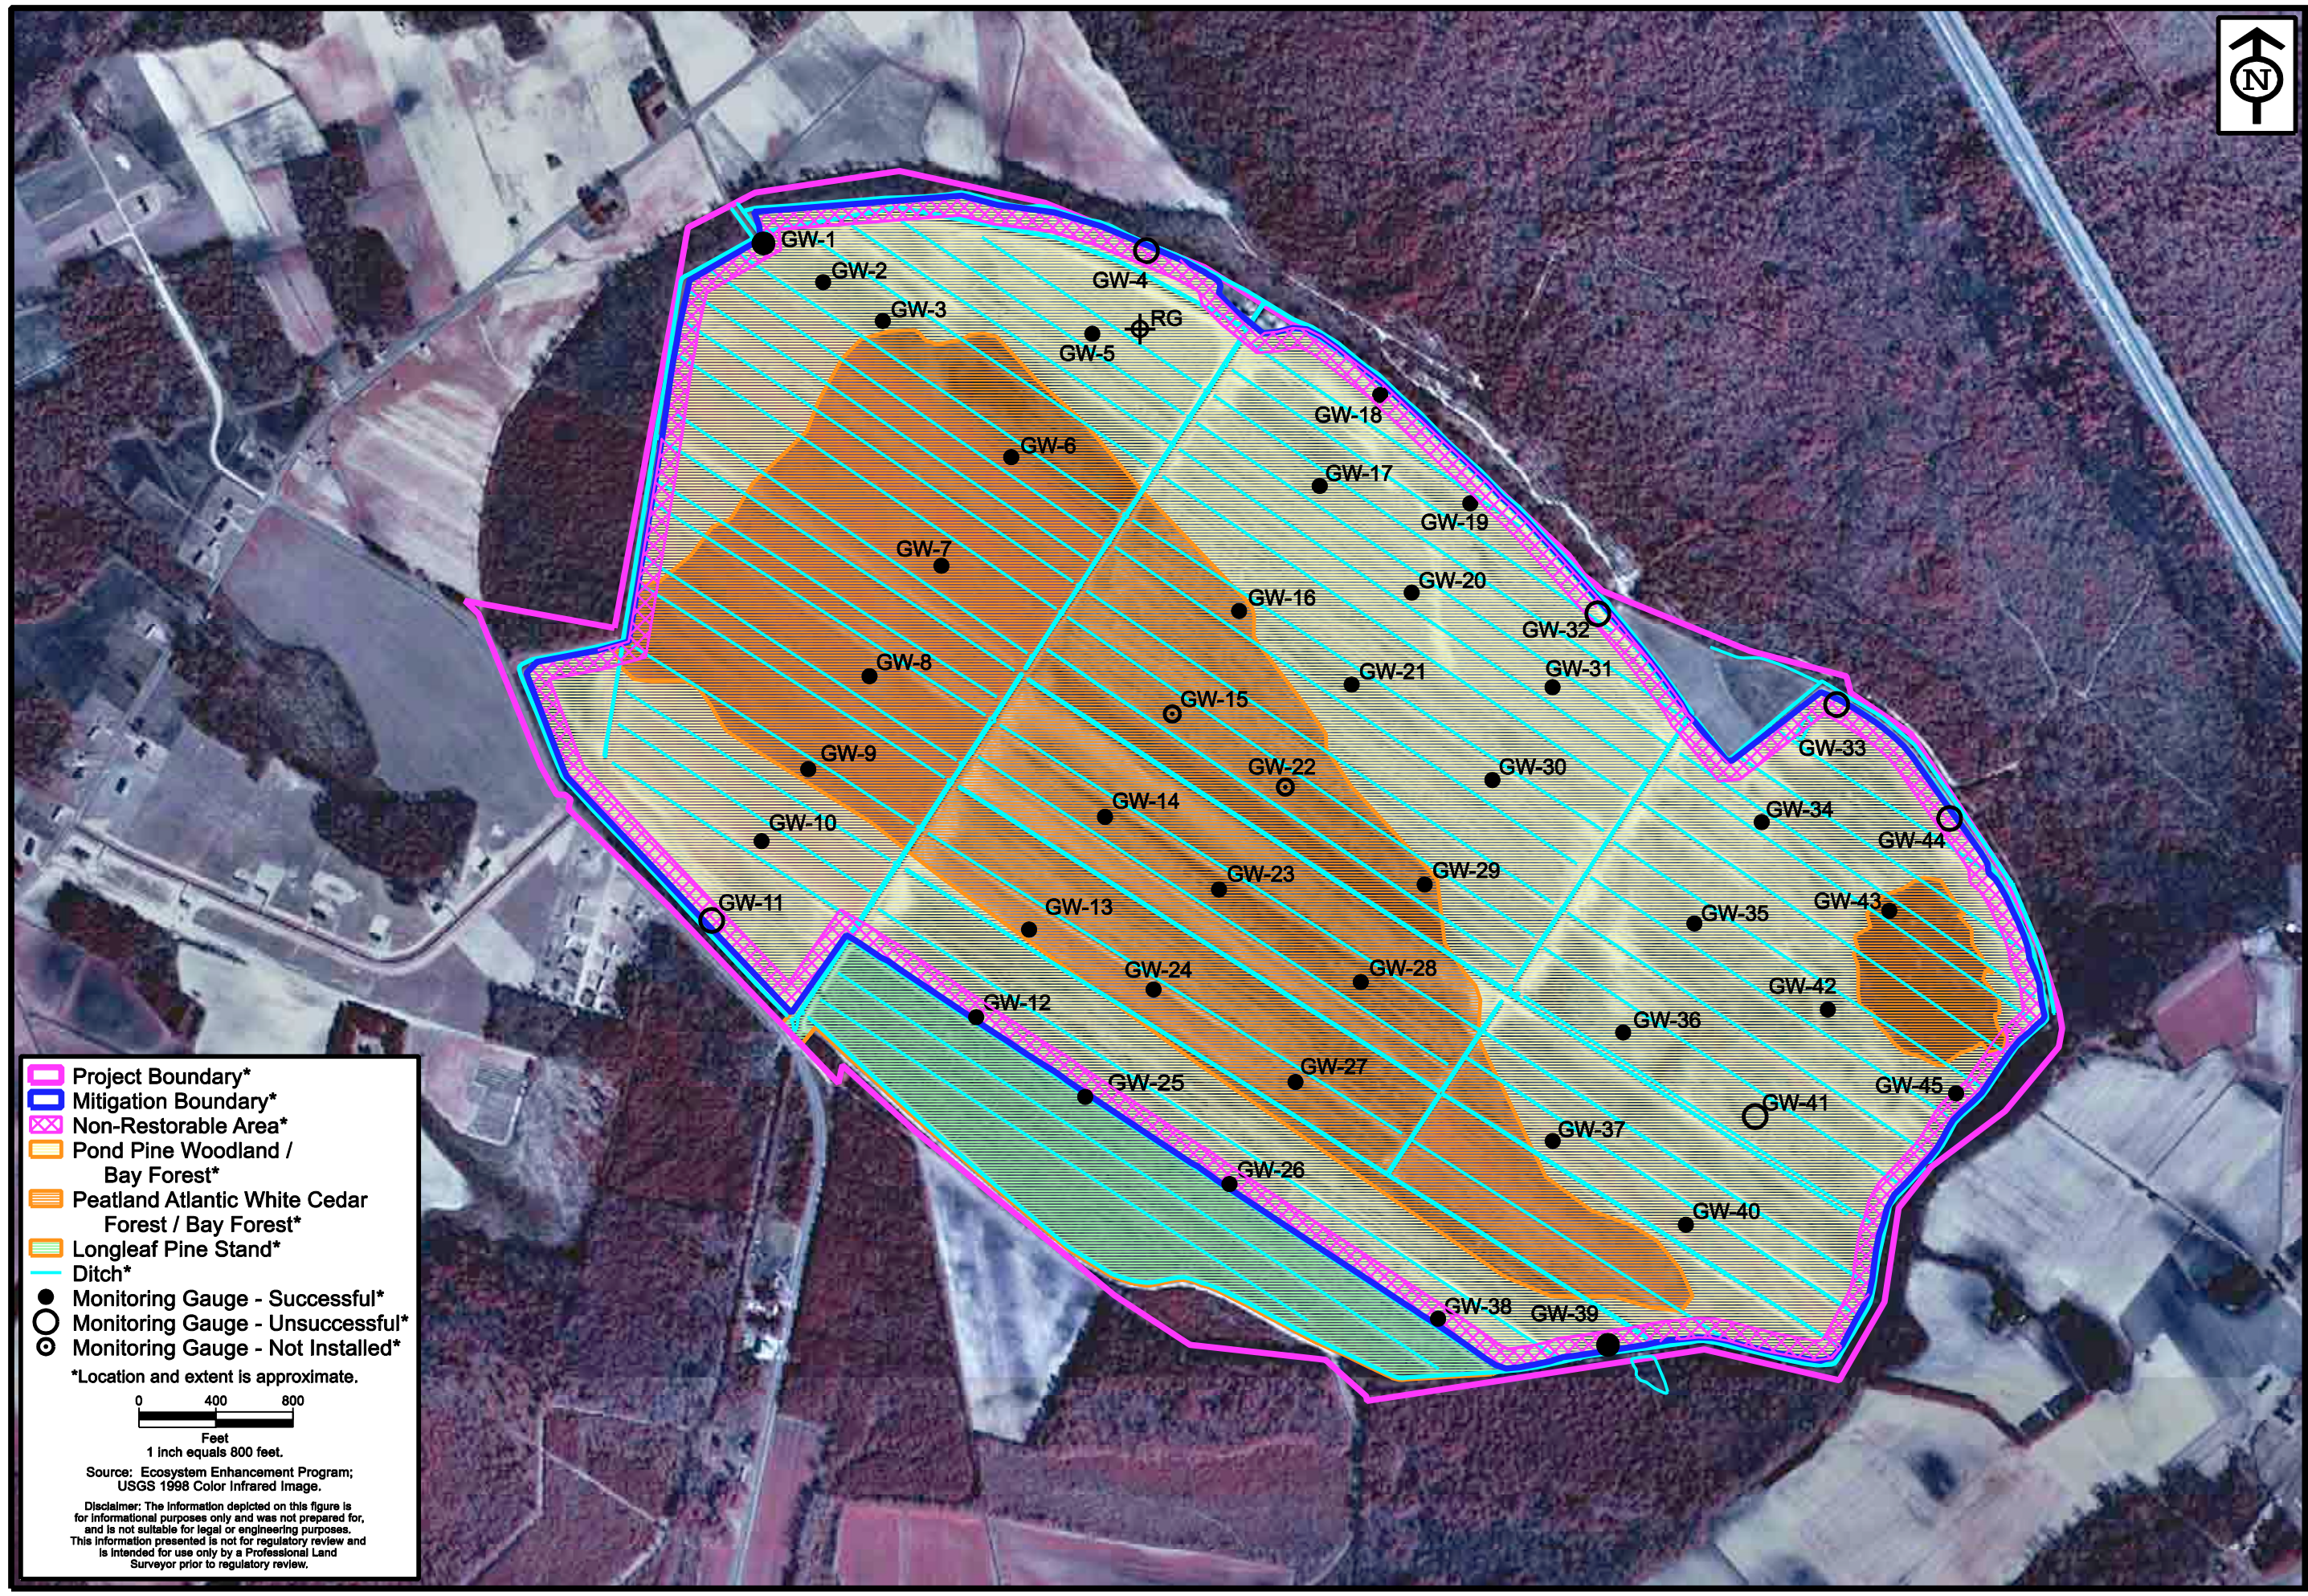
During the 2007 monitoring period, 37 of the 43 monitoring gauges met the hydrology success criteria (Table VI.), an 86.0% success rate. However, based on the JBMS Mitigation Plan, there are 13 gauges located adjacent to the perimeter ditch that area not expected to be restored to jurisdictional status. Eight of the 13 perimeter gauges met jurisdictional hydrology. Of the remaining 30 interior gauges, 29 met the hydrology success criterion, a 96.7% success rate. Hydrographs for the individual monitoring gauges can be found in Appendix B.
