**Juniper Bay Wetland Mitigation Site
Robeson County, NC**

**2008 Annual Monitoring Report
Year 3 of 5**

NCEEP Project Number 201

Date: February 2009

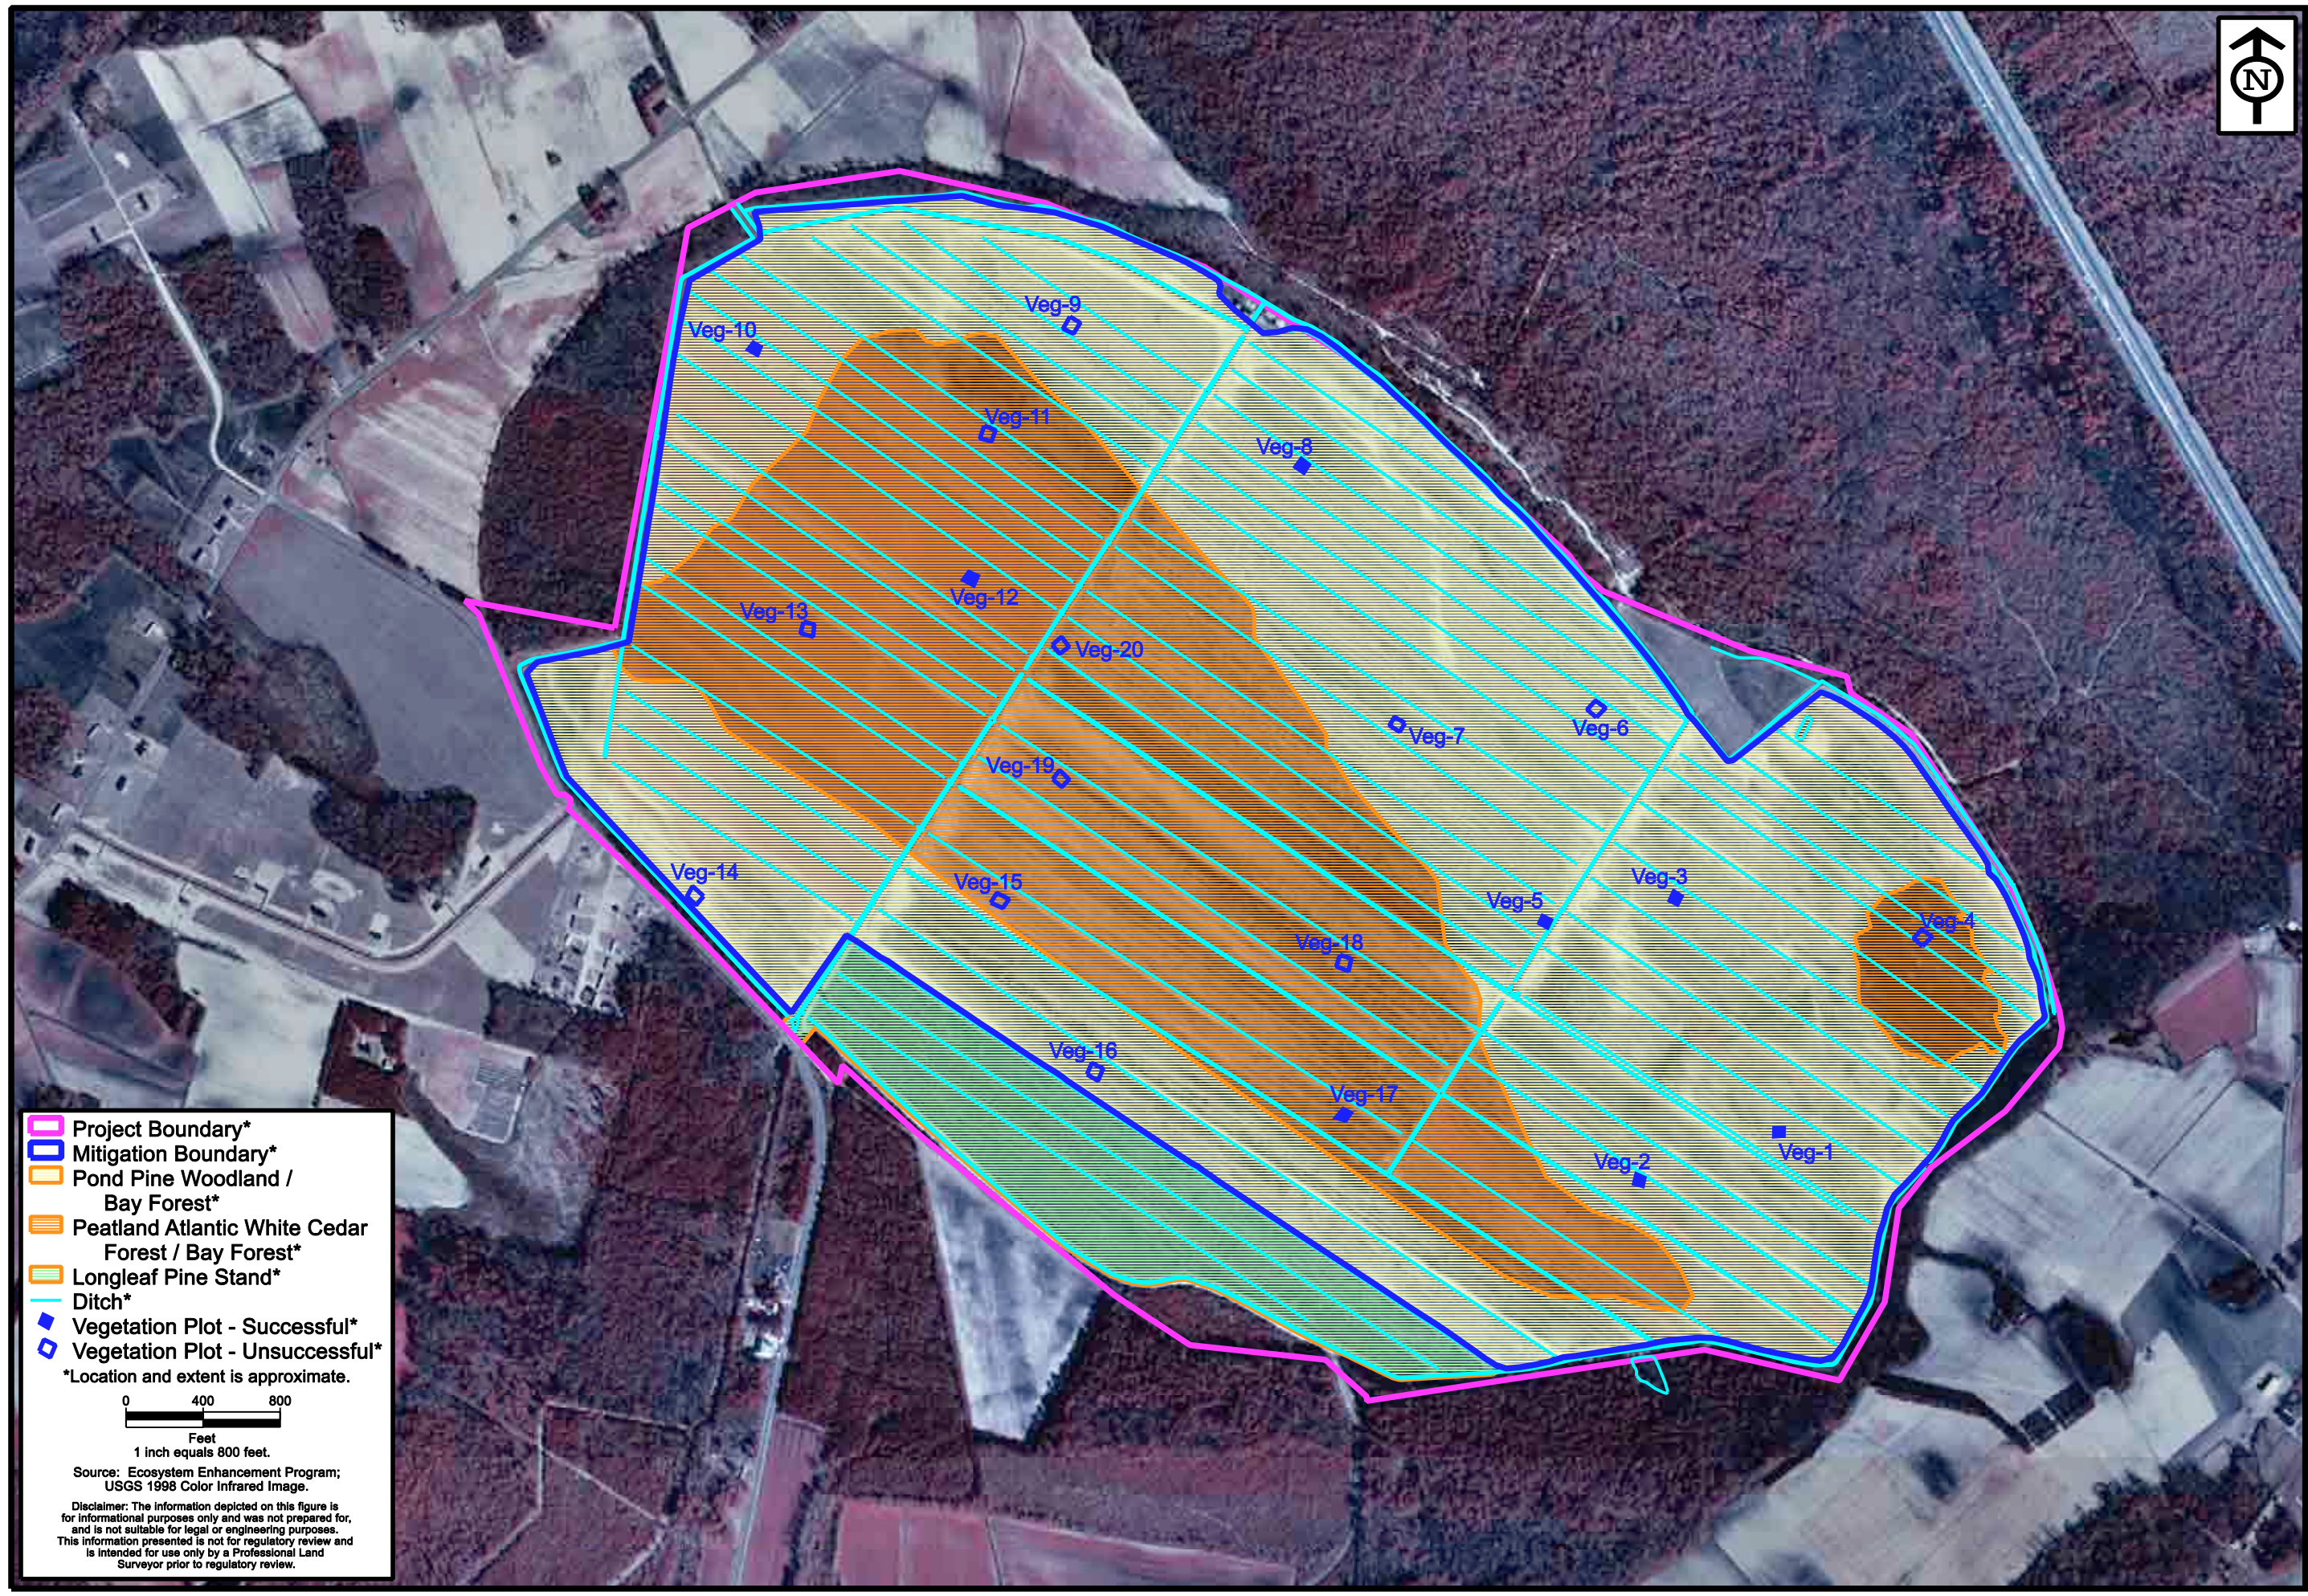
Project: ER07008.00
 Date: Nov 2008
 Drwn/Chkd: KT/GT
 Figure: 3a

Figure 3A in Appendix A provides an overview of all vegetative plot results with regard to the scale and layout of the entire project. Figure 3B in Appendix A provides an overview of the planting plan with regard to the scale and layout of the entire project.

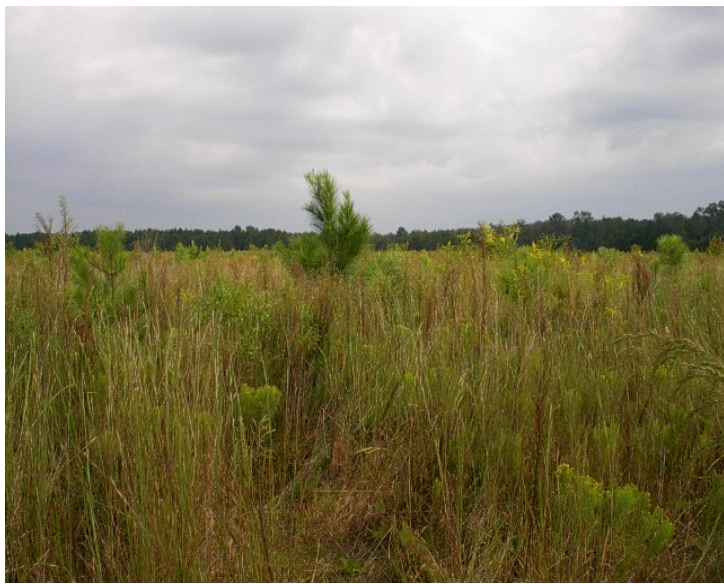
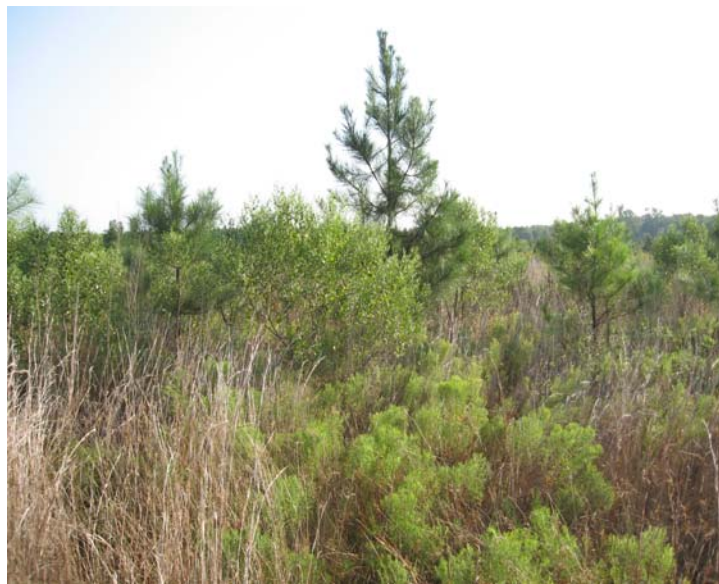
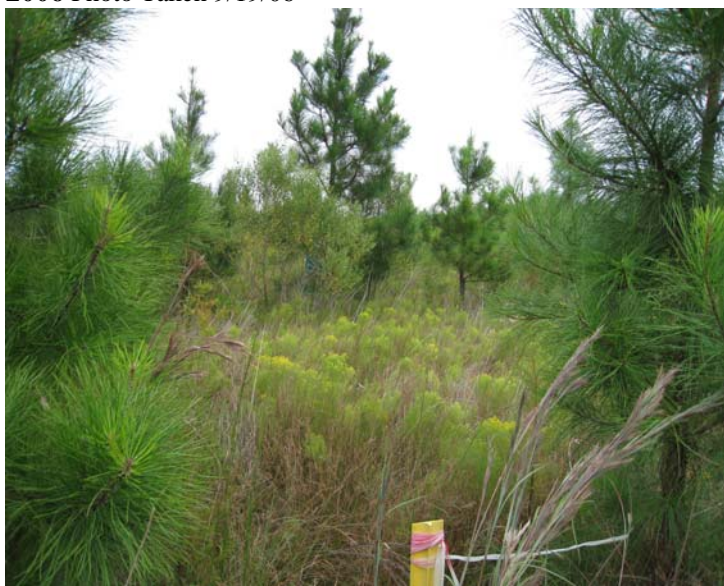
PLOT 1

The stress from the drought conditions late in the growing season of 2007 may have contributed to sapling deaths in Plots 1 and 6. Each plot experienced one stem death and there were no other discernable causes. Plot 1 met the 320 stems/acre criterion, but Plot 6 did not.

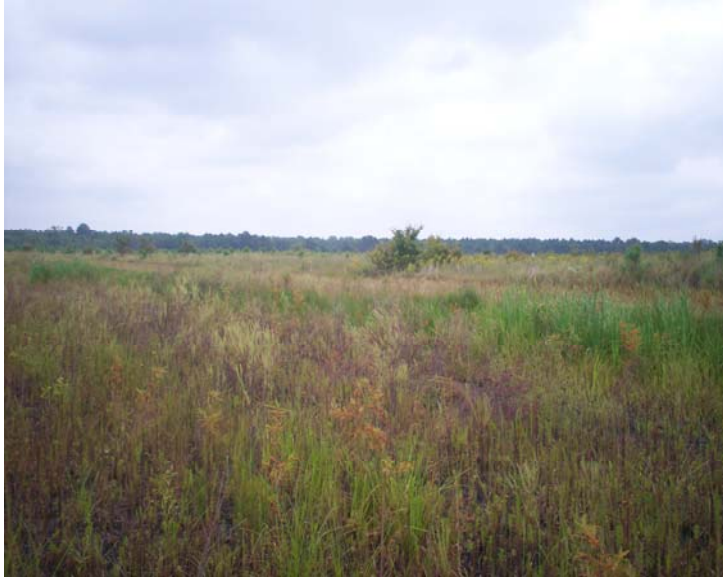
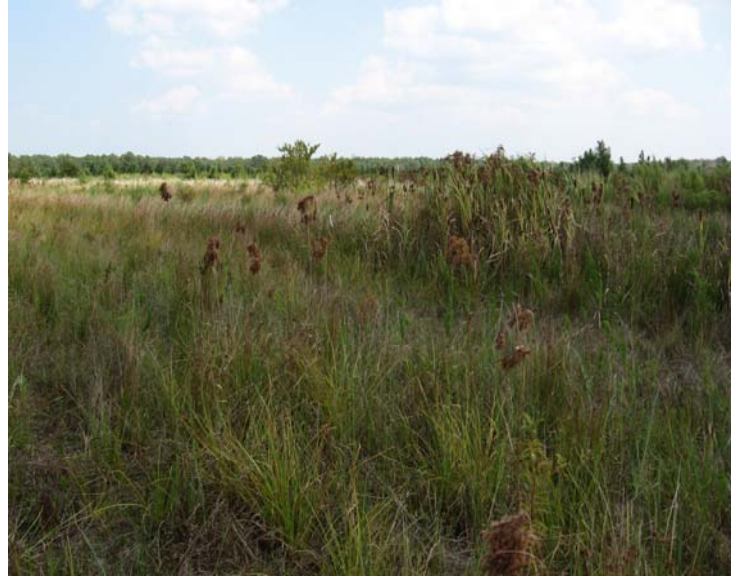
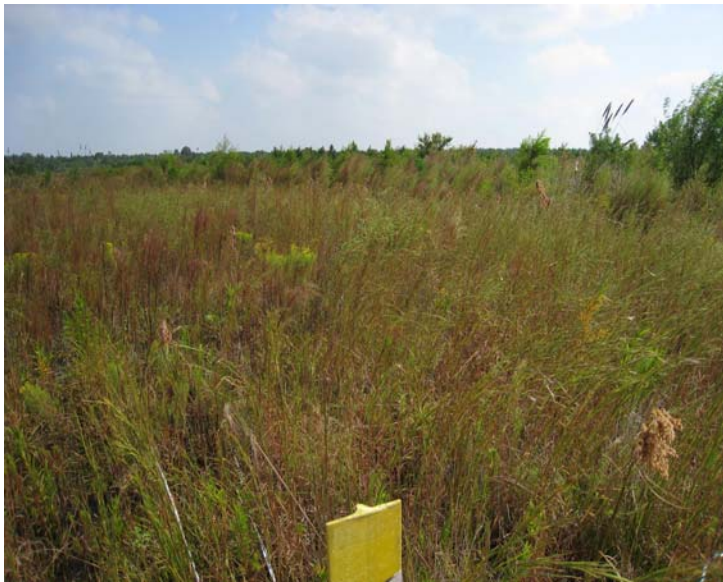
PLOT 5

Plot 5, although successful in meeting the 320 stems/acre criterion, experienced a significant loss of stems. Twenty of the 42 stems were recorded as missing during the 2007 monitoring event. The 20 stems were updated to dead status during the 2008 monitoring event. The bald cypress stems are the only species which have survived in this plot. The swamp tupelo (8), overcup oak (5), and swamp red bay (7) stems did not survive in this plot. Plot 5 is located on the edge of one of the graded southwest to northeast ditches. It appears that low water levels due to drought conditions late in the growing season of 2007 allowed vehicular traffic to travel through this area potentially contributing to the high stem mortality rate. The vehicular traffic issue through this plot was resolved prior to the 2008 growing season with perimeter flagging and instructions to others on-site to avoid this area. The remaining bald cypress stems survived the 2008 growing season with the majority in good condition.

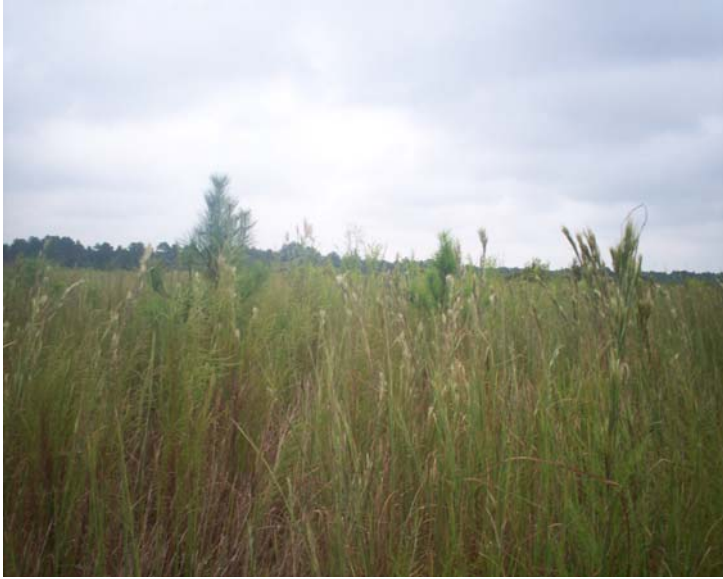
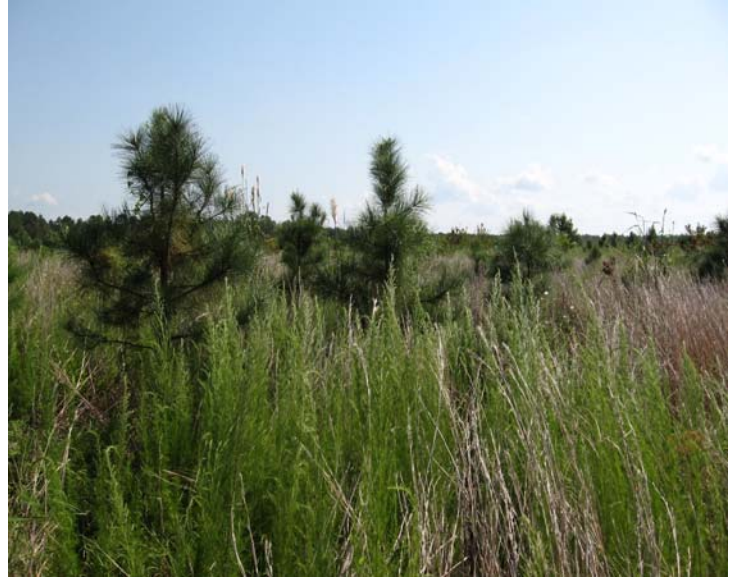
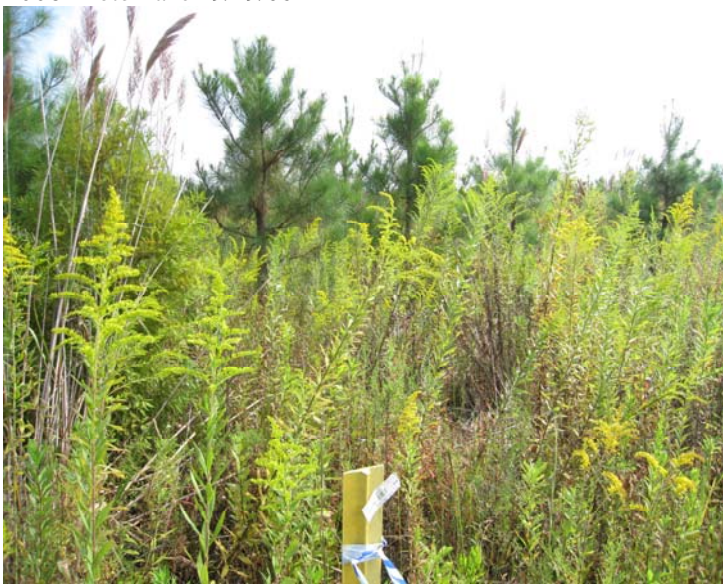
PLOT 7

Plots 7, 9, 13, 14, 16, and 19 did not meet the Year 3 success criterion of 320 stems/acre. However, these plots had 100 percent survival rates for the Year 3 monitoring event. These plots would not have met the success criteria for monitoring years three and four even with a 100 percent stem survival rate from the baseline stem counts. This demonstrates the initial planting rates were too low from the beginning as evidenced by the lack of damaged or dead stems. Plots 9 and 19 cannot meet the Year 5 survival criterion of 260 stems/acres with 100 percent stem survival rates.

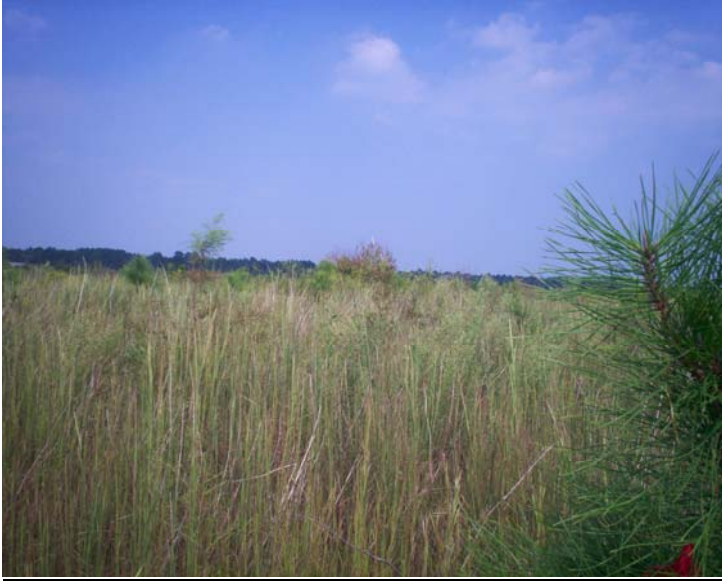
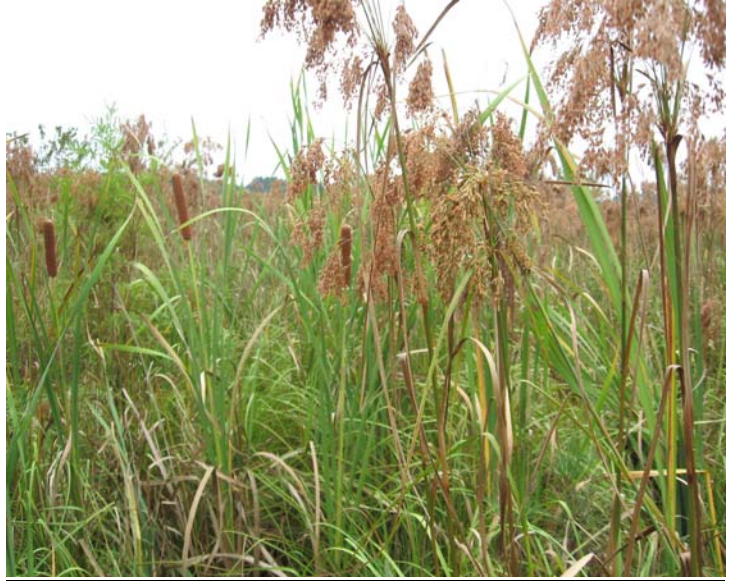
PLOT 11

Plot 11 and Plot 12 each had one dead stem during the 2008 monitoring event. These two plots experience consistent high water levels due to their location in the center of the site. Water levels during the 2008 growing season were significantly higher than in 2007, a year which experienced significant drought conditions late in the growing season. This transition between drought conditions late in 2007 and high water levels early in 2008 may have contributed to the sapling death.

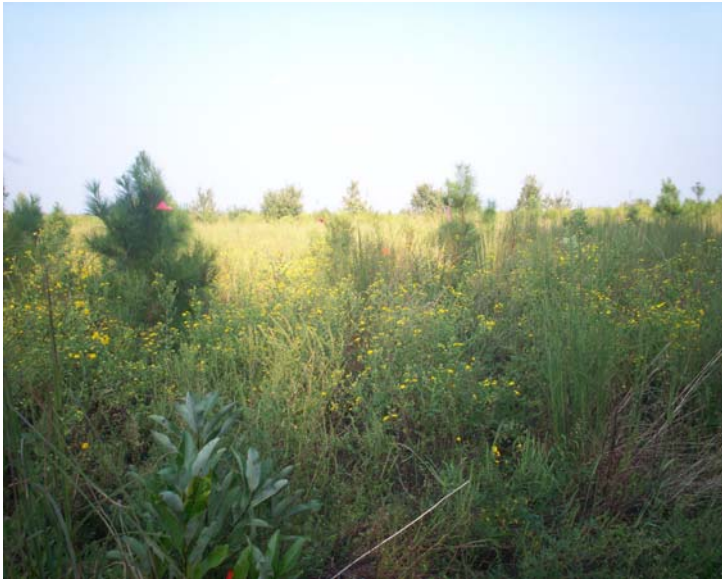
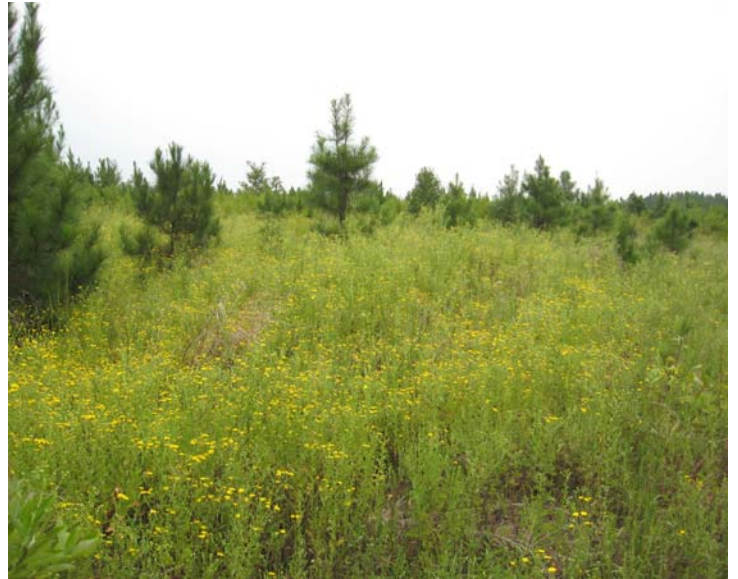
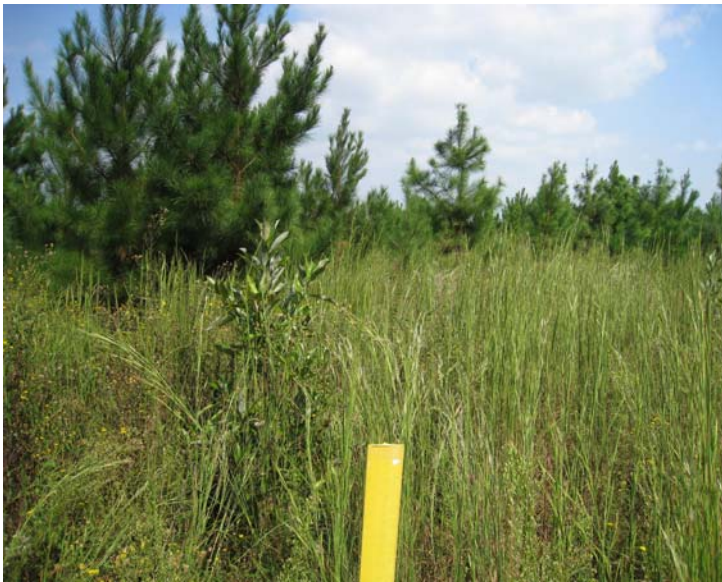
PLOT 15

Herbaceous competition and vine strangulation in Plots 12 and 15 were noted as potential issues during the 2007 monitoring event. Climbing hempweed (*Mikania scandens*) had blanketed areas of these plots. However, it appears the higher water levels early in the 2008 growing season may have inhibited the climbing hempweed's growth significantly. The climbing hempweed is still present in these plots, although vine strangulation was not evident. Therefore these plots should continue to be monitored for this issue throughout the 2009 monitoring season. Plot 15 did have one stem death due to beaver.

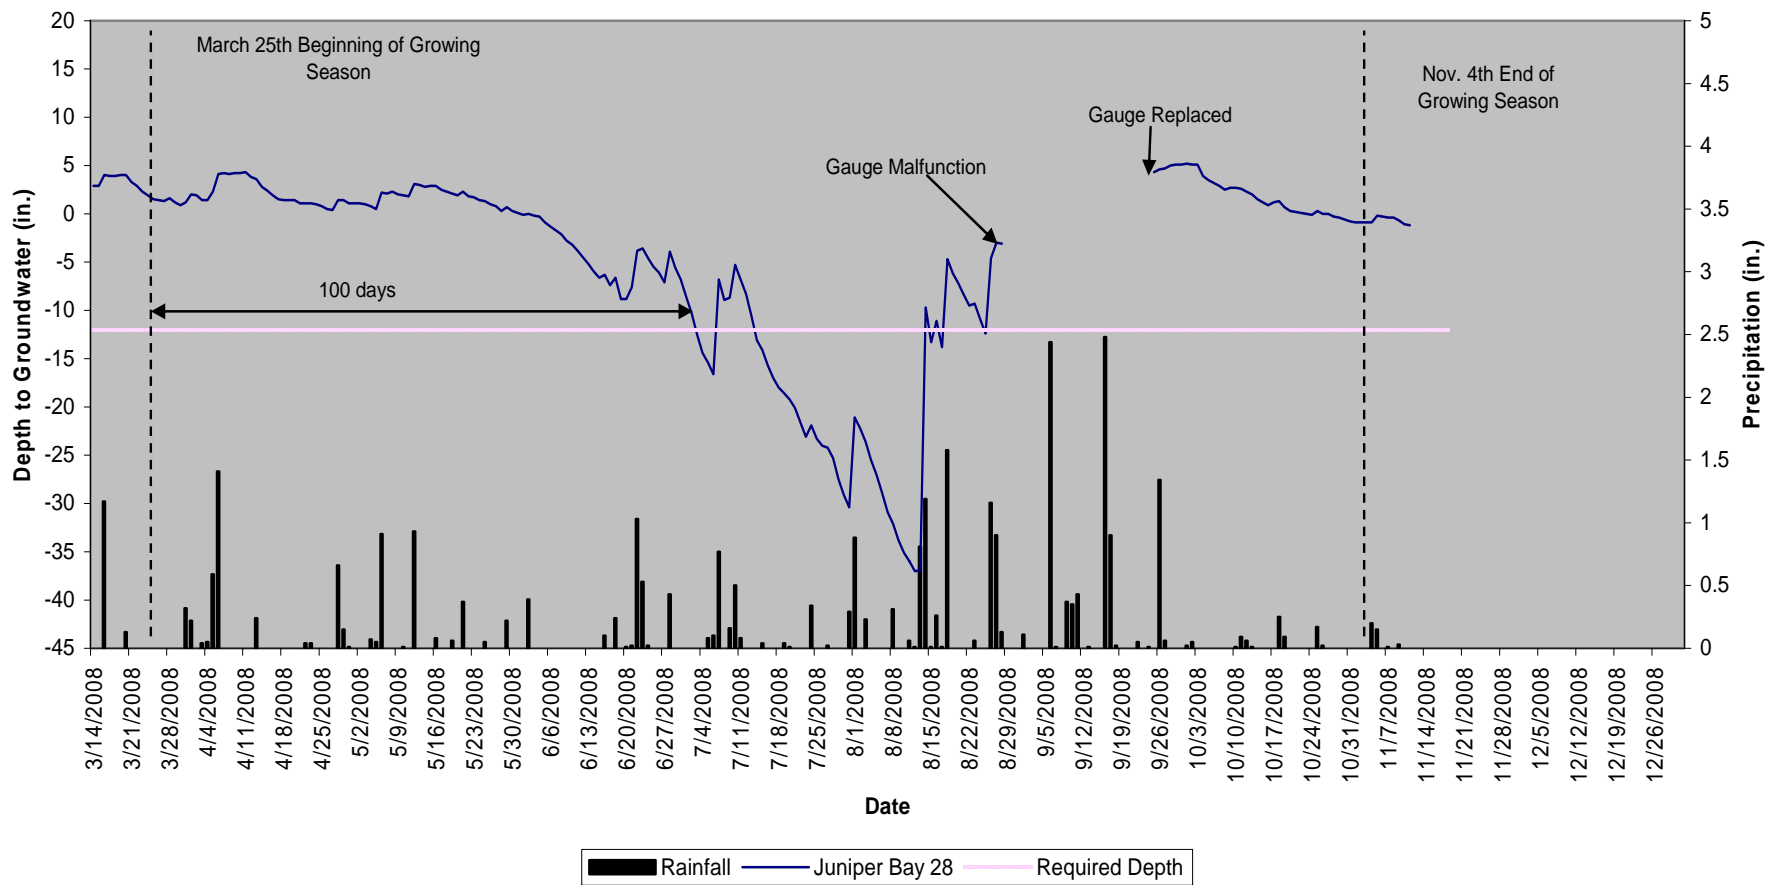
**Juniper Bay
28
40" Groundwater**

Gauges GW-3, GW-11, GW-12, GW-28, GW-33, and GW-42 malfunctioned for short periods of the growing season and were replaced. Gauges GW-3, GW-28, and GW-42 met the hydrologic success criterion regardless of the periods of missing data. The missing data for GW-42 did not affect the longest consecutive hydroperiod. Gauges GW-11 and GW-33 did not meet the hydrologic success criterion. The missing data from GW-11 and GW-33 was extrapolated by examining the periods before and after the missing data along with the hydrologic data of the gauges adjacent to the malfunctioning gauges. Using this extrapolated data, it can be assumed that GW-11 and GW-33 would not have met the hydrologic success criterion. GW-3 recorded 72 consecutive days of jurisdictional hydrology after one initial data gap. Using adjacent data points to extrapolate missing data, it can be assumed that GW-3 would have met the jurisdictional hydrology criterion for 79 consecutive days or 35.1% of the growing season. Gauge GW-12 recorded 12 consecutive days of jurisdictional hydrology after one data gap. Using adjacent data points to extrapolate the missing data, it can be assumed that GW-12 would have made jurisdictional hydrology for 30 consecutive days or 13.3% of the growing season.
