**Kentwood Park (Bushy Branch) Stream
Restoration Monitoring Report
EEP Project # 205
Monitoring Year – 01
2005**

Appendix A2: Vegetative Problem Area Plan View
 Kentwood Park, Wake County, EEP Project Number 205 - MY01

Appendix B1: Stream Problem Area Plan View
 Kentwood Park, Wake County, EEP Project Number 205 - MY01

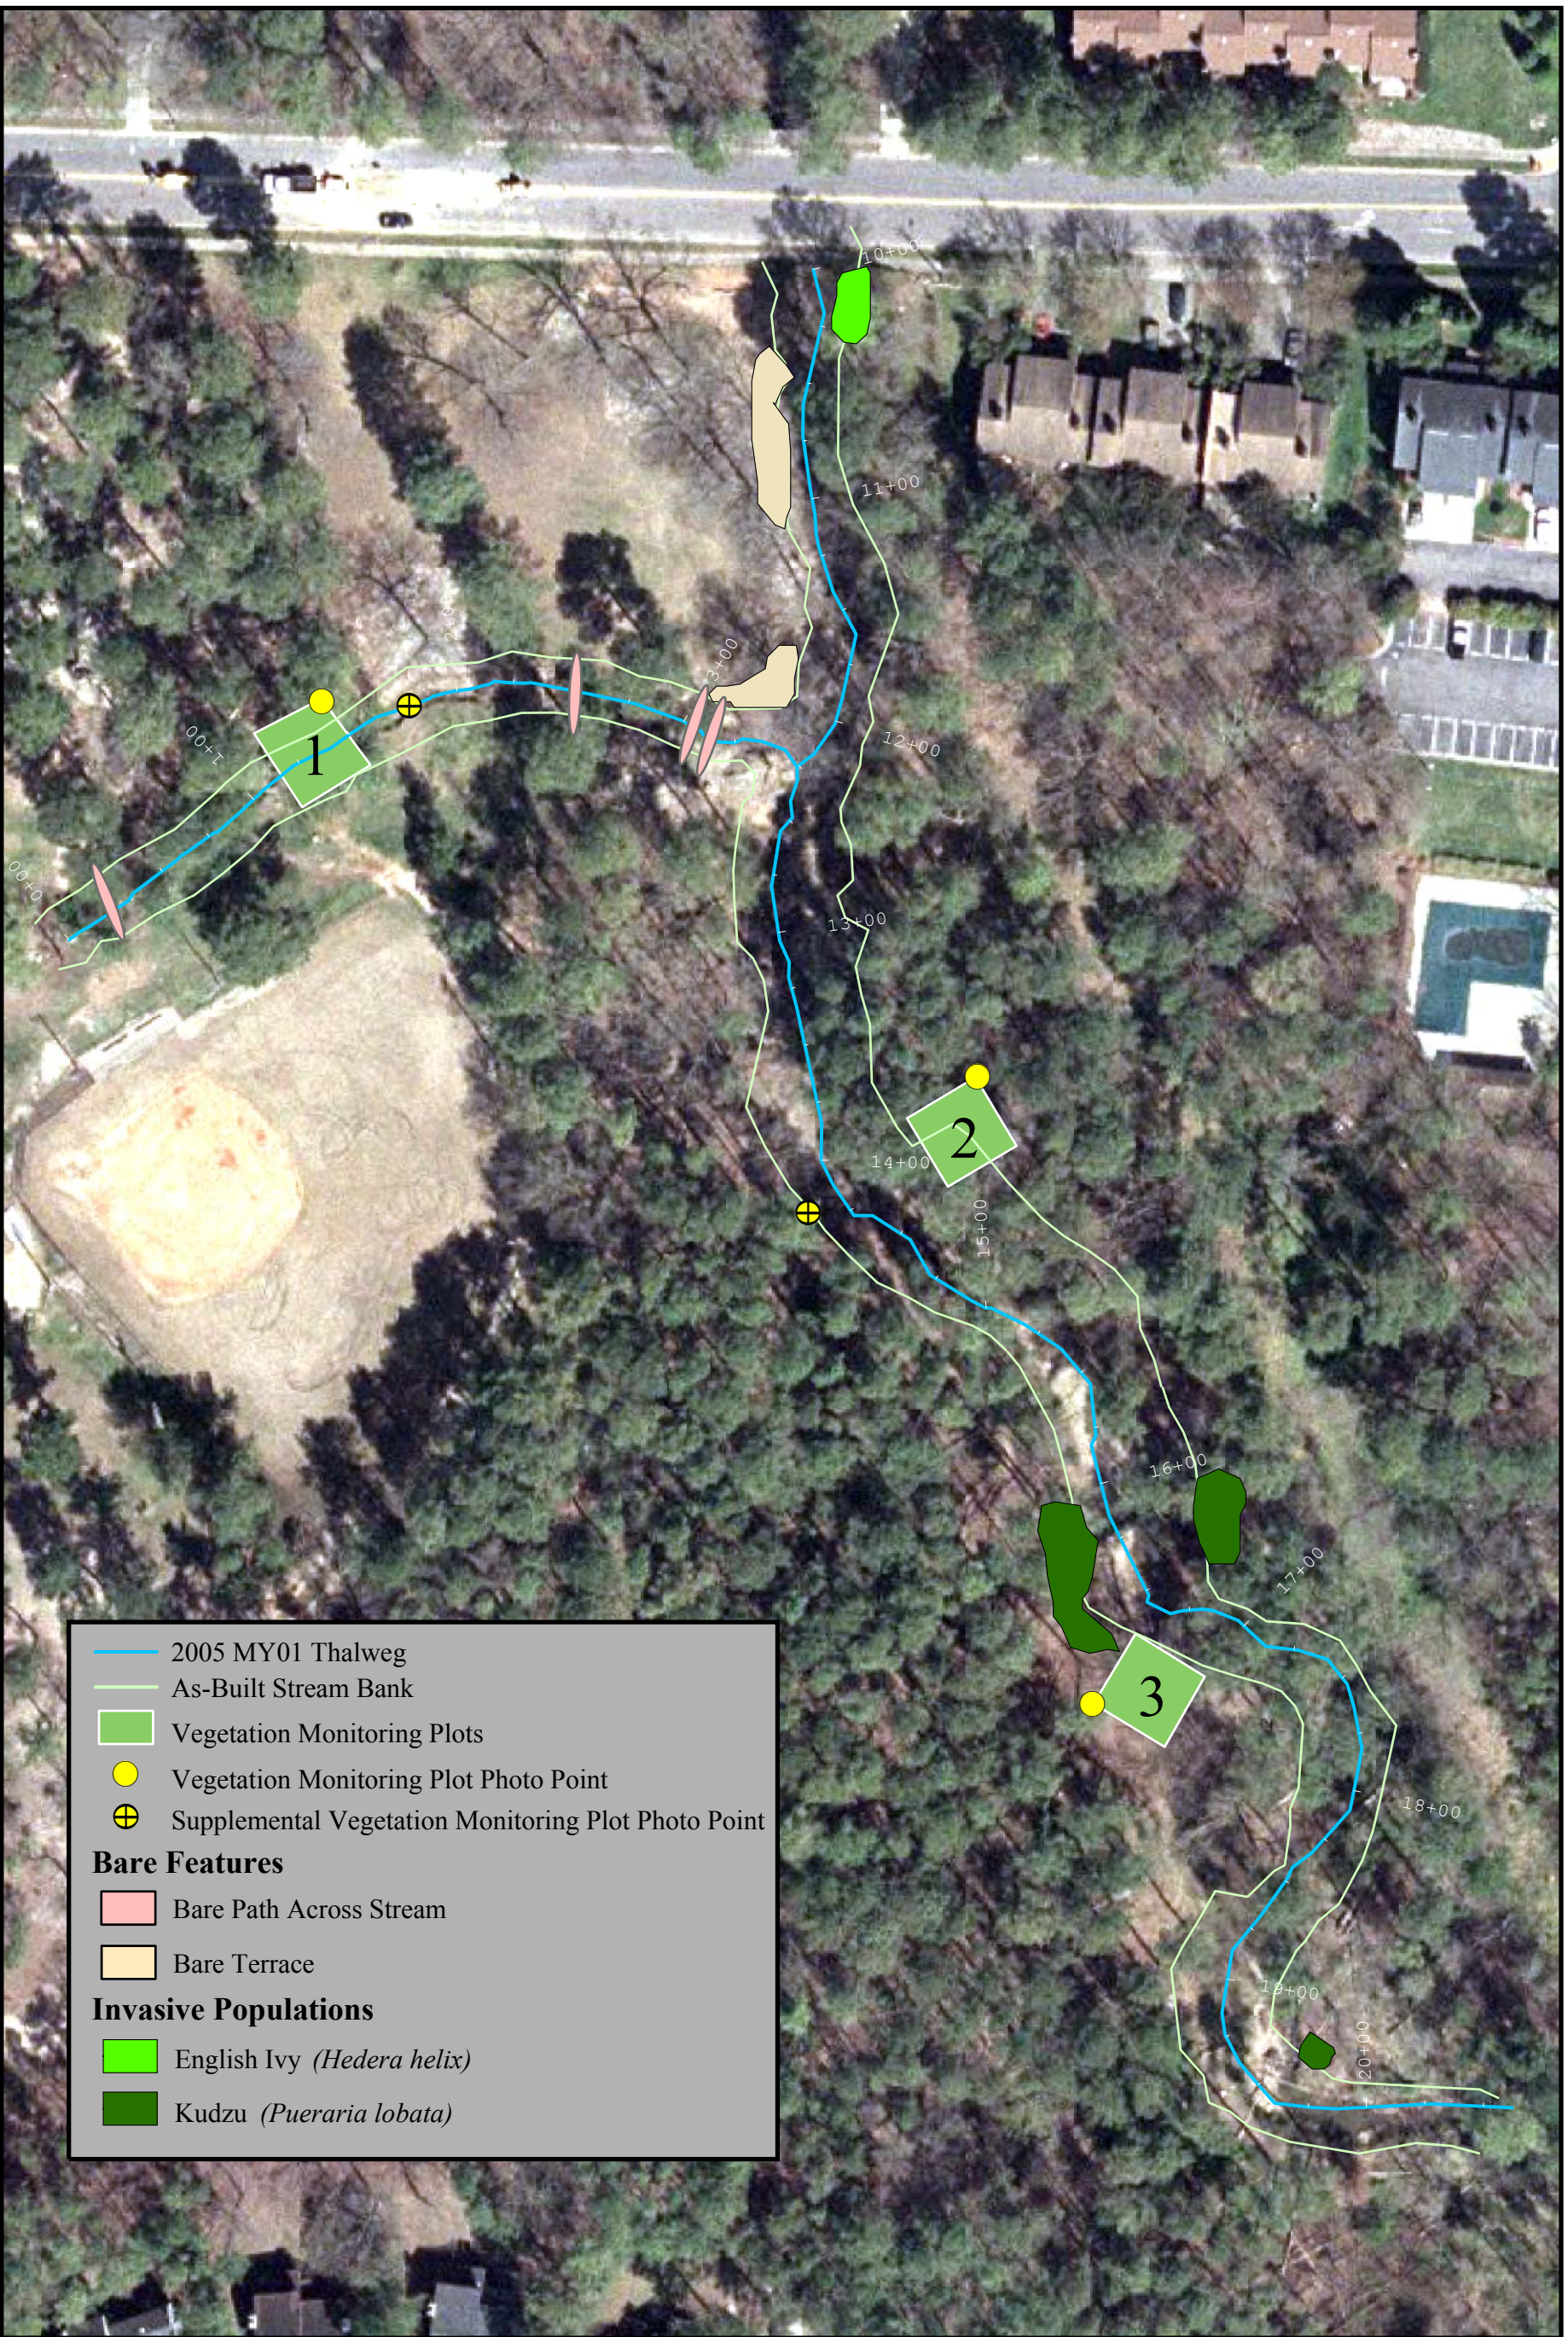
Date: 12-29-05
 Note: Area of invasive populations and bare terraces estimated from visual field inspections. Stream banks adjusted to accommodate discrepancies between as-built and monitoring year 01 surveys.
 Source: USGS High Resolution Orthoimage, Raleigh-Durham, NC, 2003.

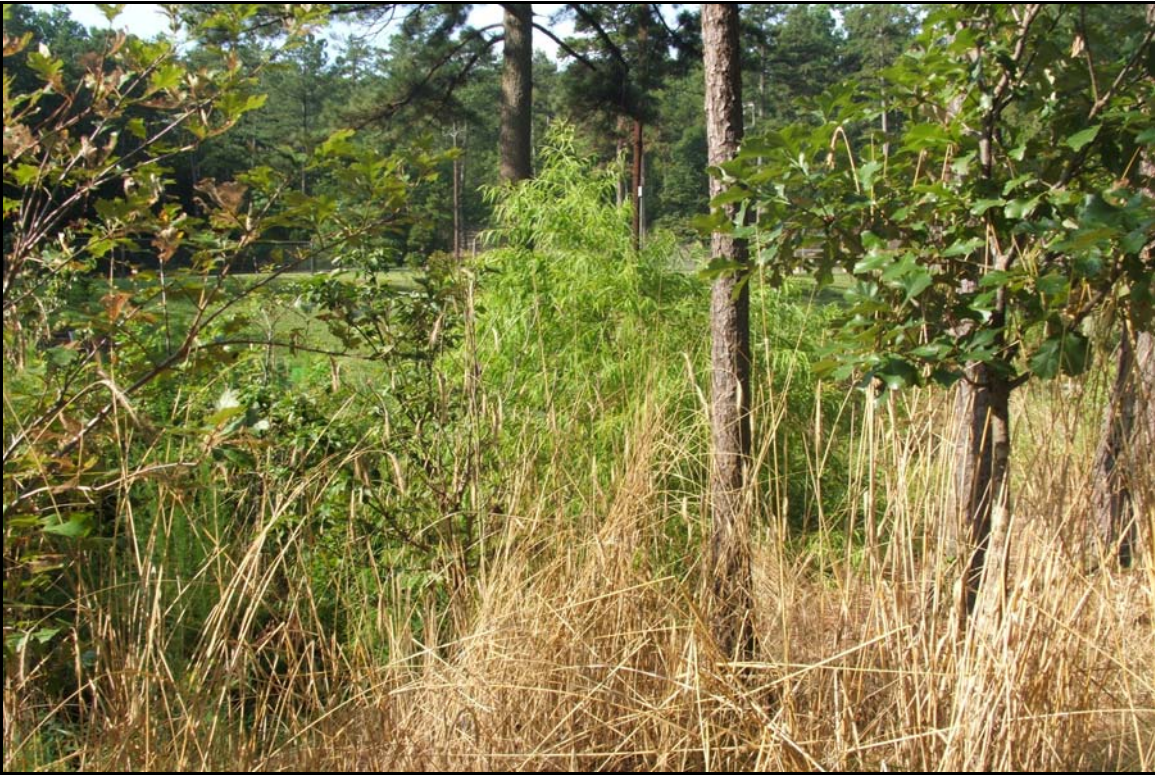
Plot 1 Photo – Taken looking south from the north corner. 7/20/05 - MY 01.

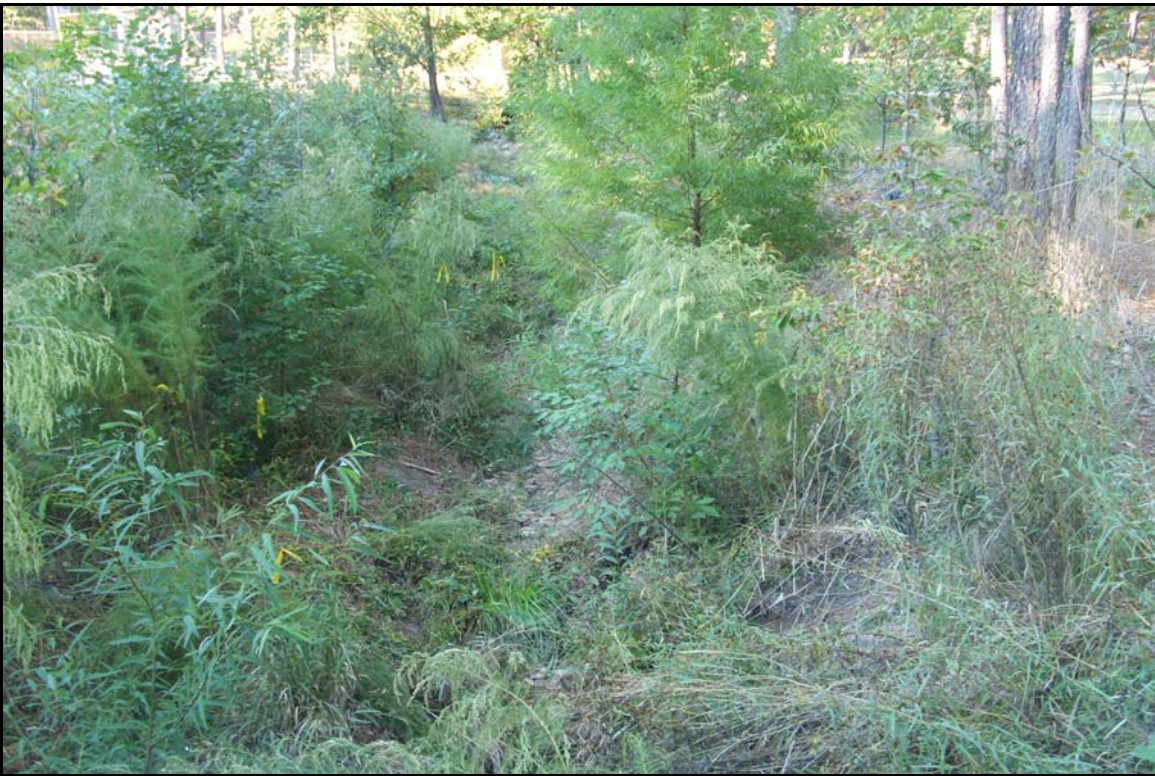
Plot 1 Supplemental Photo – Taken looking upstream towards the center of the plot from established photo station #3. 10/27/05 - MY 01.

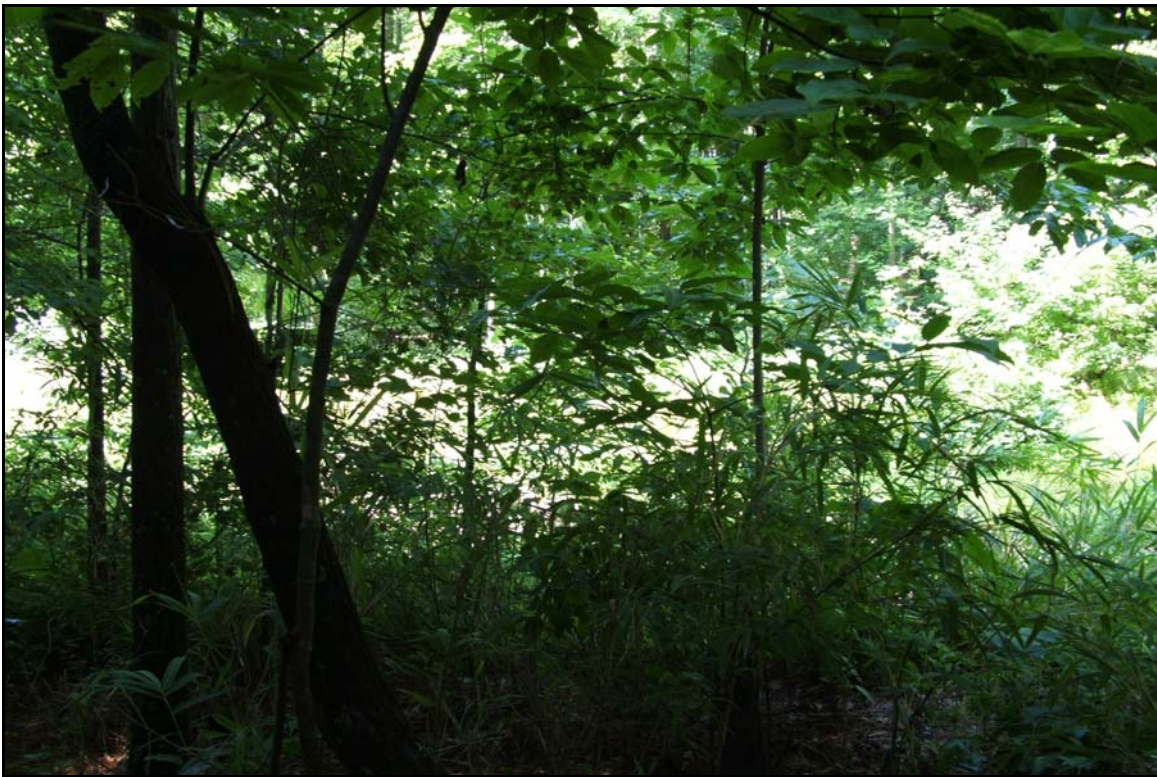
- The majority of the *Ilex verticillata*, *Sambucus canadensis*, *Cornus amomum*, *Platanus occidentalis*, and *Alnus serrulata* mortality can be attributed to the low survival rate of these species in vegetation plot 2. Since much of plot 2 is located on a bankfull bench; subject to frequent storm discharges, this part of the plot is subjected to large flows, which may cause some of the plantings to become uprooted and flow downstream.

Plot 2 Photo – Taken looking south from the north corner. 7/20/05 - MY 01.

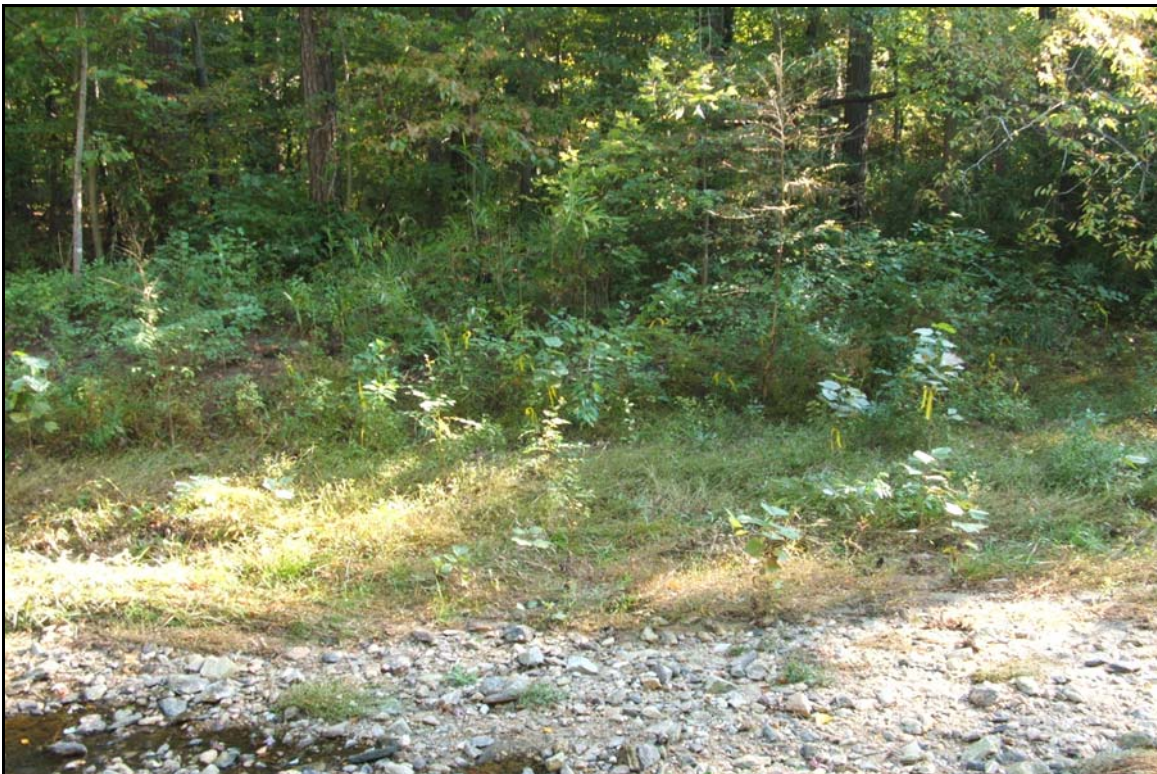
Plot 2 Supplemental Photo – Taken looking at center of plot from the top of the right bank across the stream from the veg plot. 10/27/05 - MY 01.

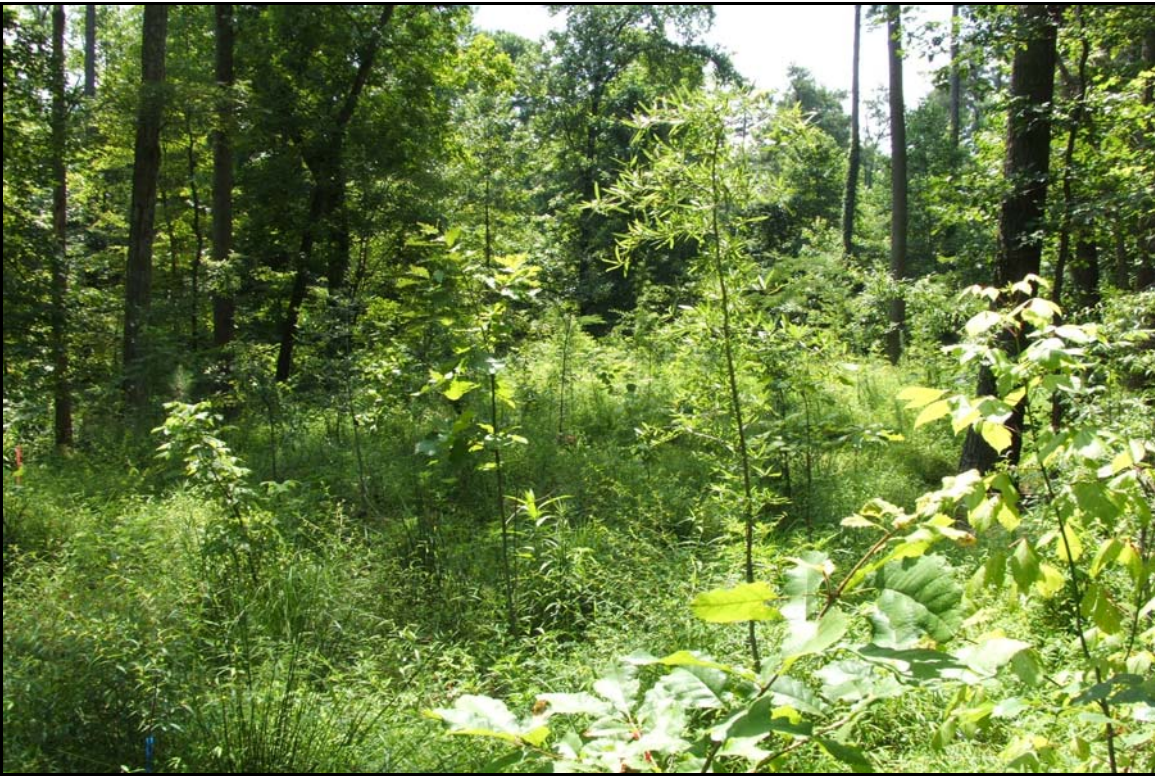
- In plot 3, there were two *Liriodendron tulipifera* trees that were standing dead with no obvious causes of the mortality. In this case it is assumed that these trees did not survive the planting process.

Plot 3 Photo – Taken looking east from the west corner. 7/20/05 - MY 01.

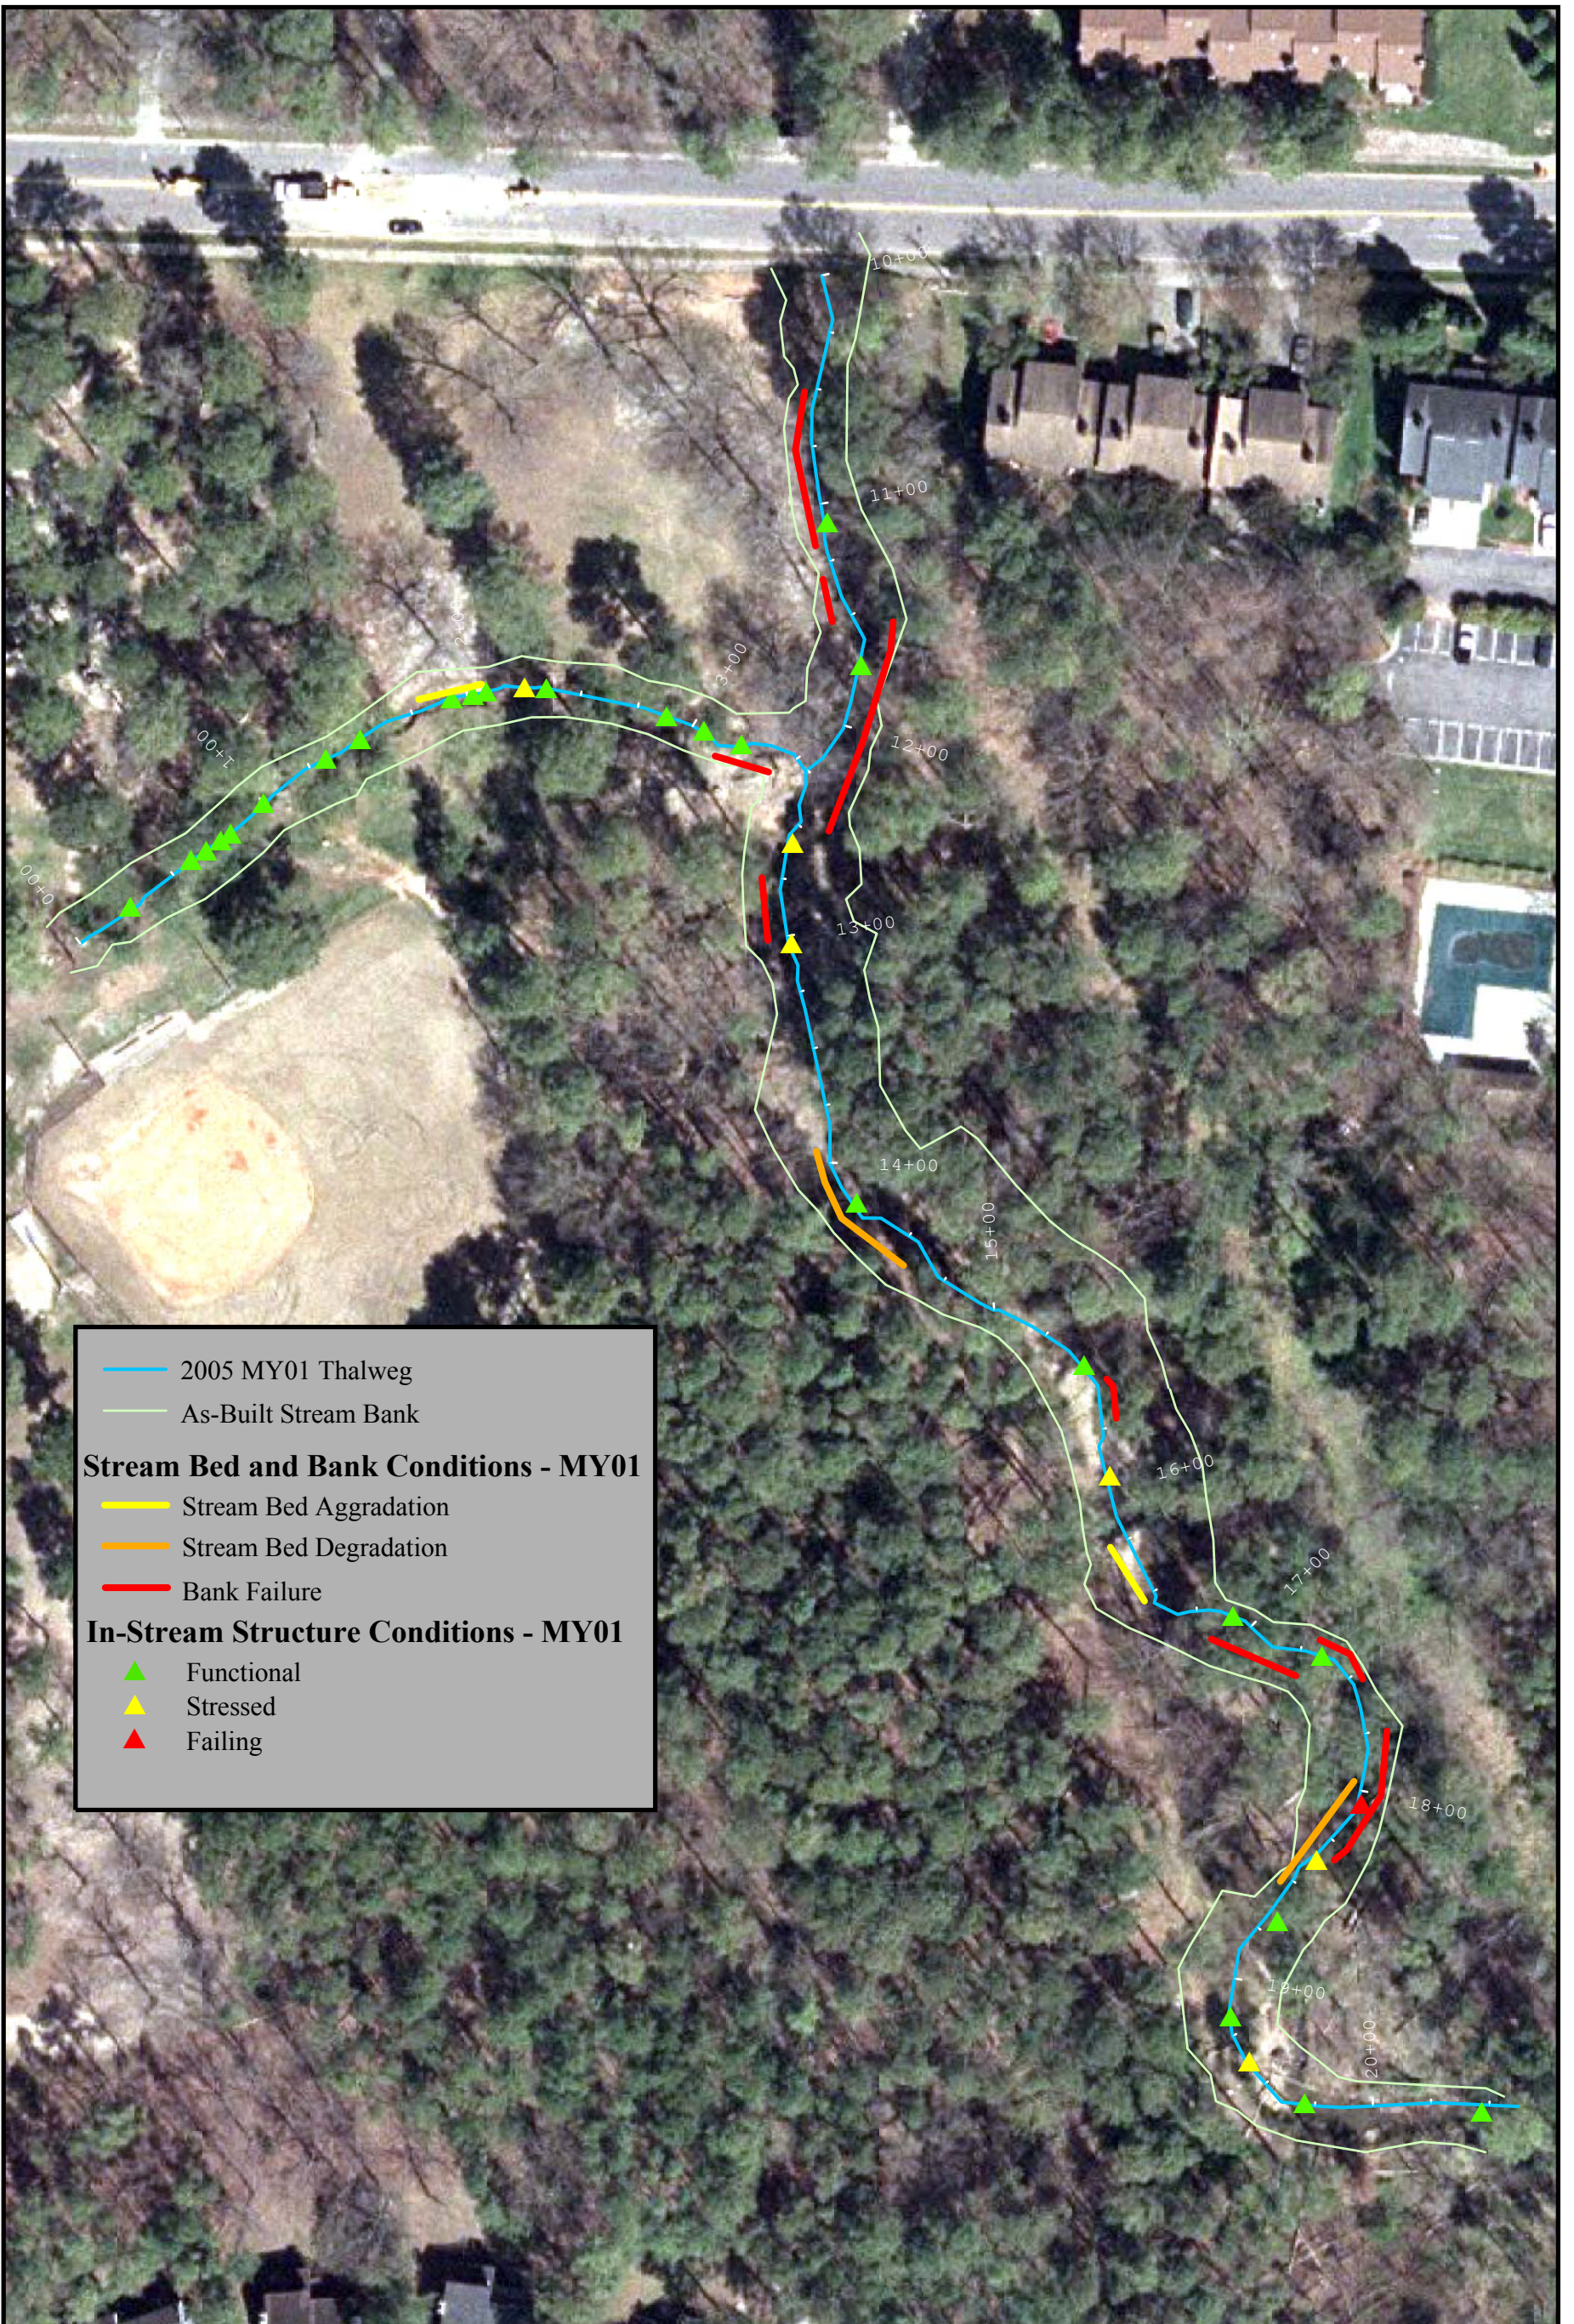
2005 MY01 Thalweg
	As-Built Stream Bank
Stream Bed and Bank Conditions - MY01	
	Stream Bed Aggradation
	Stream Bed Degradation
	Bank Failure
In-Stream Structure Conditions - MY01	
	Functional
	Stressed
	Failing

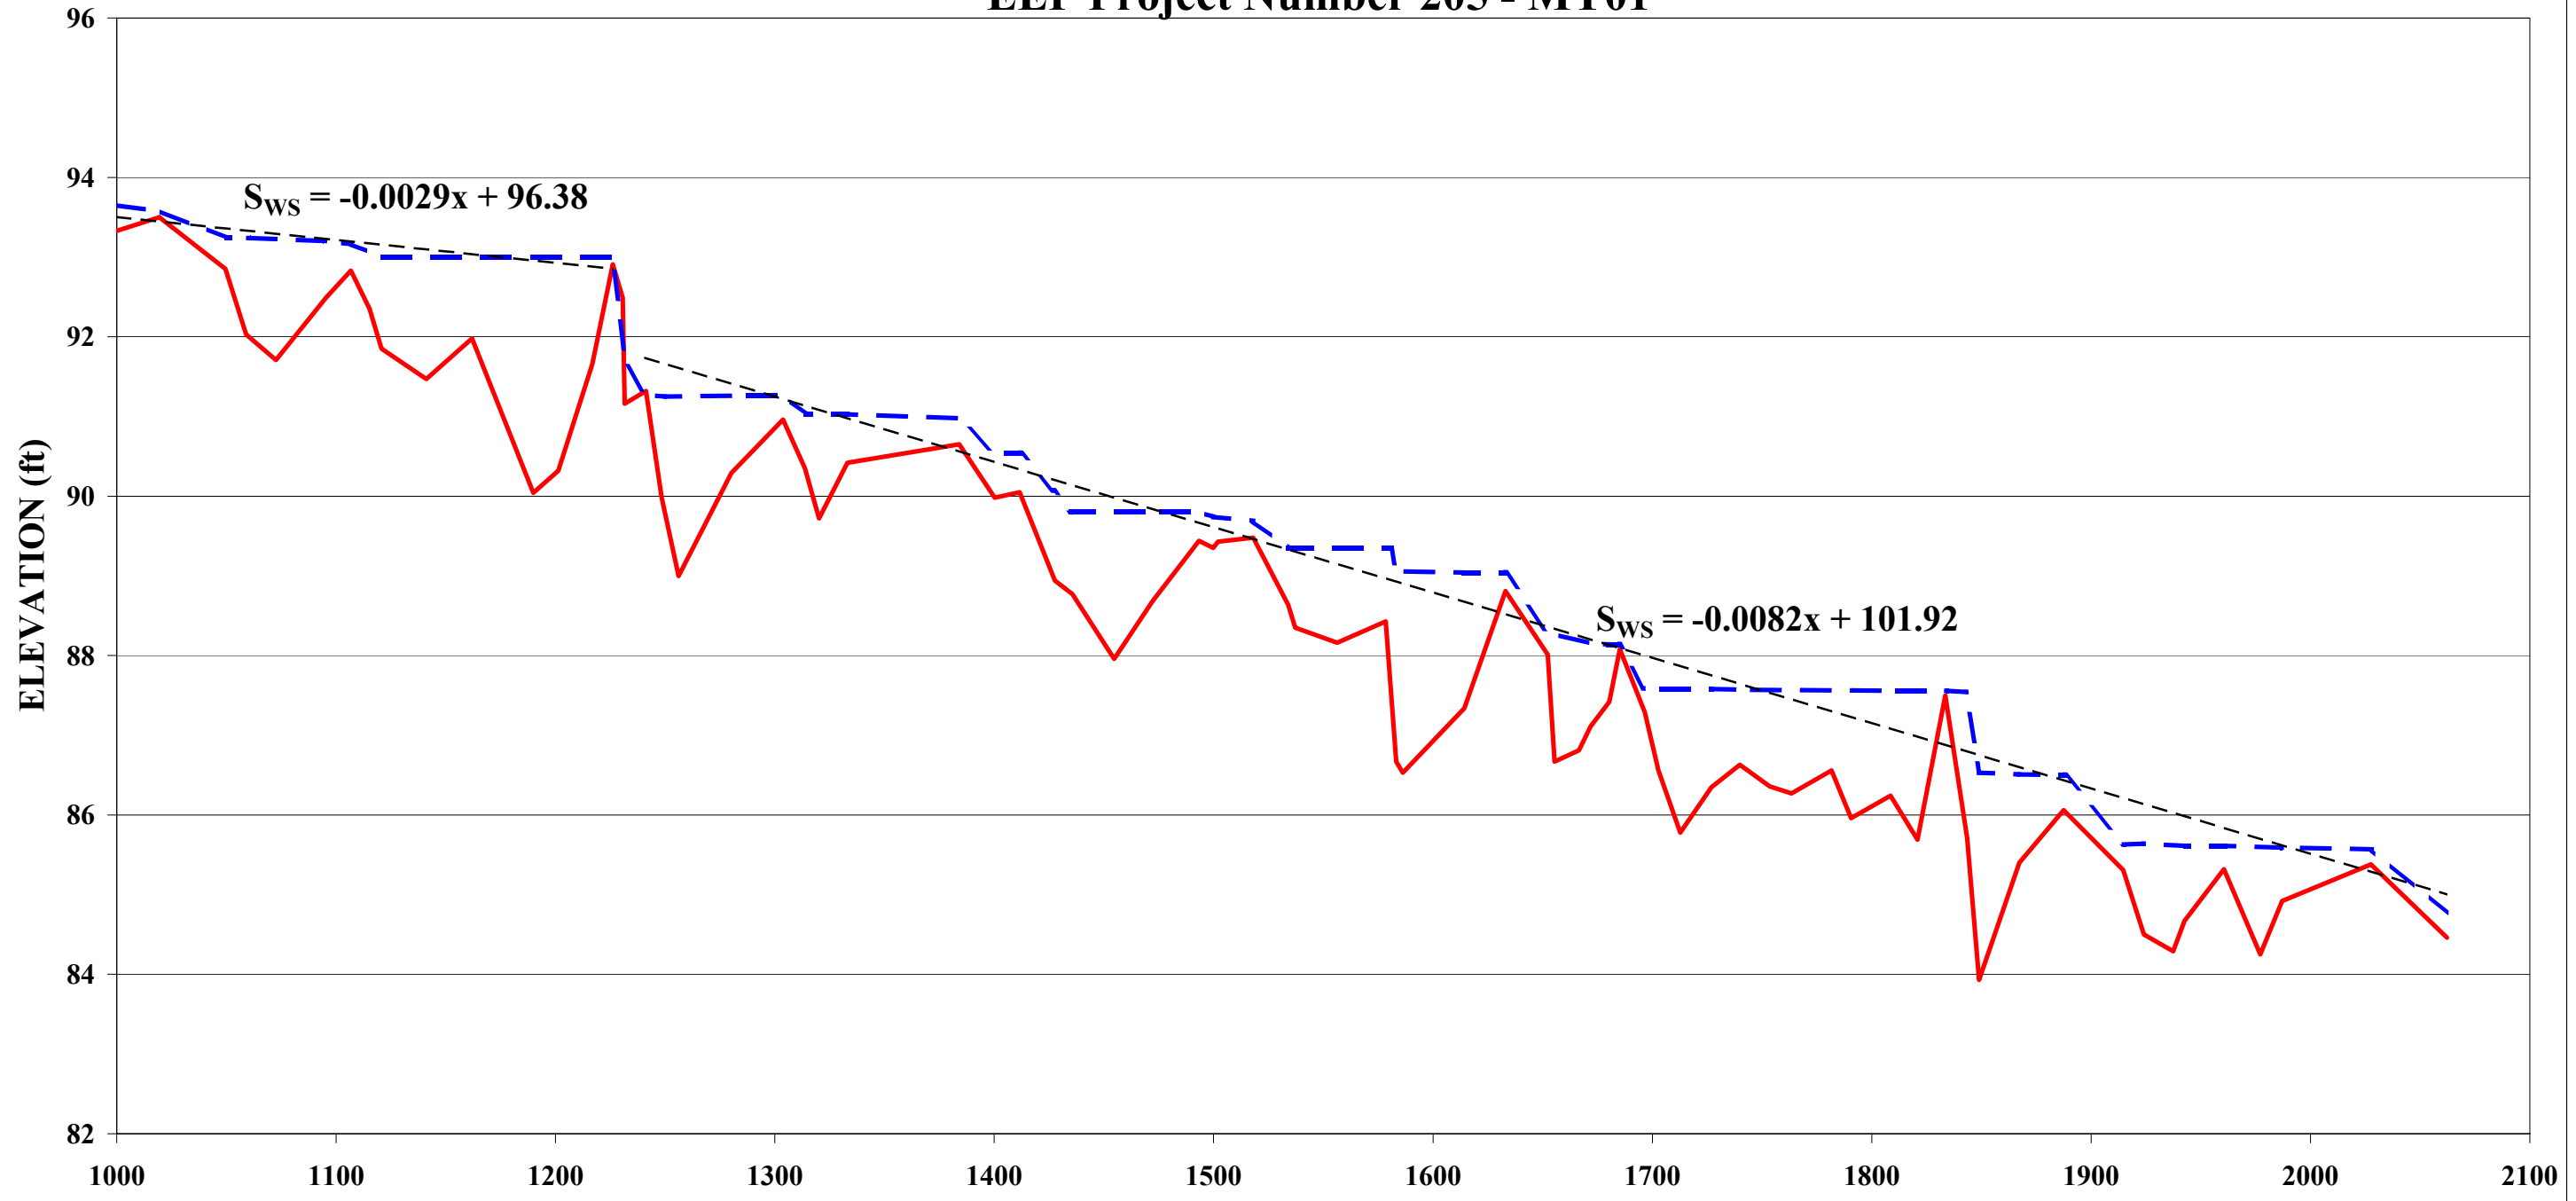
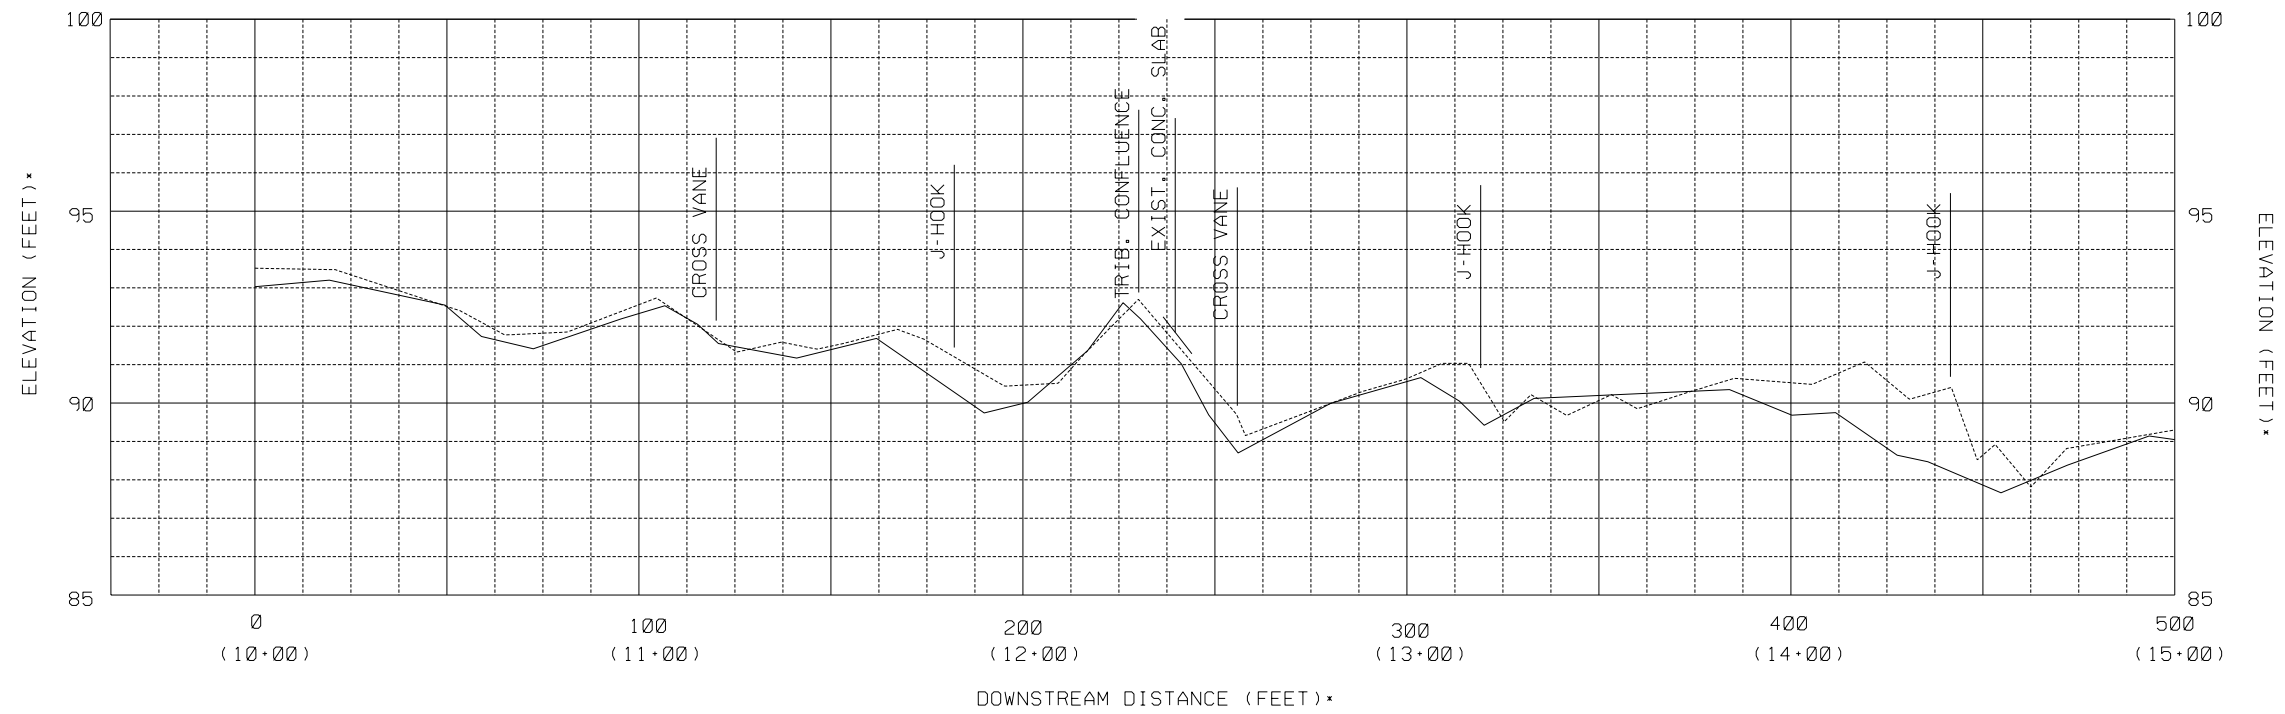
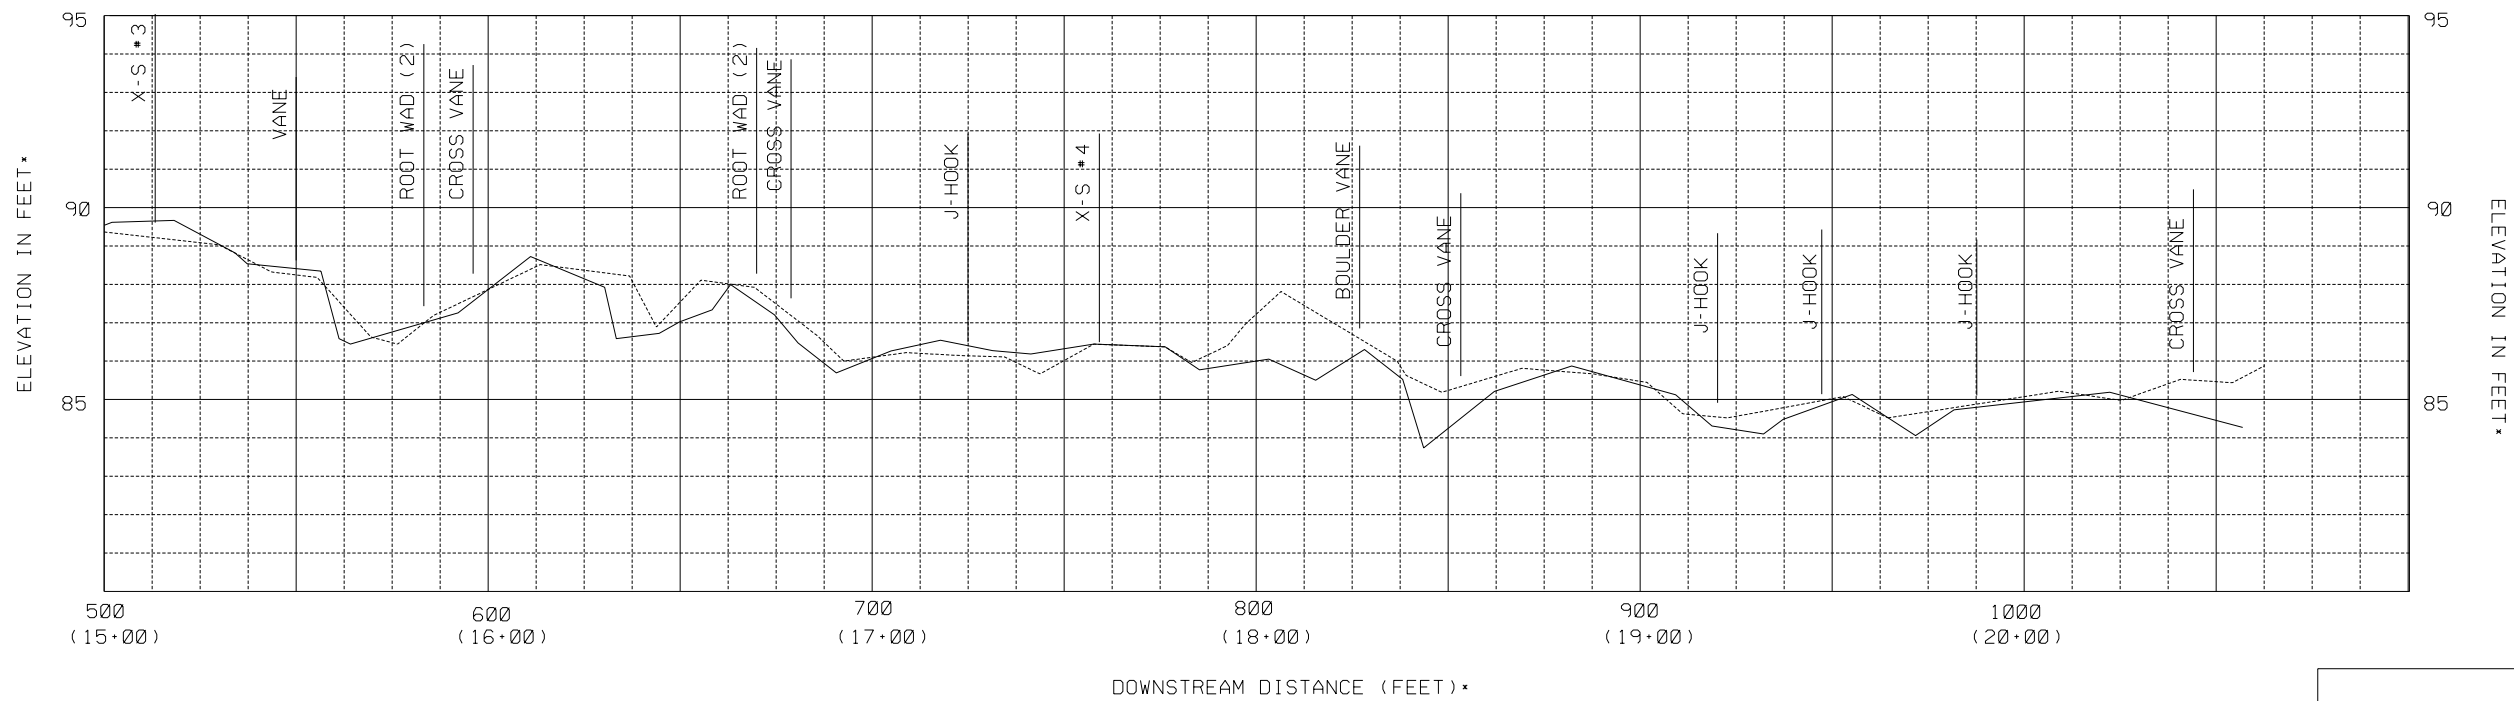
Appendix B6a - Longitudinal Profile for Bushy Branch
Kentwood Park, Wake County
EEP Project Number 205 - MY01

MONITORING YEAR 01 PROFILE BASED ON CURRENT THALWEG LOCATION WHICH HAS MIGRATED IN SOME PLACES, DUE TO NATURAL STREAM PROCESSES, SINCE AS BUILT SURVEY IN 2004.
