**Kentwood Park (Bushy Branch) Stream
Restoration Monitoring Report
EEP Project # 205
Monitoring Year – 01
2005**

Appendix A2: Vegetative Problem Area Plan View
 Kentwood Park, Wake County, EEP Project Number 205 - MY01

Appendix B1: Stream Problem Area Plan View
 Kentwood Park, Wake County, EEP Project Number 205 - MY01

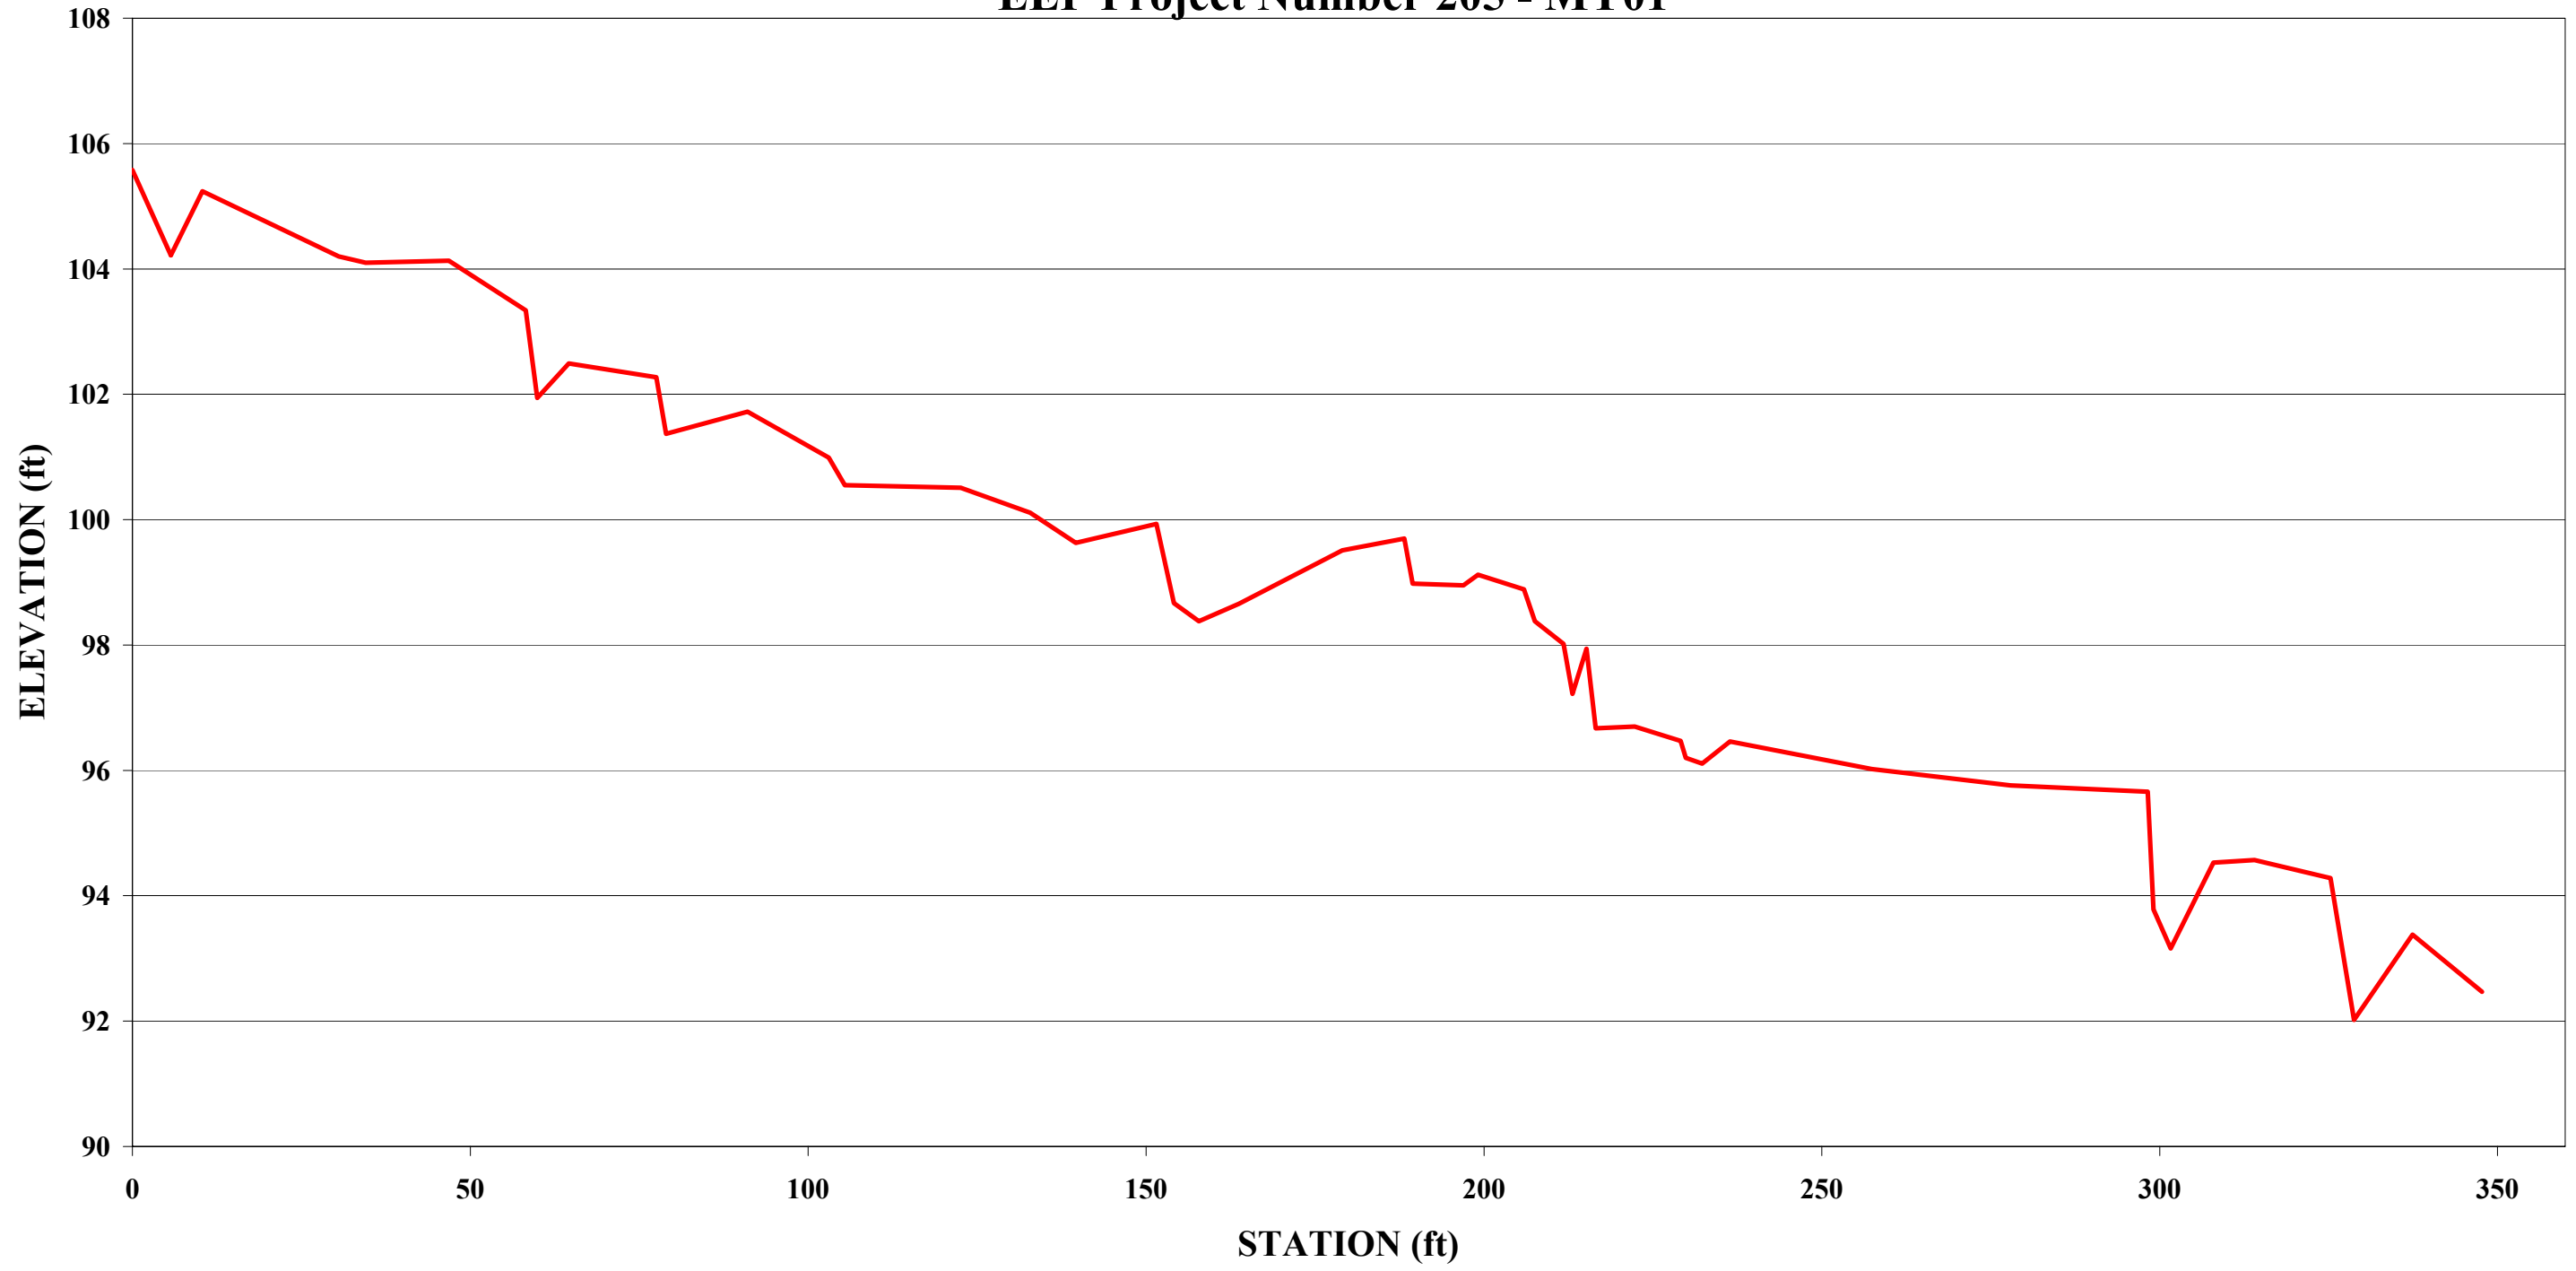
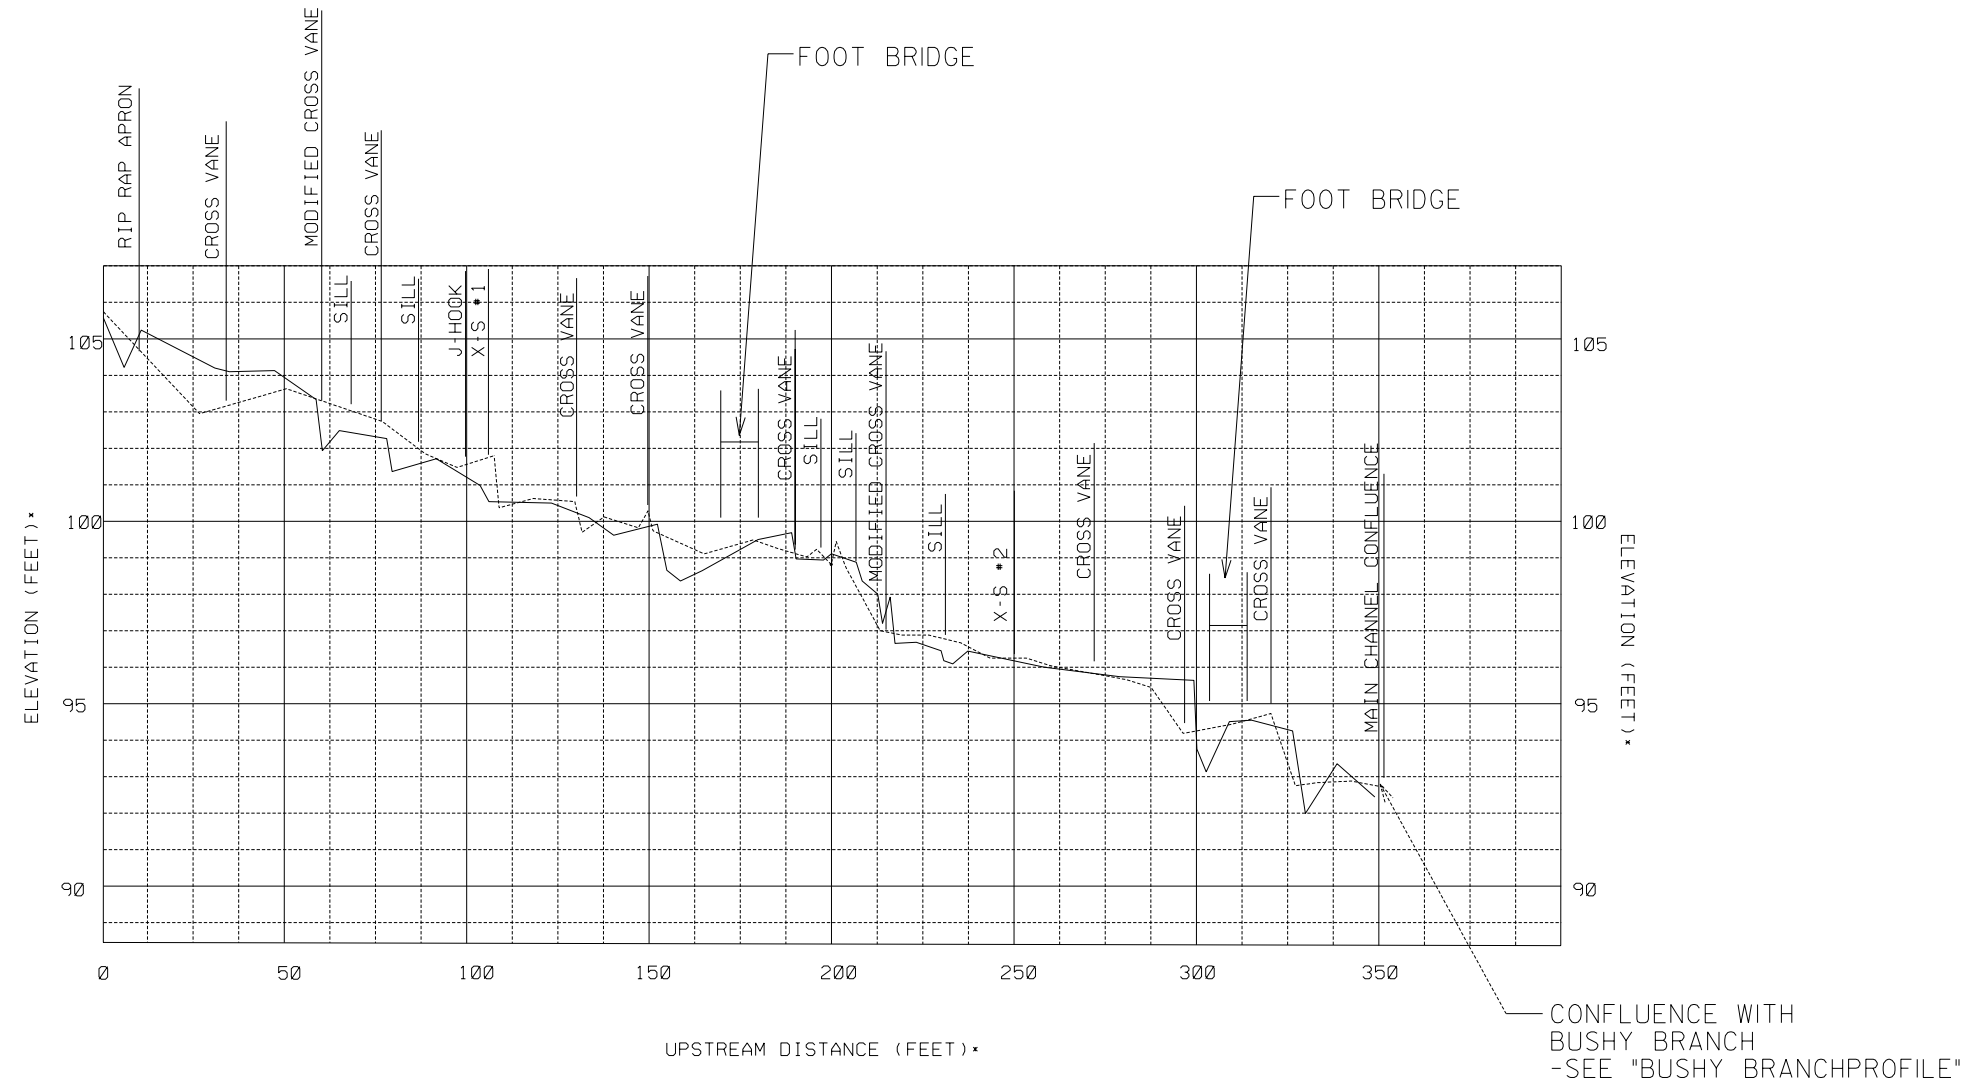
**Appendix B6b - Longitudinal Profile for UT to Bushy Branch
Kentwood Park, Wake County
EEP Project Number 205 - MY01**

•NOTE:
 MONITORING YEAR 01 PROFILE BASED ON CURRENT THALWEG LOCATION WHICH HAS MIGRATED IN SOME PLACES, DUE TO NATURAL STREAM PROCESSES, SINCE AS BUILT SURVEY IN 2004.

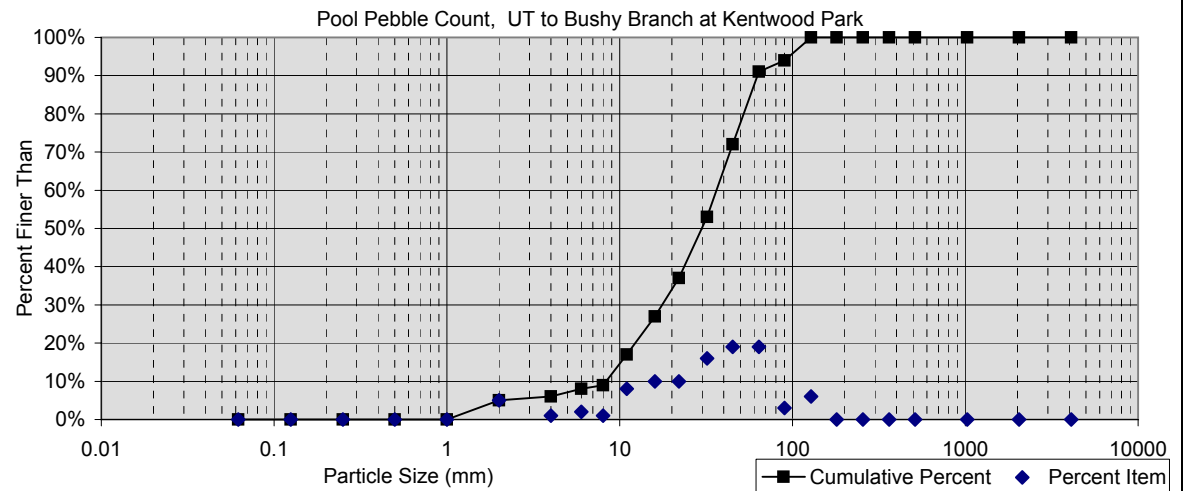
Note: **XS 2**

Size percent less than (mm)					Percent by substrate type					
D16	D35	D50	D84	D95	silt/clay	sand	gravel	cobble	boulder	bedrock
10.571	20.64	29.8	56	95	0%	5%	86%	9%	0%	0%

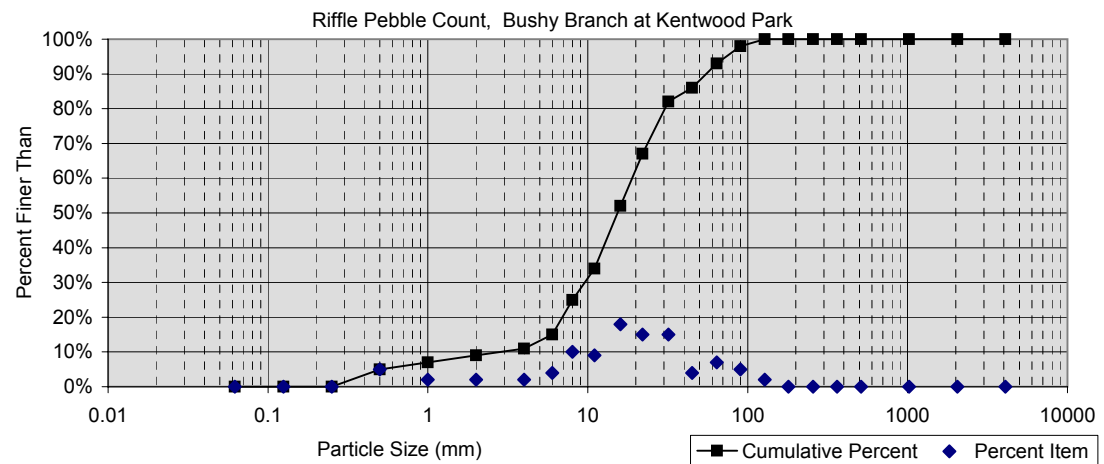
Note: XS 3

Size percent less than (mm)					Percent by substrate type					
D16	D35	D50	D84	D95	silt/clay	sand	gravel	cobble	boulder	bedrock
6.175	11.23	15.3	38	73	0%	9%	84%	7%	0%	0%

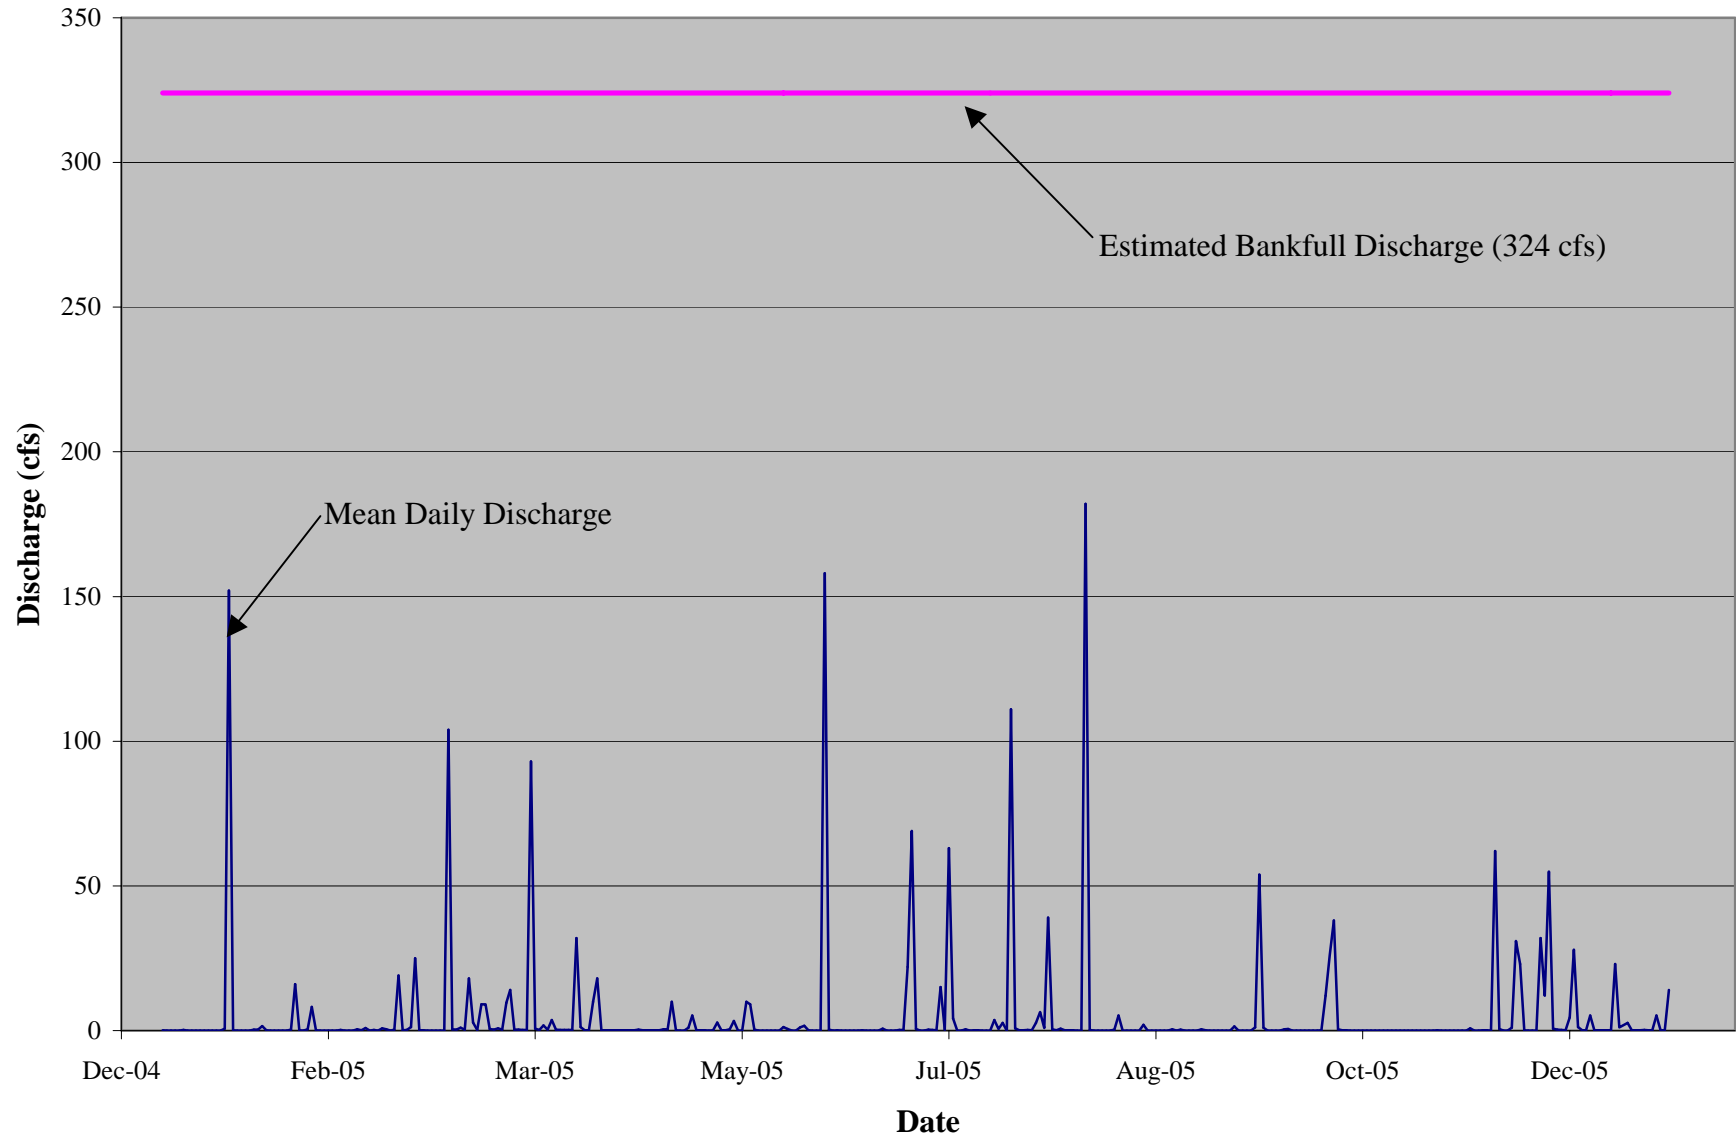
Pigeon House Creek - USGS Gauge 0208732534

The Kentwood Park Stream Restoration Site does not have a gauge installed to record bankfull events. In order to approximate the number of bankfull events USGS gauge data has been used as a secondary surrogate. Two gauges, both within three miles of the Kentwood Park Site, were used for this purpose. Since the bankfull discharge of the gauged streams is unknown, a flood frequency analysis was performed using an annual maximum series (AMS) for a period of 7 to 8 years to determine an approximate bankfull discharge. For this report it was assumed that the bankfull discharge is associated with a return period of 1.5 years. Due to the urban nature of the restoration site and its location outside the immediate drainages of the gauged streams this data is not a substitute for an on-site recording device. The three streams and the gauges' approximate distance from Kentwood Park are as follows; Pigeon House Creek, 2.4 miles; and Rocky Branch, 1mile.
