**Kentwood Park (Bushy Branch) Stream
Restoration Monitoring Report
EEP Project # 205
Monitoring Year – 02
2006**

January 2007

KENTWOOD PARK (BUSHY BRANCH)
MONITORING PLAN VIEW
WAKE COUNTY
EEP PROJECT NUMBER 205 - MY02

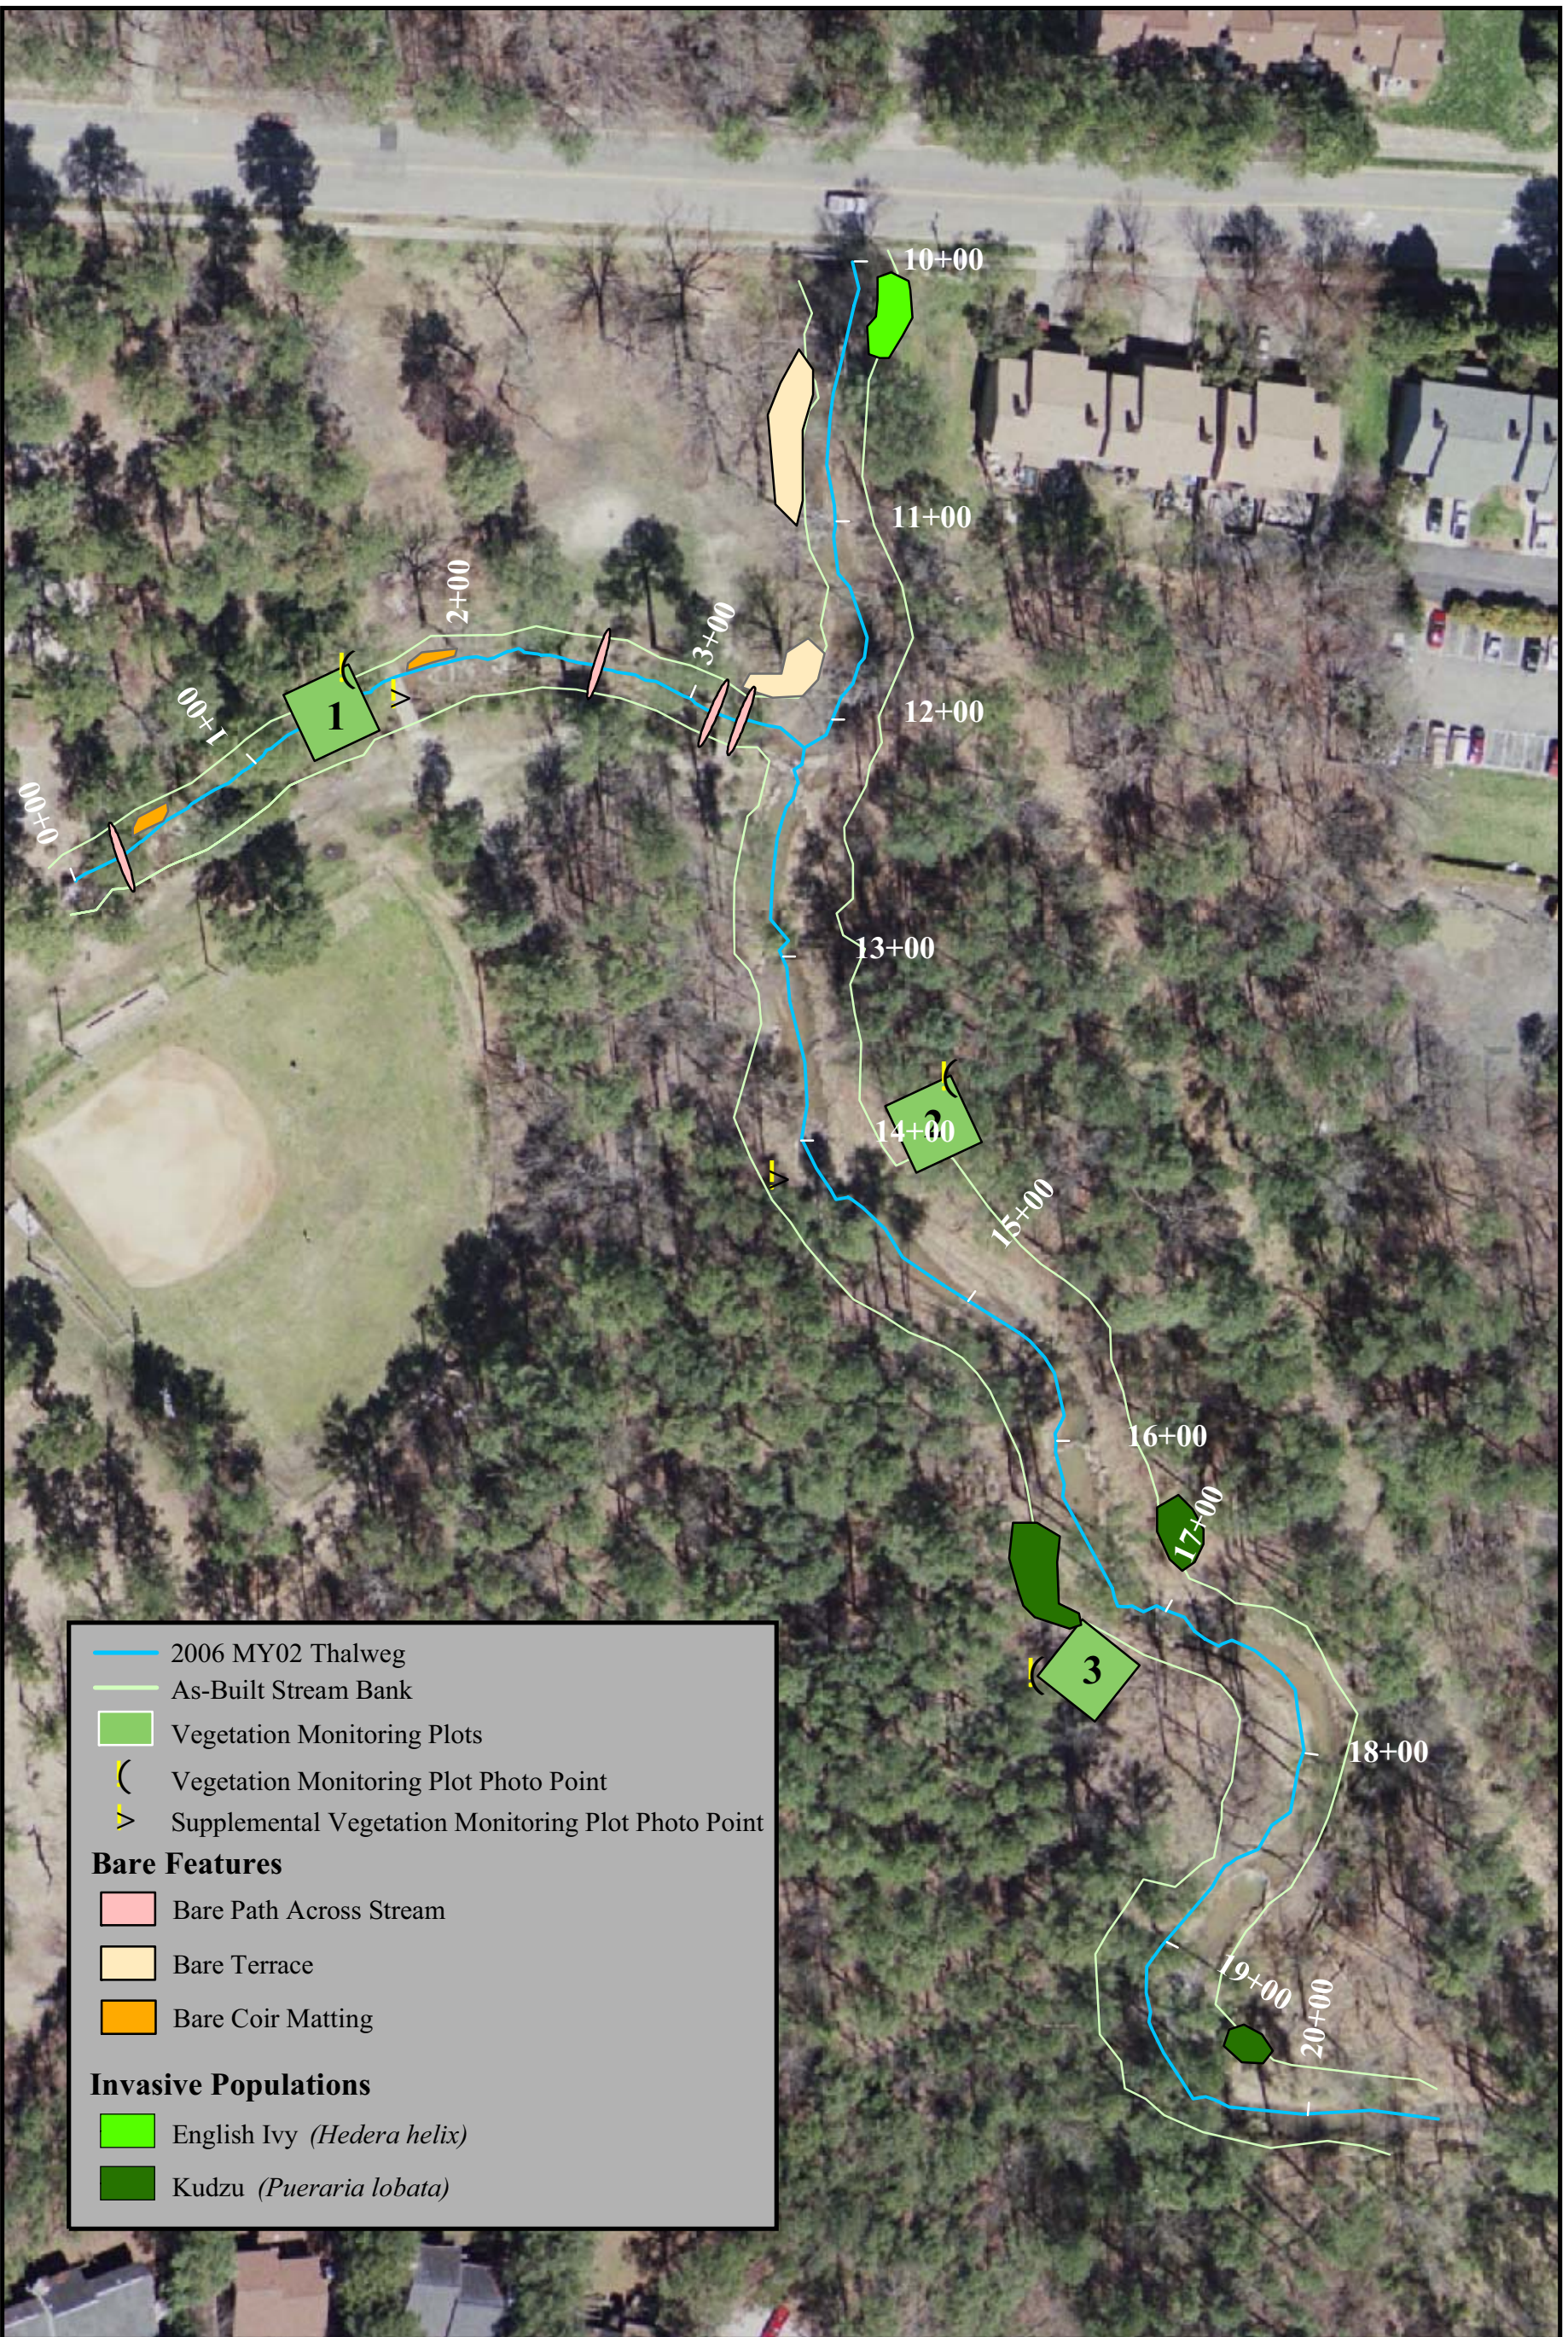
Appendix A2: Vegetative Problem Area Plan View
 Kentwood Park, Wake County, EEP Project Number 205 - MY02

Table A3a. Vegetative Problem Areas			
Project Number and Name: 205 – Kentwood Park (Bushy Branch)			
Segment/Reach: Bushy Branch (1,070 ft.)			
Feature/Issue	Station # / Range	Probable Cause	Photo #
Bare Terrace	10+50 - 11+10	Foot traffic from disc golf course	
	11+50 - 12+00	Foot traffic from disc golf course	
Invasive/Exotic Population	10+00 - 10+50	English Ivy: encroachment from outside project	VP1
	16+00 - 16+75 and 19+25 - 19+75	Kudzu: unknown	VP2
	Scattered Throughout	Mimosa: outside seed source	VP2
	Heavy Throughout	Microstegium: previously established	VP3
	Scattered Throughout	Japanese honeysuckle: previously established	
	Scattered Throughout	Chinese privet: previously established	
	Scattered Throughout	Thorny olive: previously established	VP4

Table A3b. Vegetative Problem Areas			
Project Number and Name: 205 – Kentwood Park (Bushy Branch)			
Segment/Reach: UT to Bushy Branch (350 ft.)			
Feature/Issue	Station # / Range	Probable Cause	Photo #
Bare Coir Matting	00+25 – 00+70	Poor subsoil, foot traffic on matting	VP5
	01+75 – 02+10	Poor subsoil, foot traffic on matting	
Bare Terrace	03+25 - 03+50	Foot traffic from disc golf course	
Path worn across stream area	00+25	Disc golf players crossing stream	VP6
	02+50	Disc golf players crossing stream	
	03+05	Disc golf players crossing stream	
	03+20	Disc golf players crossing stream

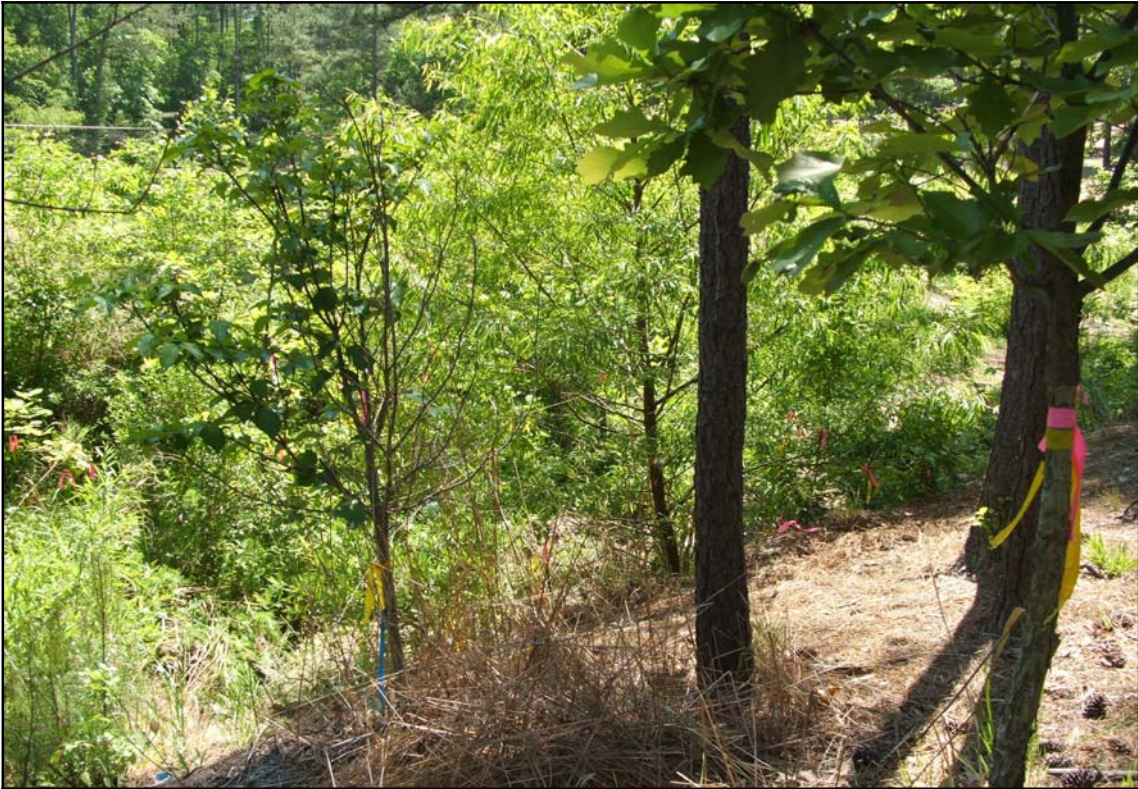
- One *Euonymus americana* found in plot 1 had resprouted from the original planting, but had not been counted in monitoring year 01. The surviving *Euonymus americana* in plot 1 retained very few leaves. Browsing pressure is believed to be the cause of the *Euonymus americana* mortality.

- The high mortality of *Oxydendrum arboreum* in plot 1 may have been due to dry growing conditions. Since plot 1 is located on an intermittent stream reach, the reach is frequently dry during the growing season.

Plot 1 Photo – Taken looking south from the north corner. 5/4/06 - MY 02.

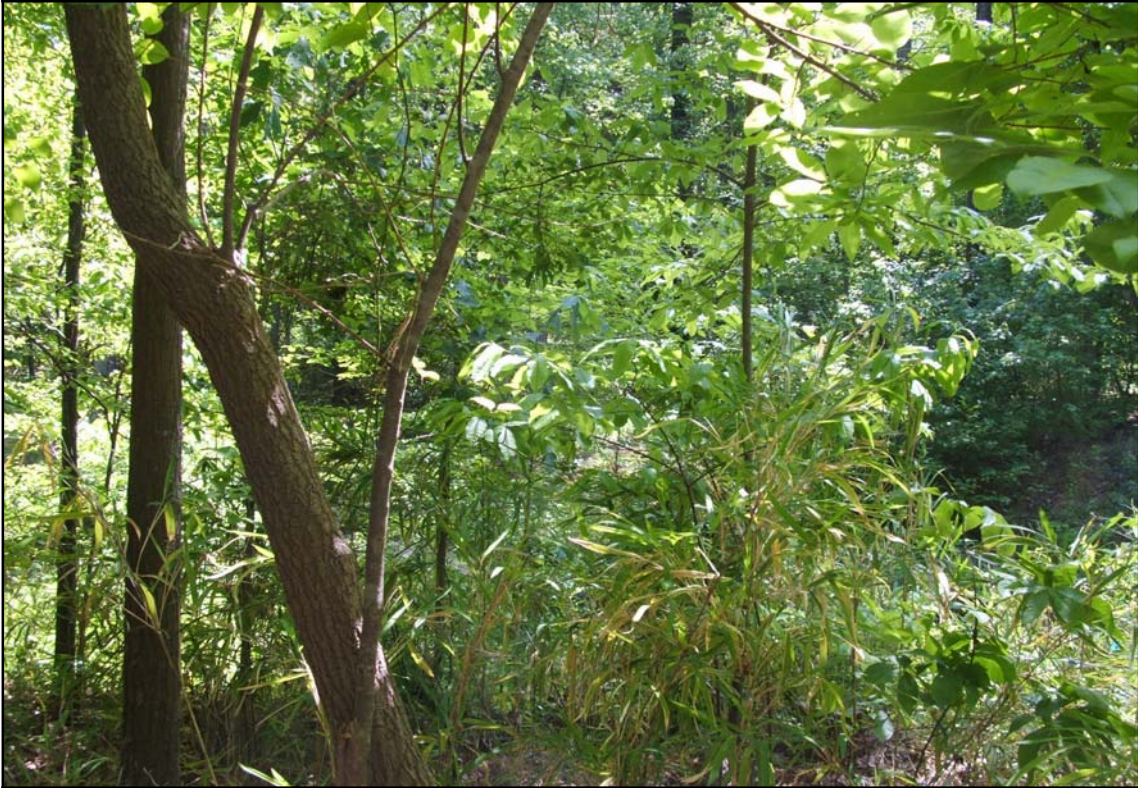
- The majority of the *Ilex verticillata*, *Sambucus canadensis*, *Cornus amomum*, *Platanus occidentalis*, and *Alnus serrulata* mortality can be attributed to the low survival rate of these species in vegetation plot 2. Since much of plot 2 is located on a bankfull bench; subject to frequent storm discharges, this part of the plot is subjected to large flows, which may cause some of the plantings to become uprooted and flow downstream.

Plot 2 Photo – Taken looking south from the north corner. 5/4/06 - MY 02.

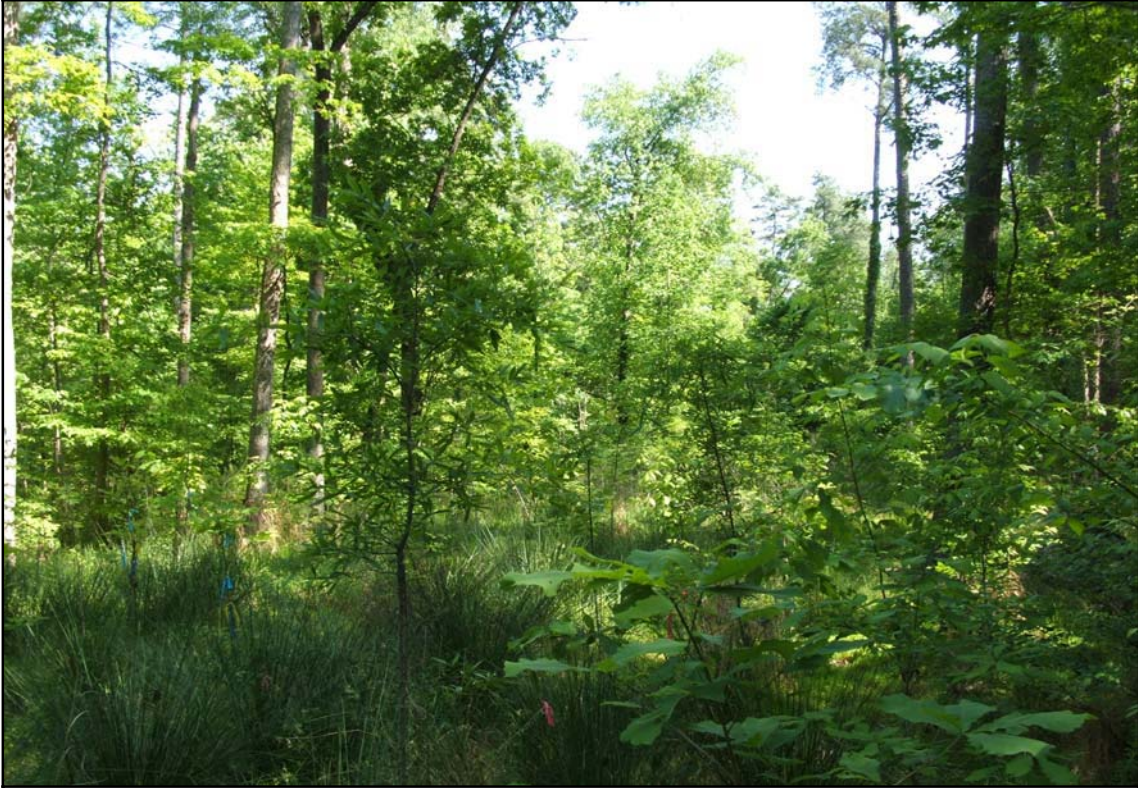
- The *Hamamelis virginiana* increased in number because plants that were considered dead in monitoring year 1 had resprouted or put out new growth.
- In plot 3, the two *Liriodendron tulipifera* trees that were standing dead during monitoring year 1, were not found during the current monitoring. It is assumed that the dead trees were either removed manually or knocked over during a storm.

- There is over 100% survival for *Quercus phellos* in plot 3. This is due to a miscount during the as-built stem count.
- There is also over 100% survival for *Nyssa sylvatica* and *Betula nigra* in plots 1 and 2. This is due to either a miscount during the as-built and first year monitoring stem count or resprouts from the original plantings that had died back.
- The *Acer negundo* decreased in number in plot 3 because one of the trees had been cut down. This appears to be from beaver activity; however no significant beaver damage was documented throughout the rest of the site.

Plot 3 Photo – Taken looking east from the west corner. 5/4/06 - MY 02.

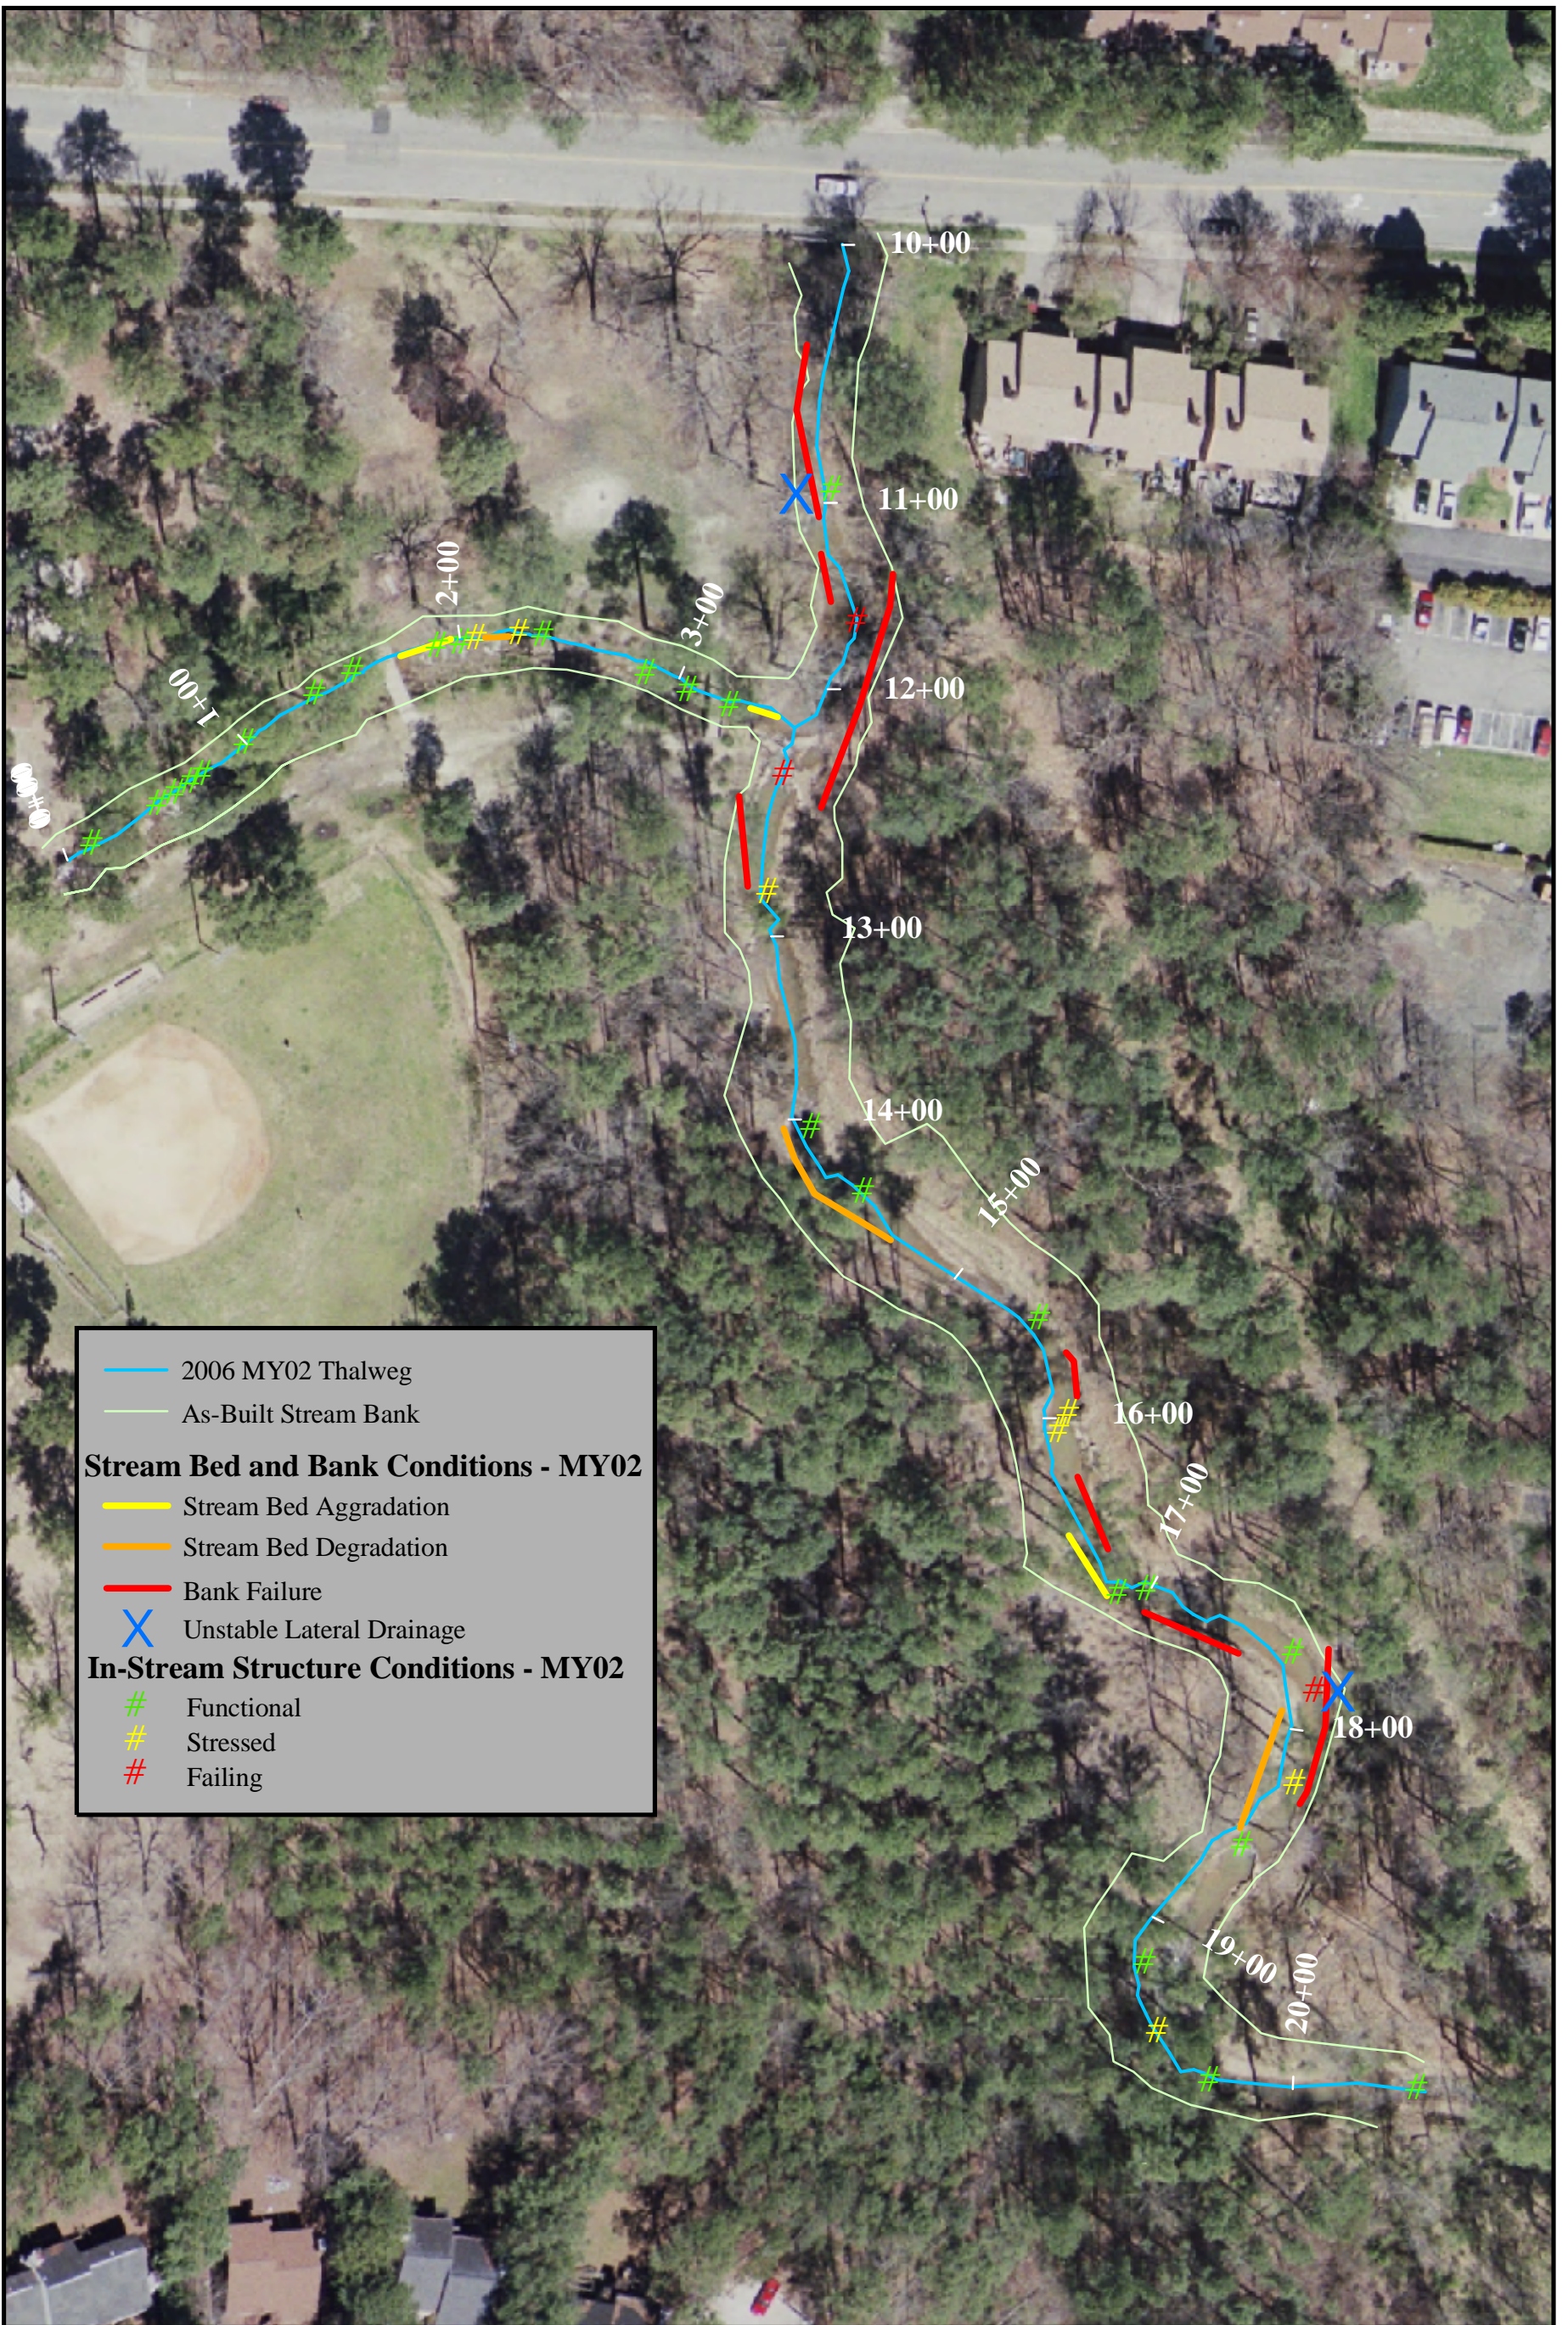
Appendix B1: Stream Problem Area Plan View
 Kentwood Park, Wake County, EEP Project Number 205 - MY02

Table B1a. Stream Problem Areas			
Project Number and Name: 205 – Kentwood Park (Bushy Branch)			
Segment/Reach: Bushy Branch (1,070 ft.)			
Feature Issue	Station numbers	Suspected Cause	Photo #
Aggradation/Bar Formation	16+30 - 16+60	unknown	
Bed Degradation	14+00 - 14+60	unknown	
	18+00 - 18+60	unknown	
Bank Scour	10+50-11+20	unknown	SP1
	11+30-11+50	unknown	
	11+60-12+50	unknown	
	12+75-13+00	scour from misdirected cross vane	
	15+50-15+65	unknown	
	16+00-16+30	unknown	
	16+80-17+25	unknown	
	17+50-18+30	unknown	
Engineered Structures - back or arm scour	11+75	unknown	SP2
	12+60	improper placement	
	13+10	poorly backfilled vane arm	
	18+00	unknown	
	18+30	unknown	
	19+40	poorly backfilled vane arm	
Engineered Structures – piping	16+00	poor fabric installation	SP3
Root Wads - scour	16+00	unknown	SP4

Table B1b. Stream Problem Areas			
Project Number and Name: 205 – Kentwood Park (Bushy Branch)			
Segment/Reach: UT to Bushy Branch (350 ft.)			
Feature Issue	Station numbers	Suspected Cause	Photo #
Aggradation/Bar Formation	01+80 - 02+00	herbaceous vegetation accumulating soil	SP5
	03+30 - 03+40	herbaceous vegetation accumulating soil	
Bed Degradation	02+25	unstable soils downstream of sill damaged by large storm event	SP6
