**Kentwood Park (Bushy Branch)  
Stream Restoration Monitoring Report  
EEP Project # 205  
Monitoring Year – 04  
2008**

**March 2009**

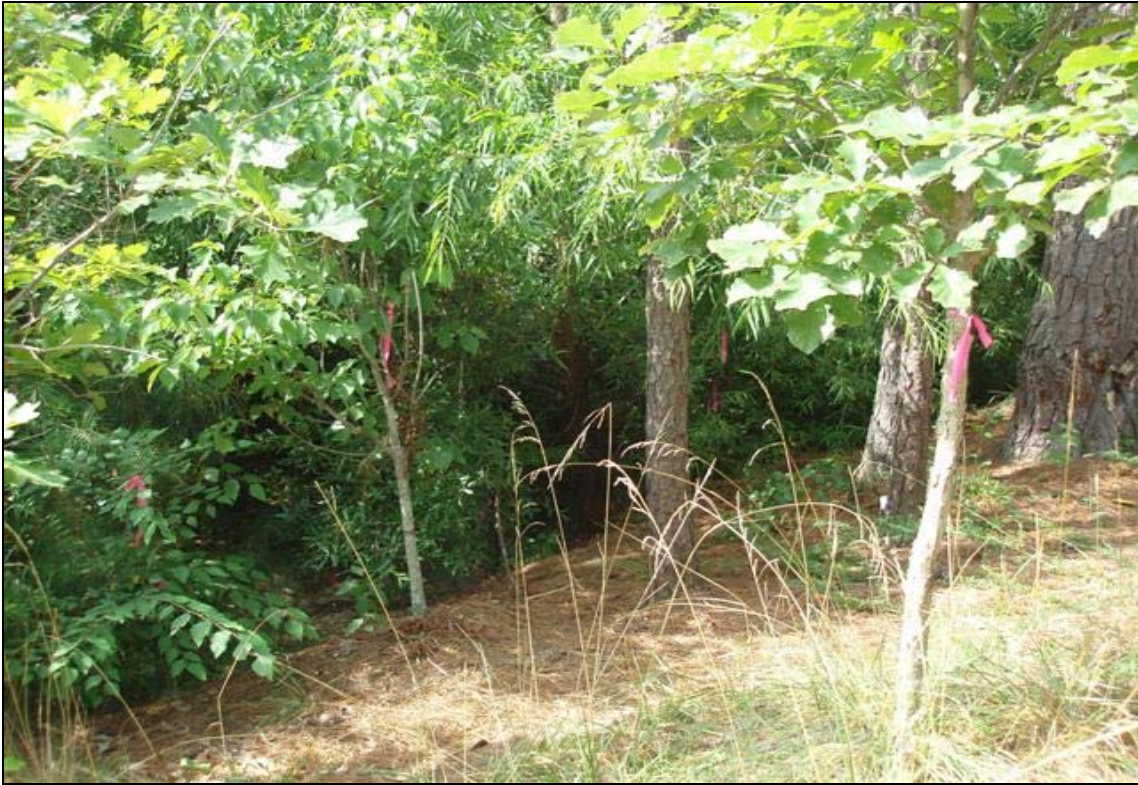
Vegetation Plot 1 Photo – Taken looking south from the north corner. 8/5/08 - MY 04

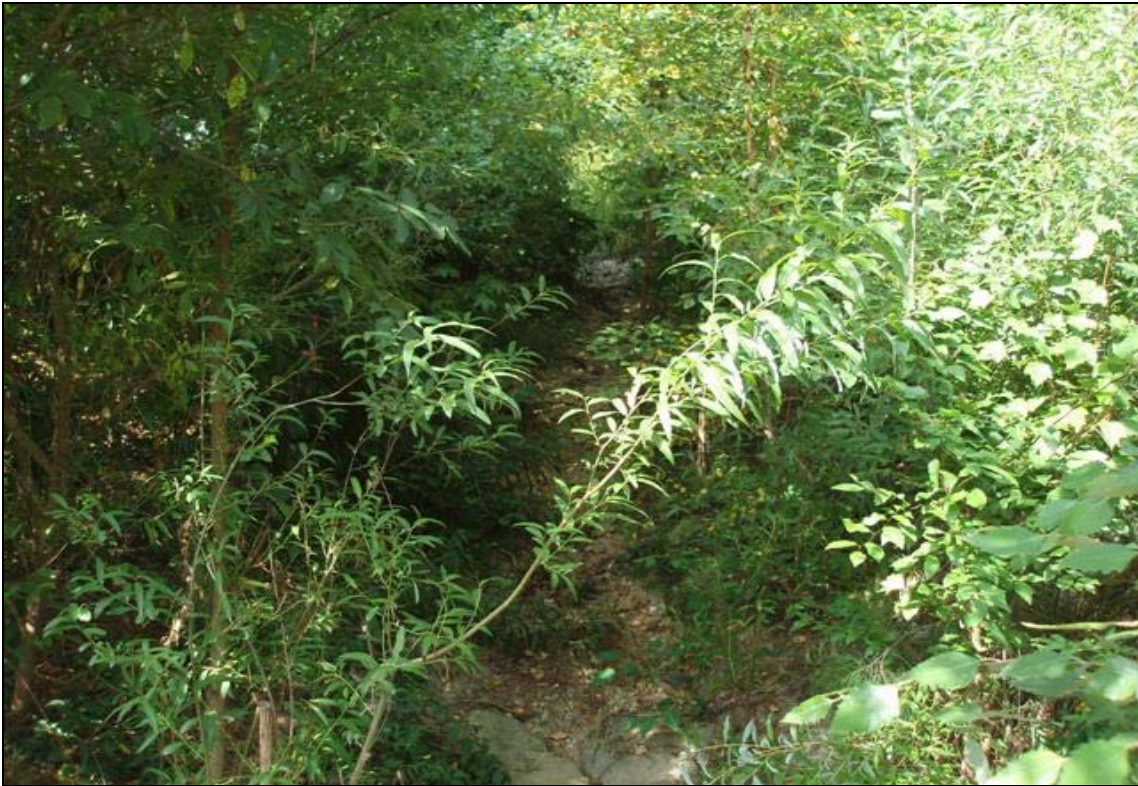
Vegetation Plot 1 Supplemental Photo – Taken looking upstream toward the center of the plot from established photo station #3. 8/5/08 - MY 04

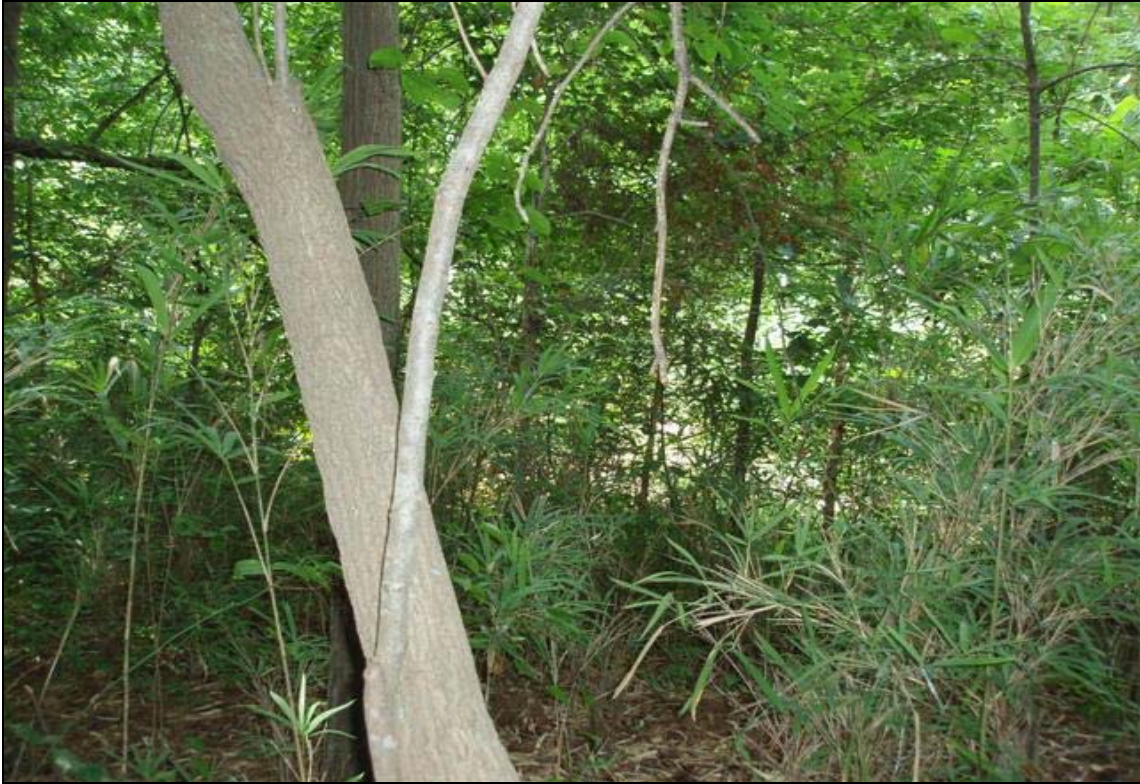
Vegetation Plot 2 Photo – Taken looking south from the north corner. 8/5/08 - MY 04

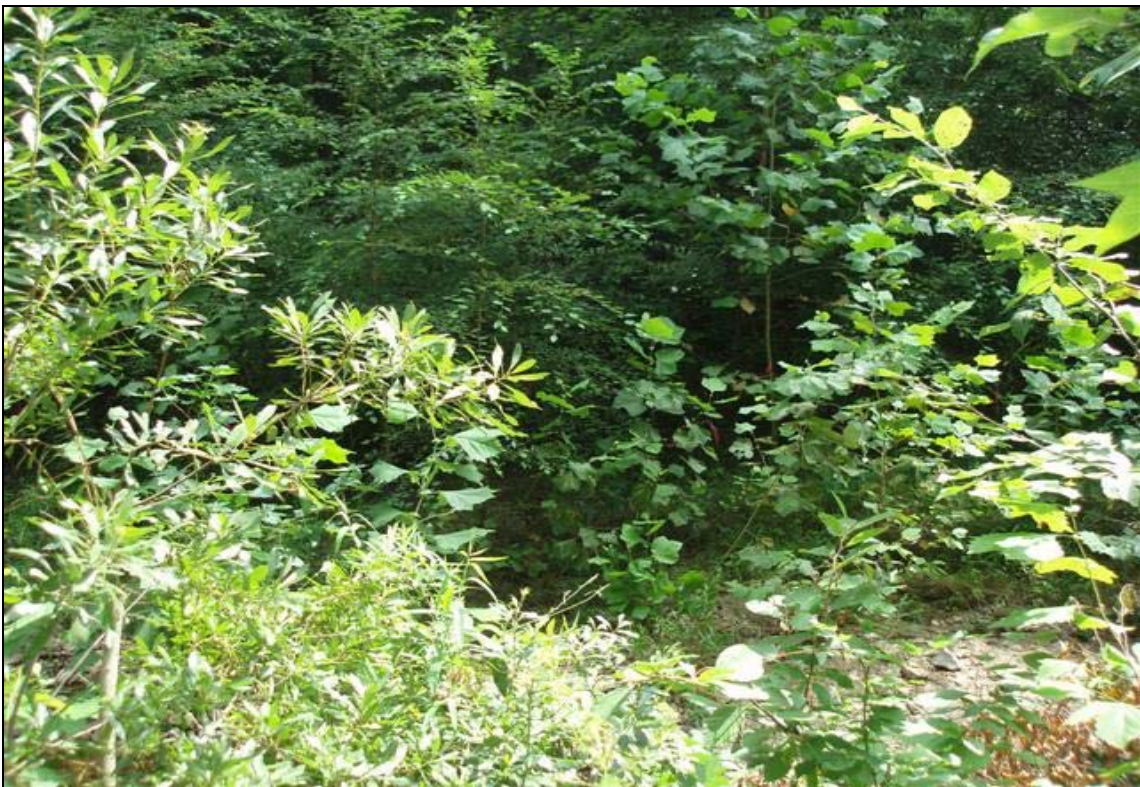
Vegetation Plot 2 Supplemental Photo – Taken looking at center of plot from the top of the right bank across the stream from the vegetation plot. 8/5/08 - MY 04

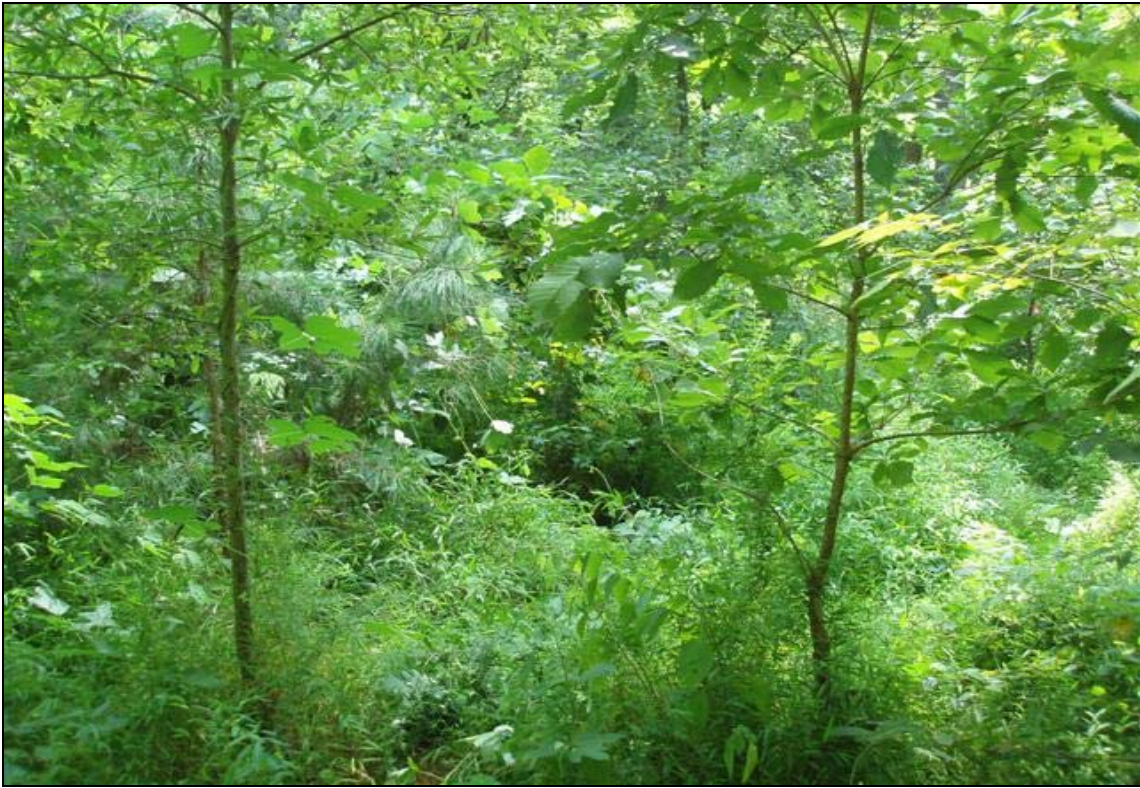
Vegetation Plot 3 Photo – Taken looking east from the west corner. 8/5/08 - MY 04

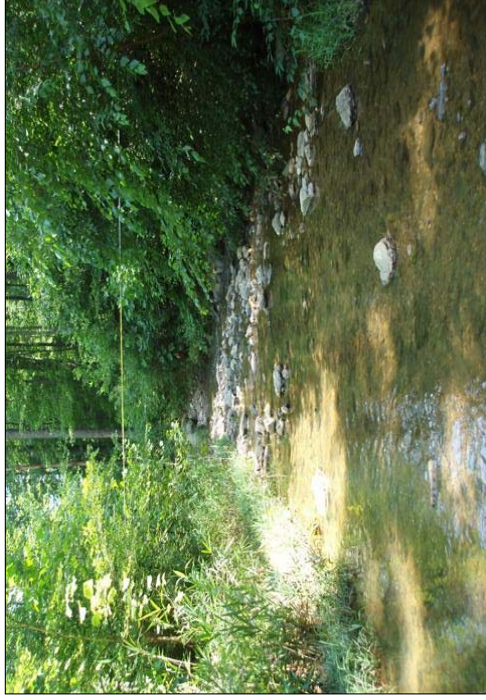
Neuse River Basin, Kentwood Park, Bushy Branch, XS - 2a, Riffle

SUMMARY DATA	
<b>Bankfull Elevation:</b>	92.4
<b>Bankfull Cross-Sectional Area:</b>	32.1
<b>Bankfull Width:</b>	23.9
<b>Flood Prone Area Elevation:</b>	94.1
<b>Flood Prone Width:</b>	41
<b>Max Depth at Bankfull:</b>	1.7
<b>Mean Depth at Bankfull:</b>	1.3
<b>W / D Ratio:</b>	17.8
<b>Entrenchment Ratio:</b>	1.7
<b>Bank Height Ratio:</b>	1.0

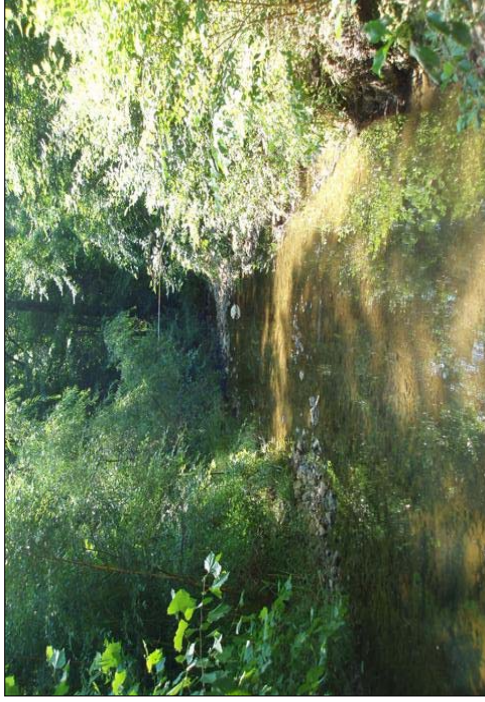
Neuse River Basin, Kentwood Park, Bushy Branch, XS - 3, Riffle

SUMMARY DATA	
<b>Bankfull Elevation:</b>	91.8
<b>Bankfull Cross-Sectional Area:</b>	39.9
<b>Bankfull Width:</b>	21.6
<b>Flood Prone Area Elevation:</b>	94.2
<b>Flood Prone Width:</b>	38
<b>Max Depth at Bankfull:</b>	2.4
<b>Mean Depth at Bankfull:</b>	1.8
<b>W / D Ratio:</b>	11.7
<b>Entrenchment Ratio:</b>	1.8
<b>Bank Height Ratio:</b>	1.4

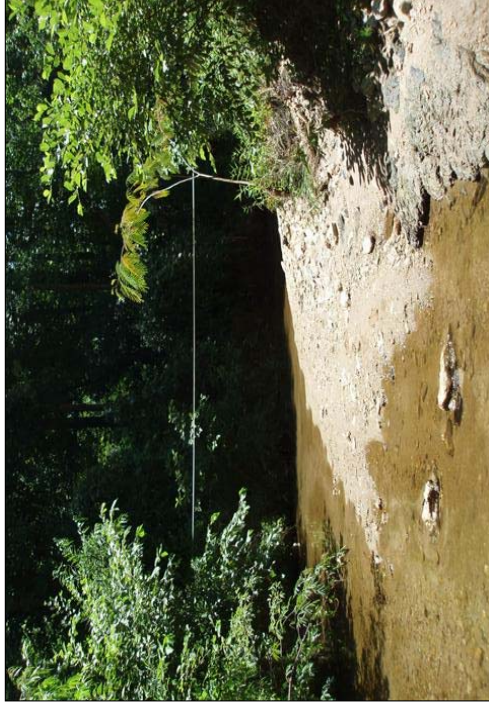
Neuse River Basin, Kentwood Park, Bushy Branch , XS - 4, Pool

SUMMARY DATA	
<b>Bankfull Elevation:</b>	89.4
<b>Bankfull Cross-Sectional Area:</b>	36.1
<b>Bankfull Width:</b>	22.2
<b>Flood Prone Area Elevation:</b>	92.7
<b>Flood Prone Width:</b>	>46
<b>Max Depth at Bankfull:</b>	3.0
<b>Mean Depth at Bankfull:</b>	1.6
<b>W / D Ratio:</b>	13.7
<b>Entrenchment Ratio:</b>	>2.0
<b>Bank Height Ratio:</b>	1.0

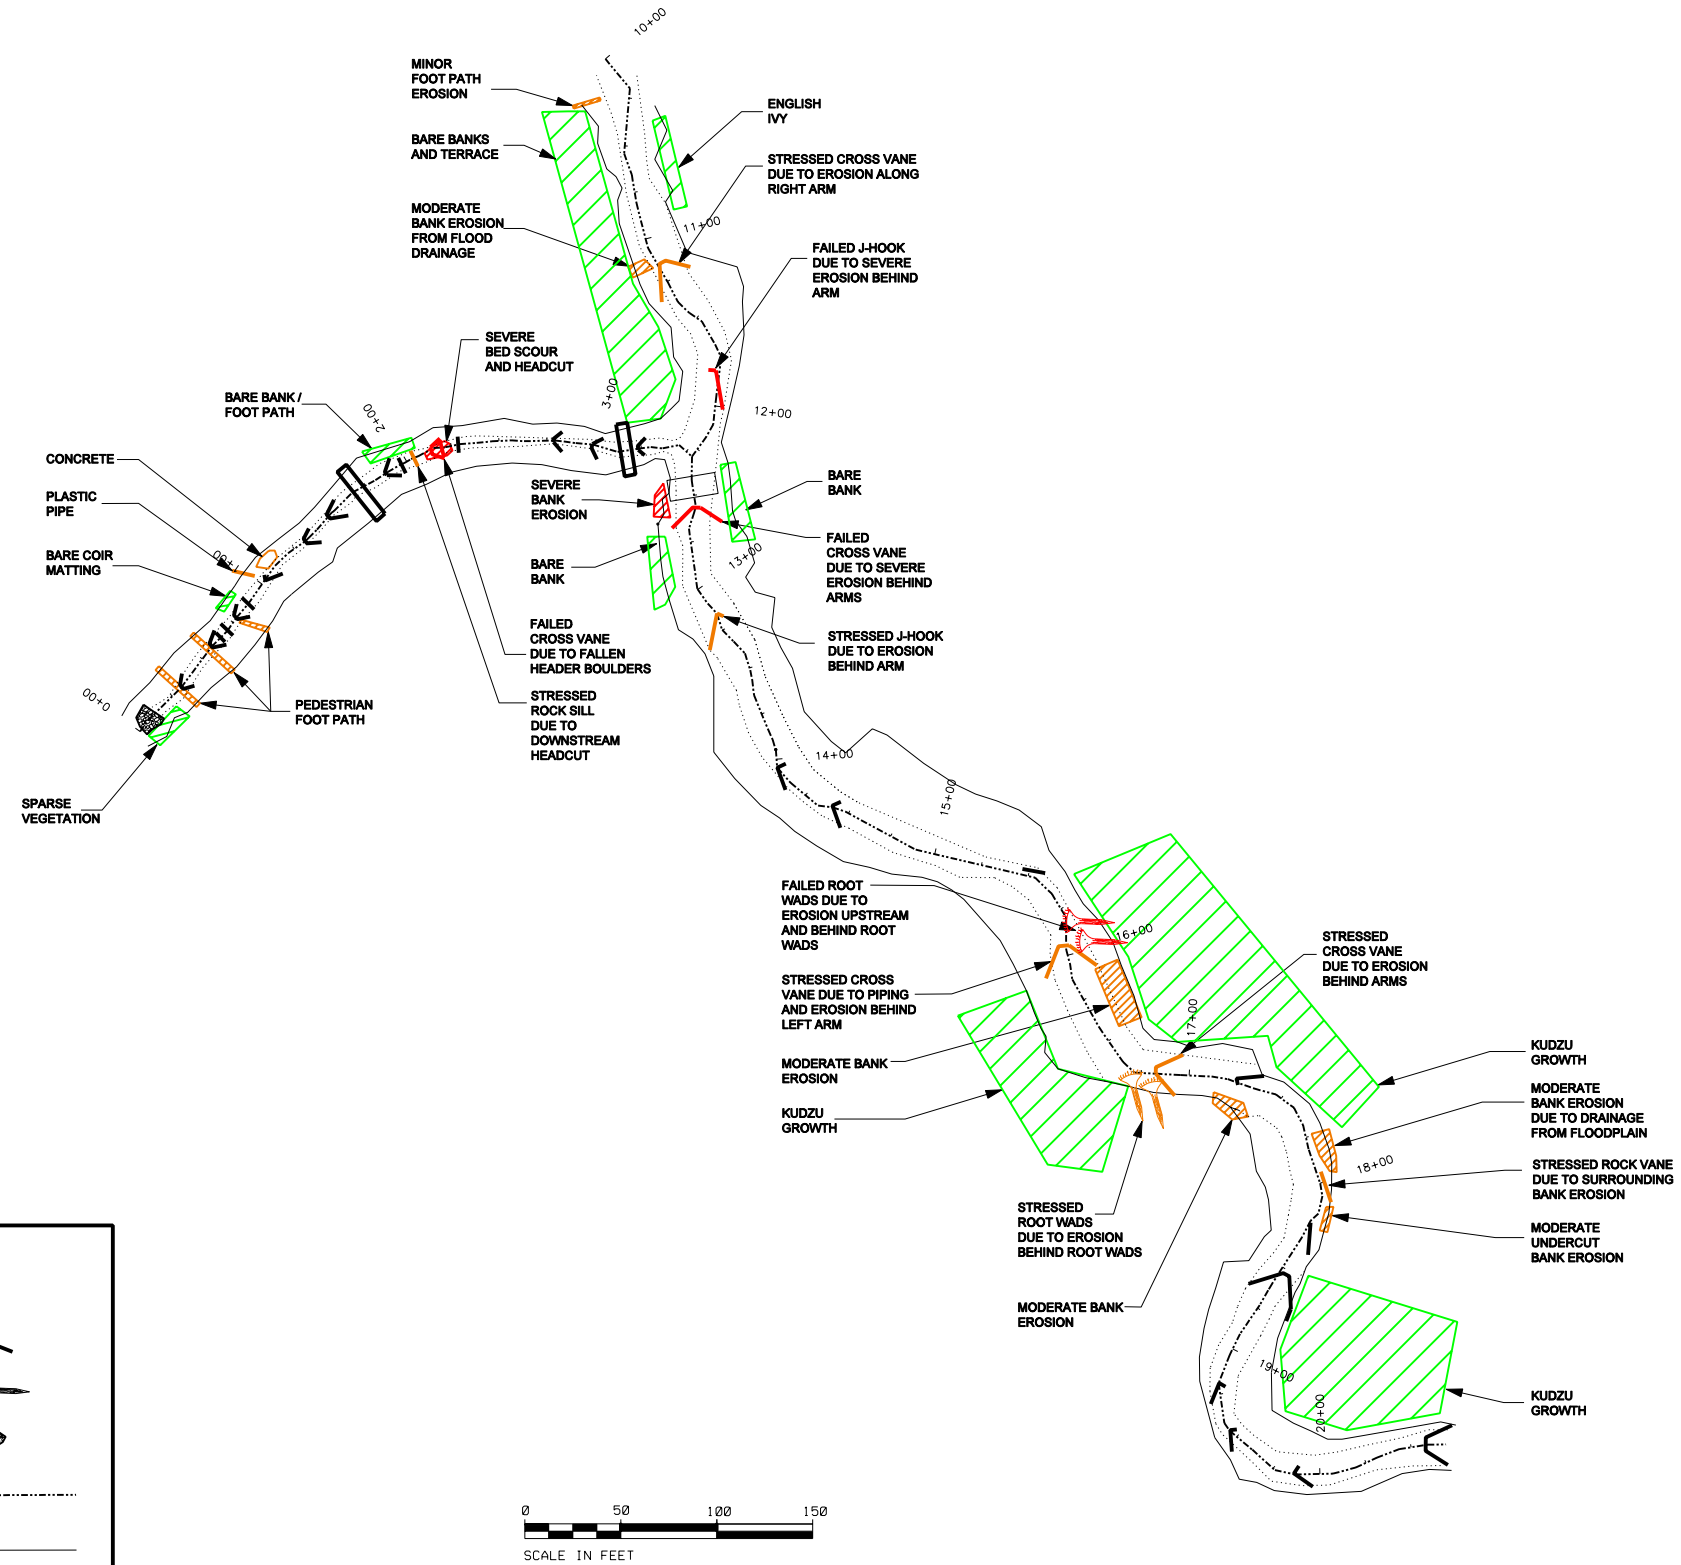
**CURRENT  
CONDITIONS  
PLAN VIEW**

The restored reach of Bushy Branch is predominately stable. This site is vertically controlled by bedrock and does not have any areas that are experiencing bed degradation or incision. There are portions of lateral instability throughout the project, though. In most of the cases the toe of the streambanks has washed out and many banks are experiencing slight undercut erosion. In a few of these cases, the bank vegetation is stabilizing these banks, but there are isolated areas that are suffering uncontrolled erosion. The in-stream structures are stable for the most part, but a few of the cross-vanes have suffered from significant back arm scour. One of the structures has fallen apart. The two sets of root wads that were installed have most of the root wad above the stream's baseflow. This has caused these root wads to begin to rot and they are also suffering from erosion behind the root wads. On UT to Bushy Creek, a scour hole downstream of a cross vane at Station 02+20 has caused the header boulder of the cross vane to fall into the hole. This headcut has begun to move upstream, stressing the structure just upstream of the affected cross vane. There are two other areas of note on the tributary: one is the small patch of concrete that was poured on

the bank and bed near Station 01+15 and the other is the outlet from a black drain pipe that has been put into the bank near Station 01+00. These issues are most likely related to the adjacent playground equipment that was replaced earlier this summer.

A repair assessment is recommended to investigate stabilizing and rebuilding the structure that has been affected by the headcut on UT to Bushy Creek. If left unstabilized, this vertical instability could continue to migrate upstream, affecting additional structures. Additional repair assessment is also recommended at the cross vane that has failed at Station 12+60. There is a pipe protected by concrete immediately upstream of this structure, which will control vertical instability, but further bank erosion could continue to take place in this location.
