**KEY BRANCH MITIGATION SITE
(Project No. .00013)**

MONITORING YEAR 2 (2005)

Submitted to:
North Carolina Department of Environment and Natural Resources
Ecosystem Enhancement Program
Raleigh, North Carolina

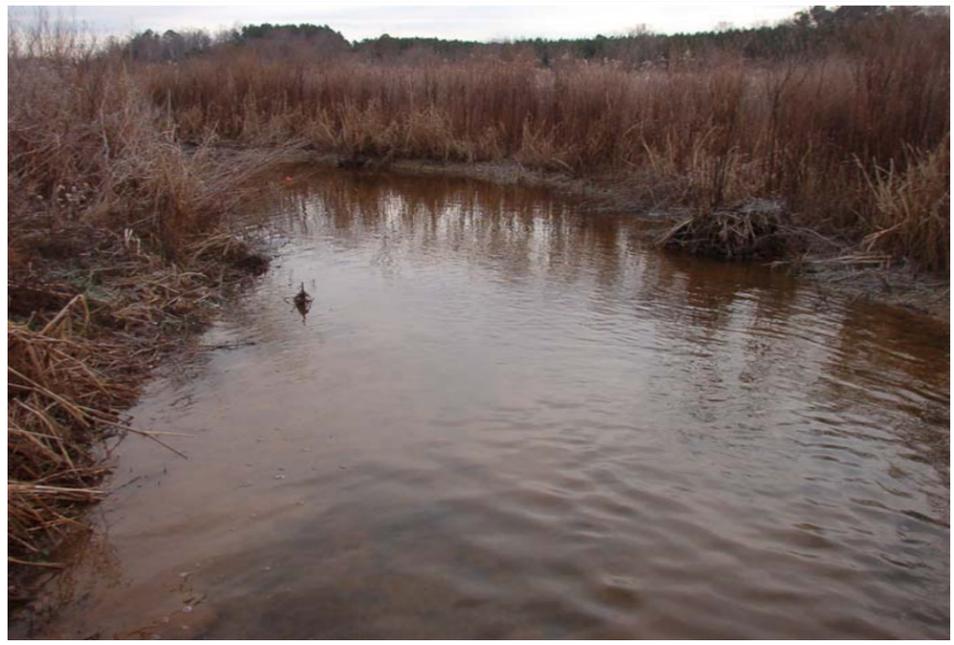
Title	Cross Section 7			Project #	.00013

Survey data from 2004 and 2005 at Cross Section 3, 5, 6, 8, and 12 correspond well in both horizontal and vertical directions, indicating that the stream is stable. Cross Sections 1, 7, 9, and 11 demonstrate slight shifts, while Cross Sections 2, 4, 7, and 10 demonstrate dramatic horizontal and vertical shifts. The considerable dissimilarity within the latter four cross sections suggests that errors exist in the 2004 data. Field observations that corroborate the deduction that the stream is stable, as observed in the aligned overlain cross sections, include: (1) well established vegetation along the stream banks and floodplain; (2) the lack of evidence of scour; (3) the lack of evidence of excessive deposition of sediment or wrack on the floodplain; and (4) the fact that clear bankfull indicators were identified at the lip of the floodplain, which serves as an indication that the channel has not aggraded or degraded.
