# Key Branch Stream and Wetland Restoration Site Year-7 Annual Monitoring Report (2010)

**Anson County, North Carolina  
WBS Element 34398.4.1  
TIP No. R-2239WM  
NCEEP Project 206**

**December 2010**

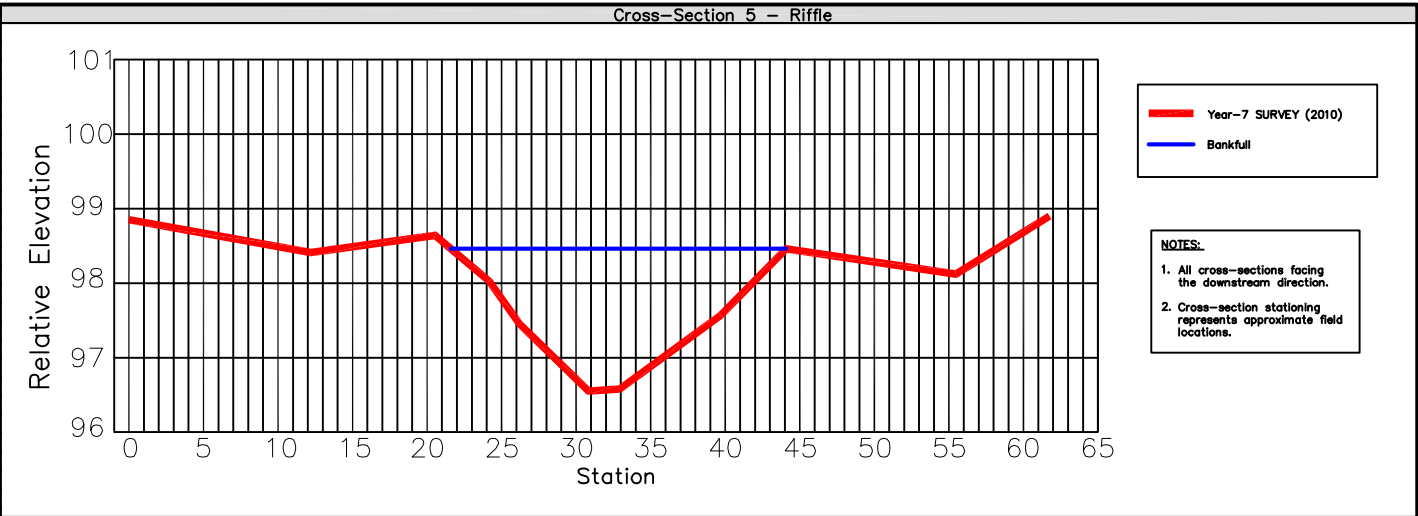
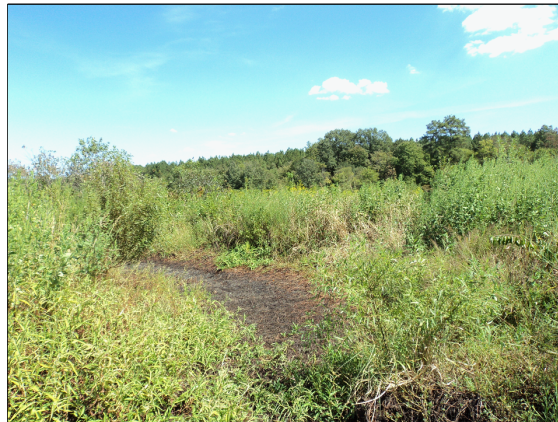
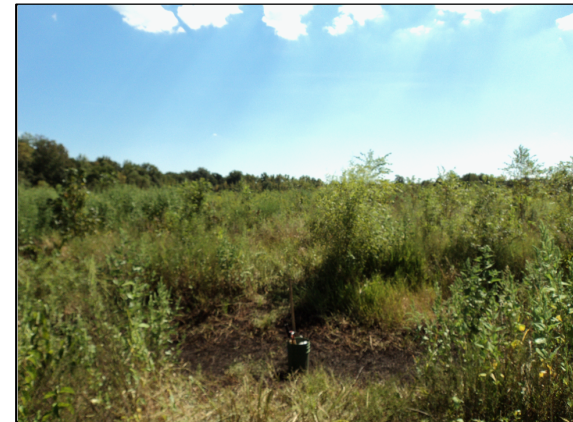
an Atkins company	Project	Key Branch Wetland and Stream Restoration Site, Anson County		Project #	206
	Survey Date	9/13/10 - 9/14/10		Figure	Cross-Section 5
	Survey Weather	Sunny		Field Team	Location
				Michael Gloden, Jeremy Schmid, Jens Geratz	Station 31+00

Summary Data	
Bankful Cross-Sectional Area	24.1
Bankfull Width	22.5
Bankfull Mean Depth	1.1
Bankfull Max Depth	1.9
Width/Depth Ratio	20.5
Entrenchment Ratio	4.4
Classification	C6

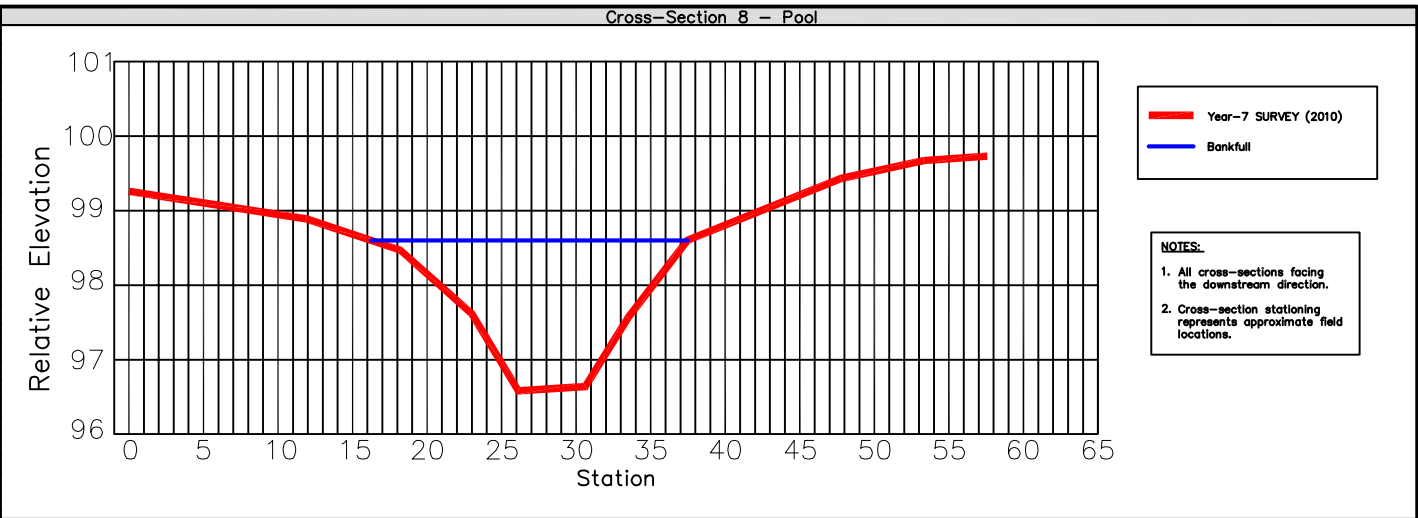
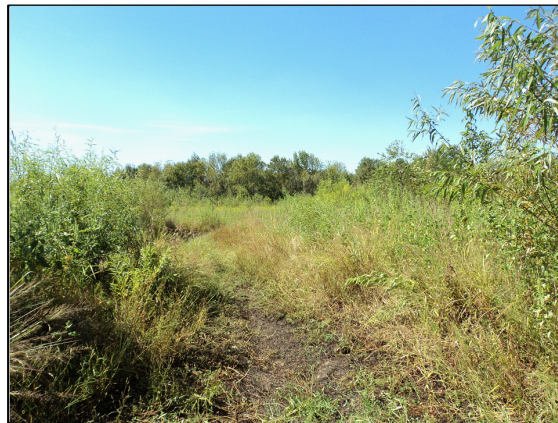
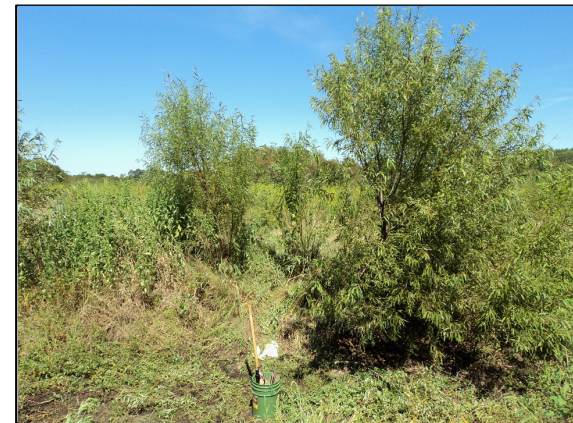
**Title** Cross-Section 8

Summary Data	
Bankful Cross-Sectional Area	22.8
Bankfull Width	21.2
Bankfull Mean Depth	1.1
Bankfull Max Depth	2.0
Width/Depth Ratio	19.3
Entrenchment Ratio	4.7
Classification	N/A

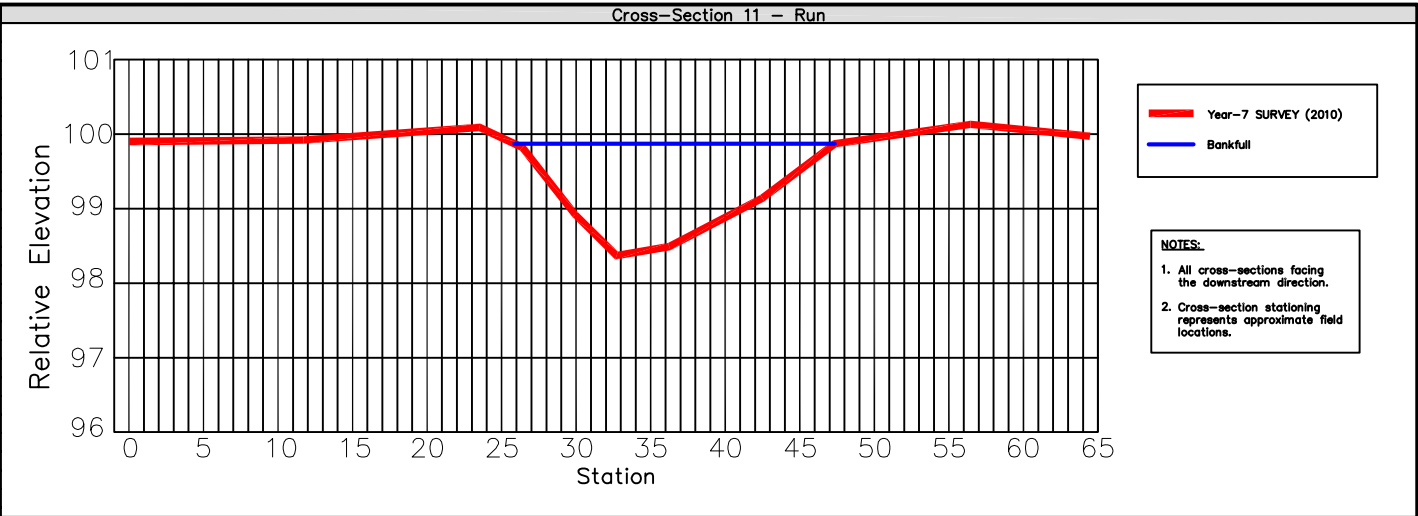
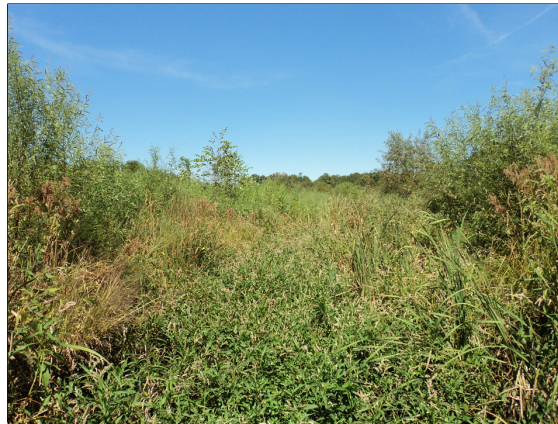
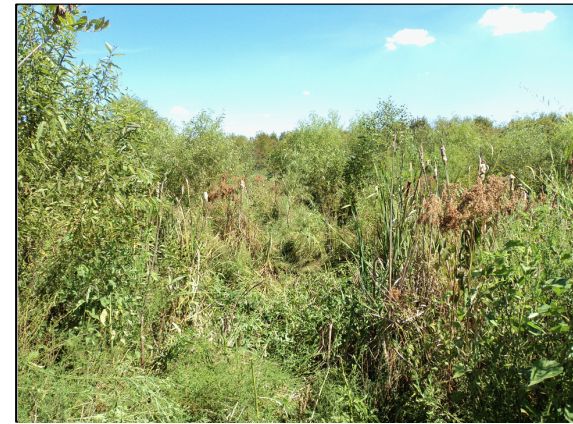
Title **Cross-Section 11**

Summary Data	
Bankful Cross-Sectional Area	18.6
Bankfull Width	21.5
Bankfull Mean Depth	0.9
Bankfull Max Depth	1.5
Width/Depth Ratio	23.9
Entrenchment Ratio	4.7
Classification	N/A
