MONITORING YEAR 1 ANNUAL REPORT

KEY MILL MITIGATION SITE

Surry County, NC
NCDEQ Contract No. 7180
DMS Project No. 100025
USACE Action ID No. SAW-2017-01504
NCDEQ DWR Certification No. 17-1045
RFP #: 16-006993

Data Collection Period: October 2020 – December 2020
Final Submission Date: March 25, 2021

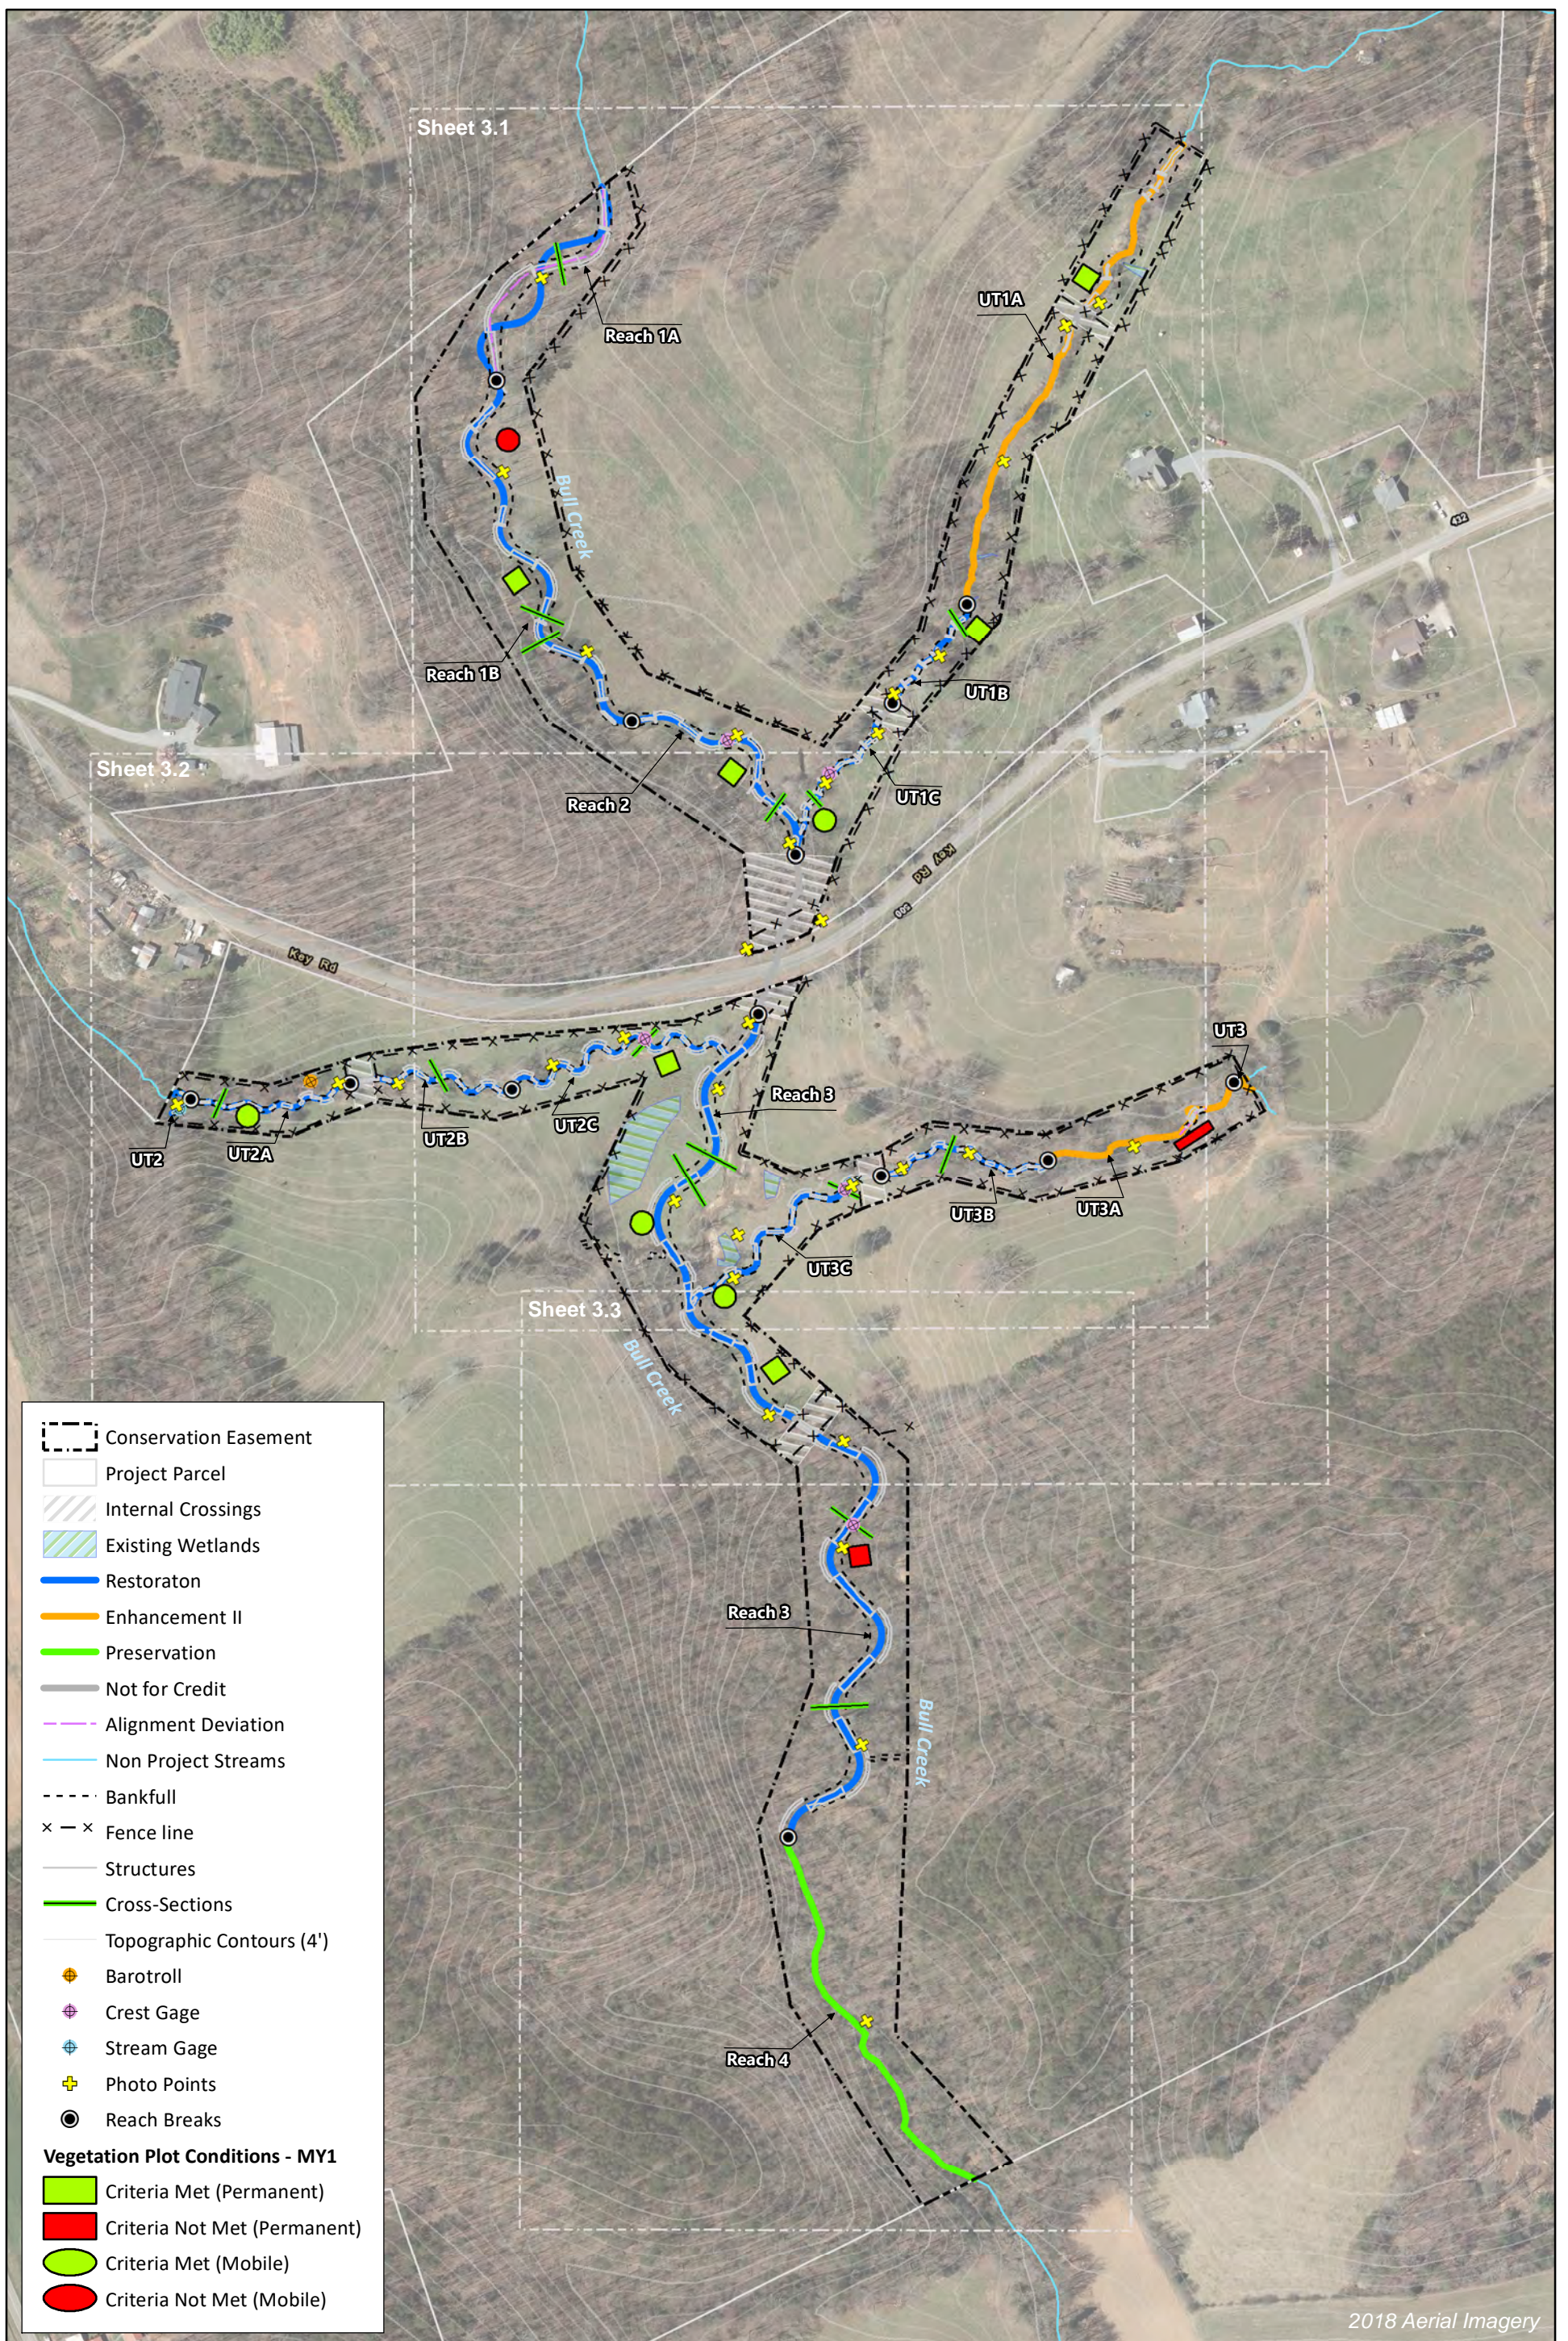
Figure 3.0 Current Conditions Plan View Map (Key)
 Key Mill Mitigation Site
 DMS Project No. 100025
 Monitoring Year 1 - 2020
 Surry County, NC

Areas of concern noted in Figures 3.0-3.3 are based on data collected during the Site assessment walk that was conducted on December 30, 2020 after repairs had been conducted on-site west of Key Road. However, the photos included in the photo log in Appendix 2 were taken on November 3 – 4, 2020,

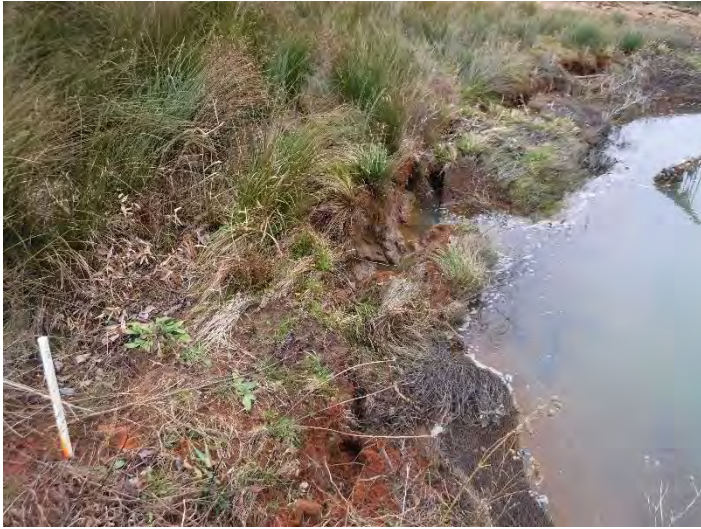
Bull Creek R2 Left Bank Scour/ Eroded at PP4 – looking downstream (12/30/2020)

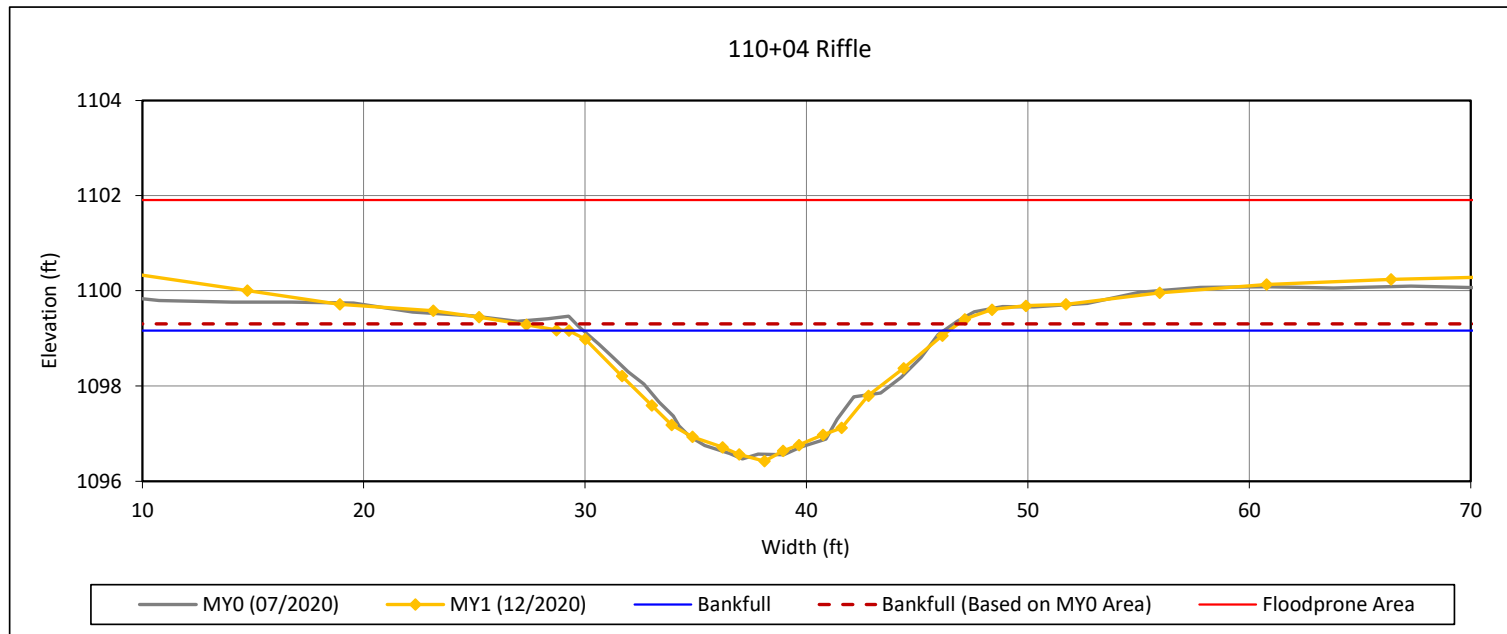
Cross-Section 2-Bull Creek Reach 1B

*Repairs conducted during MY1 resulted in a slight shift in the cross-section alignment between the MY0 and MY1 cross-section pin locations; therefore the plot was adjusted so that the cross-sections lined up for easier comparison.

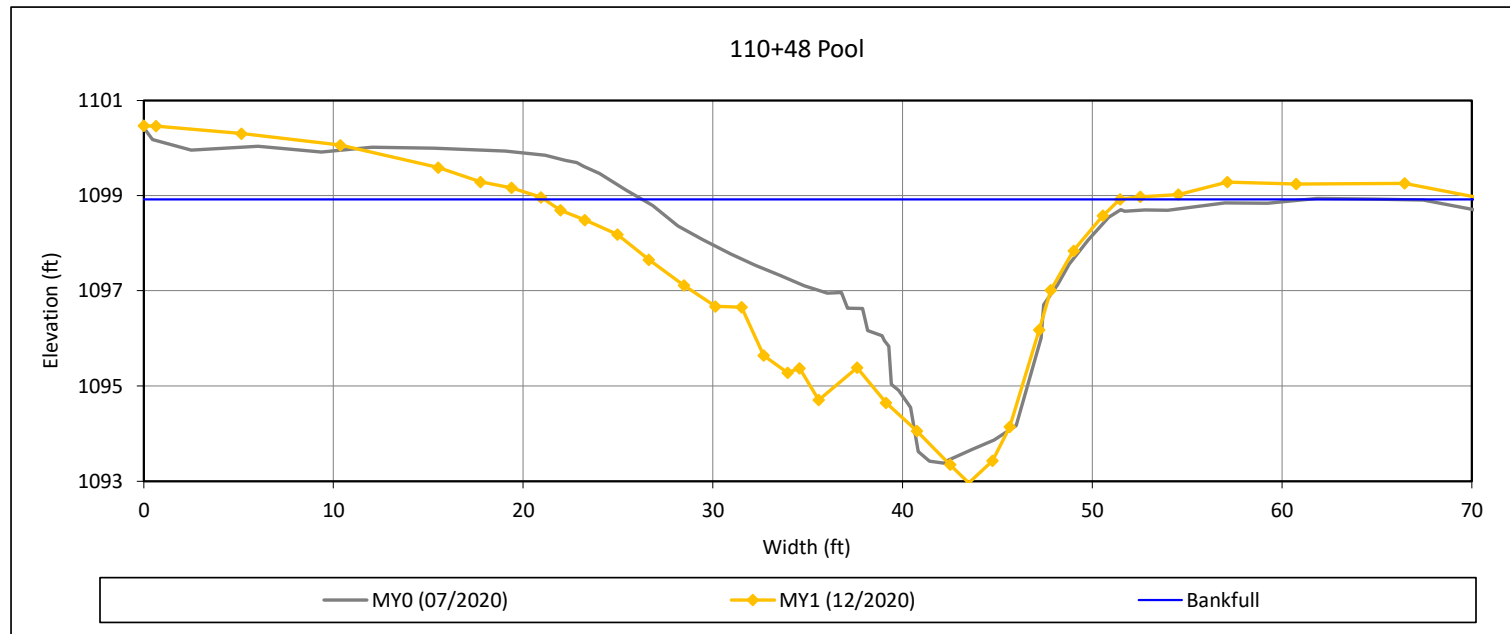
Cross-Section 3-Bull Creek Reach 1B

*Repairs were conducted on the left bank of XS3 during MY1 prior to the collection of the MY1 cross-section data and photos. The MY1 plot line shows the repaired cross-sectional profile. Also the station number for XS3 was incorrectly reported on the MY0 cross-section plot, it should have been reported as Station 110+48 as shown in the above plot.

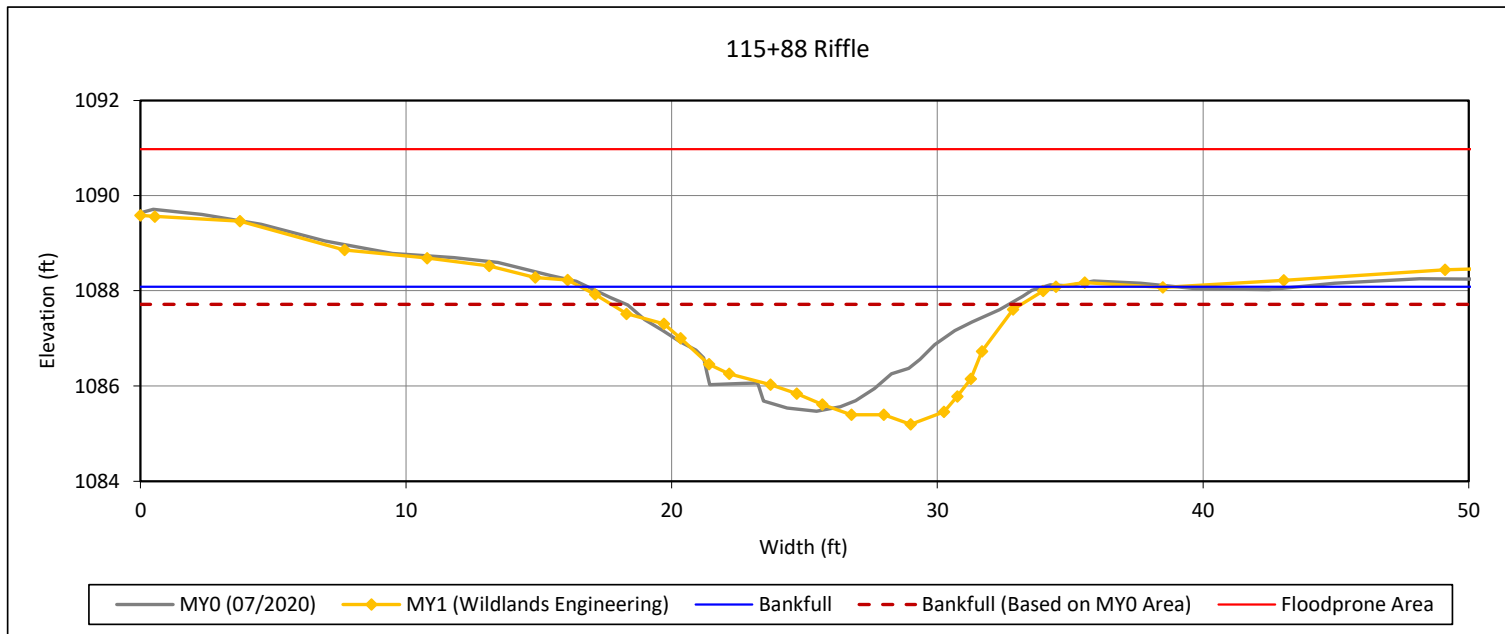
Cross-Section 4-Bull Creek Reach 2

*Repairs were conducted on the right bank of XS4 during MY1 prior to the collection of the MY1 cross-section data and photos. The MY1 plot line shows the repaired cross-sectional profile. Also the station number for XS4 was incorrectly reported on the MY0 cross-section plot, it should have been reported as Station 115+88 as shown in the above plot.

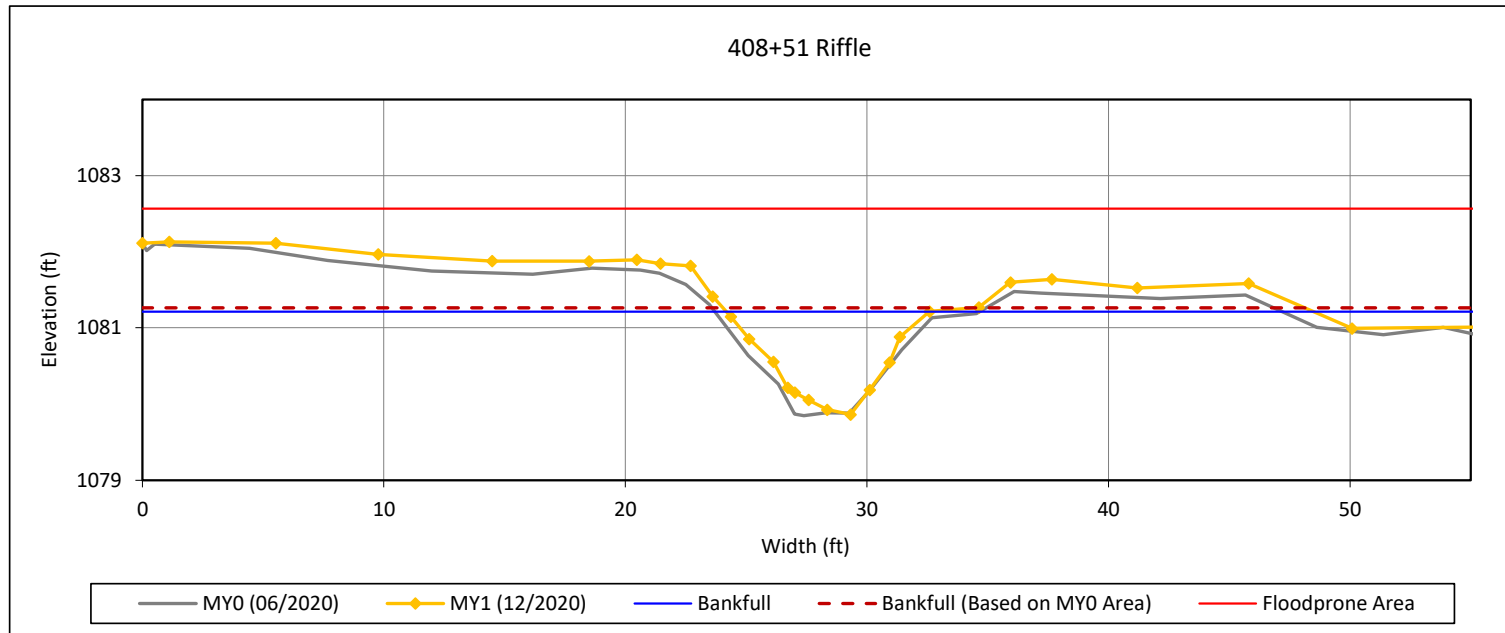
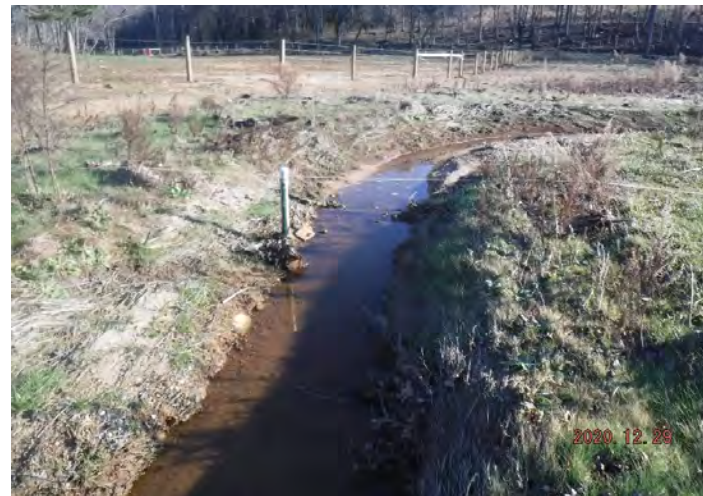
Cross-Section 15-UT3C

6.4	x-section area (ft.sq.)
8.4	width (ft)
0.8	mean depth (ft)
1.4	max depth (ft)
9.0	wetted perimeter (ft)
0.7	hydraulic radius (ft)
11.1	width-depth ratio
55.8	W flood prone area (ft)
6.6	entrenchment ratio
1.0	low bank height ratio
