AS-BUILT BASELINE MONITORING REPORT

KEY MILL MITIGATION SITE

Surry County, NC
NCDEQ Contract No. 7180
DMS Project No. 100025
USACE Action ID No. SAW-2017-01504
Yadkin River Basin
HUC 03040101

Data Collection Period: September 2019 – July 2020
Submission Date: October 5, 2020

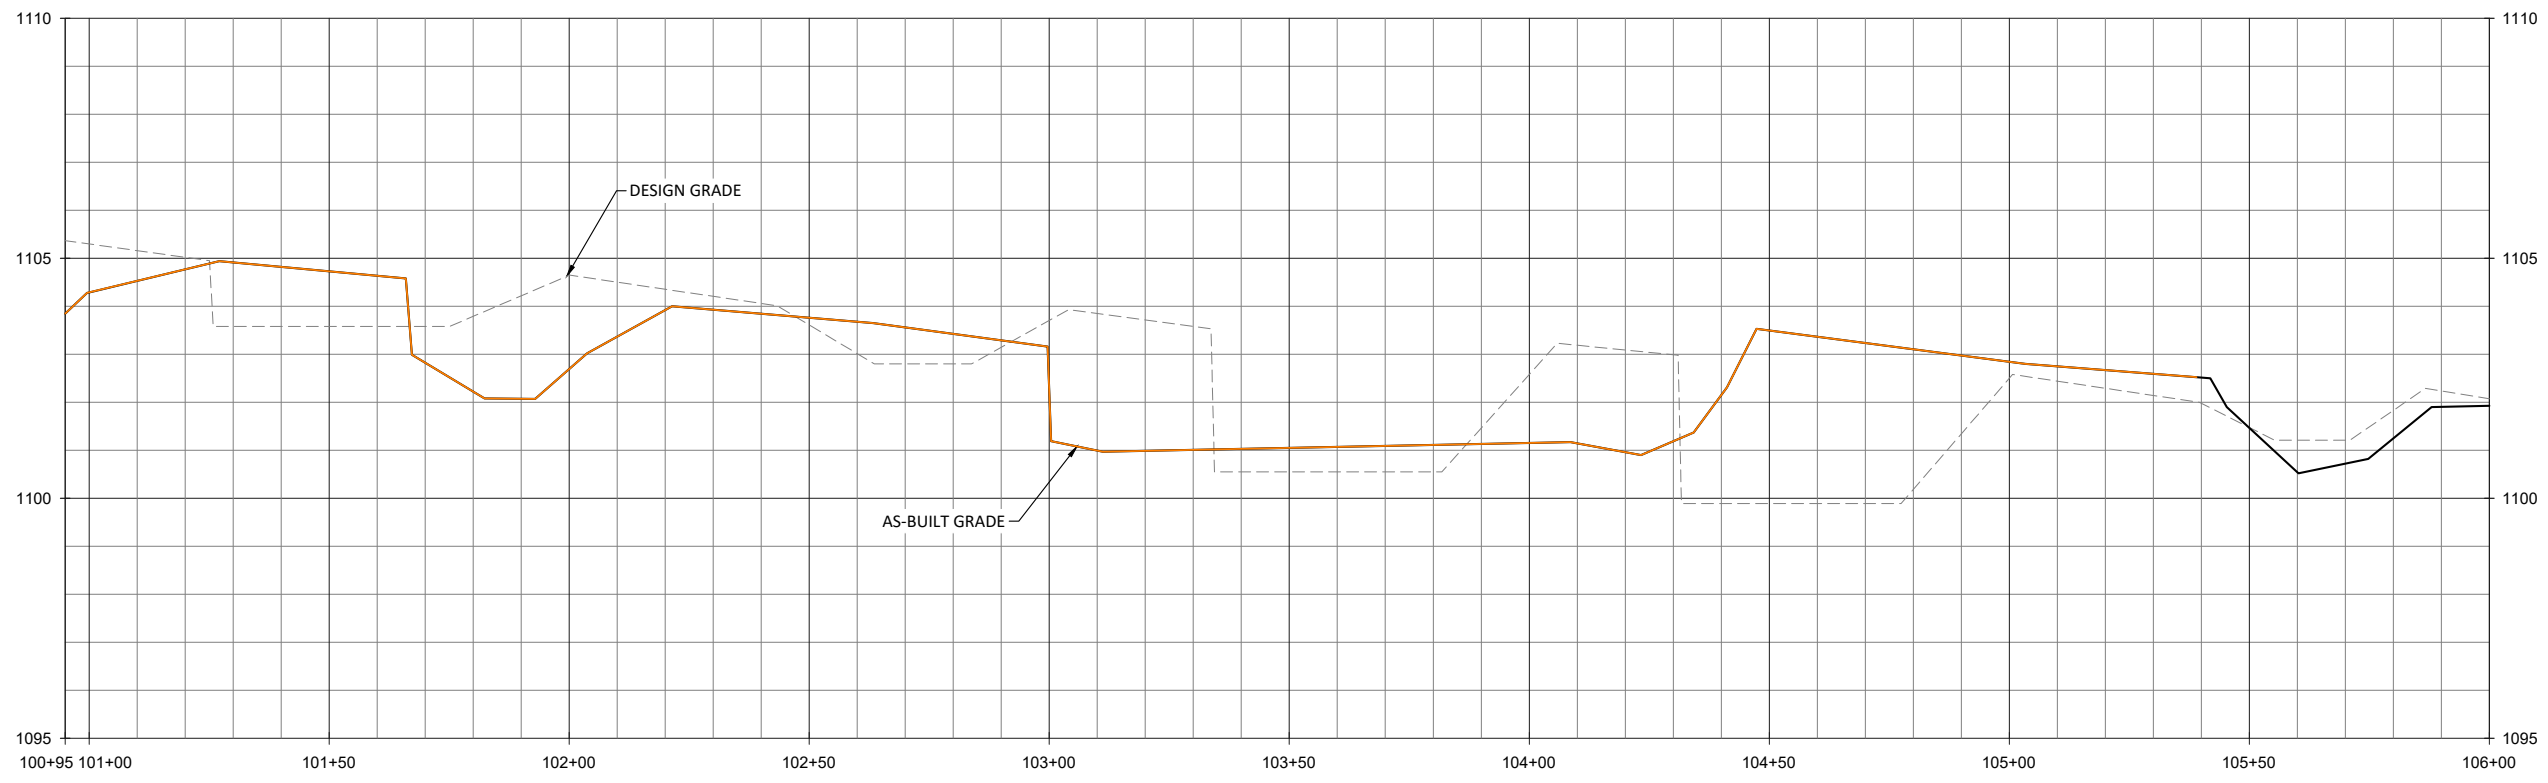
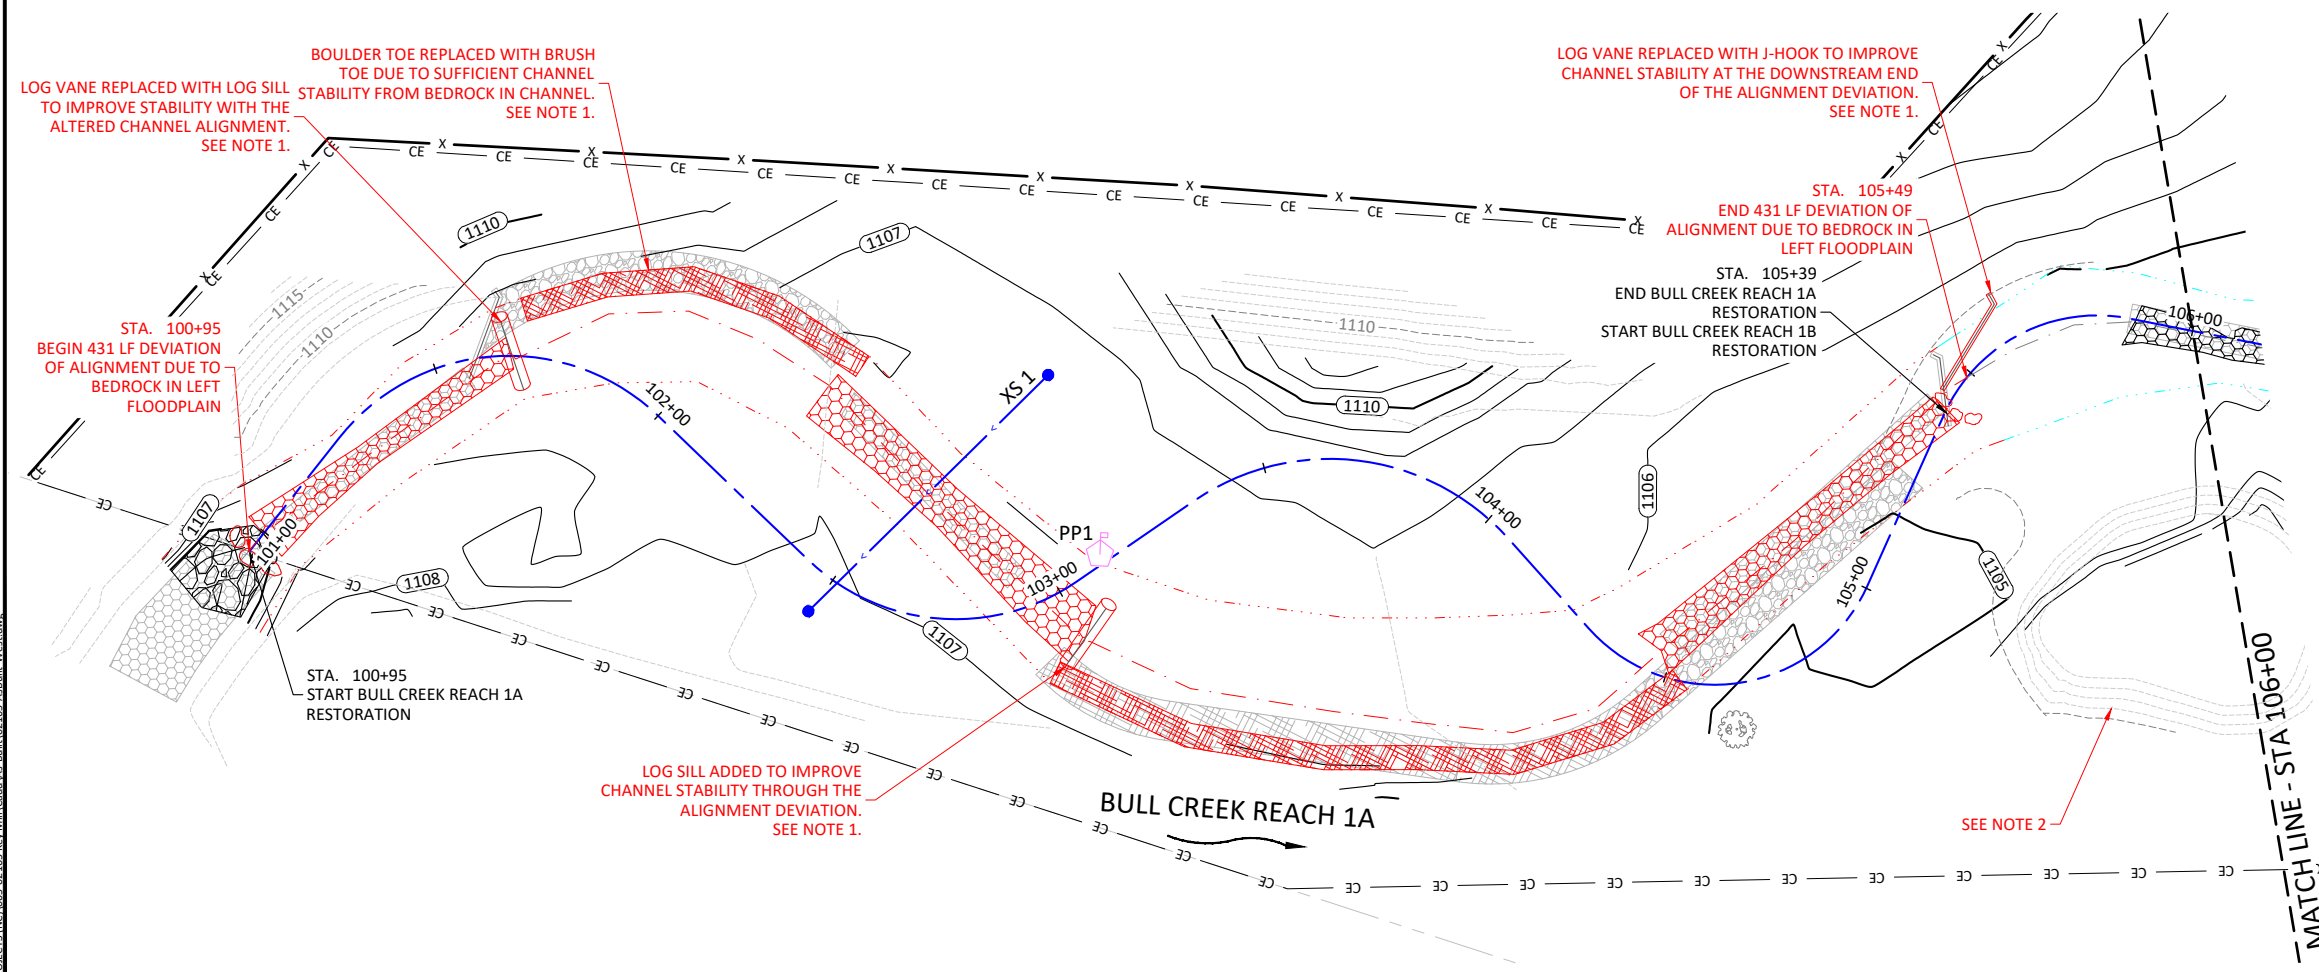
Key Mill Mitigation Site - Record Drawings
Surry County, North Carolina
 Bull Creek Reach 1A
 Stream Plan and Profile

1. STA. 100+95-105+49: THE CHANNEL DESIGN WAS ALTERED AND REALIGNED DUE TO BEDROCK THAT WAS PRESENT IN THE LEFT FLOODPLAIN WHICH RESULTED IN 431 LF OF CONSTRUCTED CHANNEL, COMPARED TO THE 454 LF IN ORIGINAL DESIGN.
2. STA. 105+75: THE VERNAL POOL AT DEPICTED LOCATION WAS NOT INSTALLED BECAUSE IT WAS NOT NECESSARY TO BALANCE ONSITE EARTHWORK VOLUMES AT THIS LOCATION.

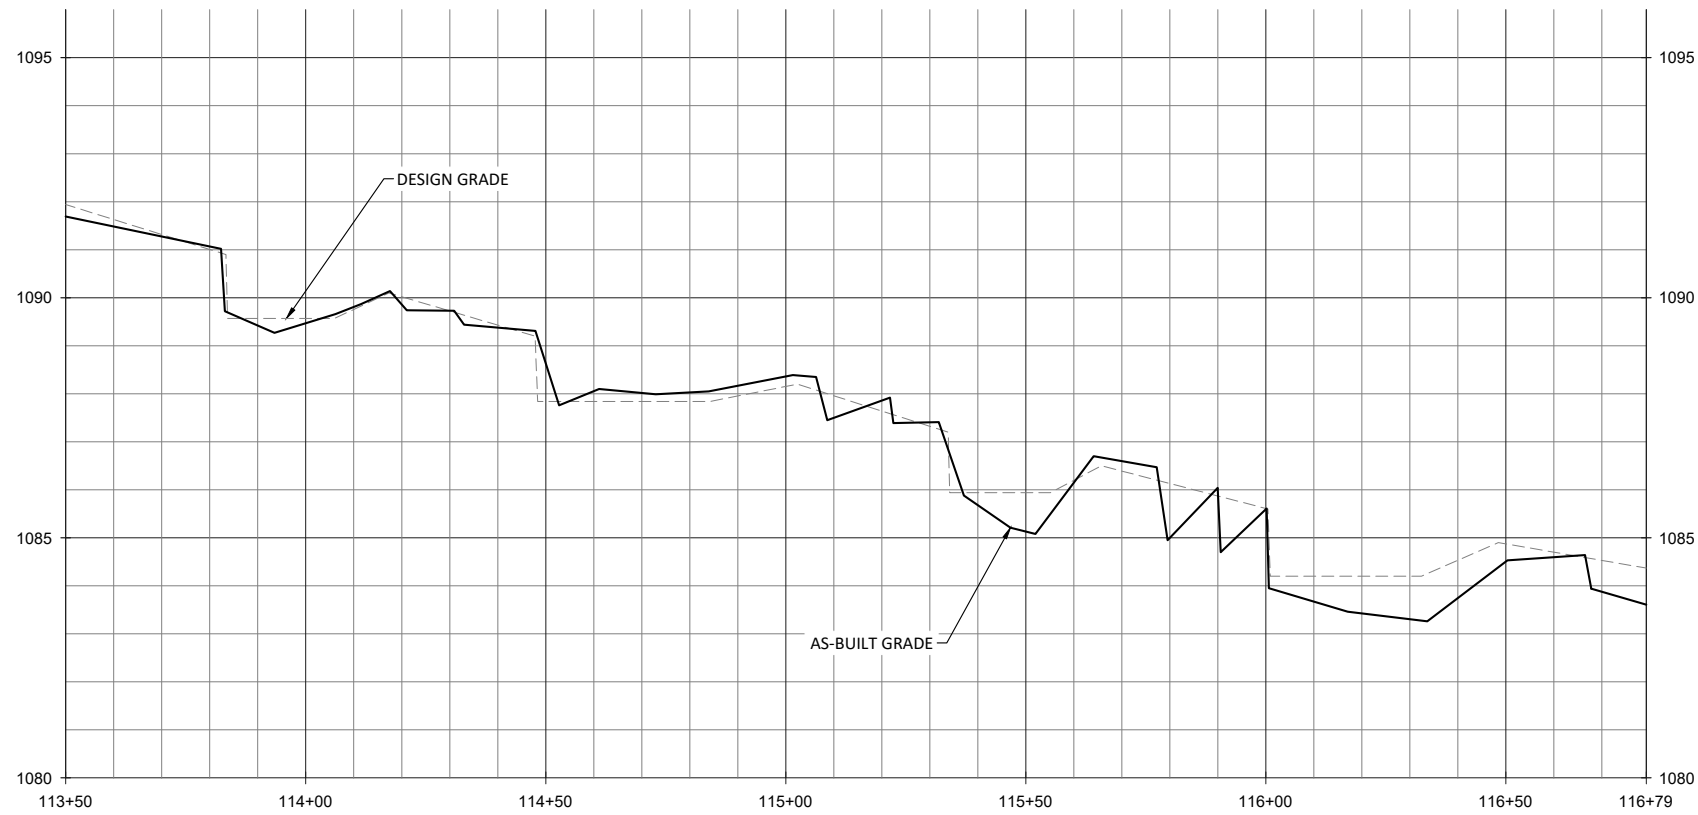
STA. 114+32: CREST GAGE WAS MOVED UPSTREAM AFTER THE AS-BUILT SURVEY WAS COLLECTED TO AVOID THE POSSIBILITY OF FALSE BANKFULL READINGS IN THE EVENT THAT WATER SHOULD BACK UP AT THE CONFLUENCE.

STA. 115+88: THE LOCATION OF XS4 WAS ADJUSTED AFTER THE AS-BUILT SURVEY WAS COLLECTED BECAUSE THE CROSS SECTION WAS INADVERTANTLY DISTURBED FROM CONSTRUCTION EQUIPMENT DURING CHANNEL REPAIRS FROM A LARGE STORM EVENT.

1. STA. 113+80: LOG SILL WAS SUBSTITUTED FOR ROCK SILL DUE TO LOCAL MATERIAL AVAILABILITY AND SITE CONDITIONS.
2. STA. 113+85: BRUSH TOE WAS SUBSTITUTED FOR BRUSH MATTRESS DUE TO SUFFICIENT BANK STABILITY FOLLOWING CONSTRUCTION OF THE PROPOSED CHANNEL.
3. STA. 115+45: BRUSH TOE WAS SUBSTITUTED FOR BOULDER TOE DUE TO SUFFICIENT BANK STABILITY FOLLOWING CONSTRUCTION OF THE PROPOSED CHANNEL.
4. STA. 116+00: LOG SILL WAS SUBSTITUTED FOR ROCK SILL DUE TO LOCAL MATERIAL AVAILABILITY AND SIMILAR FUNCTIONALITY.
5. STA. 116+62: PHOTO POINT 4A WAS ADDED AFTER THE SURVEY WAS COMPLETED AT THE REQUEST OF DMS TO CAPTURE THE CONSERVATION EASEMENT BREAK.

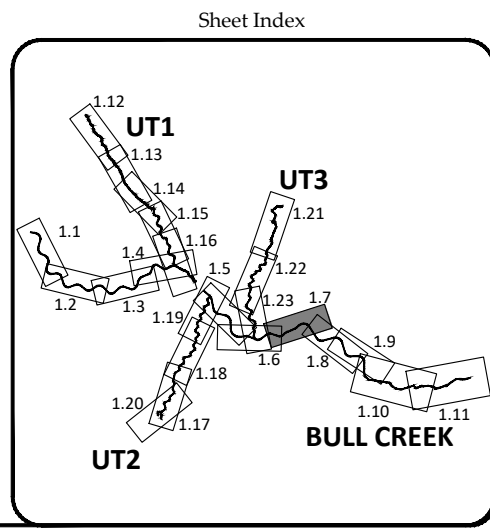
1.7

- NOTE:**
1. STA. 157+72: BRUSH MATTRESS REPLACED WITH BRUSH TOE DUE TO TIME OF YEAR OF INSTALLATION. LOG VANE REMOVED DUE TO BANK STABILITY AND HABITAT ENHANCEMENT PROVIDED BY BRUSH TOE.
 2. STA. 158+22: PHOTO POINT 7 WAS MOVED AFTER THE SURVEY WAS COMPLETED AT THE REQUEST OF DMS TO CAPTURE A DOWNSTREAM VIEW OF THE CULVERT CROSSING.
 3. STA. 158+40: ROCK SILL REPLACED WITH LOG SILL DUE TO LOCAL MATERIAL AVAILABILITY AND SIMILAR FUNCTIONALITY.
 4. STA. 159+50: PHOTO POINT 8 WAS MOVED AFTER THE SURVEY WAS COMPLETED AT THE REQUEST OF DMS TO CAPTURE AN UPSTREAM VIEW OF THE CULVERT CROSSING.
 5. STA. 159+84: BRUSH TOE WAS SUBSTITUTED FOR BOULDER TOE AND LOG VANE REMOVED DUE TO LOCAL MATERIAL AVAILABILITY AND THE BANK STABILITY AND HABITAT ENHANCEMENT PROVIDED BY BRUSH TOE.

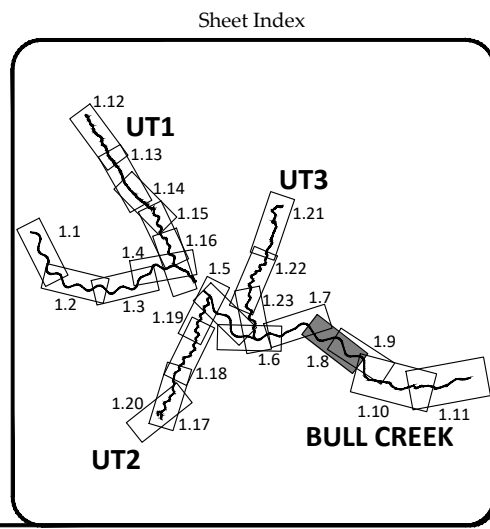
- NOTE:**
1. STA. 161+56: LOG VANE REMOVED AND BRUSH TOE ADDED TO OUTSIDE BANK TO IMPROVE STABILITY FOR THE ENTIRE OUTSIDE BANK.
 2. STA. 163+30: LOG VANE REMOVED AND BRUSH TOE EXTENDED DUE TO AVAILABILITY OF MATERIALS AND TO IMPROVE STREAM BANK STABILITY AND HABITAT.
 3. STA. 164+47: LOG VANE REMOVED, LOG SILL ADDED AND BRUSH TOE EXTENDED DUE TO LOCAL AVAILABILITY OF MATERIALS AND TO IMPROVE CHANNEL STABILITY AND HABITAT.

STA. 161+14: CROSS SECTION AND
 CREST GAGE WERE MOVED AFTER THE
 AS-BUILT SURVEY WAS COLLECTED
 BECAUSE THE CURRENT RIFFLE
 LOCATION BETTER REPRESENTS THE
 CONDITIONS OF THE REACH.

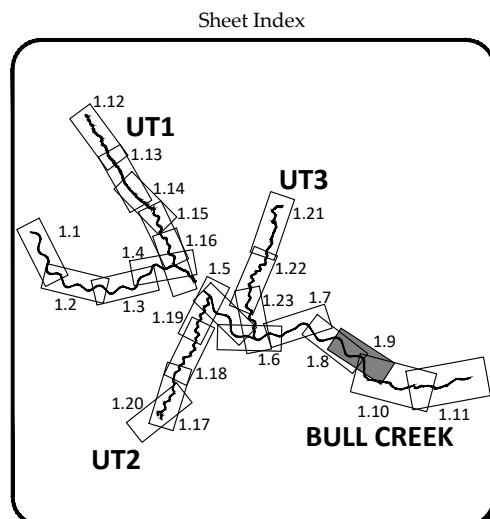
- NOTE:**
1. STA. 165+75: LOG VANE REMOVED AND BRUSH TOE EXTENDED DUE TO AVAILABILITY OF MATERIALS AND THE IMPROVED HABITAT PROVIDED BY BRUSH TOE.
 2. STA. 166+97: LOG SILL WAS SUBSTITUTED FOR ROCK SILL DUE TO LOCAL MATERIAL AVAILABILITY AND SITE CONDITIONS.
 3. STA. 167+00: BRUSH TOE WAS ADDED TO IMPROVE BANK STABILITY.

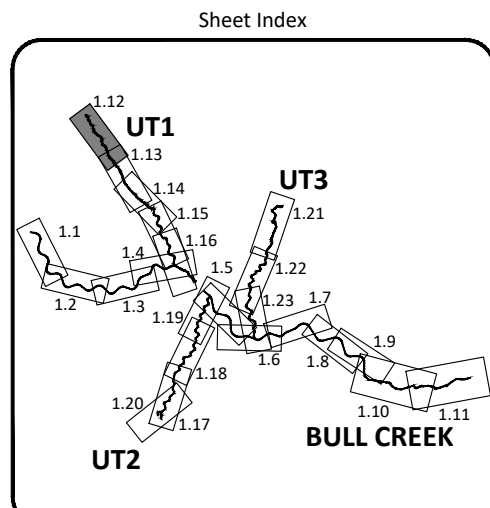
1.12
 Sheet

- NOTES:**
1. STA. 202+26: POOL WAS NOT EXCAVATED DUE TO EXISTING PROFILE STABILITY.
 2. STA. 203+32: PHOTO POINT 12 WAS MOVED AFTER THE SURVEY WAS COMPLETED AT THE REQUEST OF DMS TO CAPTURE A DOWNSTREAM VIEW OF THE CULVERT CROSSING.
 3. STA. 203+90: PHOTO POINT 12A WAS ADDED AFTER THE SURVEY WAS COMPLETED AT THE REQUEST OF DMS TO CAPTURE AN UPSTREAM VIEW OF THE CULVERT CROSSING.

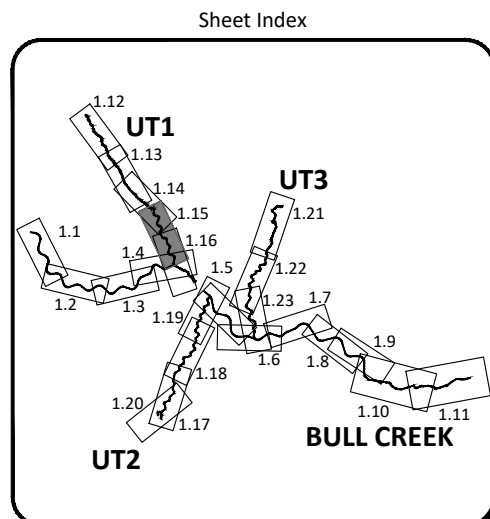
- NOTE:**
1. STA. 209+65: RIFFLE, ROCK SILL AND POOL WERE OMITTED DUE TO SUFFICIENT STABILITY AND SLOPE ON THE REACH.
 2. STA. 210+83: PHOTO POINT 14A WAS ADDED AFTER THE SURVEY WAS COMPLETED AT THE REQUEST OF DMS TO CAPTURE A DOWNSTREAM VIEW OF THE CULVERT CROSSING.
 3. STA. 211+57: PHOTO POINT 14B WAS ADDED AFTER THE SURVEY WAS COMPLETED AT THE REQUEST OF DMS TO CAPTURE AN UPSTREAM VIEW OF THE CULVERT CROSSING.
 4. STA. 212+35: UPSTREAM ROCK AND ROLL RIFFLE BOULDER SILL WAS OMITTED AND RIFFLE WAS EXTENDED TO CONNECT TO DOWNSTREAM ROCK AND ROLL RIFFLE.

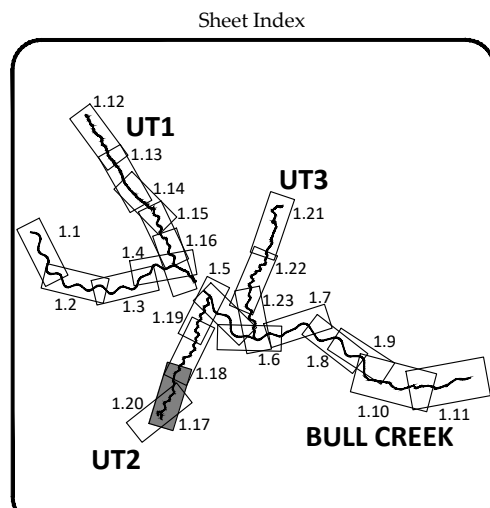
- NOTE:**
1. STA. 300+40, 302+25, & 302+83: ROCK SILLS REPLACED WITH LOG SILLS DUE TO LOCAL MATERIAL AVAILABILITY AND SIMILAR FUNCTIONALITY.
 2. STA. 302+95: PHOTO POINT 17 WAS MOVED AFTER THE SURVEY WAS COMPLETED AT THE REQUEST OF DMS TO CAPTURE A DOWNSTREAM VIEW OF THE CULVERT CROSSING.

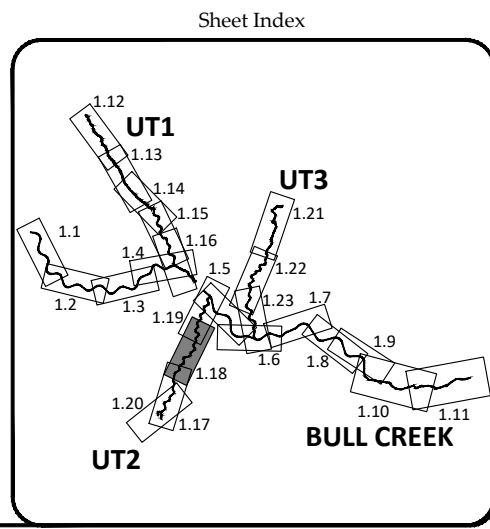
- Station 303+59: Rock sill was replaced with log sill due to local material availability and similar functionality.
- Station 303+90: Photo point 18 was moved after the survey was completed at the request of DMS to capture an upstream view of the culvert crossing.
- Station 305+90: Rock sill was replaced with log sill due to local material availability and similar functionality.

- NOTE:**
1. STA. 303+59 & 305+90: ROCK SILLS REPLACED WITH LOG SILLS DUE TO LOCAL MATERIAL AVAILABILITY AND SIMILAR FUNCTIONALITY.
 2. STA. 303+90: PHOTO POINT 18 WAS MOVED AFTER THE SURVEY WAS COMPLETED AT THE REQUEST OF DMS TO CAPTURE AN UPSTREAM VIEW OF THE CULVERT CROSSING.

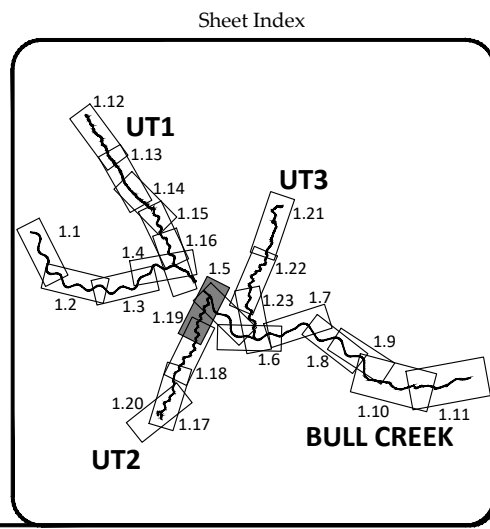
UT2C
 Stream Plan and Profile

- Station 310+33: Rock sill was replaced with log sill due to local material availability and similar functionality.

NOTE:
 1. STA. 310+33: ROCK SILL REPLACED WITH LOG SILL DUE TO LOCAL MATERIAL AVAILABILITY AND SIMILAR FUNCTIONALITY.

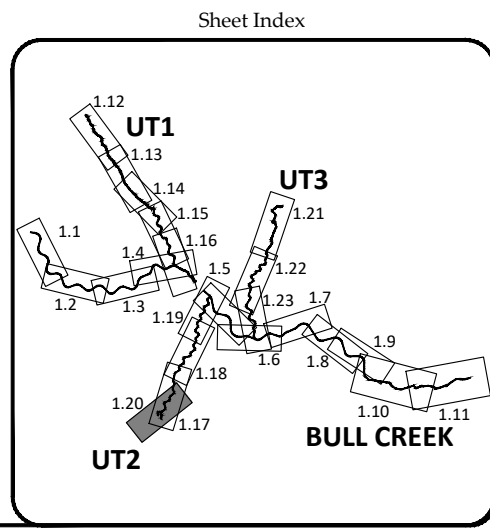
UT2
 Stream Plan and Profile

NOTE:
 1. STA. 350+08 & 350+27: ROCK SILLS REPLACED WITH LOG SILLS DUE TO LOCAL MATERIAL AVAILABILITY AND SIMILAR FUNCTIONALITY.

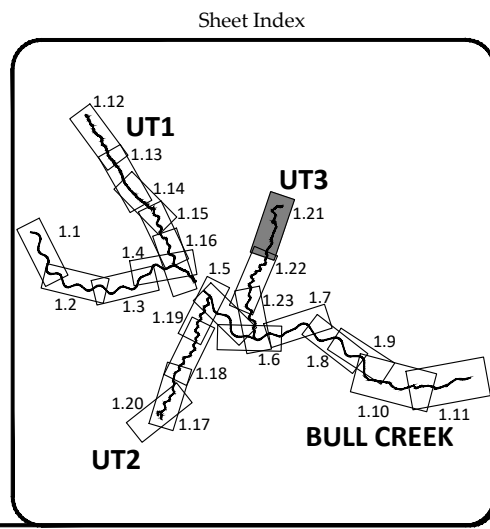
- Station 401+64 – 402+45: The channel design was altered and realigned to improve bank stability and meander pattern
- Station 401+71 - 402+29: Rock sills were replaced with log sills due to local material availability and similar functionality.

- NOTE:**
1. STA. 401+64 - 402+45: THE CHANNEL DESIGN WAS ALTERED AND REALIGNED TO IMPROVE BANK STABILITY AND MEANDER PATTERN WHICH RESULTED IN 58 LF OF CONSTRUCTED CHANNEL, COMPARED TO 81 LF IN THE ORIGINAL DESIGN.
 2. STA. 401+71 - 402+29: ROCK SILLS REPLACED WITH LOG SILLS DUE TO LOCAL MATERIAL AVAILABILITY AND SIMILAR FUNCTIONALITY.

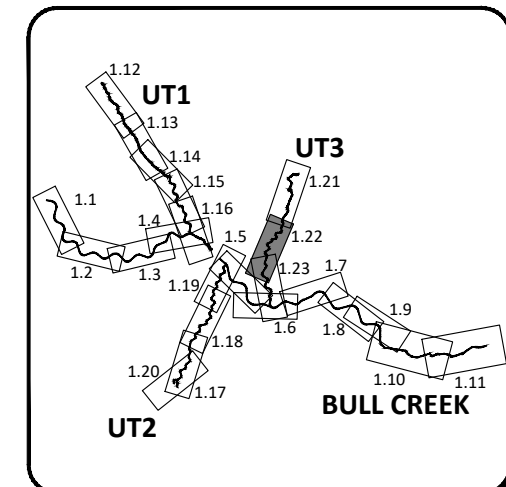
UT3B and UT3C
Stream Plan and Profile

- Station 404+89 – 407+35: Riffle elevations adjusted due to the upstream tie in elevation being changed due to field conditions.
- Station 402+82: Rock sills were replaced with log sills due to local material availability and similar functionality.

- Station 405+06: Rock sills were replaced with log sills due to local material availability and similar functionality.
- Station 405+32: Rock sills were replaced with log sills due to local material availability and similar functionality.

- Station 405+58: Rock sills were replaced with log sills due to local material availability and similar functionality.
- Station 405+82: Rock sills were replaced with log sills due to local material availability and similar functionality.

- Station 406+59: Rock sills were replaced with log sills due to local material availability and similar functionality.
- Station 406+85: Rock sills were replaced with log sills due to local material availability and similar functionality.

- Station 407+09: Rock sills were replaced with log sills due to local material availability and similar functionality.

- Station 407+35: Rock sills were replaced with log sills due to local material availability and similar functionality.
- Station 407+41: Photo point 22A was added after the survey was completed at the request of DMS to capture a downstream view of the culvert crossing.

- NOTE:**
1. STA. 404+82, 405+06, 405+32, 405+58, 405+82, 406+59, 406+85, 407+09 AND 407+35: ROCK SILLS REPLACED WITH LOG SILLS DUE TO LOCAL MATERIAL AVAILABILITY AND SIMILAR FUNCTIONALITY.
 2. STA. 404+89 - 407+35: RIFFLE ELEVATIONS ADJUSTED DUE TO THE UPSTREAM TIE IN ELEVATION BEING CHANGED DUE TO FIELD CONDITIONS.
 3. STA. 407+41: PHOTO POINT 22A WAS ADDED AFTER THE SURVEY WAS COMPLETED AT THE REQUEST OF DMS TO CAPTURE A DOWNSTREAM VIEW OF THE CULVERT CROSSING.

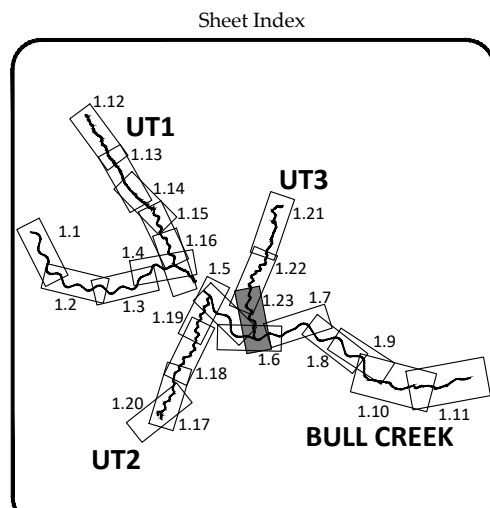
- Station 408+22: Rock sills were replaced with log sills due to local material availability and similar functionality.
- Station 408+33: Photo point 24 was moved after the survey was completed at the request of DMS to capture an upstream view of the culvert crossing.
- Station 411+86: Rock sills were replaced with log sills due to local material availability and similar functionality.

- NOTE:**
1. STA. 408+22: ROCK SILLS REPLACED WITH LOG SILLS DUE TO LOCAL MATERIAL AVAILABILITY AND SIMILAR FUNCTIONALITY.
 2. STA. 408+33: PHOTO POINT 24 WAS MOVED AFTER THE SURVEY WAS COMPLETED AT THE REQUEST OF DMS TO CAPTURE AN UPSTREAM VIEW OF THE CULVERT CROSSING.
 3. STA. 411+86: ROCK SILL REPLACED WITH LOG SILL DUE TO LOCAL MATERIAL AVAILABILITY AND SIMILAR FUNCTIONALITY.

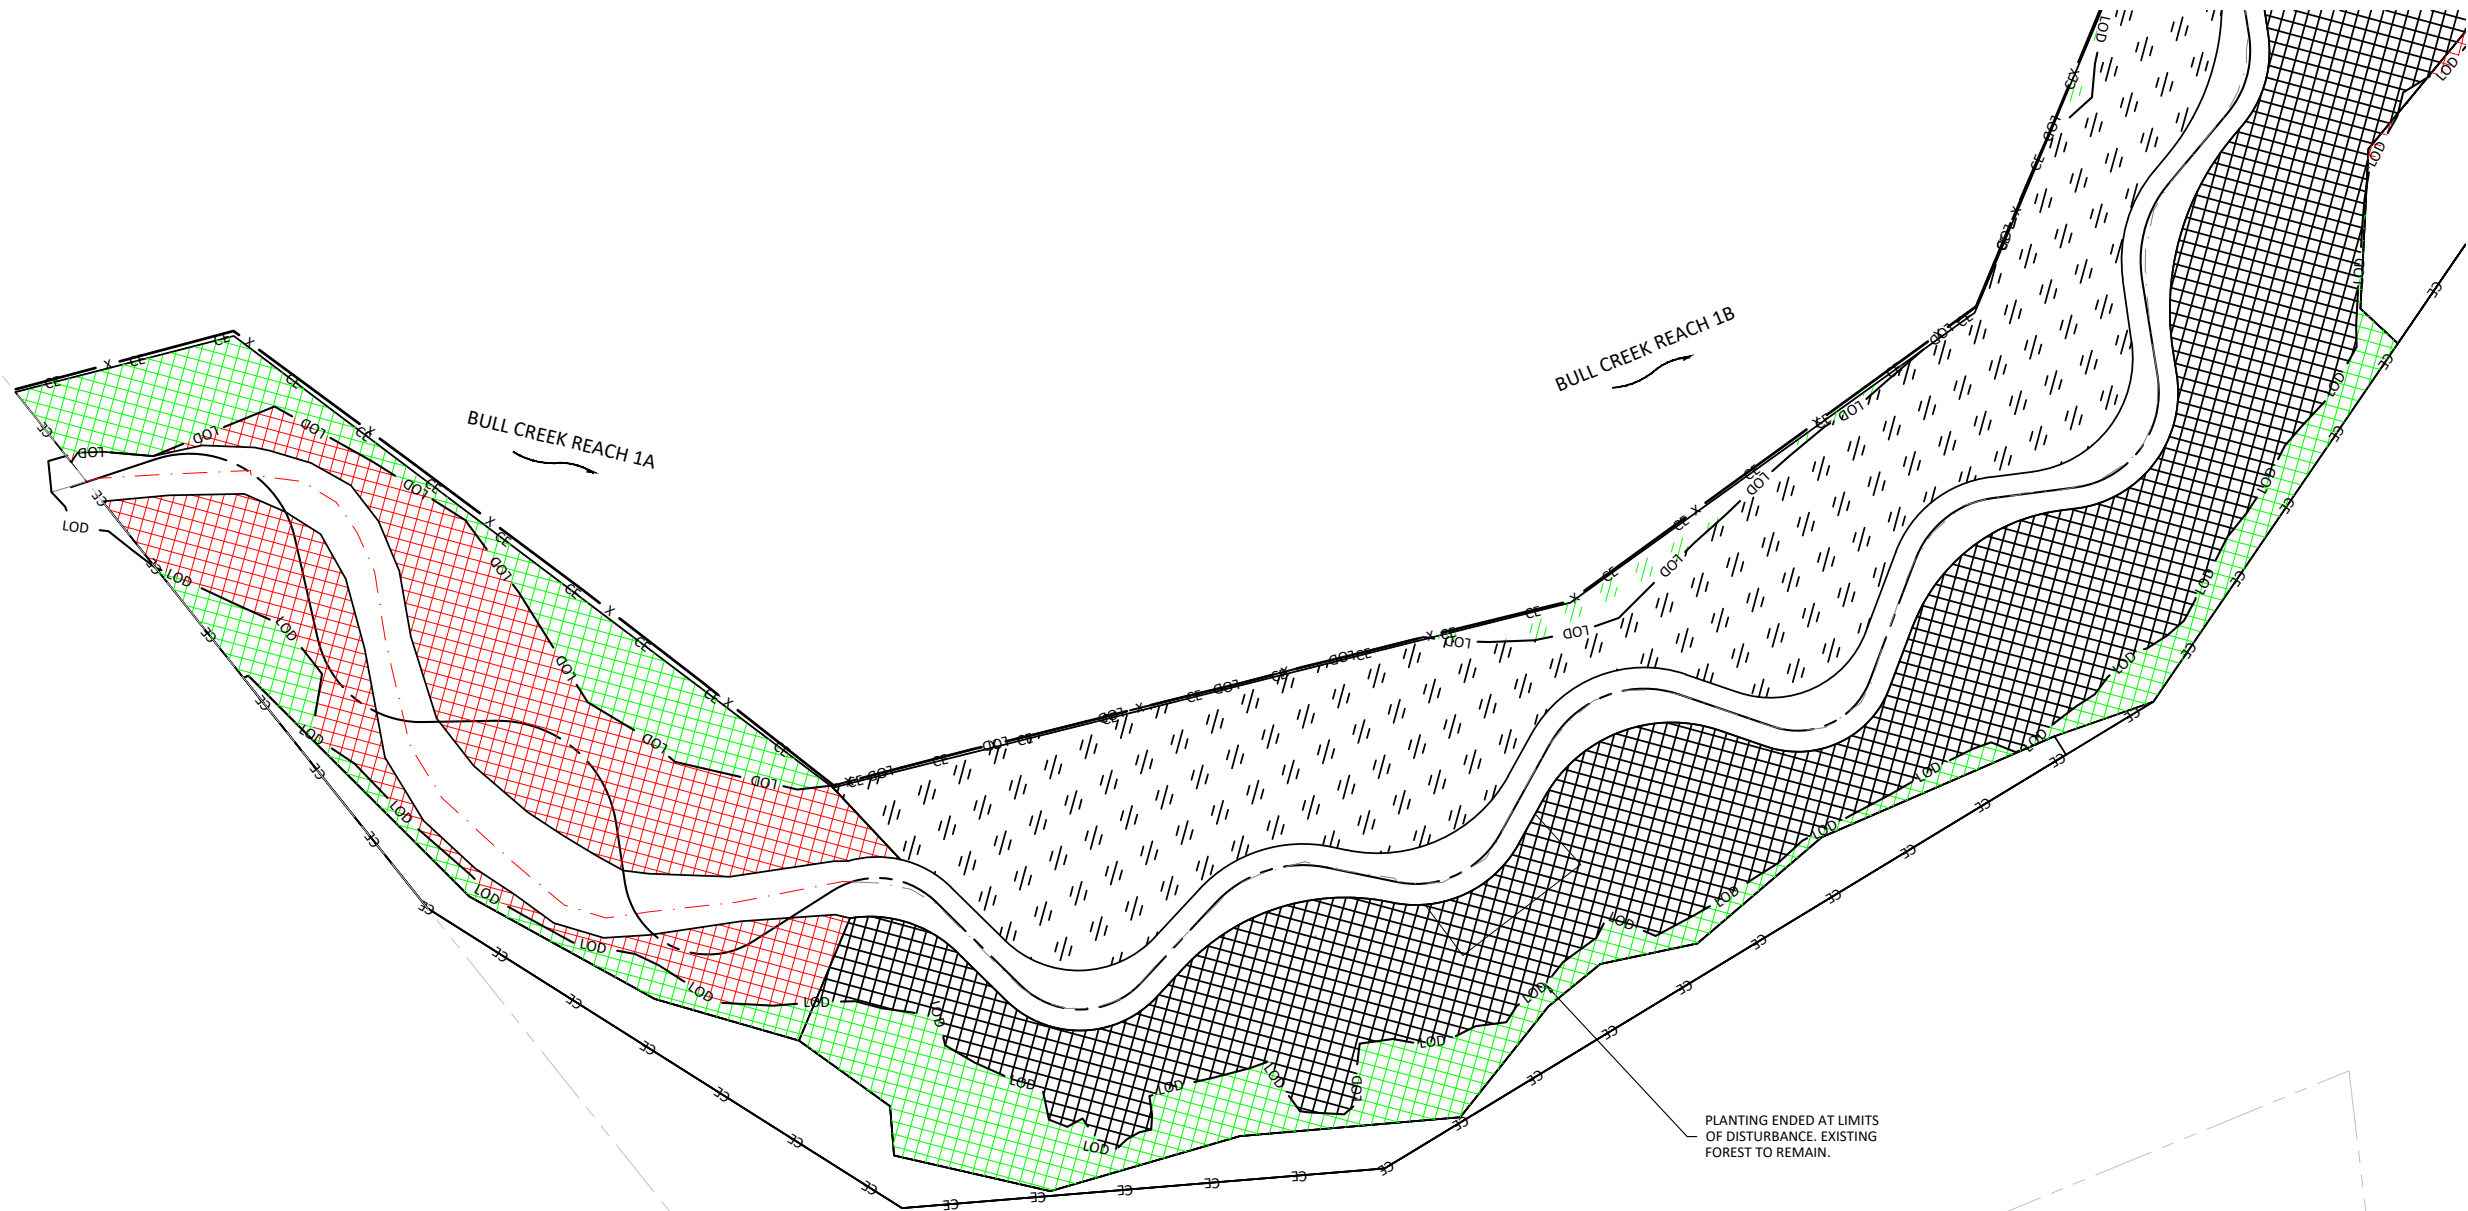
Bull Creek West
 Planting Plan

1. DEVIATIONS TO THE DESIGN PLANTING PLAN THAT WERE INSIDE OF THE AS-BUILT LIMIT OF DISTURBANCE AND WERE PLANTED ARE SHOWN IN RED.
2. DEVIATIONS TO THE DESIGN PLANTING PLAN THAT WERE OUTSIDE THE AS-BUILT LIMIT OF DISTURBANCE AND WERE NOT PLANTED ARE SHOWN IN GREEN.
3. STA.100+95-105+39: PLANTING AREA ALTERED DUE TO BEDROCK THAT WAS PRESENT IN THE LEFT FLOODPLAIN.
