MONITORING YEAR 3 ANNUAL REPORT

KEY MILL MITIGATION SITE

Surry County, NC

DMS Project No. 100025

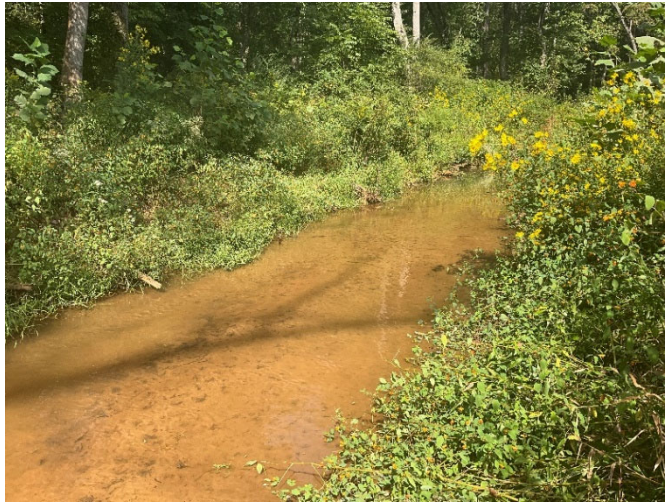
Bull Creek Reach 1A: aggradation at station 104+00 – 104+25 – looking upstream (09/19/2022)

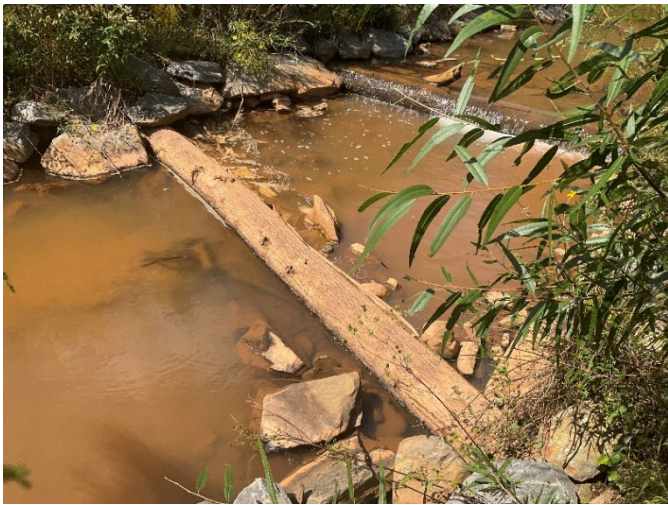
Bull Creek Reach 3: log roller riffle at station 164+00 with piping under one of the structure's logs – looking upstream (09/19/2022)

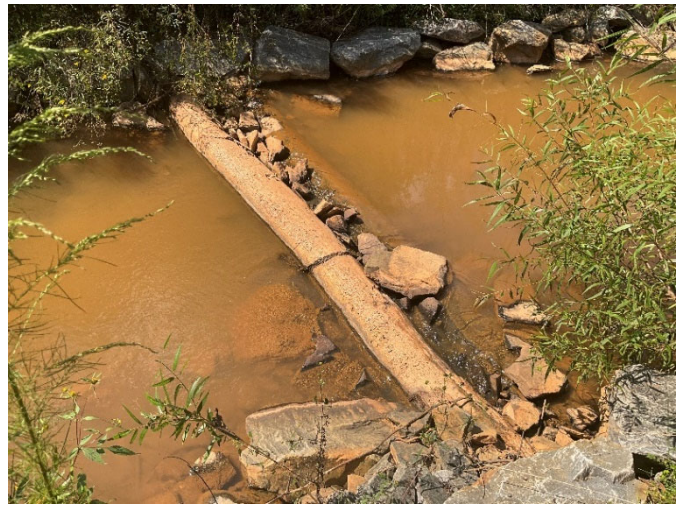
Bull Creek Reach 3: log roller riffle at station 164+00 with one of its header logs dislocated from its footer log (09/19/2022)

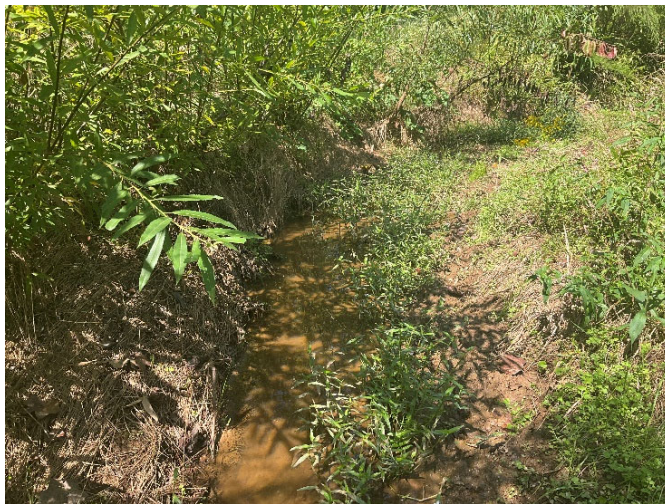
UT3C: aggradation at stations 408+52 – 408+87 & 409+08 – 409+75 – looking upstream (09/19/2022)
