# MONITORING YEAR 4 ANNUAL REPORT

## KEY MILL MITIGATION SITE

Surry County, NC  
NCDEQ Contract No. 7180  
DMS Project No. 100025  
USACE Action ID No. SAW-2017-01504  
NCDEQ DWR Certification No. 17-1045  
RFP #: 16-006993 (September 16, 2016)

Data Collection Period: February 2023 – November 2023  
Submission: February 2024

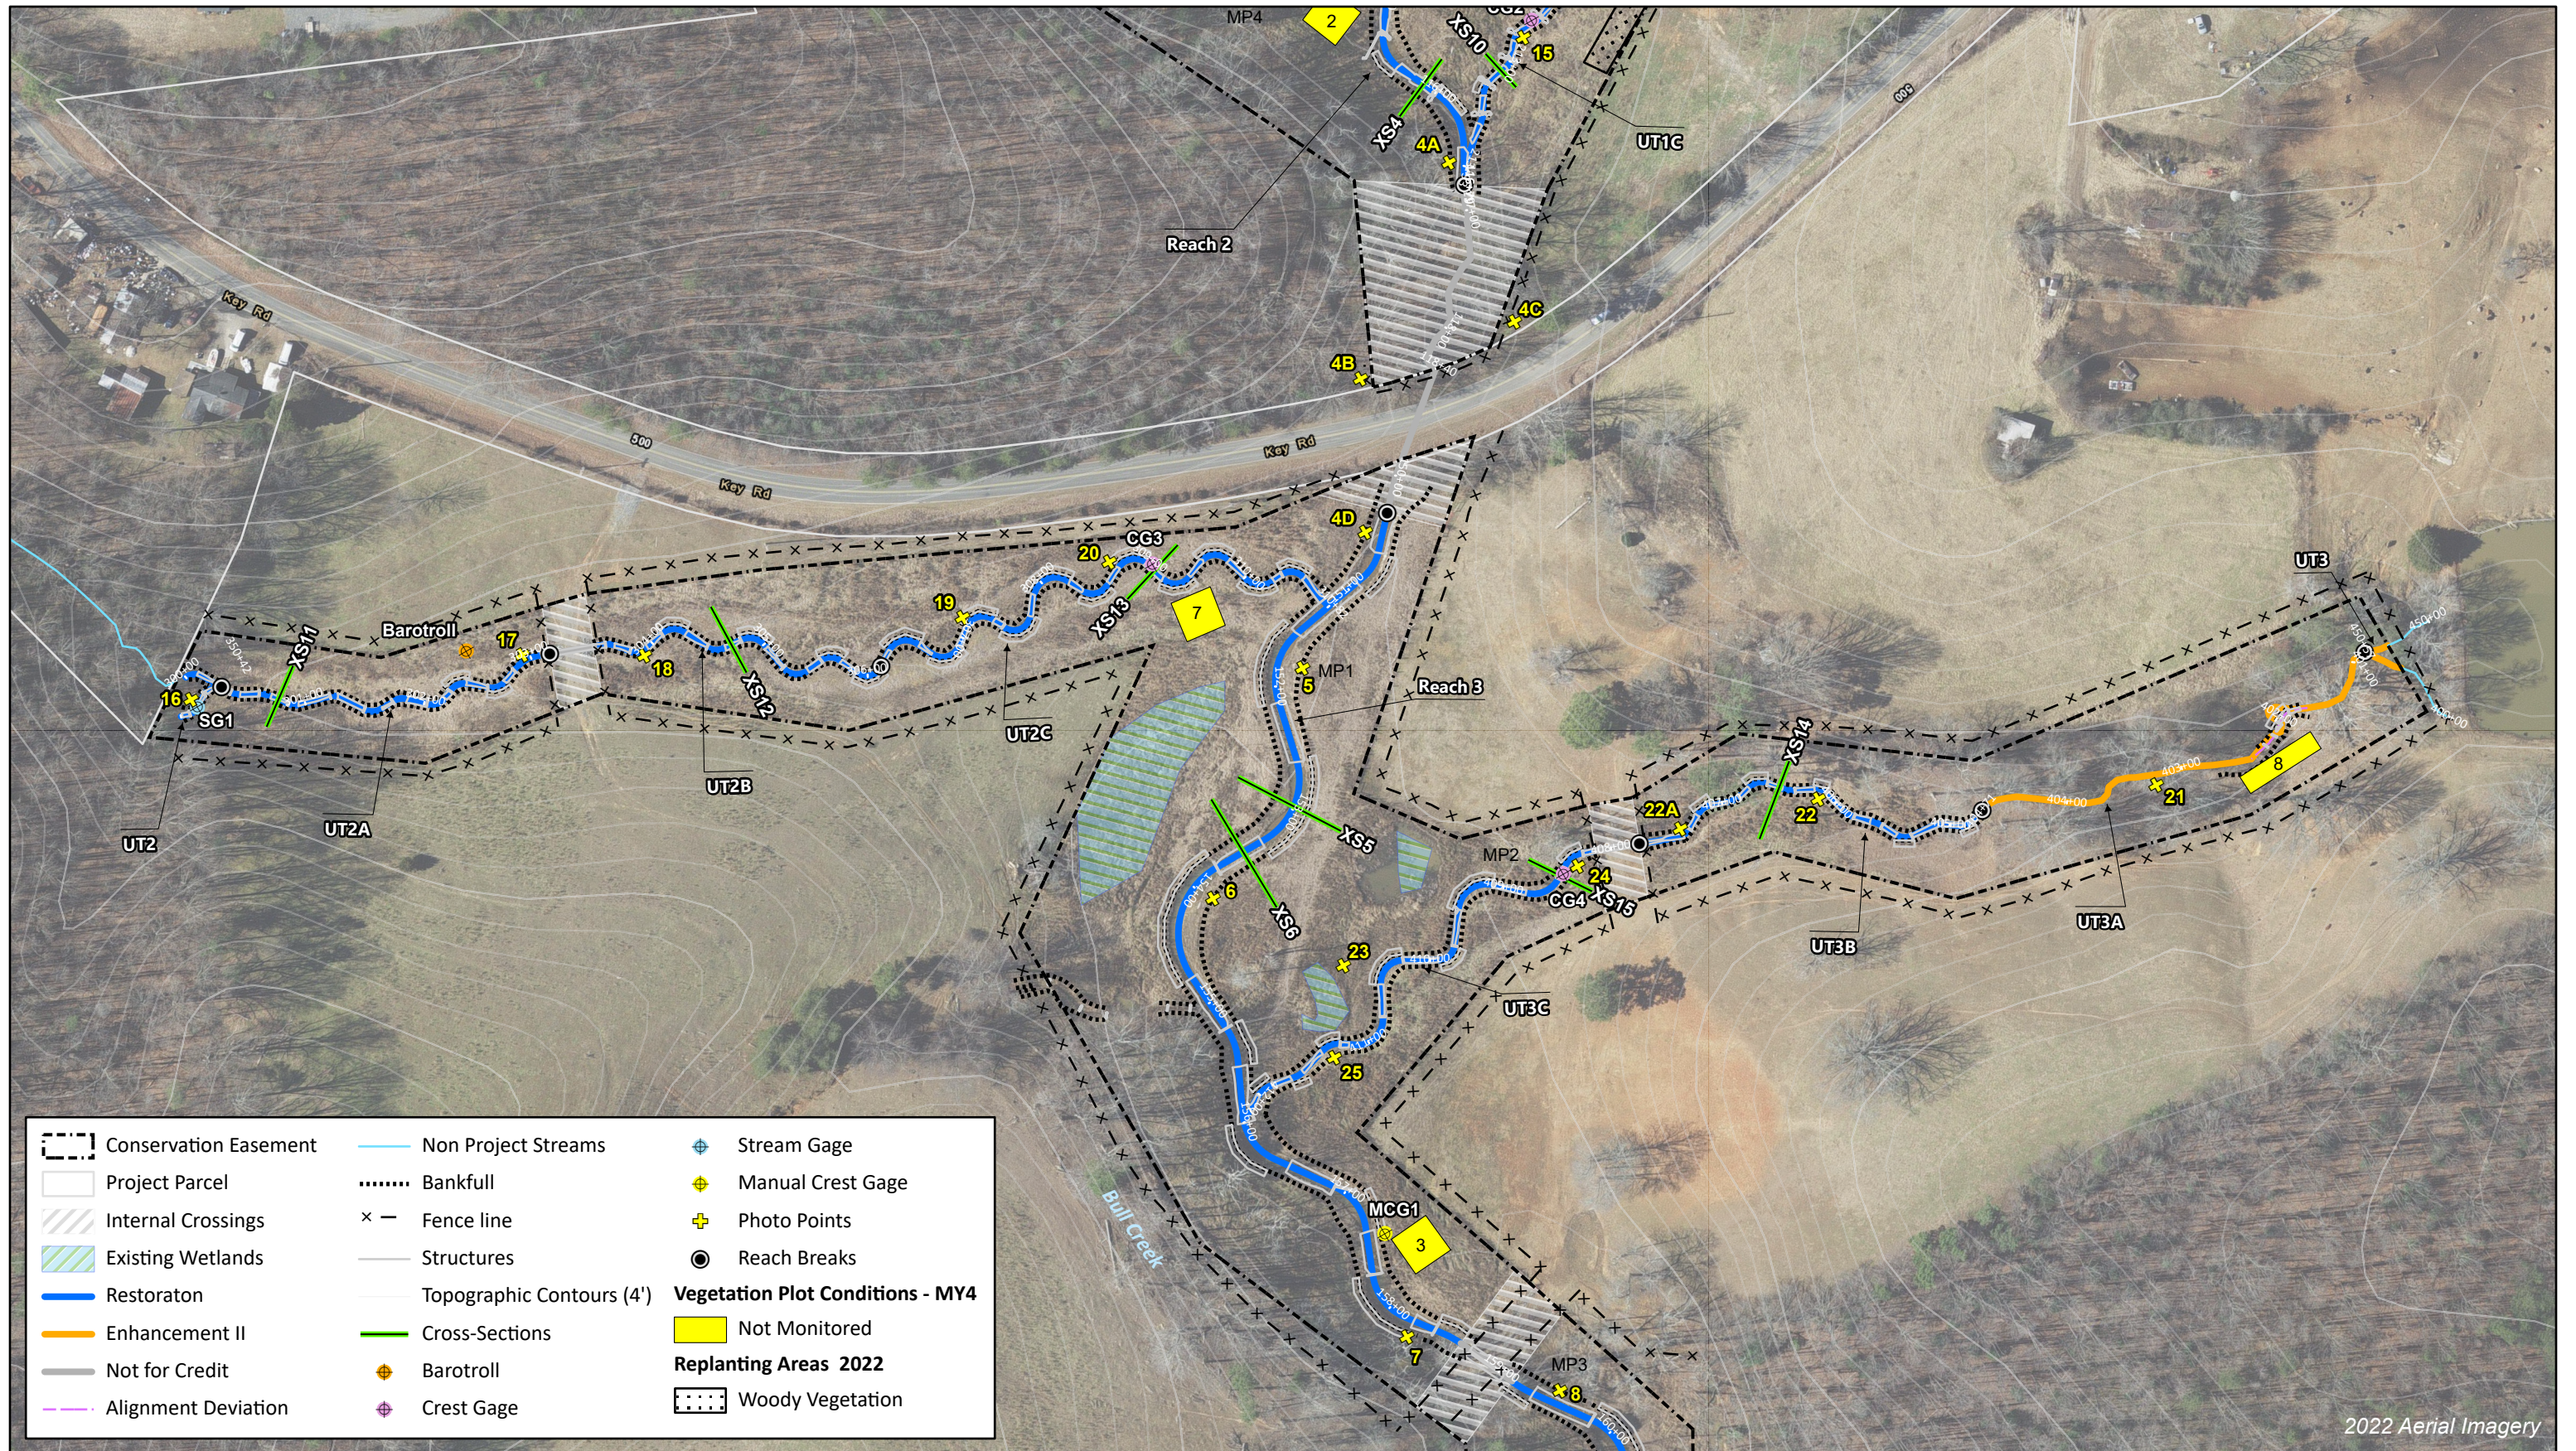
Figure 1a. Current Condition Plan View Map  
 Key Mill Mitigation Site  
 DMS Project No. 100025  
 Monitoring Year 4 - 2023  
 Surry County, NC

The MY4 visual assessment revealed that the majority of the project reaches, bed and banks are stable with only minor instances of scour and localized structure issues, neither of which compromise the channel or structure integrity. However, on Bull Creek Reach 2, there is active erosion and minor piping occurring behind a j-hook structure at station 115+30 caused by continuous storm events. Wildlands will conduct hand repairs in MY5 by re-grading and re-stabilizing the left bank. Repair activities will also include re-seeding, adding herbaceous plugs and live stake fascines to stabilize the banks and prevent excess sediment from entering the stream. Wildlands will continue to monitor all areas of concern and document repairs and management activities in the MY5 report. Refer to CCPV Figures 1 – 1c and Appendix A for stream stability tables, AOC photographs.

**DMS' comment: A hand repair is planned for a j-hook structure on Bull Creek Reach 2 in MY5 to address active erosion and minor piping. Please include an update in the MY5 report and include before/after photos of the work.**

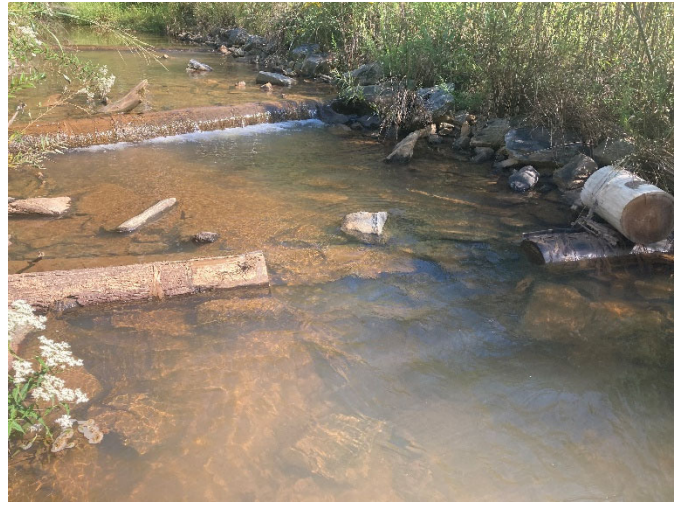
Bull Creek Reach 3: Log roller riffle at station 164+00 with piping under one of the structure's logs (09/19/2022)

Bull Creek Reach 3: Log cut at station 164+00, water is able to flow freely (09/06/23)

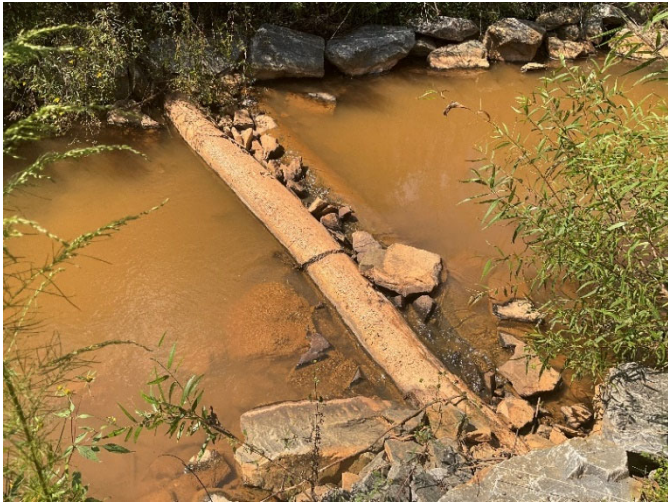
Bull Creek Reach 3: Log roller riffle at station 164+00 with one of its header logs dislocated from its footer log (09/19/2022)

Bull Creek Reach 3: Filter Fabric added and secured to log roller at station 164+00, water is no longer piping (04/25/23)

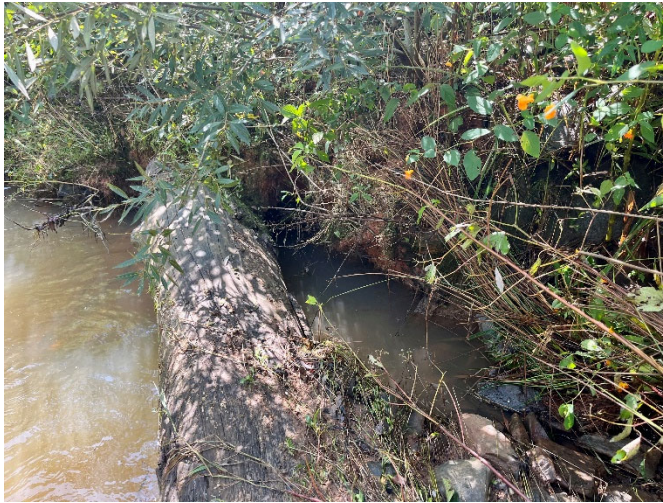
Bull Creek Reach 2: J-hook structure at station 115+30 with piping starting to occur from bank erosion (09/13/2023)

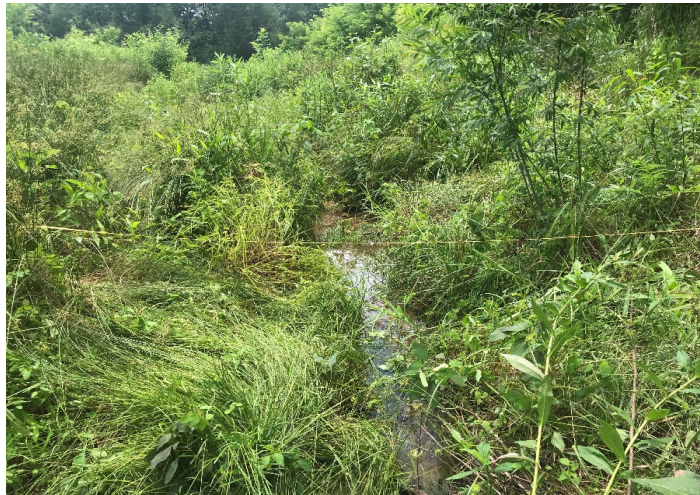
### Cross-Section 9-UT1B

\*The station number for XS9 was incorrectly reported on the MY0 cross-section plot, it should have been reported as Station 209+24 as shown in the above plot.
