**Kings Creek  
Stream Restoration  
NCEEP Project Number: 208  
Contract Number: D09082S  
Monitoring Year 5  
2013 Final Report**

**Submitted to  
North Carolina Ecosystem Enhancement Program  
North Carolina Department of Environment and Natural Resources  
November 2013**

# **Kings Creek Stream Restoration 2013 Monitoring Report (MY 5)**

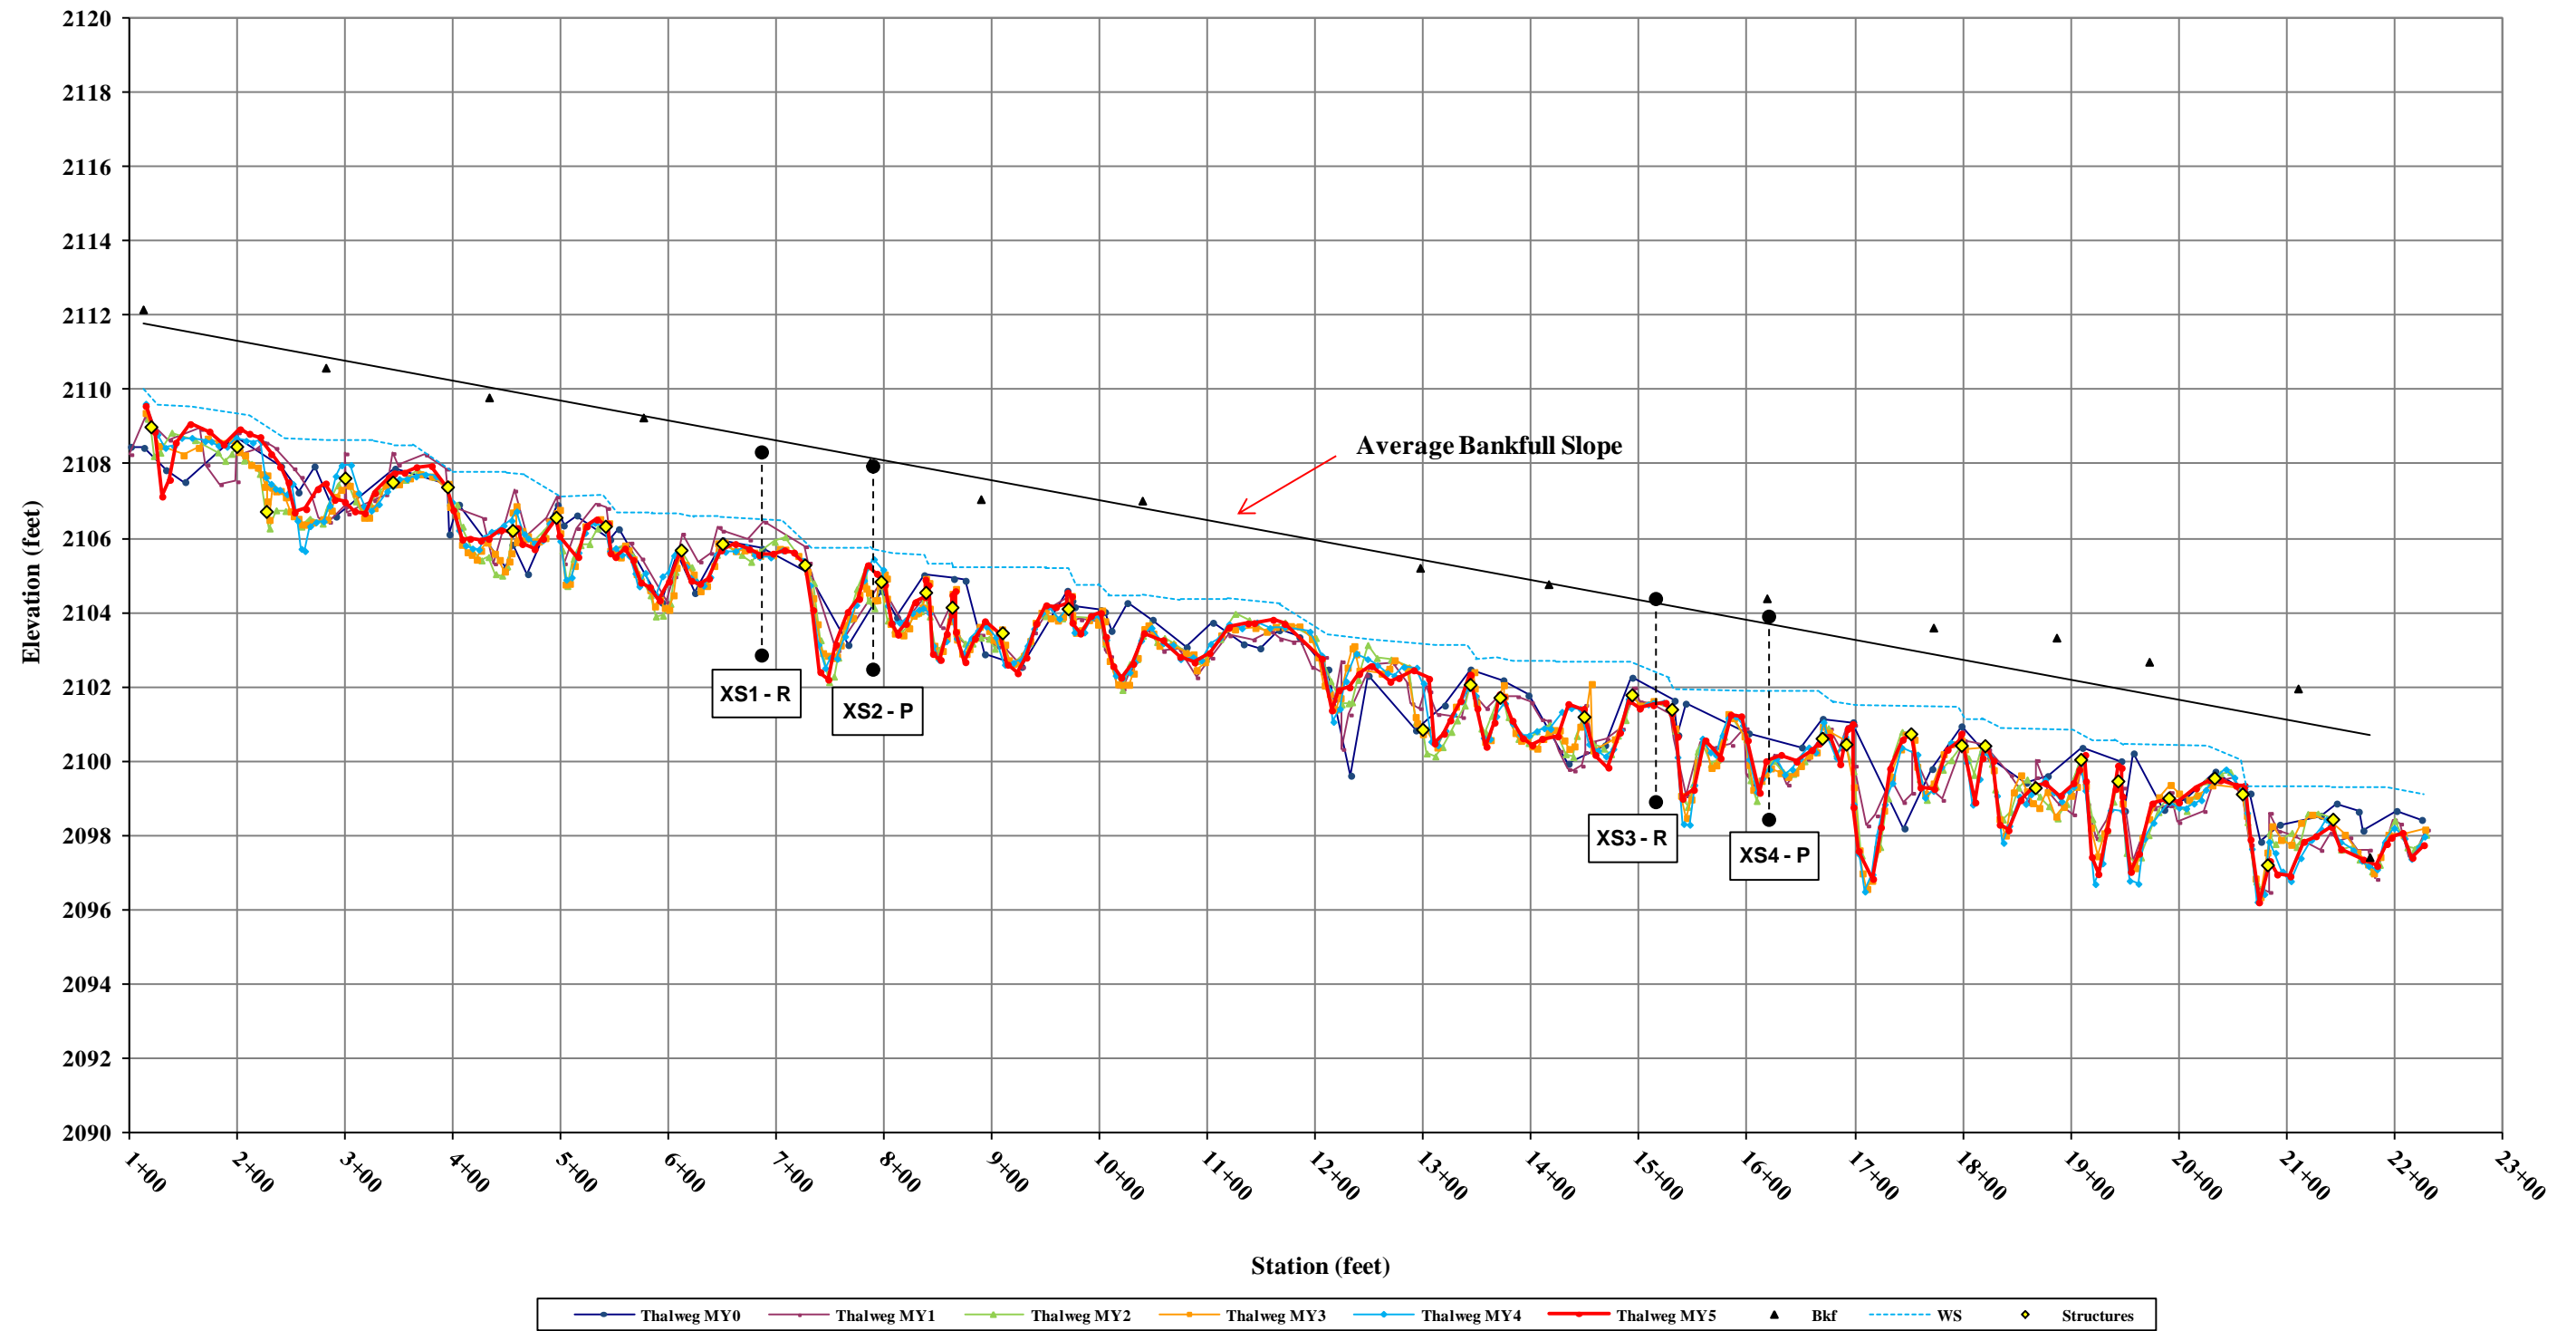
### Kings Creek Longitudinal Profile Stationing 1+14 - 22+28

Stream longitudinal profiles have remained relatively stable among monitoring years. The primary stream issue observed during MY5 was bank erosion resulting from thalweg migration and low woody stem densities. In particular, thalweg migration has continued at station 2+00 (83 feet) and 5+25 (38 feet) causing further bank erosion. These two areas of concern have continued to actively erode between monitoring years. Including these two areas, 16% of the project area is currently actively eroding. All other morphological metrics indicated performance percentages averaging between 88 and 100%. Two bankfull events, one event on January 31<sup>st</sup> and one event on July 3<sup>rd</sup>, were documented during MY5. The former was documented using wrack lines as well as the crest gauge. High rainfall in the area and anecdotal evidence of overbank flows confirmed the second bankfull event.
