Monitoring Report – MY6
FINAL VERSION
Lake Wendell Mitigation Project
Calendar Year of Data Collection: 2023

NCDEQ DMS Project Identification # 97081
NCDEQ DMS Contract # 6826
Neuse River Basin (Cataloging Unit 03020201)
USACE Action ID Number: SAW-2016-00876
NCDEQ DWR Project # 2016-0385 V2
Johnston County, NC
Contracted Under RFP # 16-006477
Data Collection Period: March & October 2023
Submission Date: December 29, 2023

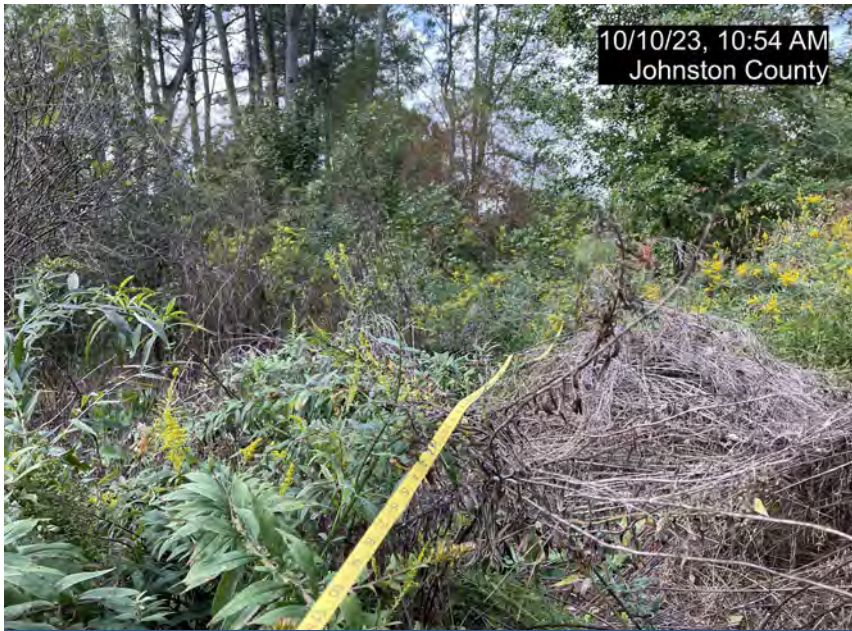
Random Veg Transect in VPA1, Southwest, October 10, 2023 (MY-06)

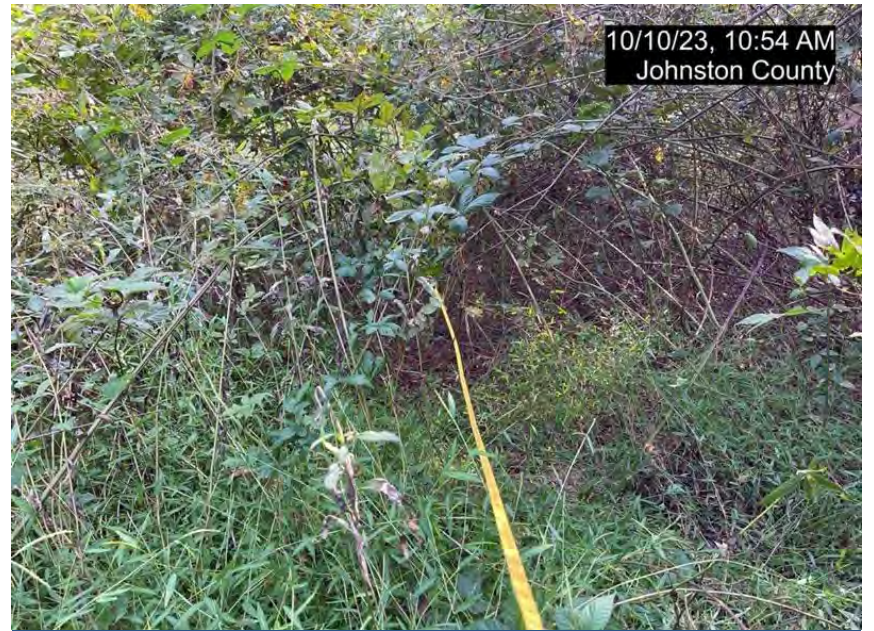
Random Veg Transect in VPA1, Northeast, October 10, 2023 (MY-06)

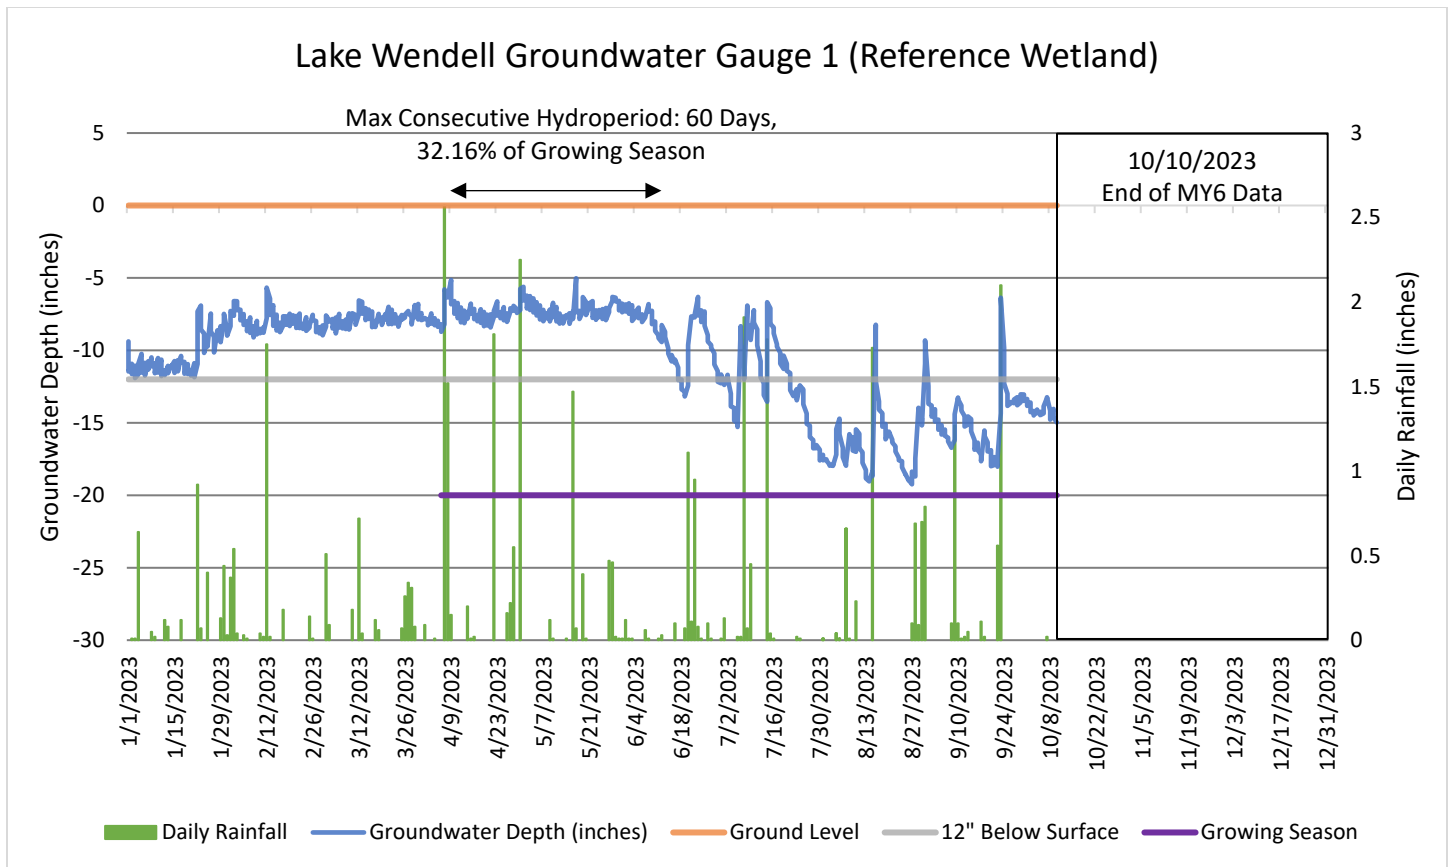
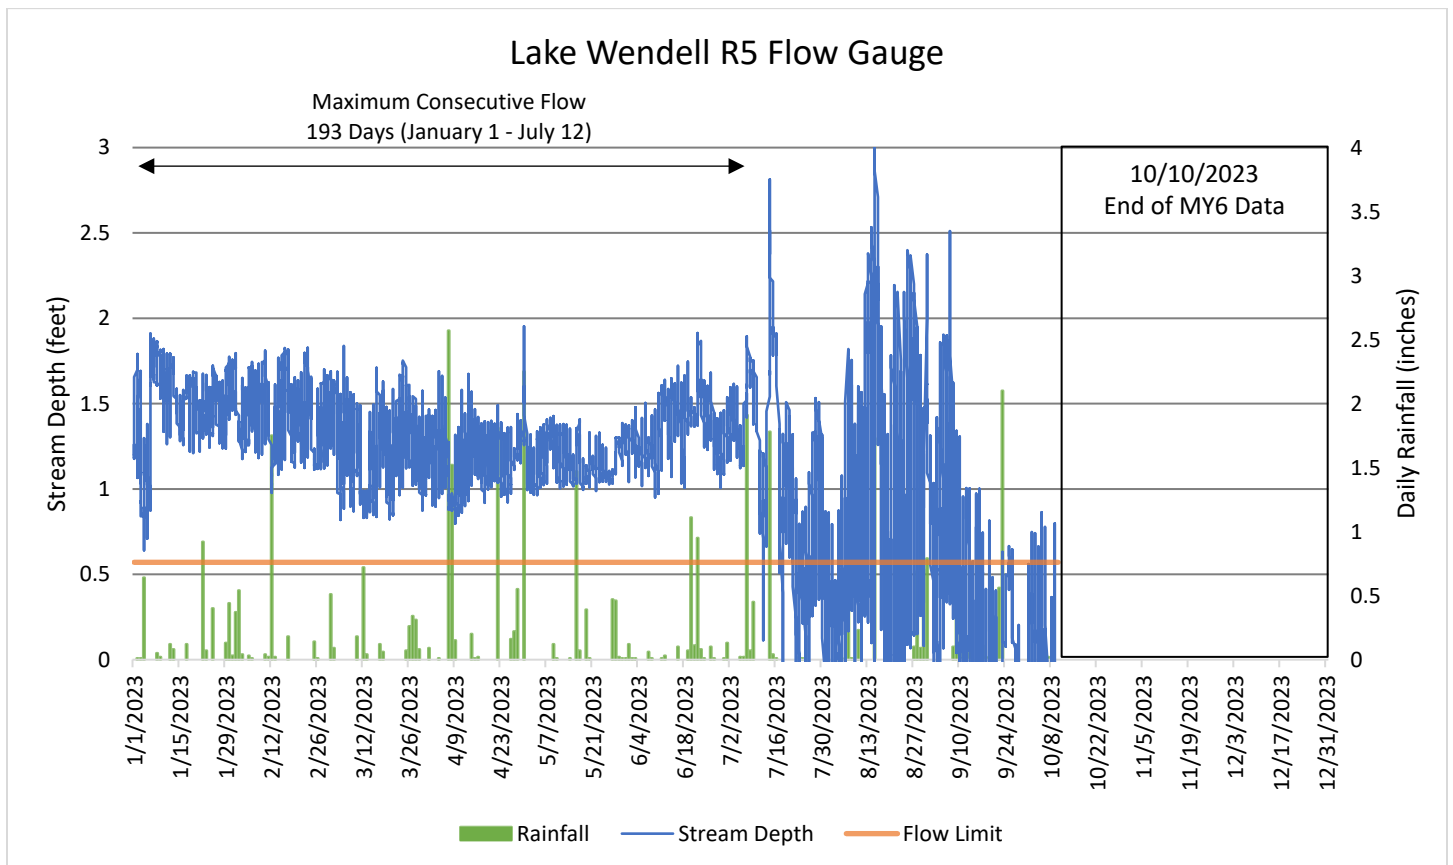
FIGURE 3a: Hydrograph Data

Jurisdictional stream flow documentation and monitoring of restored intermittent reaches is achieved by the installation of a flow gauge (continuous-read pressure transducer) within the thalweg of the channel towards the middle portion of the Reach R5 (Figure 1). Additionally, to determine if rainfall amounts are normal for the given year, precipitation data was obtained from CLAY Central Crops Research Station in Johnston County, approximately nine miles southwest of the site. The monitoring gauge documented the stream exhibited surface flow for 193 consecutive days from January 1st to July 12th, 2023 (see Figure 3a).

226 days of cumulative flow, 57 days of cumulative no flow

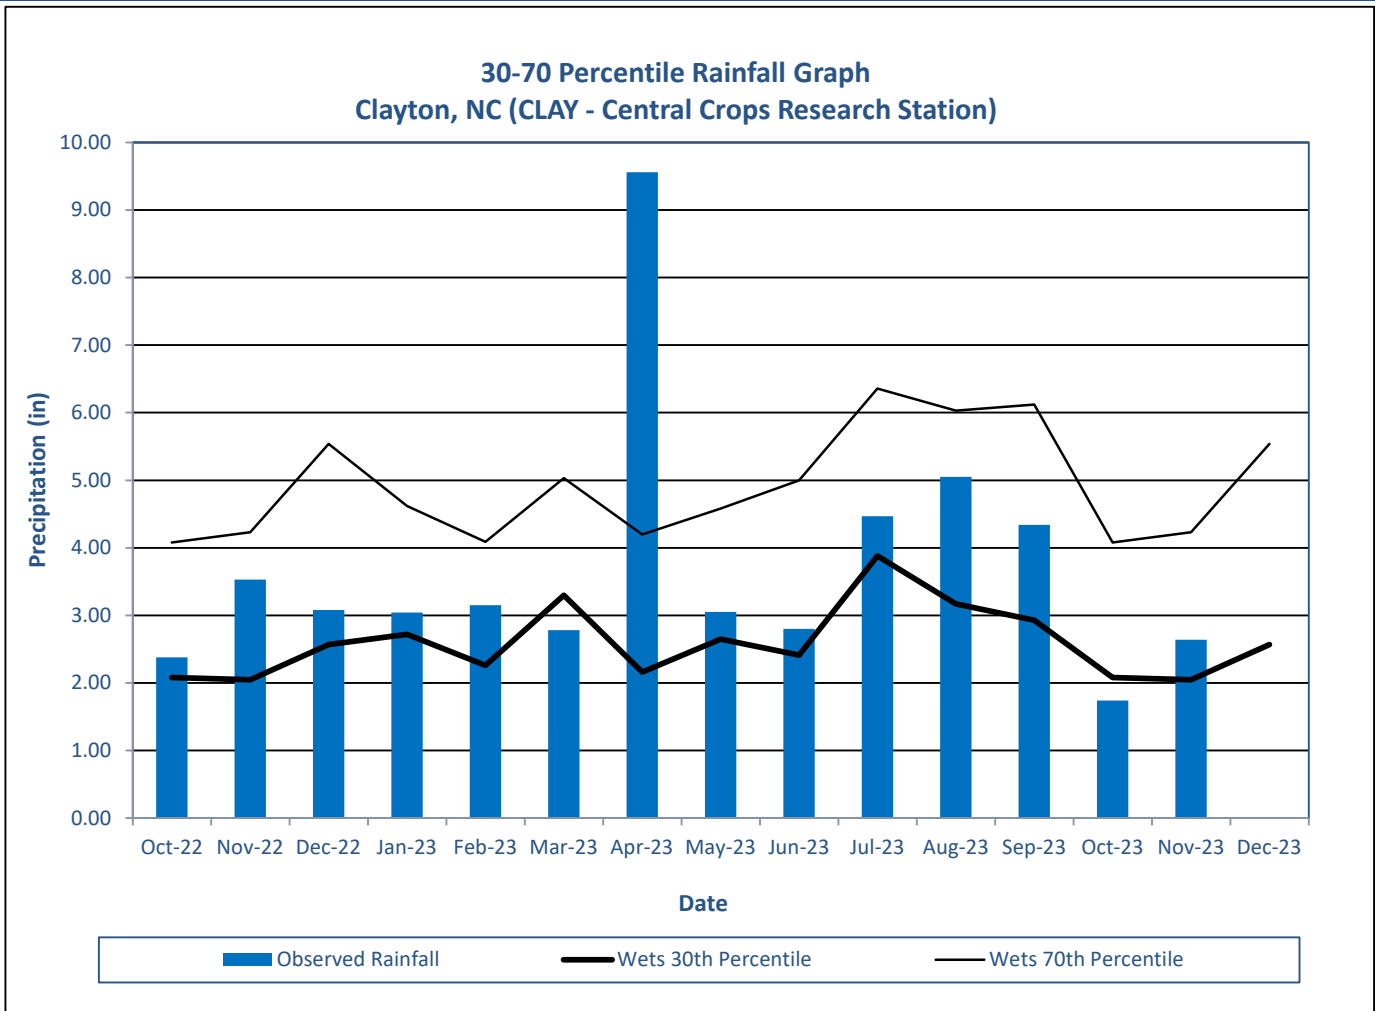
Figure 4: Monthly Rainfall Data
Lake Wendell Mitigation Project (NCDEQ DMS Project ID# 97081)
MY6 2023

*30th and 70th percentile rainfall data collected from weather station CLAY - Central Crops Research Station in Clayton, NC.

**Incomplete Month

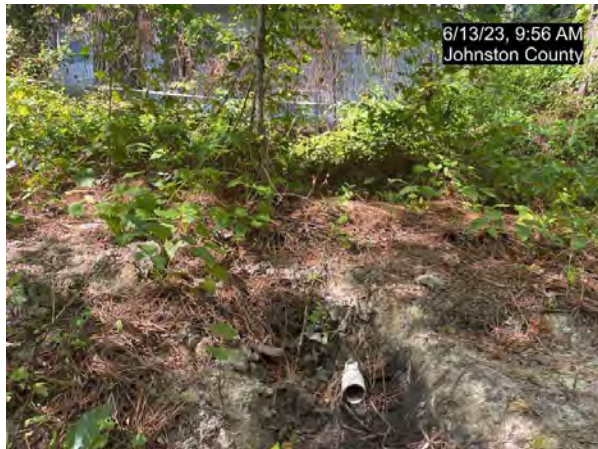
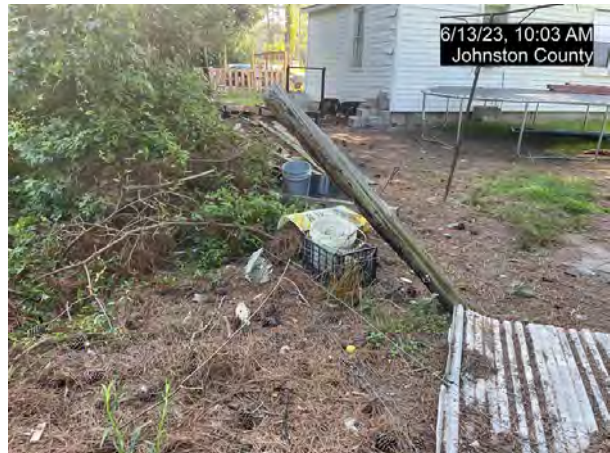
On May 23, 2023, the Division of Mitigation Services completed an easement boundary inspection of the Lake Wendell Site. There were a few items that they asked us to address with you. There is a PVC pipe from the residence of 2869 Wendell Road protruding into the conservation easement. In December 2020, we exchanged emails about this pipe and Dennis confirmed that he re-routed the water coming from the pipe somewhere outside of the easement. The Division of Mitigation Services found the PVC pipe inside the easement and requested that since the pipe is not in use that we cap the pipe. The staff from WLS cut the pipe off at the easement edge, capped it and buried it with the loose dirt surrounding the pipe on June 14th, 2023.

During the boundary inspection it was also observed that a significant amount of trash from the residence of 2709 Wendell Road had been blown and tossed into the easement area adjacent to the house. Most of the trash was removed from the easement by WLS staff on June 13th, 2023. Please instruct the tenants not to throw trash into the conservation easement as it is a violation of the easement.
