Monitoring Report – Year 1
FINAL VERSION
Lake Wendell Mitigation Project
Calendar Year of Data Collection: 2018

NCDEQ DMS Project Identification # 97081
NCDEQ DMS Contract # 6826
Neuse River Basin (Cataloging Unit 03020201)
USACE Action ID Number: SAW-2016-00876
NCDEQ DWR Project # 2016-0385
Johnston County, NC
Contracted Under RFP # 16-006477

Data Collection Period: March-November 2018, Submission Date: March 2019

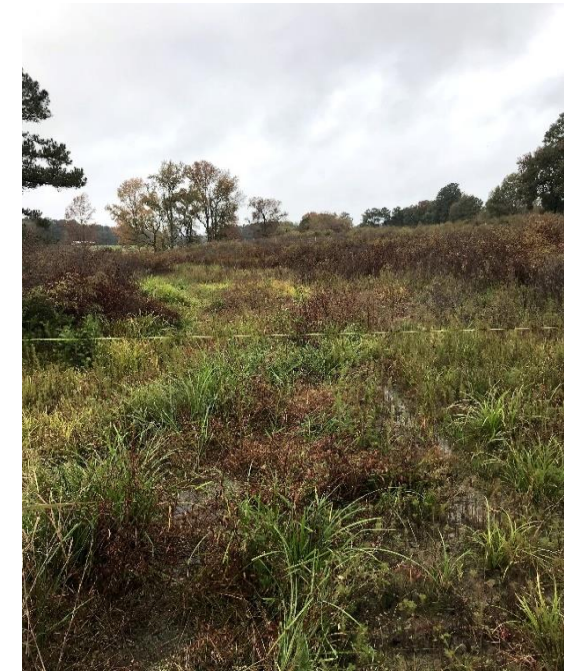
Project Name	Lake Wendell Mitigation Project
Project ID	97081
Reach ID	R1
Cross Section ID	X1
Field Crew	C. Manner, A. McIntyre

DIMENSION DATA SUMMARY: MY1 2018	
Low Top of Bank Elevation (ft)	287.4
Bankfull Cross Sectional Area (ft ²)	2.4
XS Area Change from As-built (%)	-13.4%
Bankfull Width (ft)	5.5
Max Depth (ft)	0.6
Mean Depth (ft)	0.4
Width/Depth Ratio	12.6
Flood Prone Area Width (ft)	23.0
Entrenchment Ratio	4.2
Bank Height Ratio	1.0

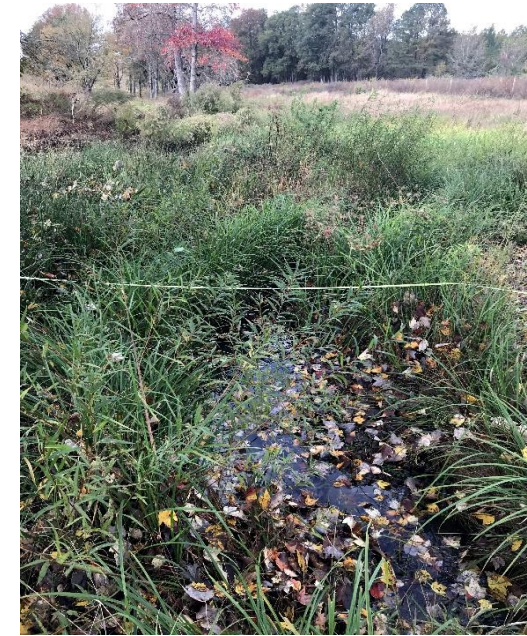
Project Name	Lake Wendell Mitigation Project
Project ID	97081
Reach ID	R2
Cross Section ID	X2
Field Crew	C. Manner, A. McIntyre

DIMENSION DATA SUMMARY: MY1 2018	
Low Top of Bank Elevation (ft)	276.2
Bankfull Cross Sectional Area (ft²)	4.4
XS Area Change from As-built (%)	0.3%
Bankfull Width (ft)	7.9
Max Depth (ft)	1.3
Mean Depth (ft)	0.6
Width/Depth Ratio	14.2
Flood Prone Area Width (ft)	45.0
Entrenchment Ratio	5.7
Bank Height Ratio	1.0

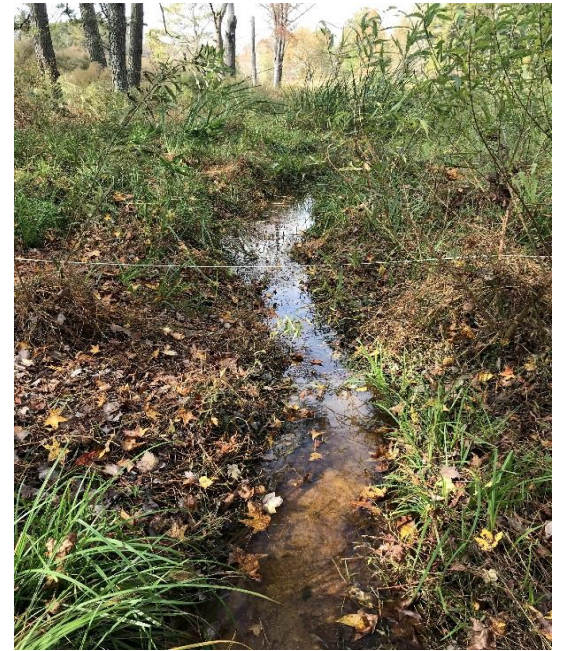
Project Name	Lake Wendell Mitigation Project
Project ID	97081
Reach ID	R2
Cross Section ID	X3
Field Crew	C. Manner, A. McIntyre

DIMENSION DATA SUMMARY: MY1 2018	
Low Top of Bank Elevation (ft)	263.2
Bankfull Cross Sectional Area (ft ²)	3.6
XS Area Change from As-built (%)	-1.5%
Bankfull Width (ft)	6.8
Max Depth (ft)	1.1
Mean Depth (ft)	0.5
Width/Depth Ratio	12.8
Flood Prone Area Width (ft)	45.0
Entrenchment Ratio	6.6
Bank Height Ratio	1.0

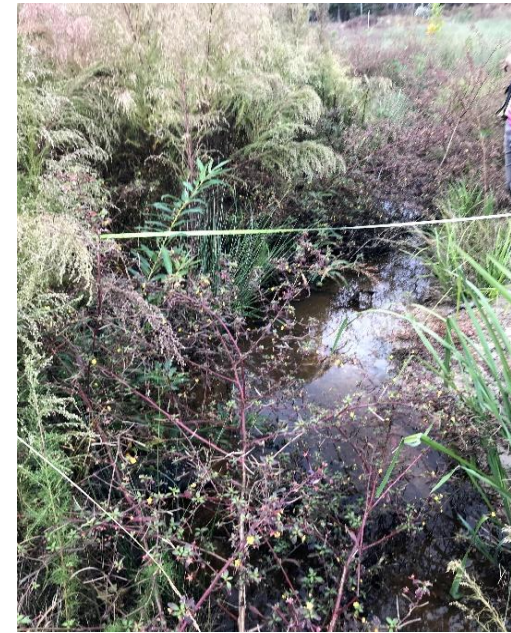
Project Name	Lake Wendell Mitigation Project
Project ID	97081
Reach ID	R3
Cross Section ID	X4
Field Crew	C. Manner, A. McIntyre

DIMENSION DATA SUMMARY: MY1 2018	
Low Top of Bank Elevation (ft)	254.2
Bankfull Cross Sectional Area (ft ²)	9.8
XS Area Change from As-built (%)	-25.9%
Bankfull Width (ft)	14.3
Max Depth (ft)	1.6
Mean Depth (ft)	0.7
Width/Depth Ratio	20.9
Flood Prone Area Width (ft)	68.0
Entrenchment Ratio	4.8
Bank Height Ratio	1.0

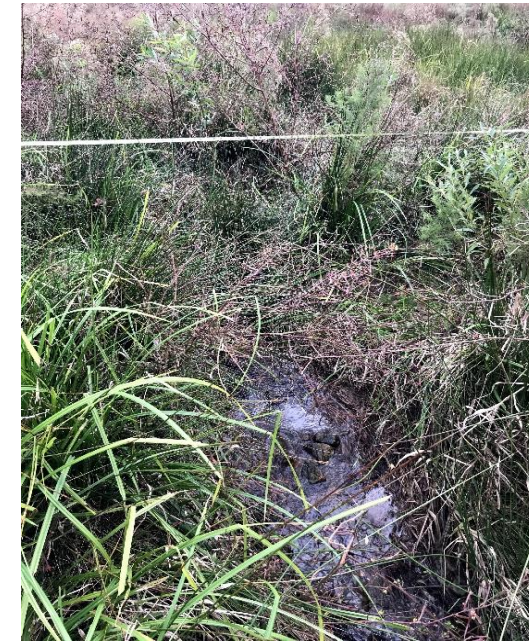
Project Name	Lake Wendell Mitigation Project
Project ID	97081
Reach ID	R3
Cross Section ID	X5
Field Crew	C. Manner, A. McIntyre

DIMENSION DATA SUMMARY: MY1 2018	
Low Top of Bank Elevation (ft)	251.4
Bankfull Cross Sectional Area (ft ²)	2.9
XS Area Change from As-built (%)	-26.2%
Bankfull Width (ft)	7.3
Max Depth (ft)	0.7
Mean Depth (ft)	0.4
Width/Depth Ratio	18.5
Flood Prone Area Width (ft)	55.5
Entrenchment Ratio	7.6
Bank Height Ratio	1.0

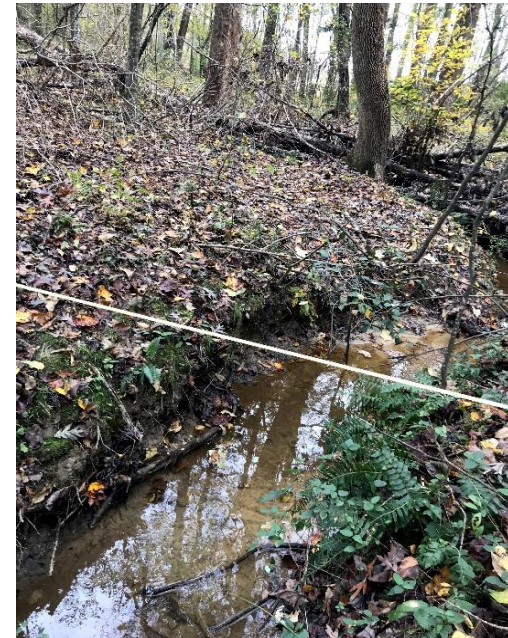
Project Name	Lake Wendell Mitigation Project
Project ID	97081
Reach ID	R4 (Preservation)
Cross Section ID	X6
Field Crew	C. Manner, A. McIntyre

DIMENSION DATA SUMMARY: MY1 2018	
Low Top of Bank Elevation (ft)	242.1
Bankfull Cross Sectional Area (ft ²)	11.2
XS Area Change from As-built (%)	1.8%
Bankfull Width (ft)	7.0
Max Depth (ft)	2.6
Mean Depth (ft)	1.6
Width/Depth Ratio	4.4
Flood Prone Area Width (ft)	49.0
Entrenchment Ratio	7.0
Bank Height Ratio	1.0

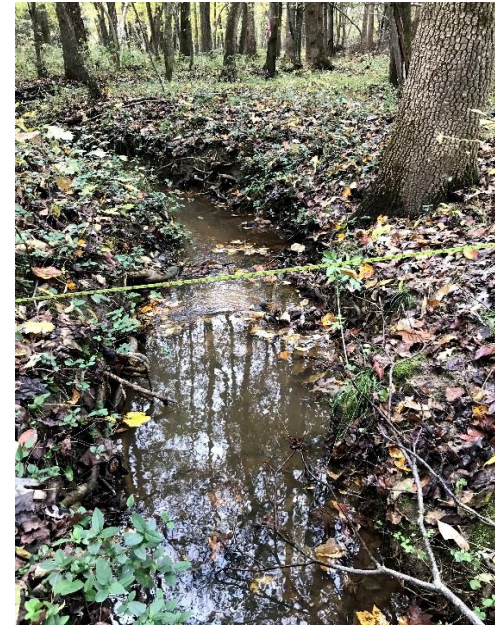
Project Name	Lake Wendell Mitigation Project
Project ID	97081
Reach ID	R4 (Preservation)
Cross Section ID	X7
Field Crew	C. Manner, A. McIntyre

DIMENSION DATA SUMMARY: MY1 2018	
Low Top of Bank Elevation (ft)	241.9
Bankfull Cross Sectional Area (ft ²)	16.8
XS Area Change from As-built (%)	9.6%
Bankfull Width (ft)	12.7
Max Depth (ft)	2.8
Mean Depth (ft)	1.3
Width/Depth Ratio	9.6
Flood Prone Area Width (ft)	44.3
Entrenchment Ratio	3.5
Bank Height Ratio	1.0

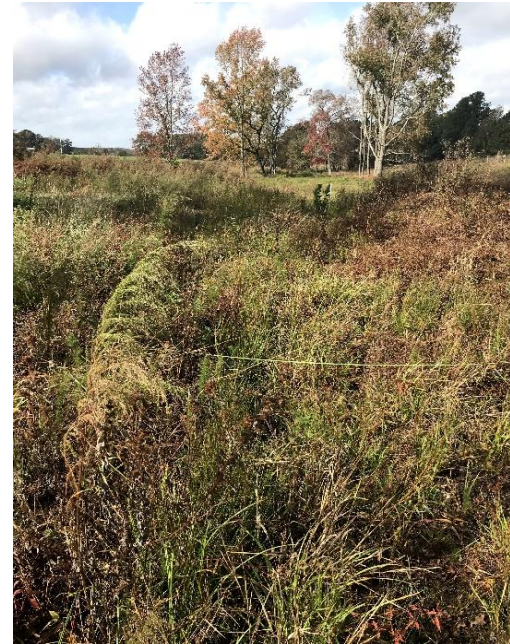
Project Name	Lake Wendell Mitigation Project
Project ID	97081
Reach ID	R5
Cross Section ID	X8
Field Crew	C. Manner, A. McIntyre

DIMENSION DATA SUMMARY: MY1 2018	
Low Top of Bank Elevation (ft)	283.8
Bankfull Cross Sectional Area (ft ²)	2.1
XS Area Change from As-built (%)	8.2%
Bankfull Width (ft)	4.6
Max Depth (ft)	0.7
Mean Depth (ft)	0.5
Width/Depth Ratio	10.1
Flood Prone Area Width (ft)	24.0
Entrenchment Ratio	5.2
Bank Height Ratio	1.0

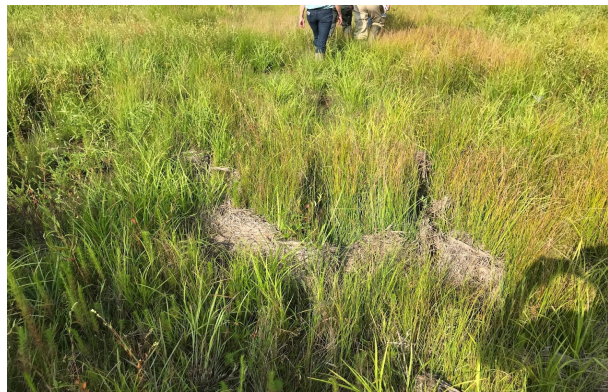
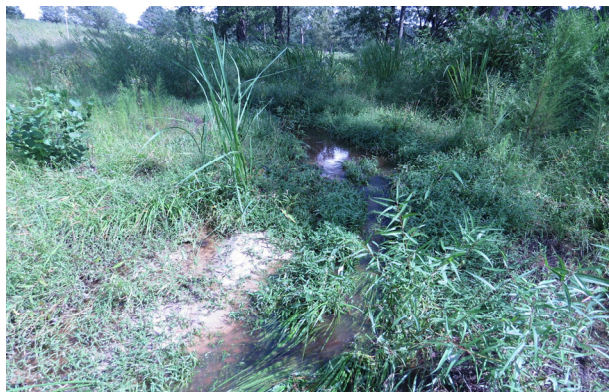
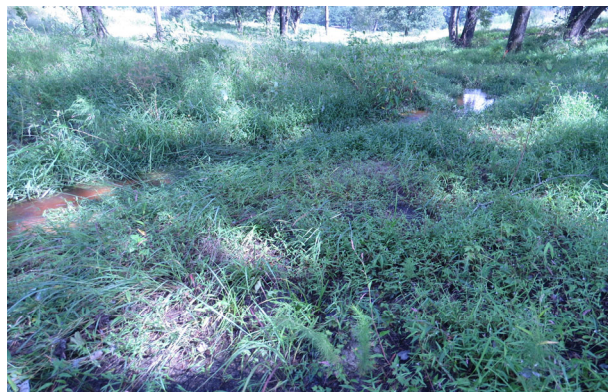
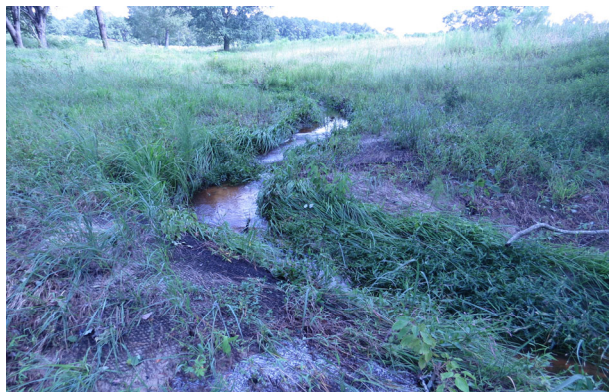
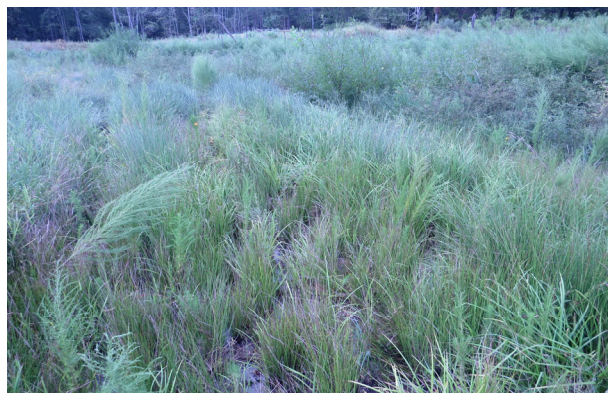
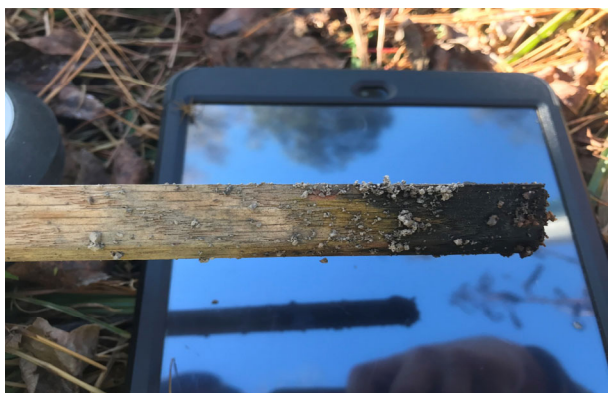
**Table 8. Verification of Flow Events
Lake Wendell Mitigation Project (NCDEQ DMS Project ID# 97081)**

Date of Data Collection	Date of Occurrence	Method	Greater than Bankfull (Bkf) or Qqs (Q2*0.66) Stage?	Photo/ Notes
8/16/2018	8/3/2018	Crest Gauge	Bkf, 3" above FP elevation	Photos
9/17/2018	9/16-9/17/2018	Observed visual indicators (wrack lines) of stage after storm event	Bkf	Photos
11/21/2018	9/16-9/17/2018	Crest Gauge	Bkf, 6" above FP elevation	Photos

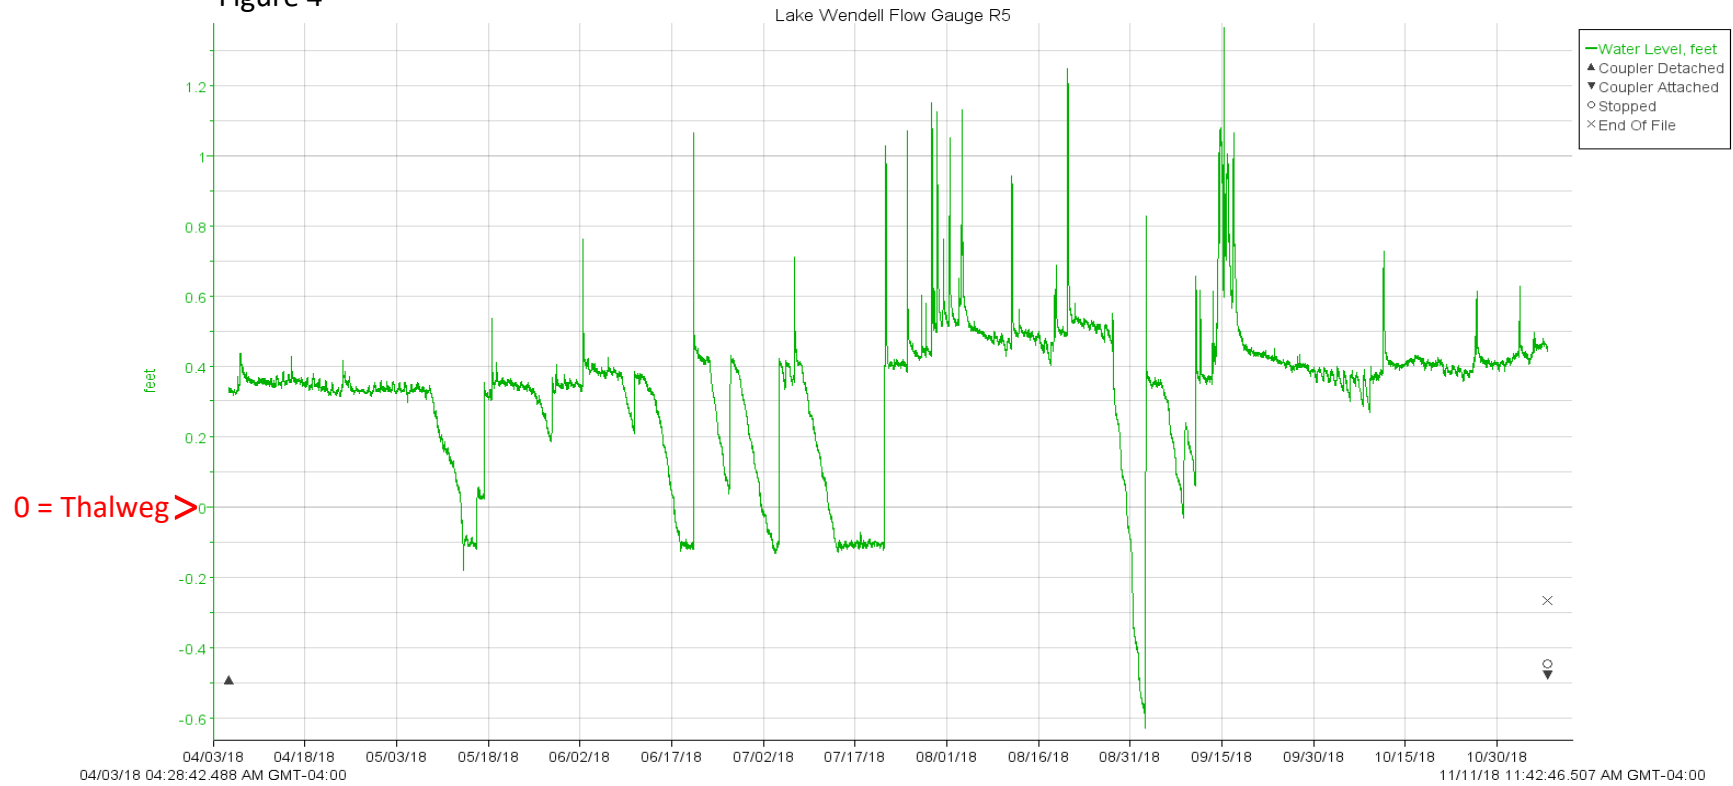
Figure 4

Jurisdictional stream flow documentation and monitoring of restored intermittent reaches includes a combination of photographic documentation and the installation of a monitoring gage (flow gage) (continuous-read pressure transducer) within the thalweg (bottom) of the channel towards the middle portion of the Reach R5 (Figure 1). Additionally, to determine if rainfall amounts are normal for the given year, precipitation data was obtained from the Johnston County weather station (COOP 317994), approximately twenty miles south of the site. The monitoring gage documented that the stream exhibited surface flow for a minimum of 30 consecutive days throughout some portion of the year during a year with normal rainfall conditions (See Figure 4).

Flow Subsurface : 28 Days out of Growing Season
Growing Season 4/5/2018-11/4/2018, 227 Days
Percent of Growing Season with Flow: 87.7%
Longest Consecutive Days of Flow: 57 Days (9/9/2018-11/4/2018)
