Monitoring Report – MY2
FINAL VERSION
Lake Wendell Mitigation Project
Calendar Year of Data Collection: 2019

NCDEQ DMS Project Identification # 97081
NCDEQ DMS Contract # 6826
Neuse River Basin (Cataloging Unit 03020201)
USACE Action ID Number: SAW-2016-00876
NCDEQ DWR Project # 2016-0385
Johnston County, NC
Contracted Under RFP # 16-006477

Data Collection Period: June-October 2019, Submission Date: December 2019

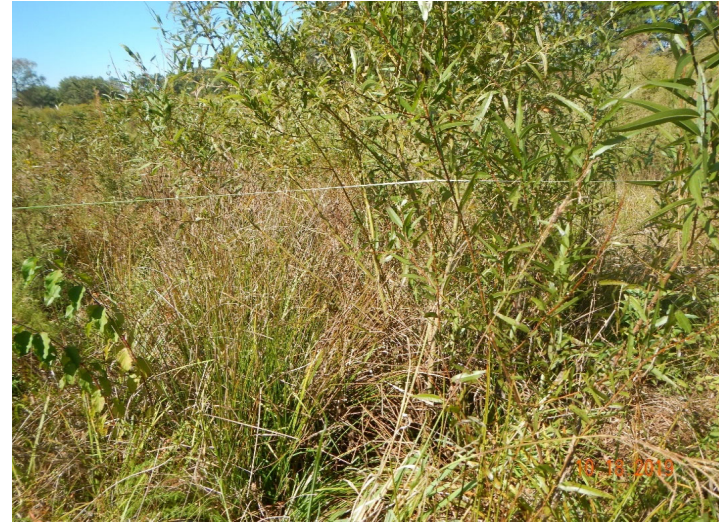
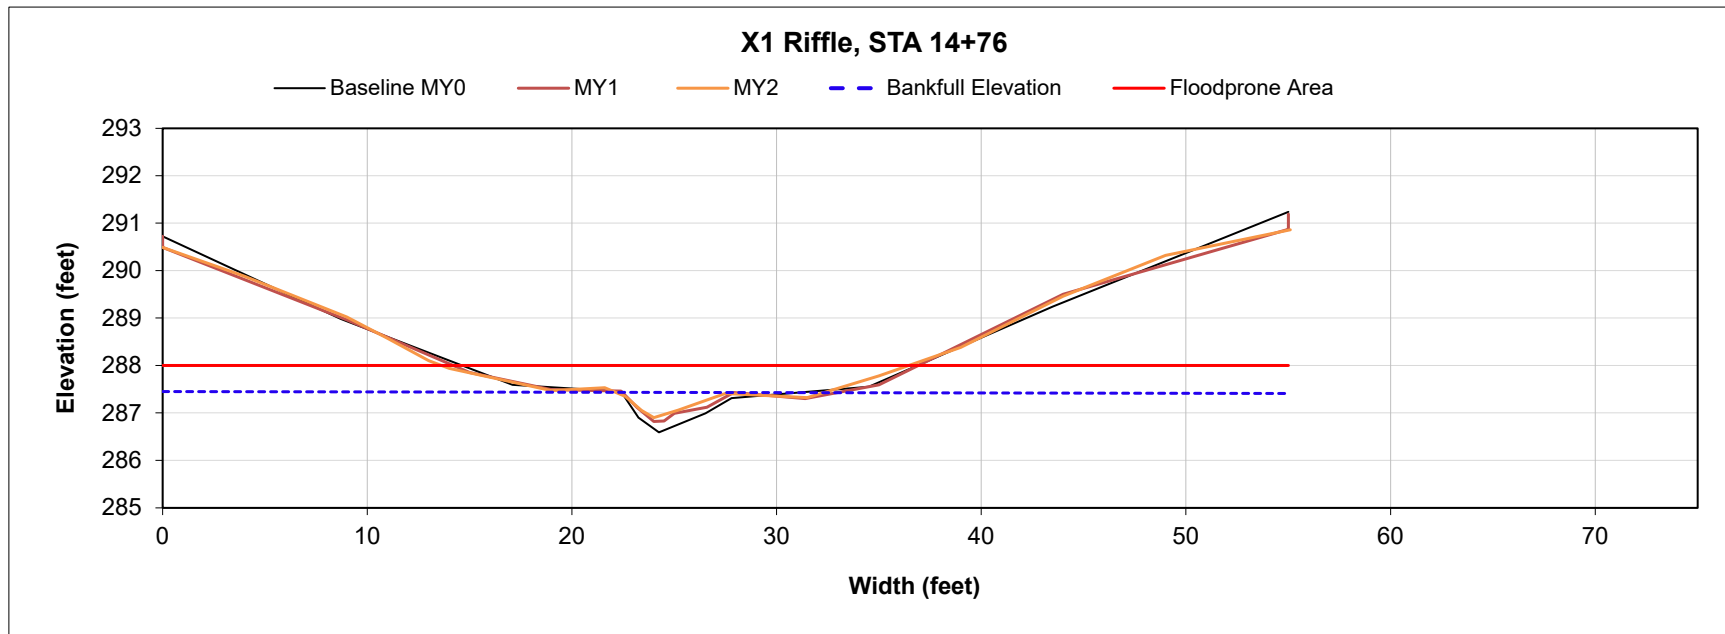
Project Name	Lake Wendell Mitigation Project
Project ID	97081
Reach ID	R1
Cross Section ID	X1
Field Crew	K. Obermiller, E. Dunnigan

Dimension Data Summary: MY2 2019	
Bankfull Elevation (ft)	287.5
Low Bank Height Elevation (ft)	287.4
Bankfull Max Depth (ft)	0.6
Low Bank Height (ft)	0.5
Bank Height Ratio	<1.0
Bankfull X-section Area (ft²)	2.0
% Change Bank Height Ratio	10.0%

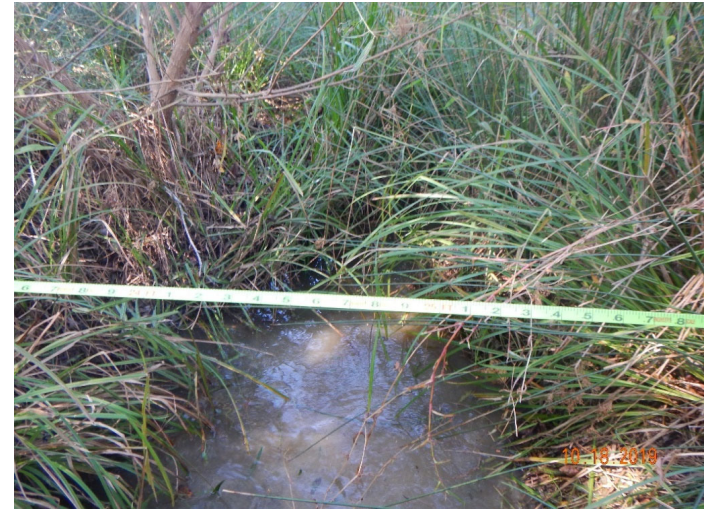
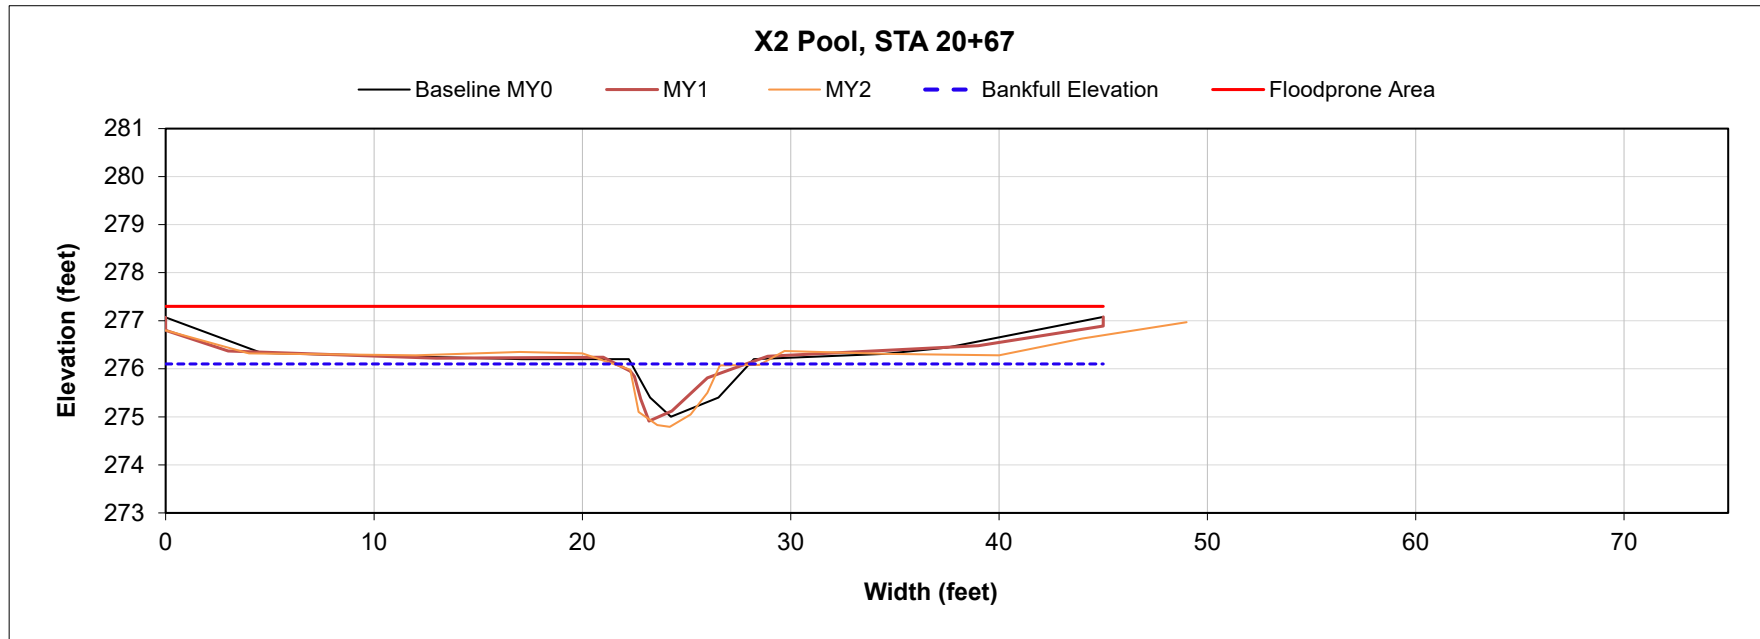
Project Name	Lake Wendell Mitigation Project
Project ID	97081
Reach ID	R2
Cross Section ID	X2
Field Crew	K. Obermiller, E. Dunnigan

Dimension Data Summary: MY2 2019	
Bankfull Elevation (ft)	276.1
Low Bank Height Elevation (ft)	276.1
Bankfull Max Depth (ft)	1.3
Low Bank Height (ft)	1.3
Bank Height Ratio	1.0
Bankfull X-section Area (ft ²)	4.1
% Change Bank Height Ratio	0.0%

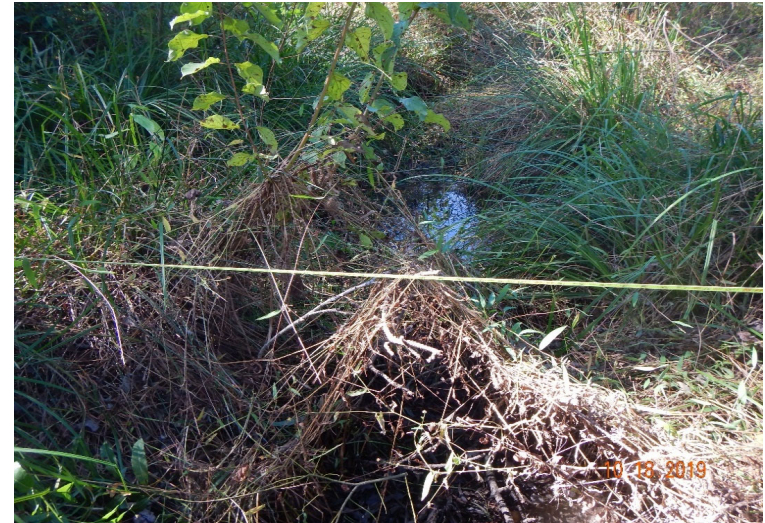
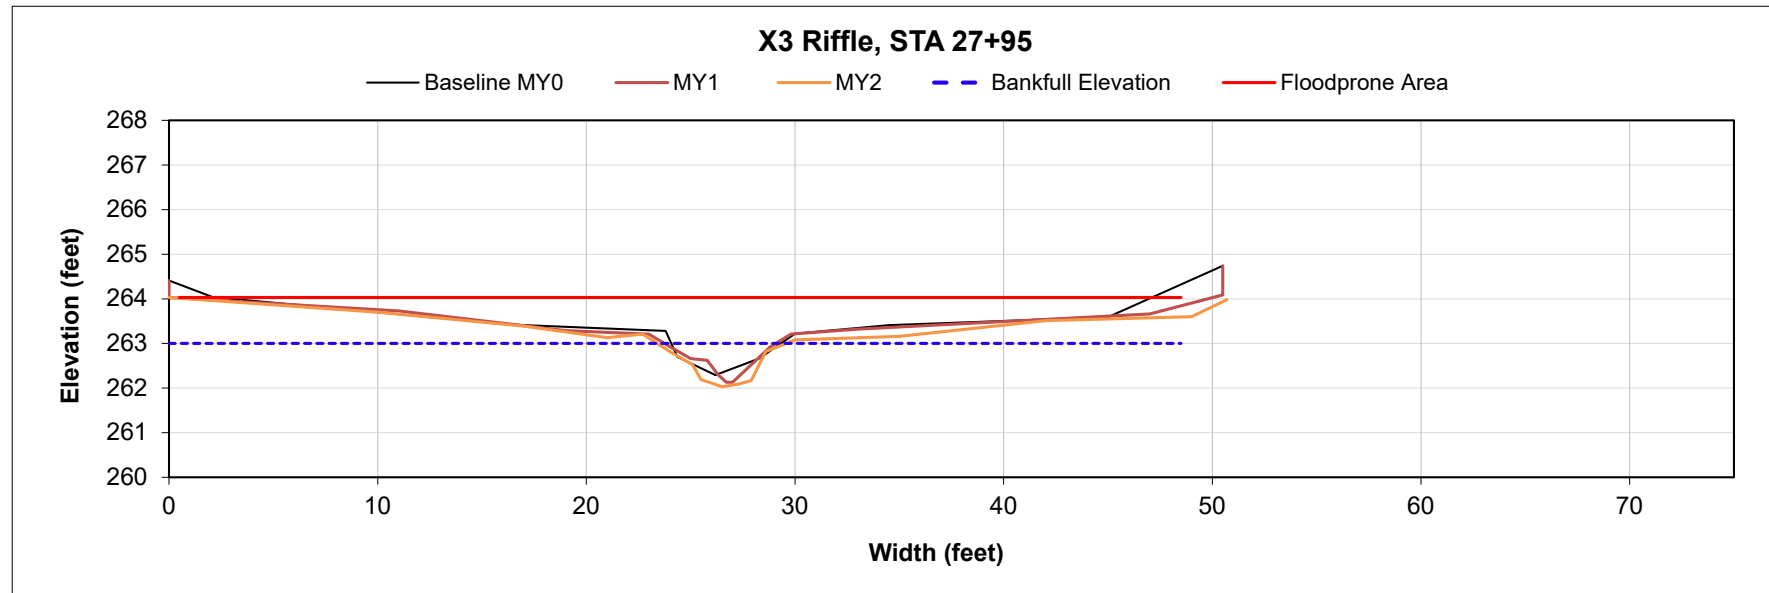
Project Name	Lake Wendell Mitigation Project
Project ID	97081
Reach ID	R2
Cross Section ID	X3
Field Crew	K. Obermiller, E. Dunnigan

Dimension Data Summary: MY2 2019	
Bankfull Elevation (ft)	263.0
Low Bank Height Elevation (ft)	263.1
Bankfull Max Depth (ft)	1.0
Low Bank Height (ft)	1.1
Bank Height Ratio	1.1
Bankfull X-section Area (ft ²)	4.1
% Change Bank Height Ratio	10.0%

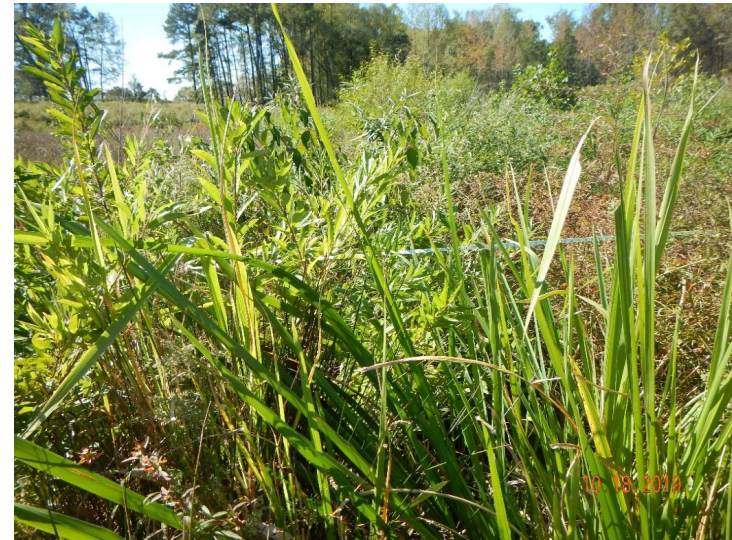
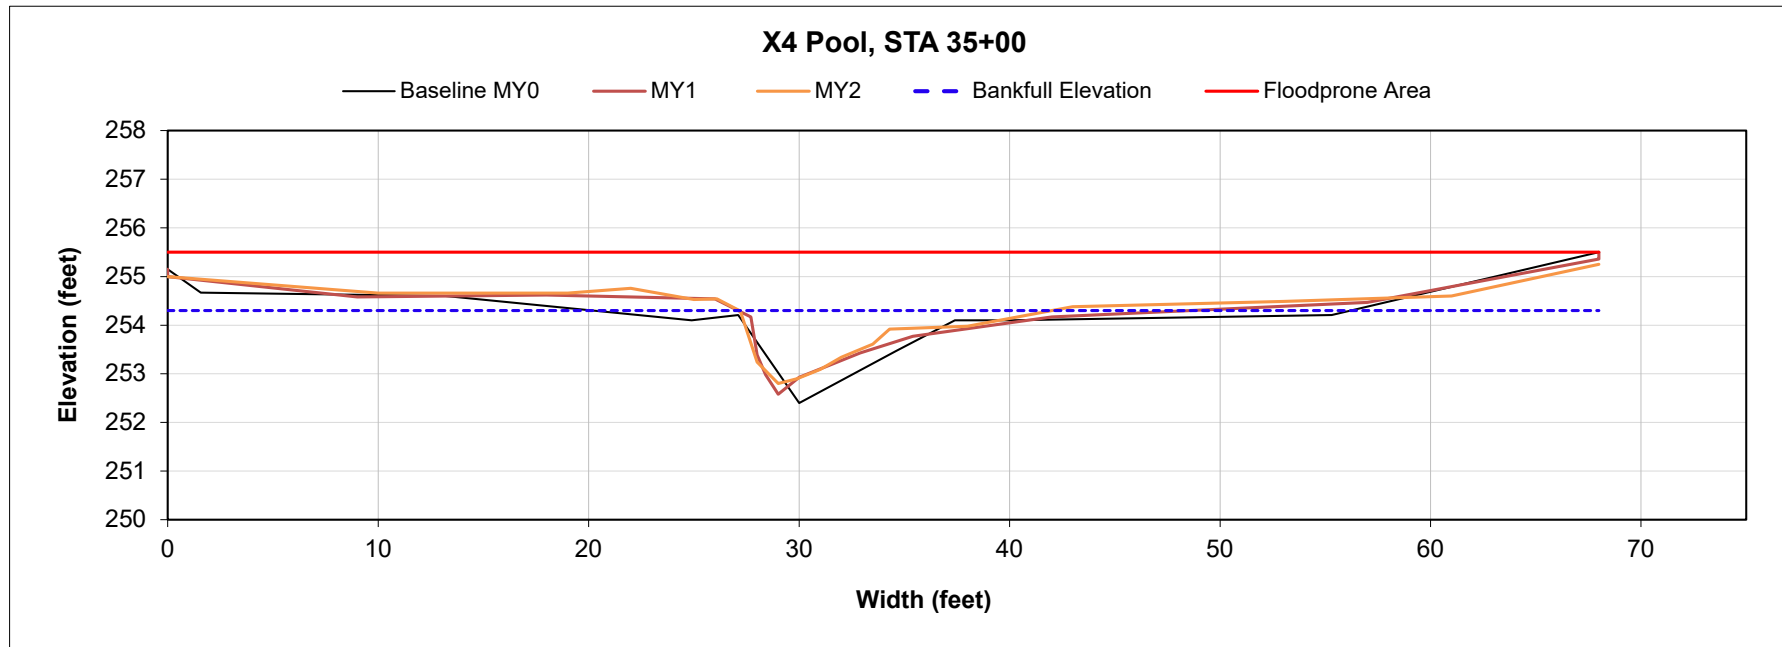
Project Name	Lake Wendell Mitigation Project
Project ID	97081
Reach ID	R3
Cross Section ID	X4
Field Crew	K. Obermiller, E. Dunnigan

Dimension Data Summary: MY2 2019	
Bankfull Elevation (ft)	254.3
Low Bank Height Elevation (ft)	254.4
Bankfull Max Depth (ft)	1.5
Low Bank Height (ft)	1.6
Bank Height Ratio	1.1
Bankfull X-section Area (ft²)	8.5
% Change Bank Height Ratio	10.0%

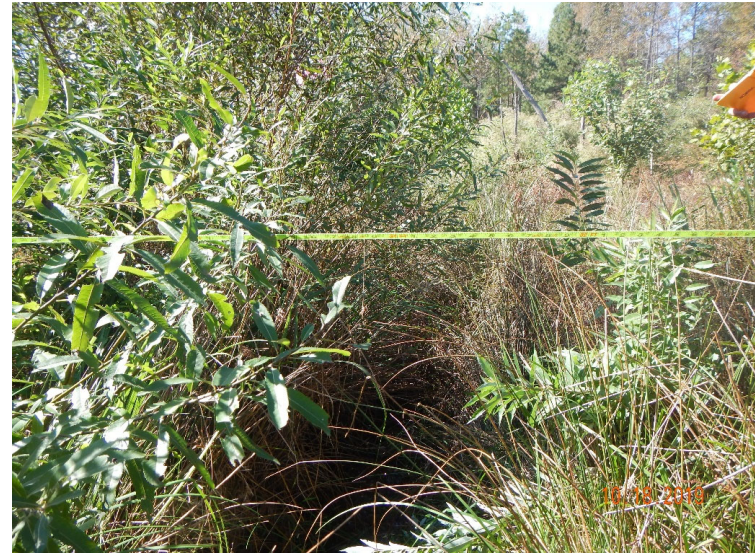
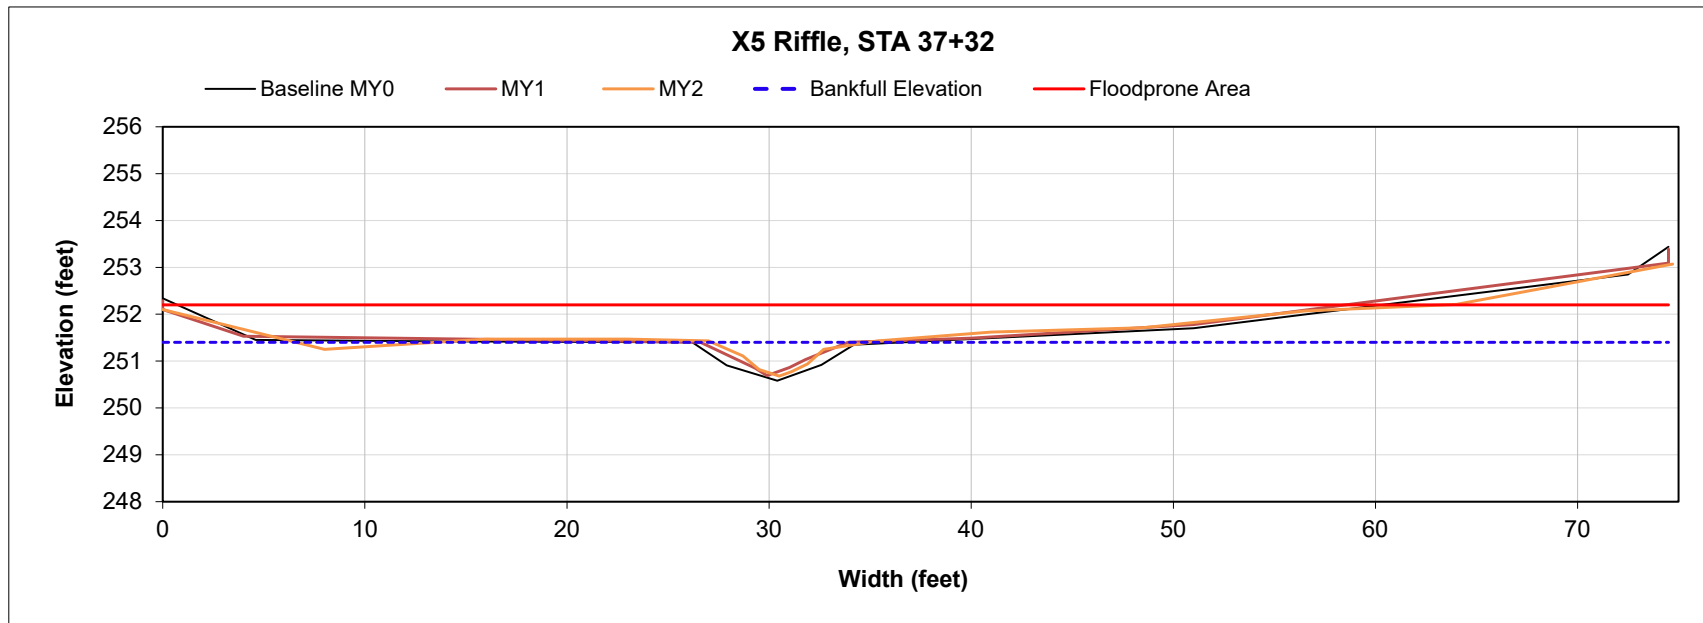
Project Name	Lake Wendell Mitigation Project
Project ID	97081
Reach ID	R3
Cross Section ID	X5
Field Crew	K. Obermiller, E. Dunnigan

Dimension Data Summary: MY2 2019	
Bankfull Elevation (ft)	251.4
Low Bank Height Elevation (ft)	251.4
Bankfull Max Depth (ft)	0.8
Low Bank Height (ft)	0.8
Bank Height Ratio	1.0
Bankfull X-section Area (ft²)	2.8
% Change Bank Height Ratio	0.0%

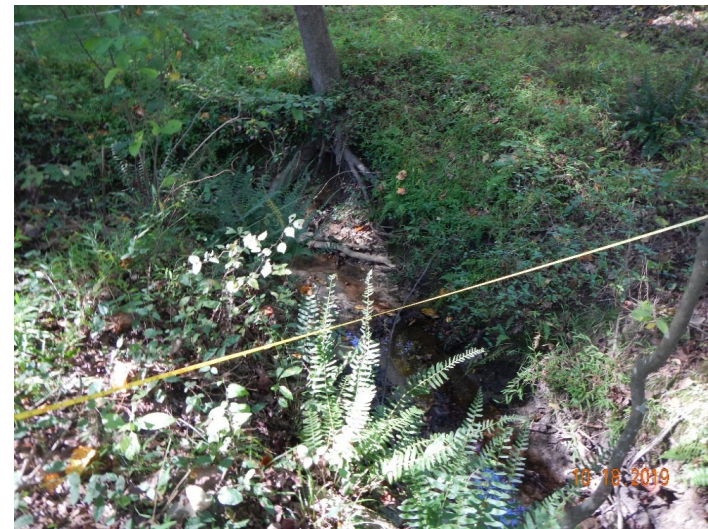
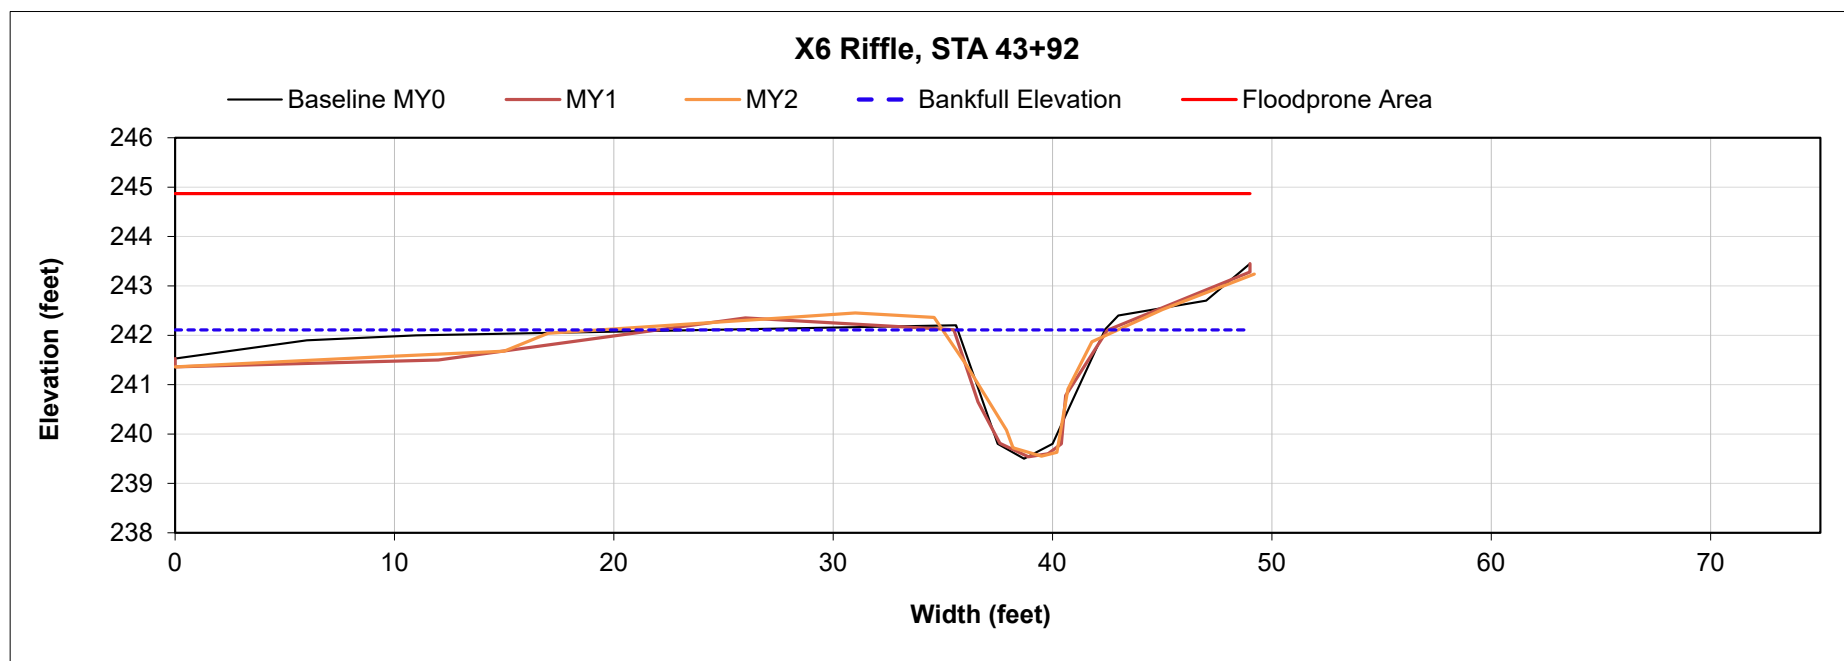
Project Name	Lake Wendell Mitigation Project
Project ID	97081
Reach ID	R4 (Preservation)
Cross Section ID	X6
Field Crew	K. Obermiller, E. Dunnigan

Dimension Data Summary: MY2 2019	
Bankfull Elevation (ft)	242.2
Low Bank Height Elevation (ft)	242.9
Bankfull Max Depth (ft)	2.7
Low Bank Height (ft)	3.4
Bank Height Ratio	1.0
Bankfull X-section Area (ft ²)	11.2
% Change Bank Height Ratio	0.0%

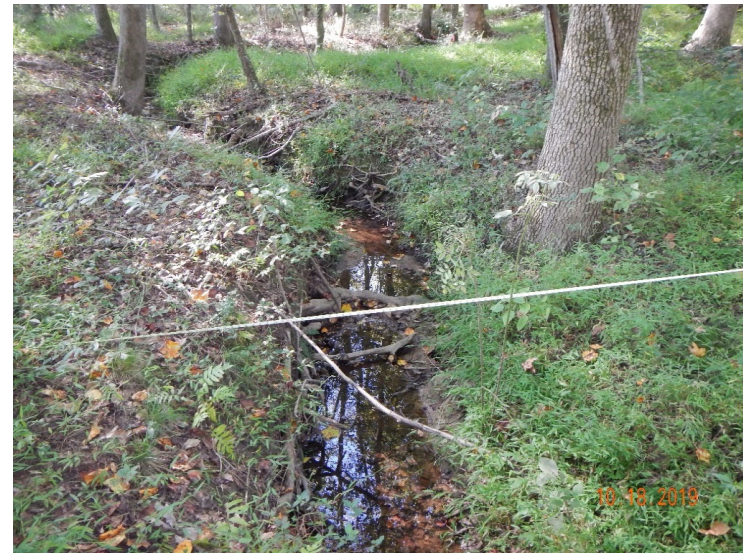
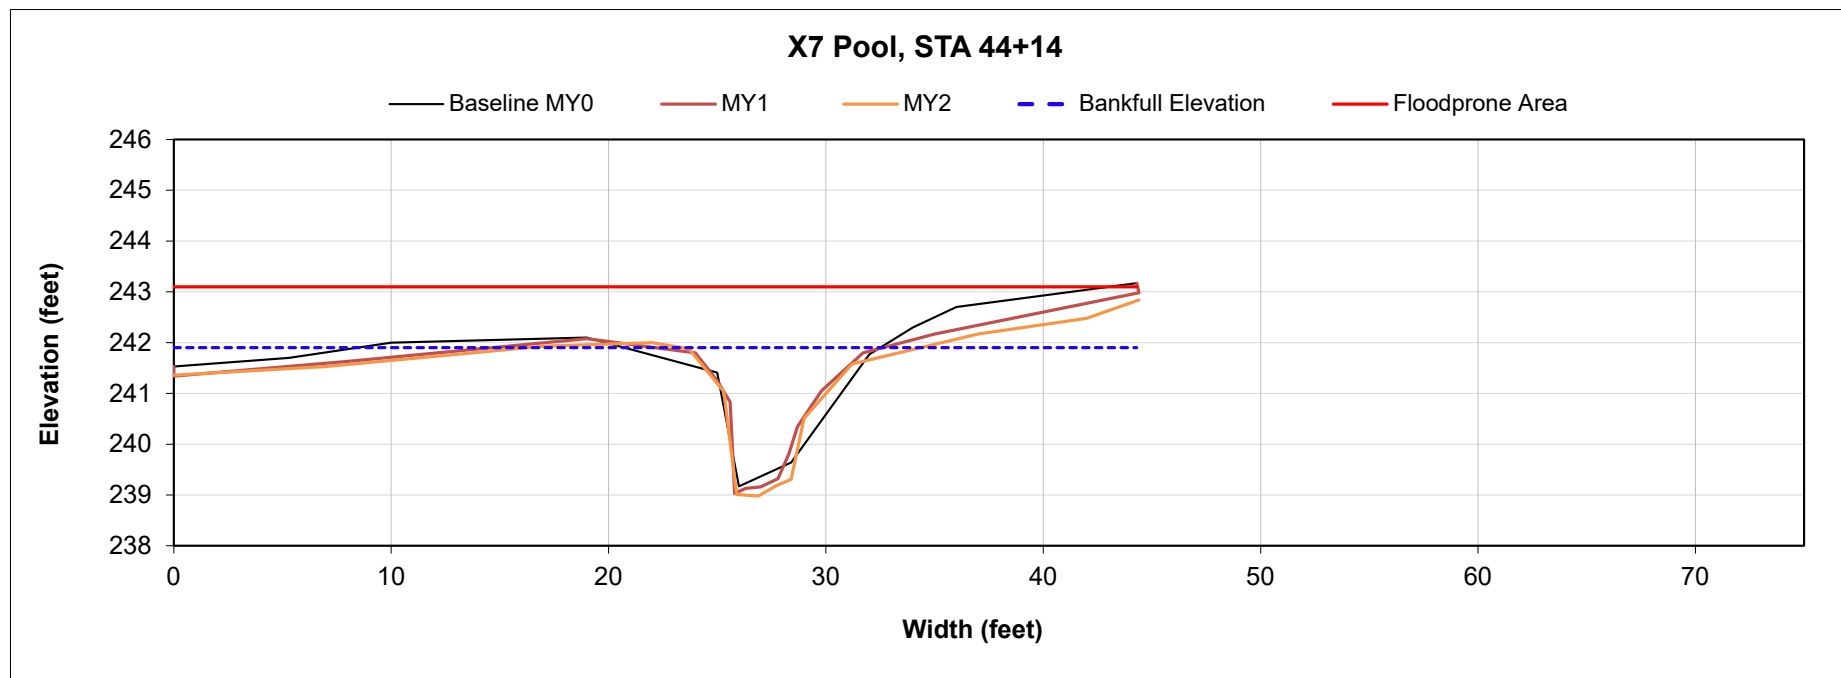
Project Name	Lake Wendell Mitigation Project
Project ID	97081
Reach ID	R4 (Preservation)
Cross Section ID	X7
Field Crew	K. Obermiller, E. Dunnigan

Dimension Data Summary: MY2 2019	
Bankfull Elevation (ft)	241.9
Low Bank Height Elevation (ft)	241.9
Bankfull Max Depth (ft)	2.9
Low Bank Height (ft)	2.9
Bank Height Ratio	1.0
Bankfull X-section Area (ft ²)	12.3
% Change Bank Height Ratio	0.0%

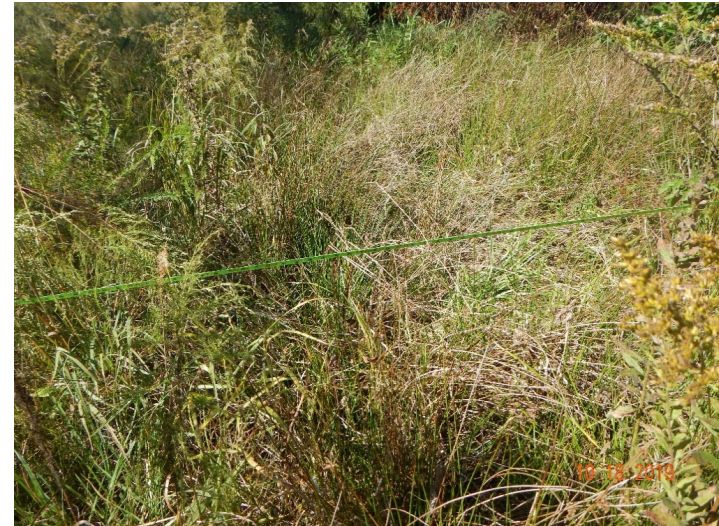
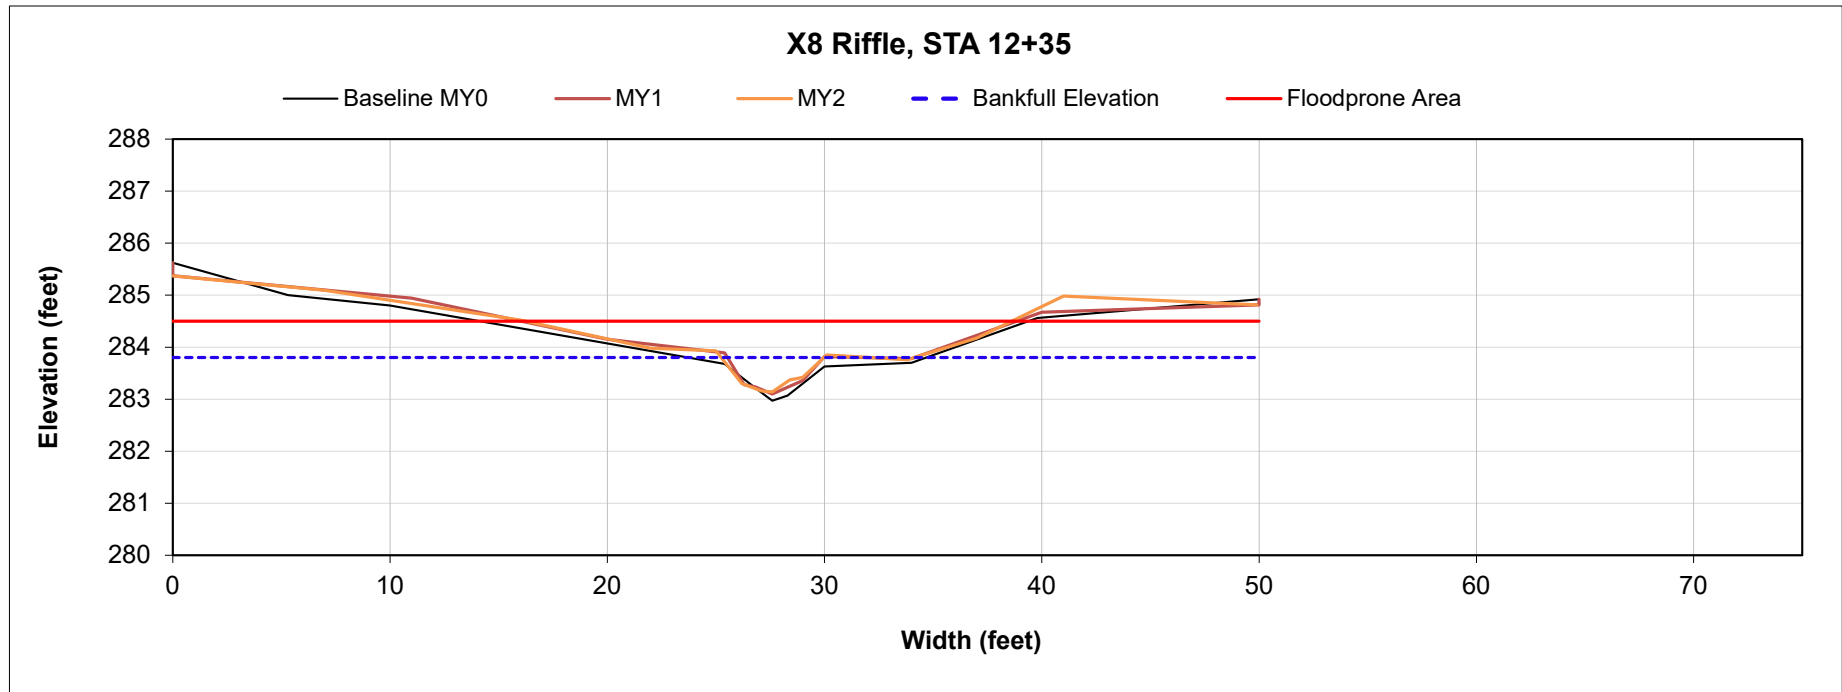
Project Name	Lake Wendell Mitigation Project
Project ID	97081
Reach ID	R5
Cross Section ID	X8
Field Crew	K. Obermiller, E. Dunnigan

Dimension Data Summary: MY2 2019	
Bankfull Elevation (ft)	283.9
Low Bank Height Elevation (ft)	283.9
Bankfull Max Depth (ft)	0.7
Low Bank Height (ft)	0.7
Bank Height Ratio	1.0
Bankfull X-section Area (ft²)	2.1
% Change Bank Height Ratio	0.0%

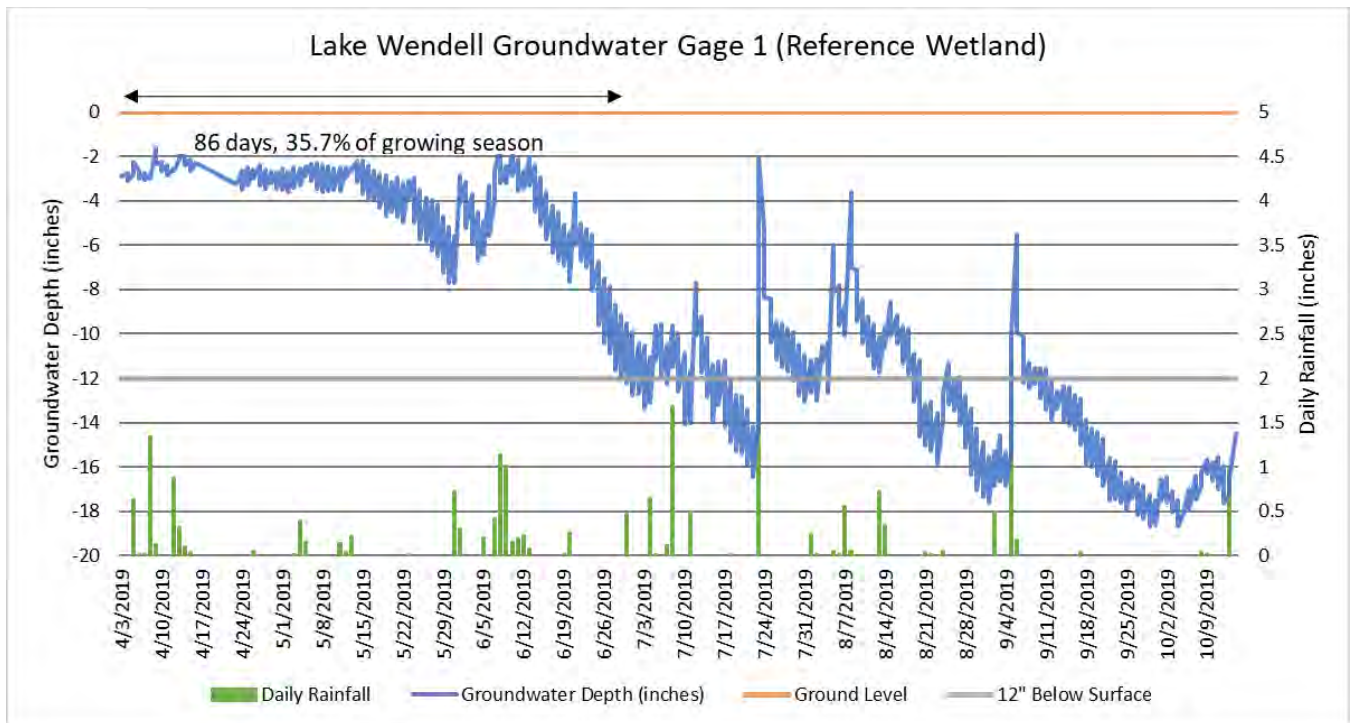
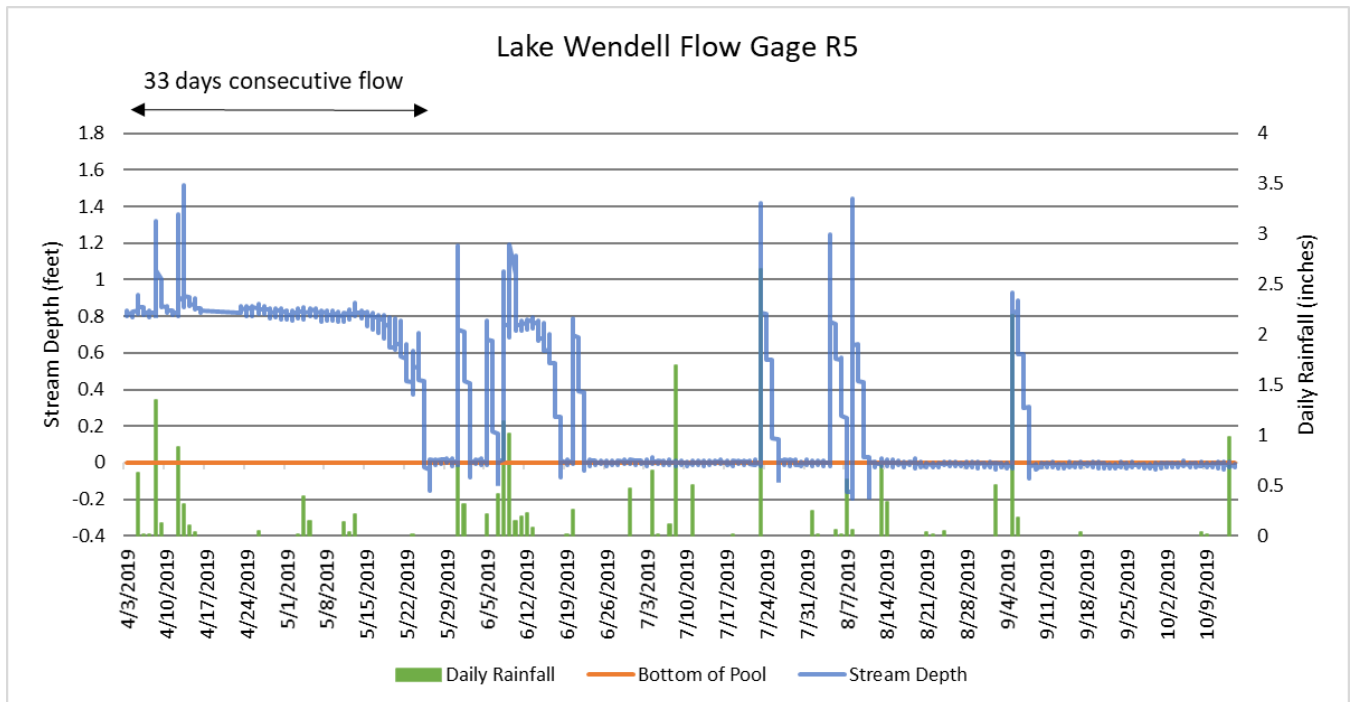
Figure 4: Groundwater Gauge Data
 Lake Wendell Mitigation Project (NCDEQ DMS Project ID# 97081)
 MY2 2019

Monitoring Gauge Name	Max Consecutive Hydroperiod: Saturation within 12 Inches of Soil Surface (Percent of Growing Season) WETS Station: 317994 - Smithfield Growing Season: 4/6-11/4 (227 days)							
	2018	2019	2020	2021	2022	2023	2024	Mean
Lake Wendell Reference Wetland	95.20%	53.52%

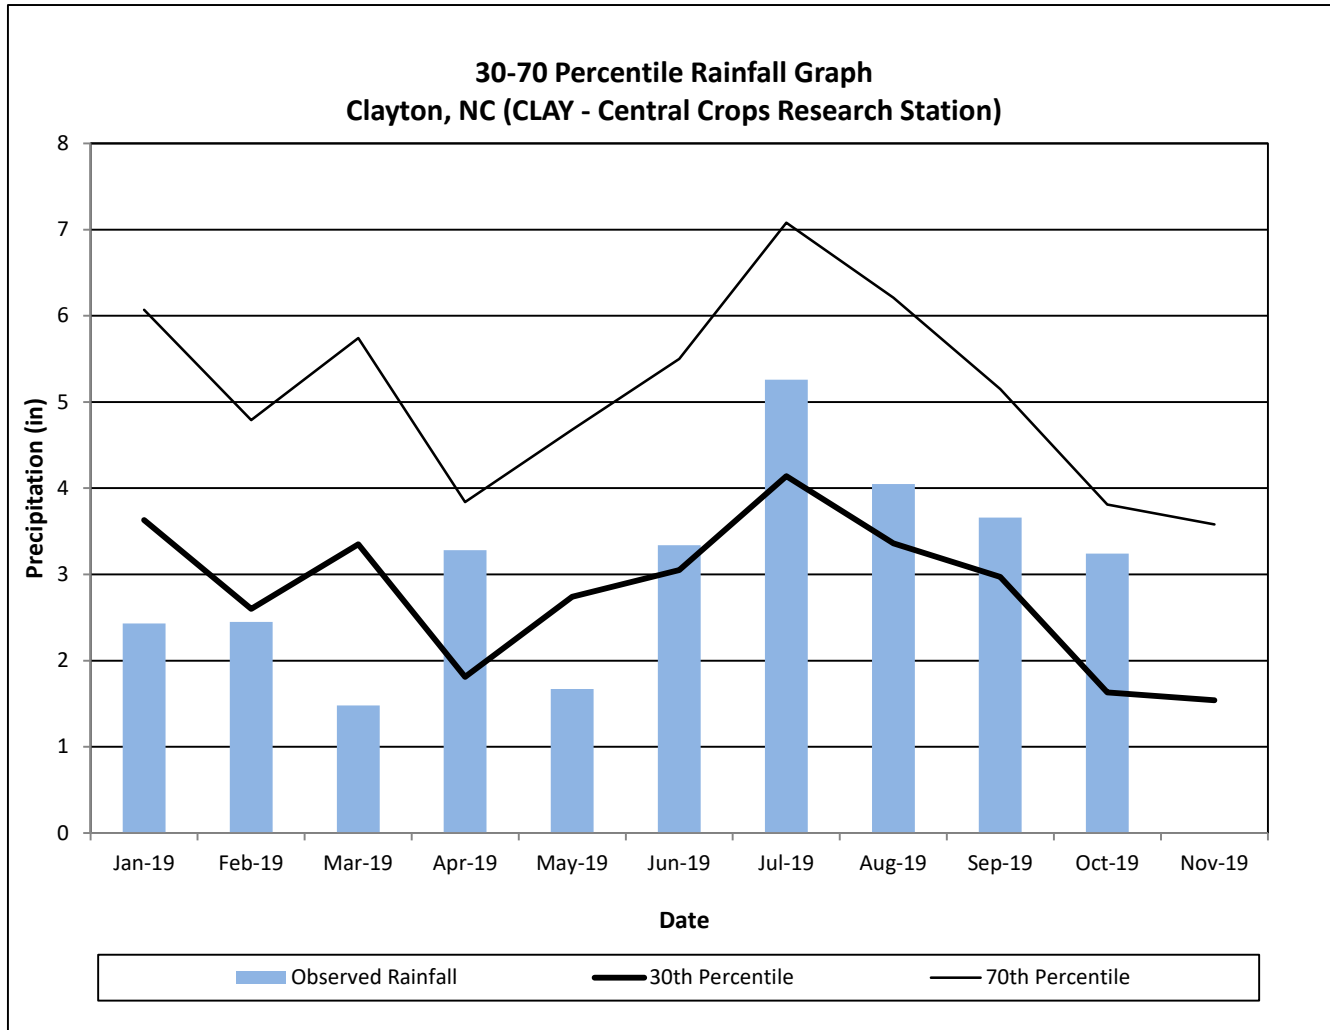
Figure 5: Monthly Rainfall Data
Lake Wendell Mitigation Project (NCDEQ DMS Project ID # 97081)
MY2 2019

Month	30%	70%	Observed
Jan-19	3.63	6.07	2.43
Feb-19	2.60	4.79	2.45
Mar-19	3.35	5.74	1.48
Apr-19	1.81	3.84	3.28
May-19	2.74	4.68	1.67
Jun-19	3.05	5.50	3.34
Jul-19	4.14	7.08	5.26
Aug-19	3.36	6.21	4.05
Sep-19	2.97	5.15	3.66
Oct-19	1.63	3.81	3.24
Nov-19	1.54	3.58	**
Dec-19	**	**	**
