Monitoring Report – MY3
FINAL VERSION
Lake Wendell Mitigation Project
Calendar Year of Data Collection: 2020

NCDEQ DMS Project Identification # 97081
NCDEQ DMS Contract # 6826
Neuse River Basin (Cataloging Unit 03020201)
USACE Action ID Number: SAW-2016-00876
NCDEQ DWR Project # 2016-0385
Johnston County, NC
Contracted Under RFP # 16-006477
Data Collection Period: September-October 2020
Submission Date: December 11, 2020

Mitigation Project Name Lake Wendell Mitigation Project
DMS ID 97081
River Basin Neuse
Cataloging Unit 03020201
County Johnston

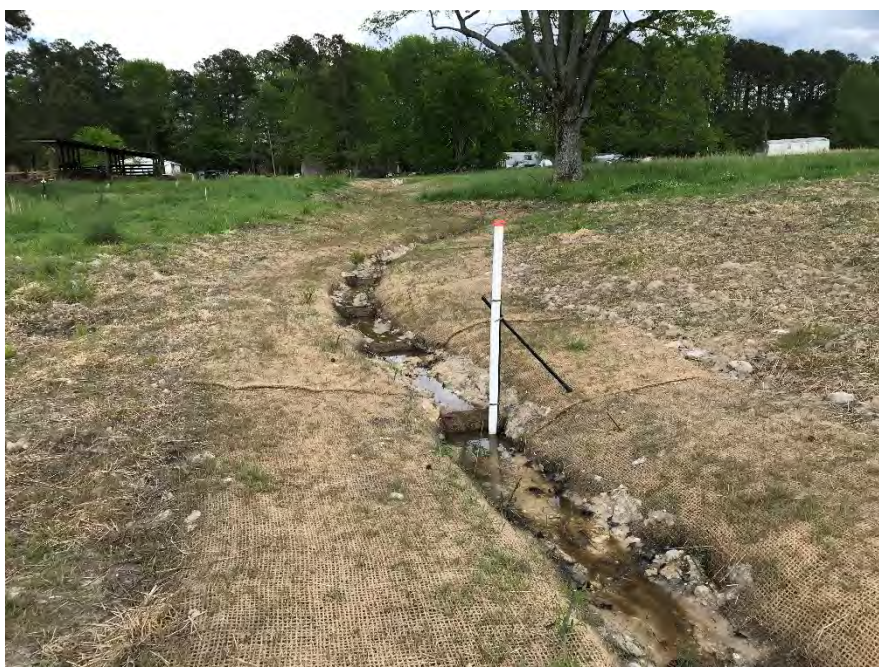
PS-13, R5, facing upstream, old crest gauge, Sta 13+50, Apr 27, 2018 (MY-00)

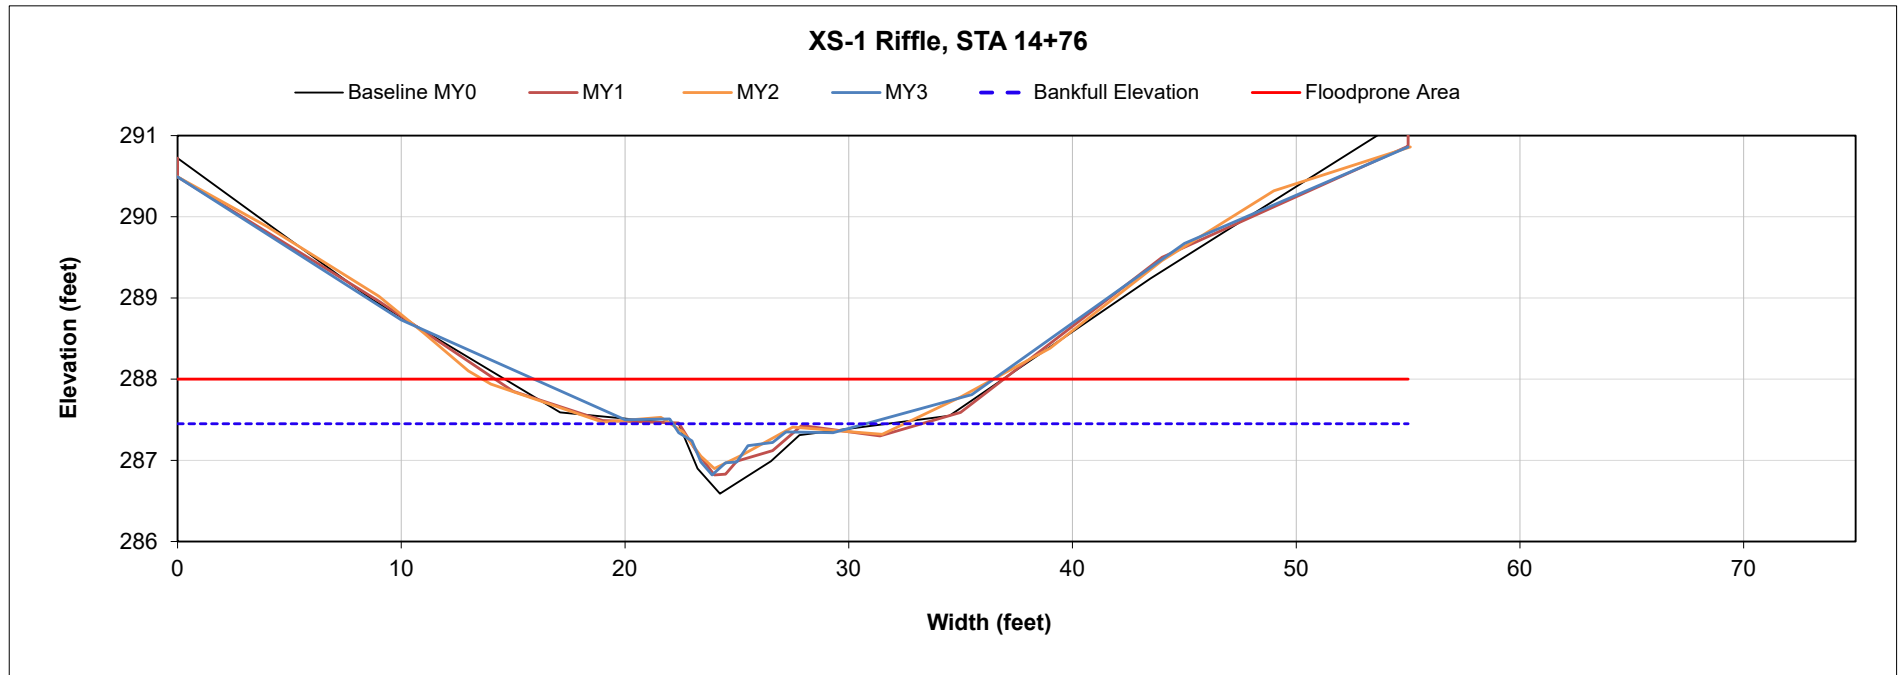
Project Name	Lake Wendell Mitigation Project
Project ID	97081
Reach ID	R1
Cross Section ID	XS-1
Field Crew	K. Obermiller, E. Dunnigan

Dimension Data Summary: MY3 2020	
Bankfull Elevation (ft)	287.5
Low Bank Height Elevation (ft)	287.4
Bankfull Max Depth (ft)	0.6
Low Bank Height (ft)	0.5
Bank Height Ratio	< 1.0
Bankfull X-section Area (ft ²)	2.0
% Change Bank Height Ratio	20.0%

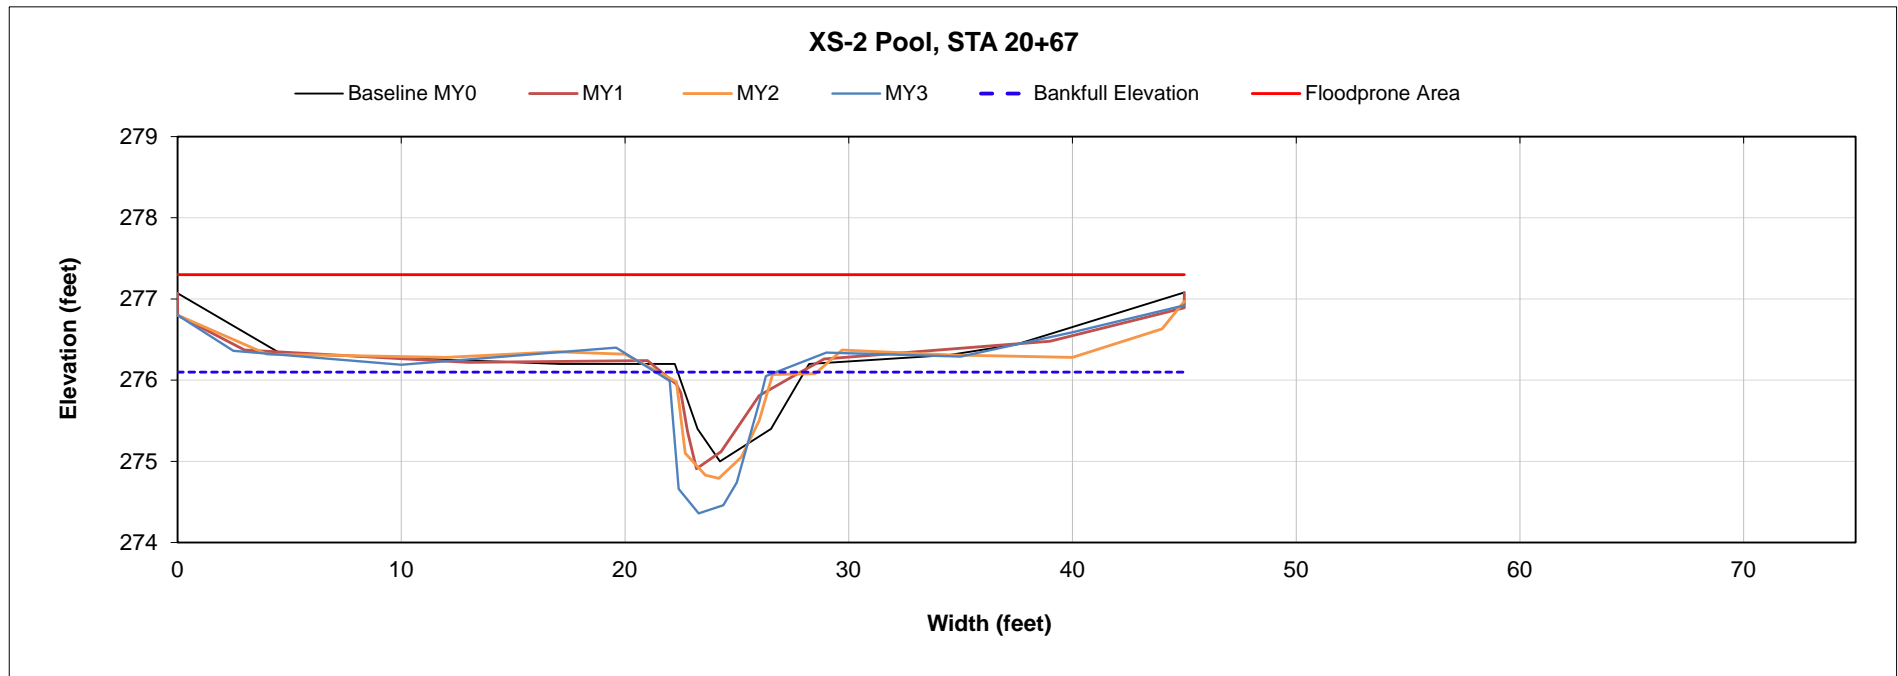
Project Name	Lake Wendell Mitigation Project
Project ID	97081
Reach ID	R2
Cross Section ID	XS-2
Field Crew	K. Obermiller, E. Dunnigan

Dimension Data Summary: MY3 2020	
Bankfull Elevation (ft)	275.8
Low Bank Height Elevation (ft)	276.0
Bankfull Max Depth (ft)	1.4
Low Bank Height (ft)	1.6
Bank Height Ratio	1.1
Bankfull X-section Area (ft ²)	4.1
% Change Bank Height Ratio	10.0%

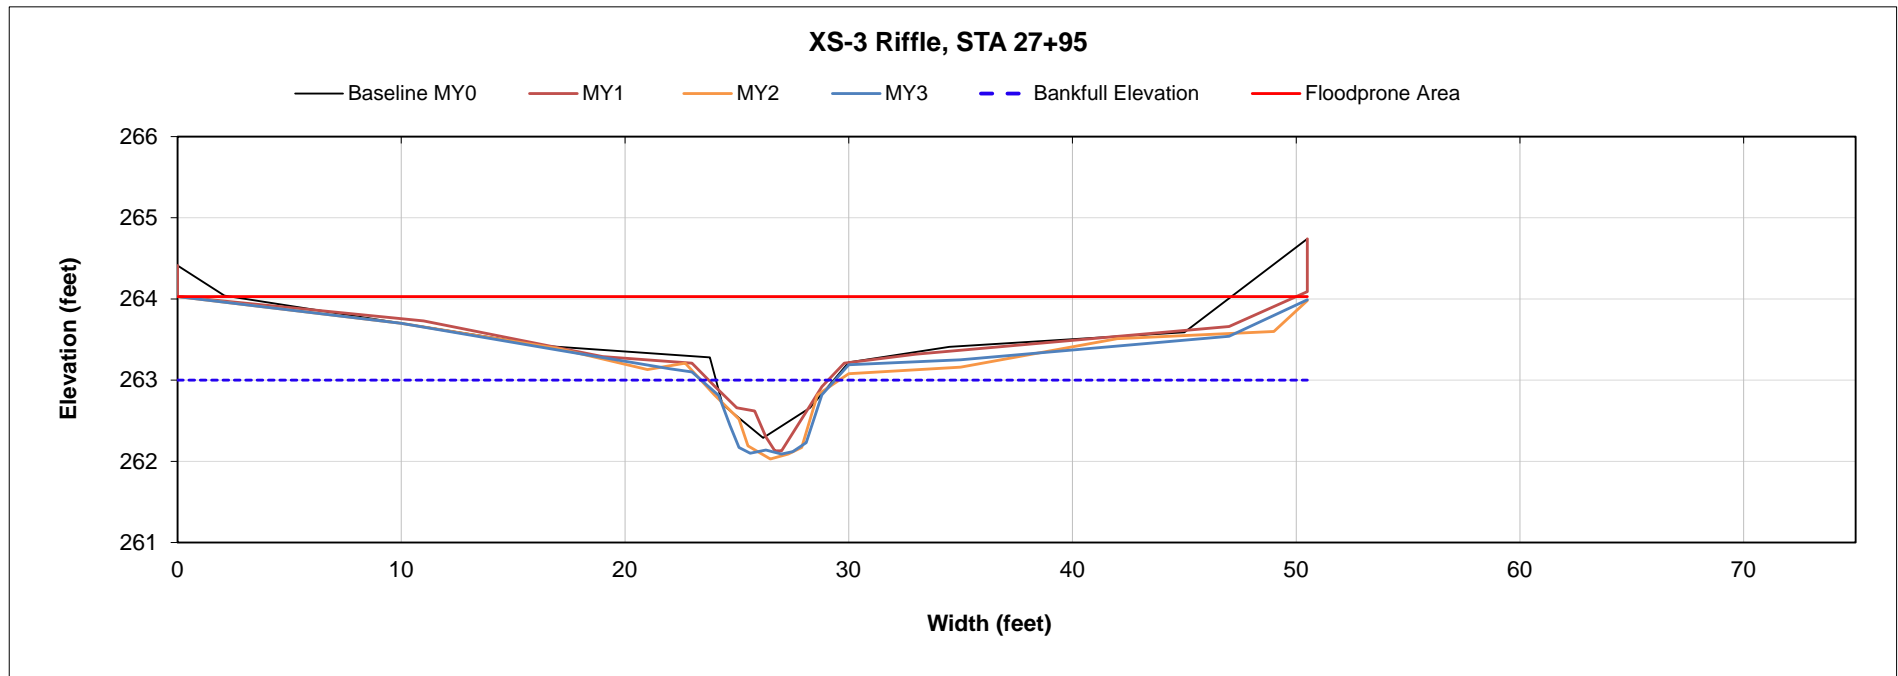
Project Name	Lake Wendell Mitigation Project
Project ID	97081
Reach ID	R2
Cross Section ID	XS-3
Field Crew	K. Obermiller, E. Dunnigan

Dimension Data Summary: MY3 2020	
Bankfull Elevation (ft)	263.0
Low Bank Height Elevation (ft)	263.1
Bankfull Max Depth (ft)	0.9
Low Bank Height (ft)	1.0
Bank Height Ratio	1.1
Bankfull X-section Area (ft ²)	3.5
% Change Bank Height Ratio	10.0%

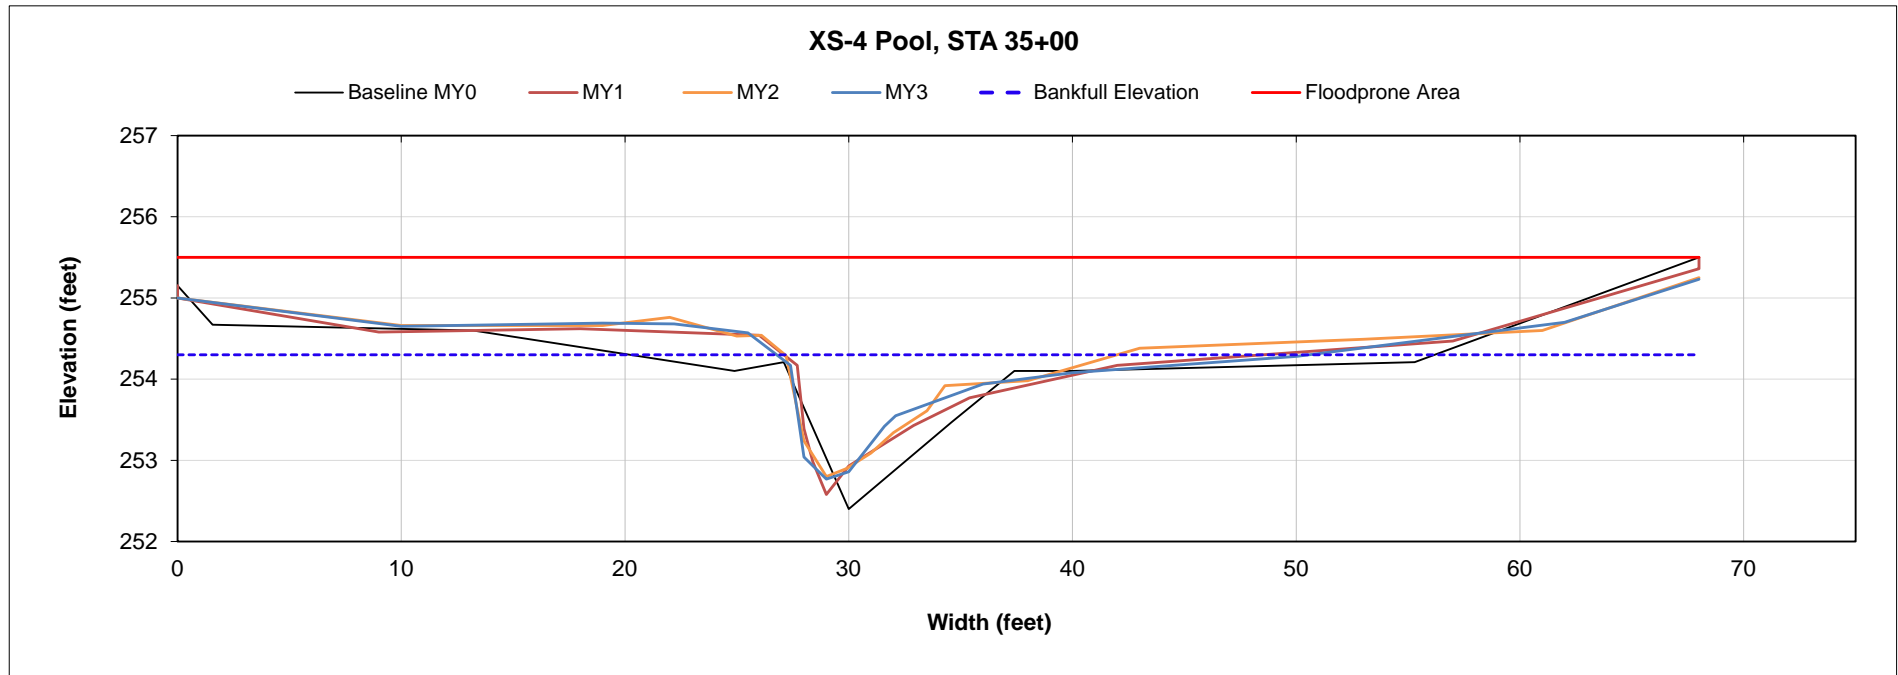
Project Name	Lake Wendell Mitigation Project
Project ID	97081
Reach ID	R3
Cross Section ID	XS-4
Field Crew	K. Obermiller, E. Dunnigan

Dimension Data Summary: MY3 2020	
Bankfull Elevation (ft)	254.2
Low Bank Height Elevation (ft)	254.1
Bankfull Max Depth (ft)	1.5
Low Bank Height (ft)	1.3
Bank Height Ratio	< 1.0
Bankfull X-section Area (ft ²)	8.5
% Change Bank Height Ratio	10.0%

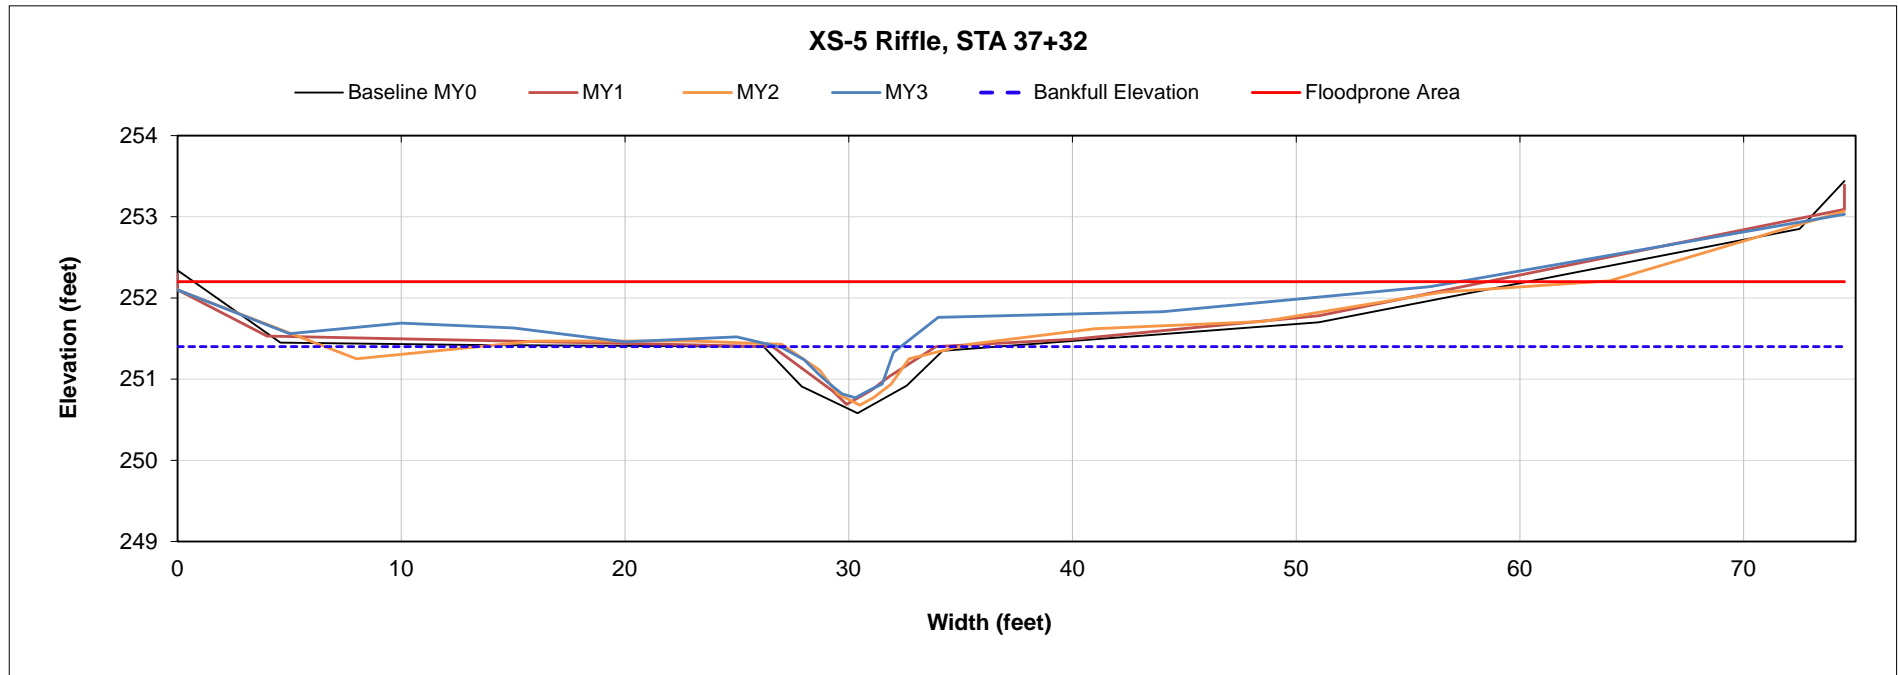
Project Name	Lake Wendell Mitigation Project
Project ID	97081
Reach ID	R3
Cross Section ID	XS-5
Field Crew	K. Obermiller, E. Dunnigan

Dimension Data Summary: MY3 2020	
Bankfull Elevation (ft)	251.5
Low Bank Height Elevation (ft)	251.5
Bankfull Max Depth (ft)	0.8
Low Bank Height (ft)	0.8
Bank Height Ratio	1.0
Bankfull X-section Area (ft ²)	2.7
% Change Bank Height Ratio	0.0%

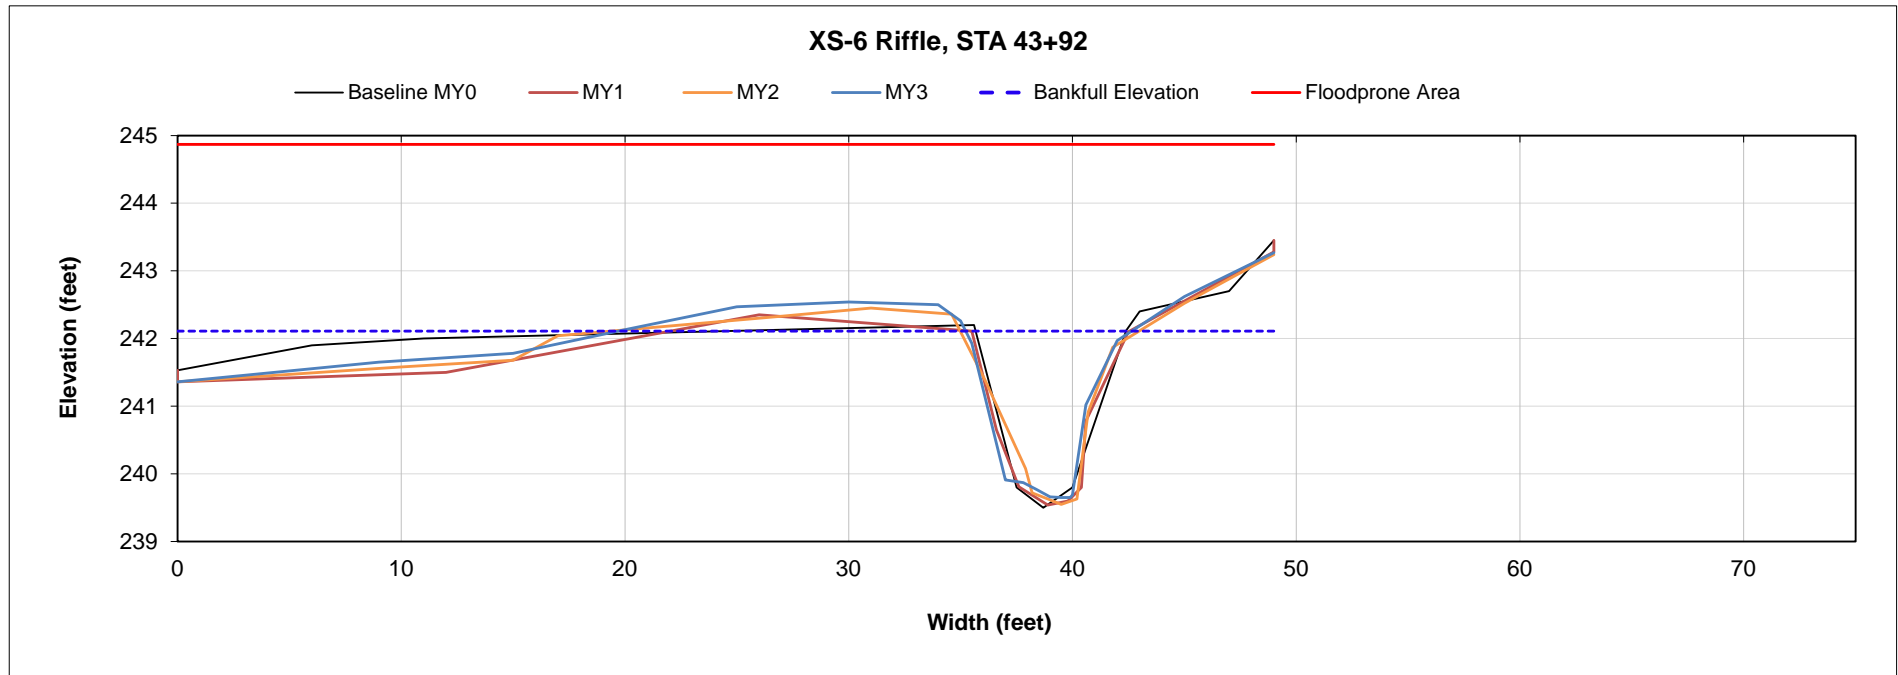
Project Name	Lake Wendell Mitigation Project
Project ID	97081
Reach ID	R4 (Preservation)
Cross Section ID	XS-6
Field Crew	K. Obermiller, E. Dunnigan

Dimension Data Summary: MY3 2020	
Bankfull Elevation (ft)	242.2
Low Bank Height Elevation (ft)	242.3
Bankfull Max Depth (ft)	2.5
Low Bank Height (ft)	2.6
Bank Height Ratio	1.0
Bankfull X-section Area (ft²)	11.2
% Change Bank Height Ratio	0.0%

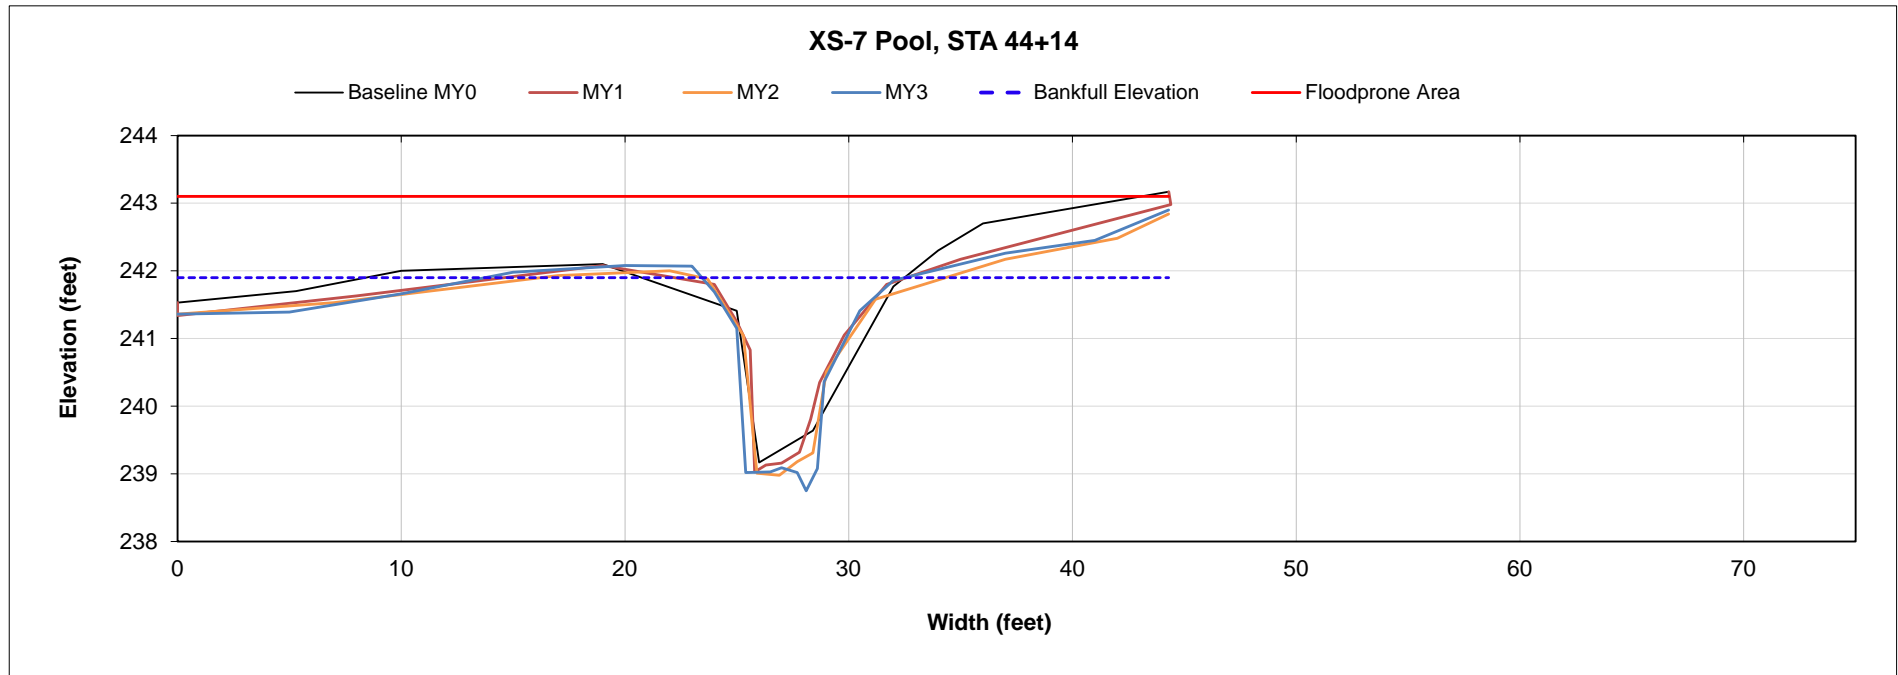
Project Name	Lake Wendell Mitigation Project
Project ID	97081
Reach ID	R4 (Preservation)
Cross Section ID	XS-7
Field Crew	K. Obermiller, E. Dunnigan

Dimension Data Summary: MY3 2020	
Bankfull Elevation (ft)	241.8
Low Bank Height Elevation (ft)	241.9
Bankfull Max Depth (ft)	3.0
Low Bank Height (ft)	3.1
Bank Height Ratio	1.0
Bankfull X-section Area (ft ²)	12.3
% Change Bank Height Ratio	0.0%

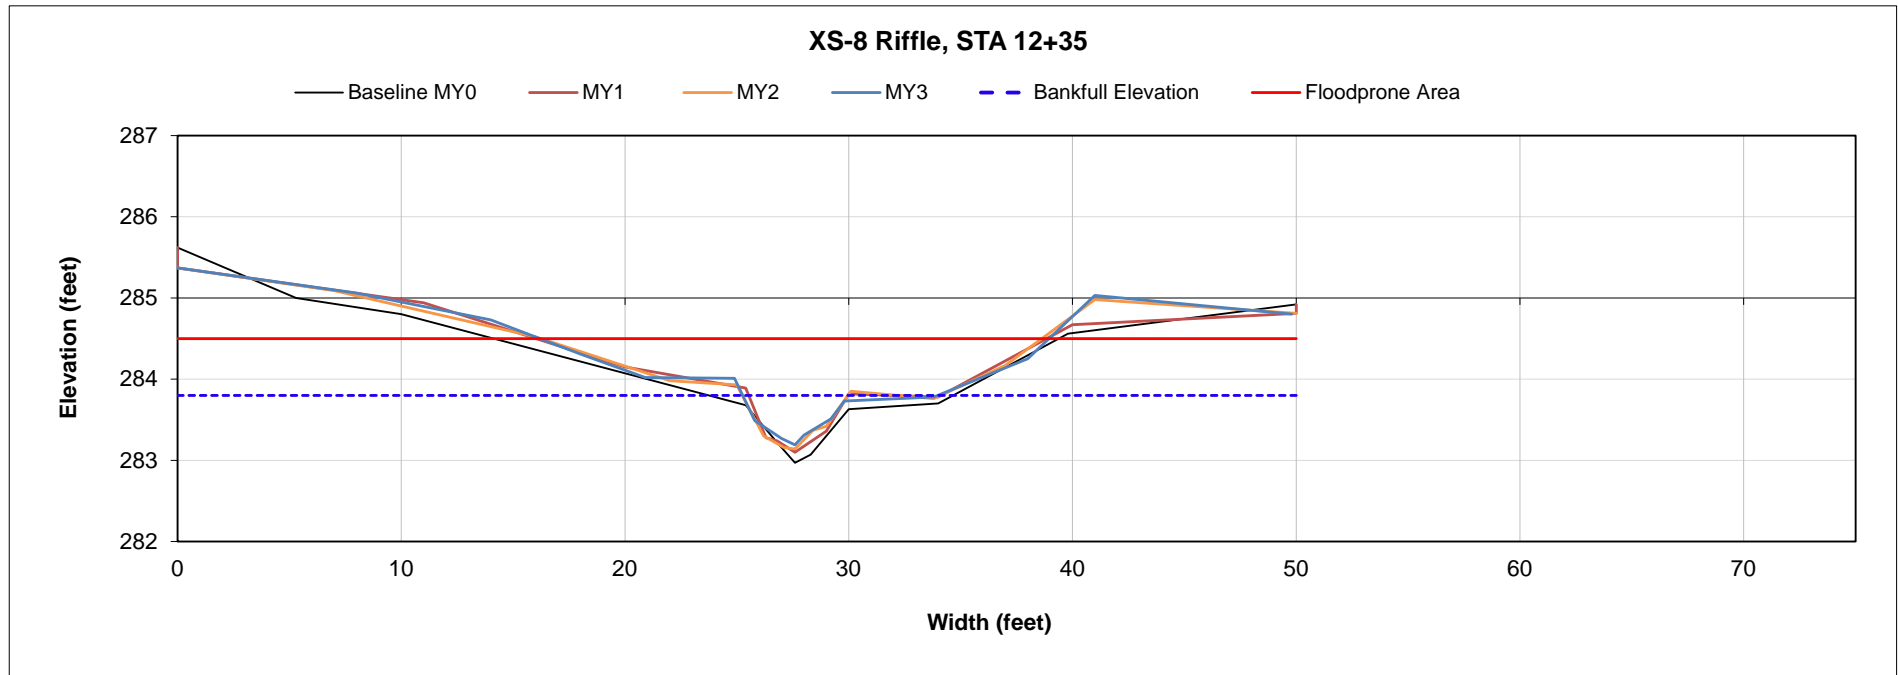
Project Name	Lake Wendell Mitigation Project
Project ID	97081
Reach ID	R5
Cross Section ID	XS-8
Field Crew	K. Obermiller, E. Dunnigan

Dimension Data Summary: MY3 2020	
Bankfull Elevation (ft)	283.8
Low Bank Height Elevation (ft)	283.7
Bankfull Max Depth (ft)	0.6
Low Bank Height (ft)	0.5
Bank Height Ratio	< 1.0
Bankfull X-section Area (ft ²)	2.1
% Change Bank Height Ratio	10.0%

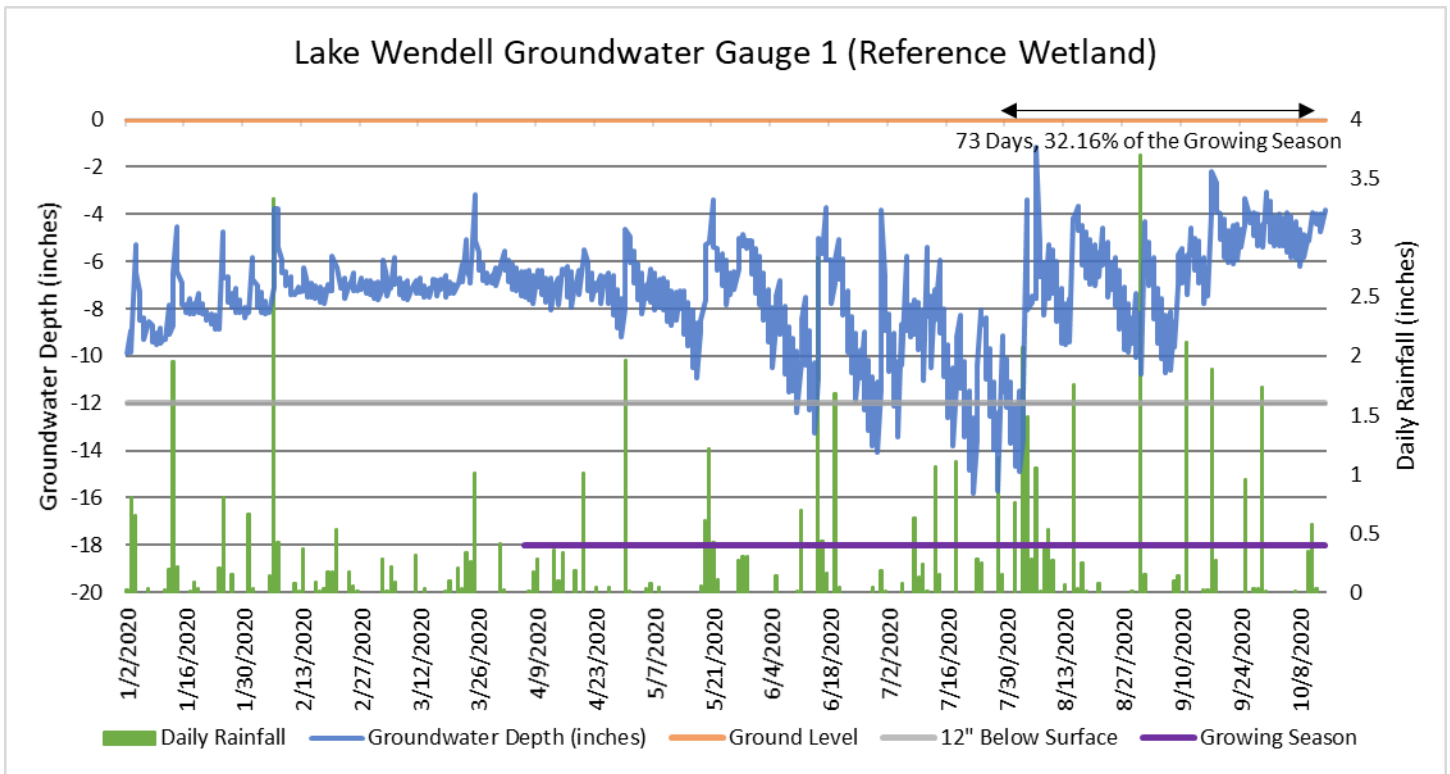
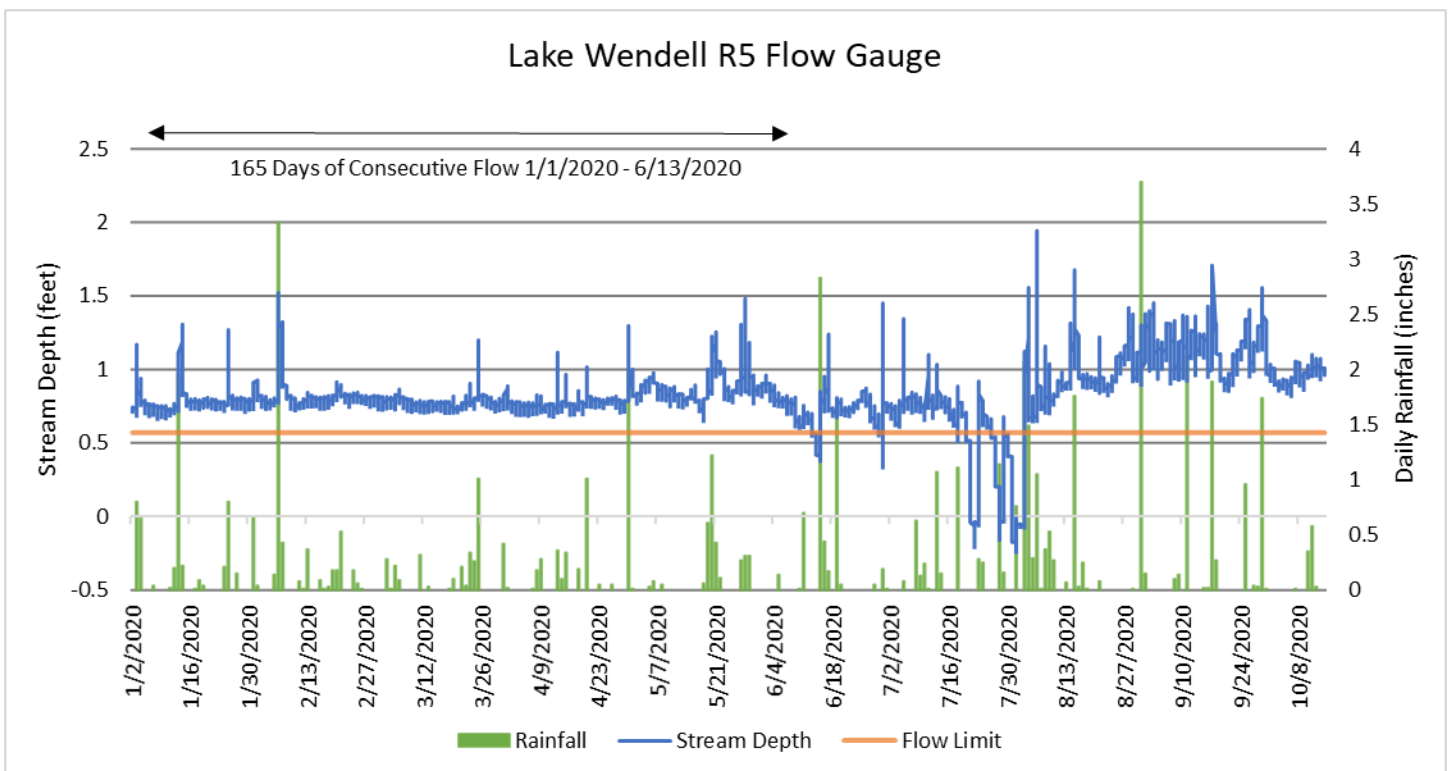
Figure 4a: Gauge Graphs (pressure transducers)

Jurisdictional stream flow documentation and monitoring of restored intermittent reaches is achieved by the installation of a flow gauge (continuous-read pressure transducer) within the thalweg of the channel towards the middle portion of the Reach R5 (Figure 1). Additionally, to determine if rainfall amounts are normal for the given year, precipitation data was obtained from CLAY Central Crops Research Station in Johnston County, approximately nine miles southwest of the site. The monitoring gauge documented that the stream exhibited surface flow for a minimum of 30 consecutive days throughout some portion of the year during a year with normal rainfall conditions (See Figure 4).

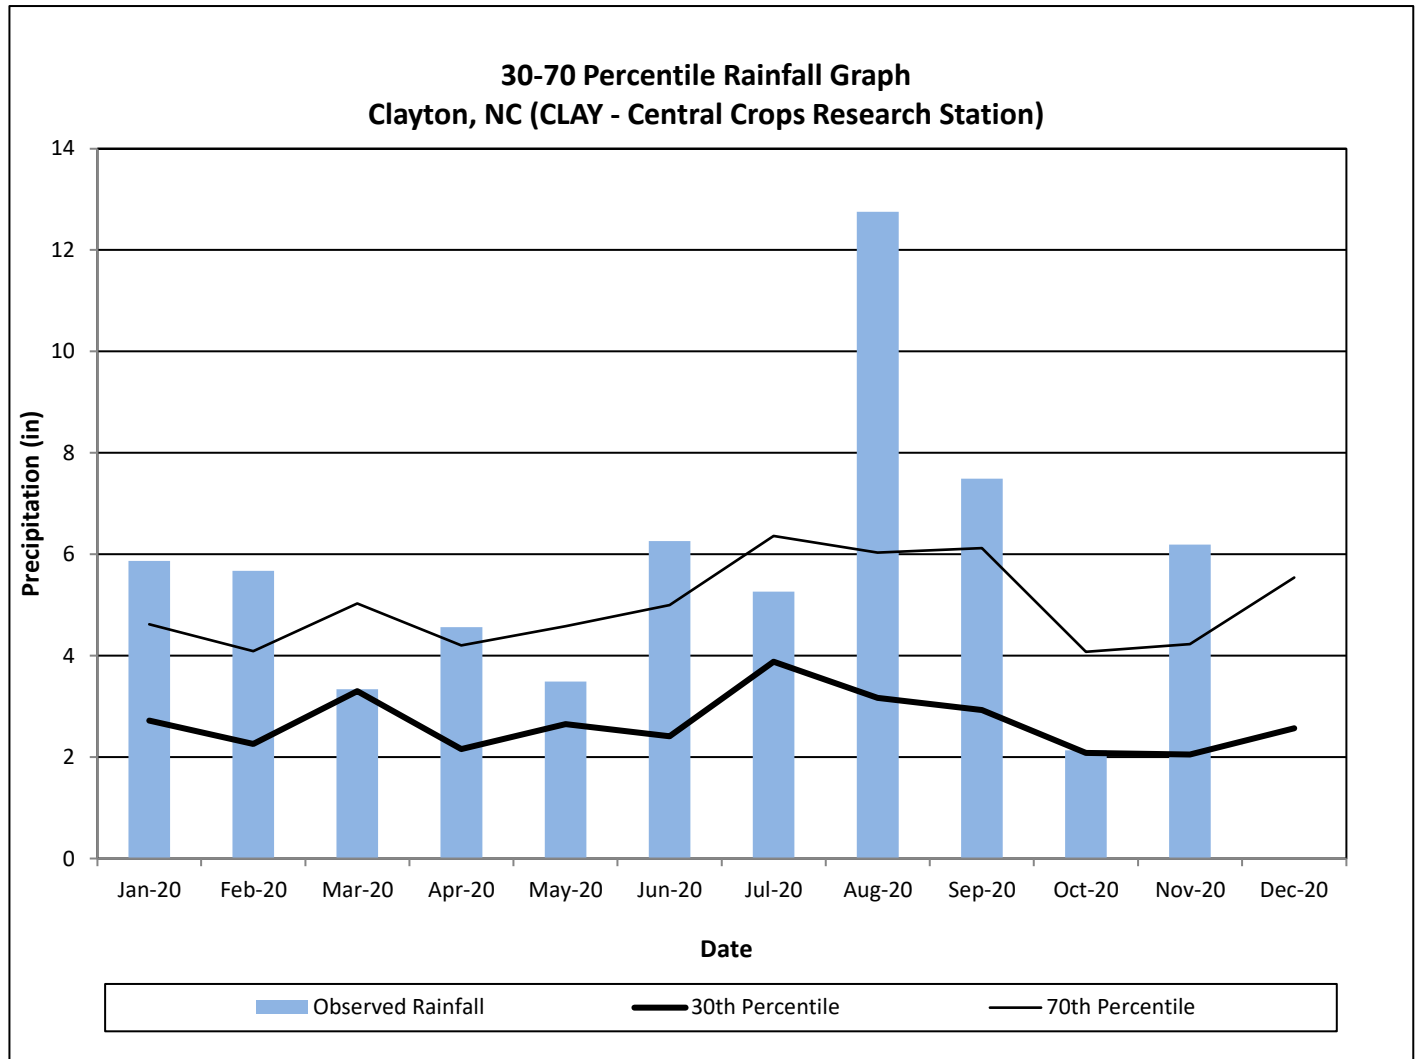
Figure 5: Monthly Rainfall Data
Lake Wendell Mitigation Project (NCDEQ DMS Project ID# 97081)
MY3 2020

Month	30%	70%	Observed
Jan-20	2.72	4.62	5.87
Feb-20	2.26	4.09	5.67
Mar-20	3.30	5.03	3.34
Apr-20	2.16	4.20	4.56
May-20	2.65	4.58	3.49
Jun-20	2.41	5.00	6.26
Jul-20	3.88	6.36	5.26
Aug-20	3.17	6.03	12.75
Sep-20	2.93	6.12	7.49
Oct-20	2.08	4.08	2.13
Nov-20	2.05	4.23	6.19
Dec-20	2.57	5.54	**

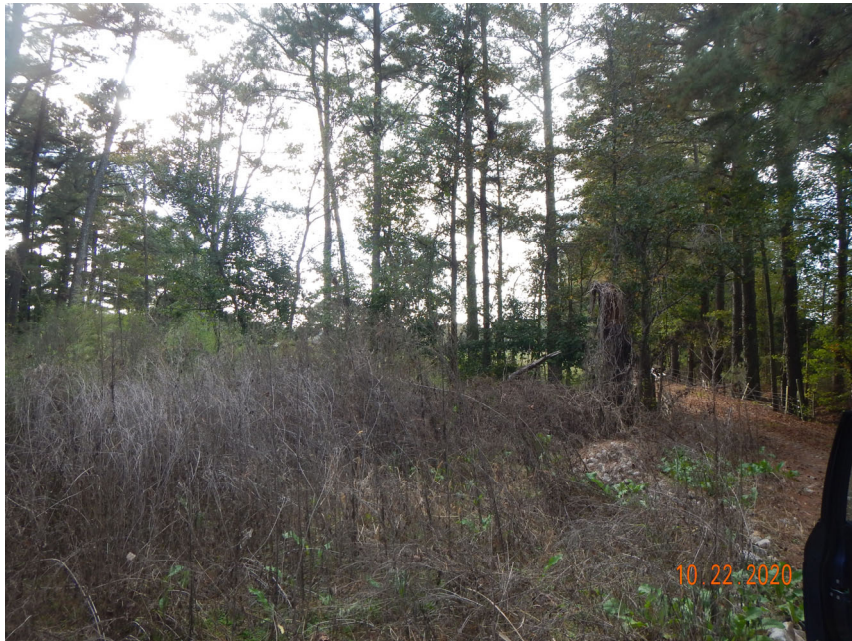
During the project construction, invasive species exotic vegetation was either mechanically removed or chemically treated both to control its presence and reduce its spread within the conservation easement areas. During MY3 an area of concern was observed along R1 buffer as shown on the Figure 1. This area was utilized as a temporary staging area during construction and contains invasive species vegetation (kudzu) along the right buffer. This area was managed twice during MY3, with kudzu crown removal happening during the summer and foliar spray of the limited remaining stems in October using a 3 percent solution of Garlon 3A (see table below for treatments). Following these treatments, the percent cover of kudzu was reduced to approximately 5%. WLS will continue to monitor and treat the kudzu during MY4.

Kudzu Problem Area, October 22, 2020 (MY-03)

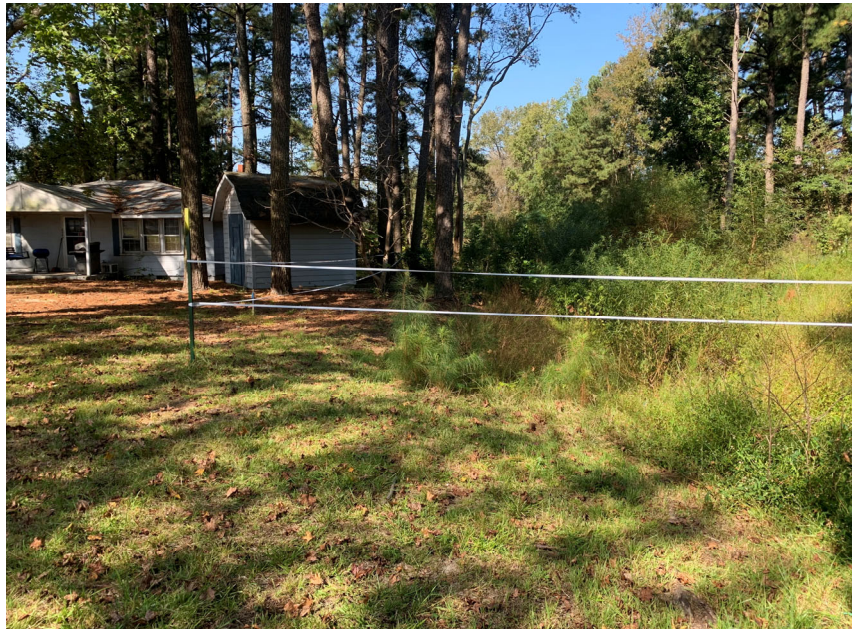
The MY3 vegetation monitoring was also conducted utilizing visual assessment throughout the easement. The results of the visual assessment did not indicate any negative changes to the existing vegetation community. An area of encroachment approximately 0.008 acres was found along R1, see Figure 1. This area has been mowed by the adjacent homeowner and is currently vegetated with fescue. Management of this area has already begun and includes additional signage and a physical barrier (horse tape) to delineate the easement boundary and discourage further mowing. During MY4 additional trees will be planted in this area to ensure tree cover is achieved. Trees planted will be from the approved list in the mitigation plan. A previous area of concern is located along R1 buffer as shown on the CCPV (noted first in MY1). This area was utilized as a temporary staging area during construction and contains invasive vegetation (kudzu) along the right buffer. The area was treated twice during the 2020 year, once in March and once in October (see table below for treatments). Following these treatments, the percent cover of kudzu was reduced to approximately 5%. This area will continue to be treated during MY4 and documented in future reports.

Encroachment Area, October 7, 2020 (MY-03)
