Monitoring Report – MY4  
FINAL VERSION  
Lake Wendell Mitigation Project  
Calendar Year of Data Collection: 2021

NCDEQ DMS Project Identification # 97081  
NCDEQ DMS Contract # 6826  
Neuse River Basin (Cataloging Unit 03020201)  
USACE Action ID Number: SAW-2016-00876  
NCDEQ DWR Project # 2016-0385 V2  
Johnston County, NC  
Contracted Under RFP # 16-006477  
Data Collection Period: September 2021  
Submission Date: October 20<sup>th</sup>, 2021

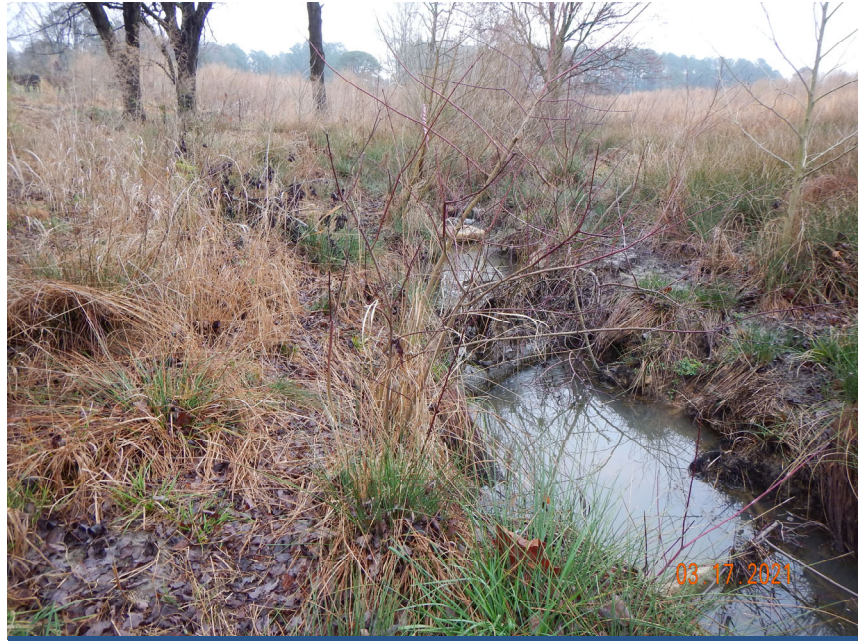
PS-5, R2, facing upstream, Sta 26+50, March 17, 2021 (MY-04)

Minor piping was noted in MY3 at two instream structures near approximate stations 26+00 (SPA1) and 26+50 (SPA2). During MY4 these areas were live staked to prevent further erosion and provide bank stability. Both structures are failing, but there is not a systemic problem upstream or downstream and no immediate remedial action is proposed at this time. Monitoring of these areas will continue in MY5.

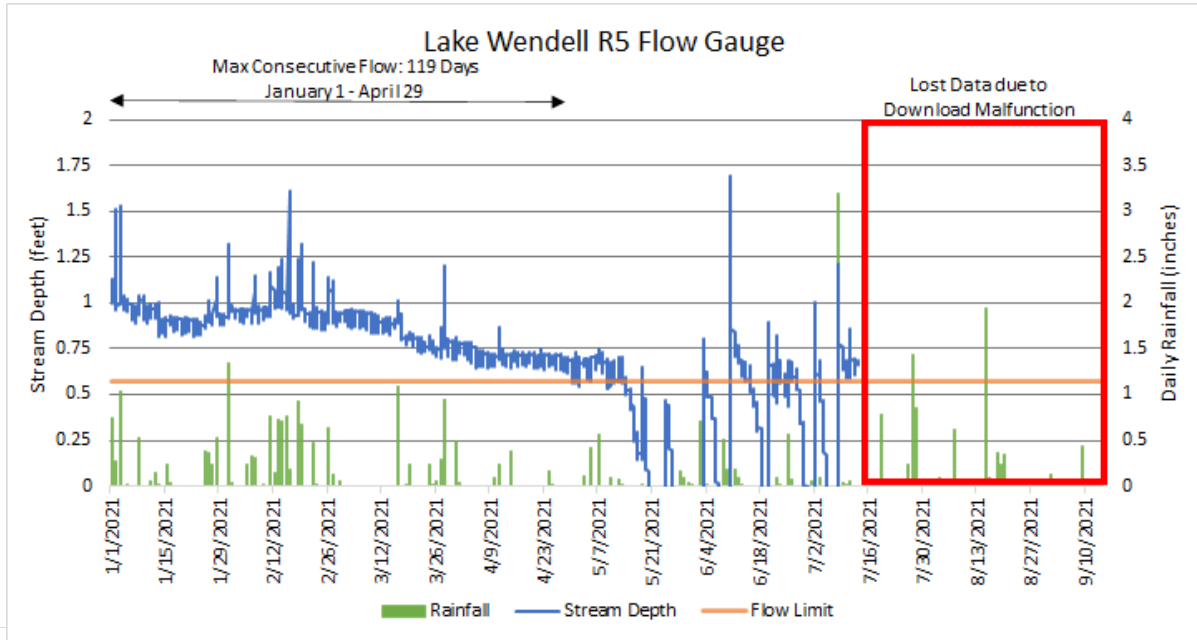
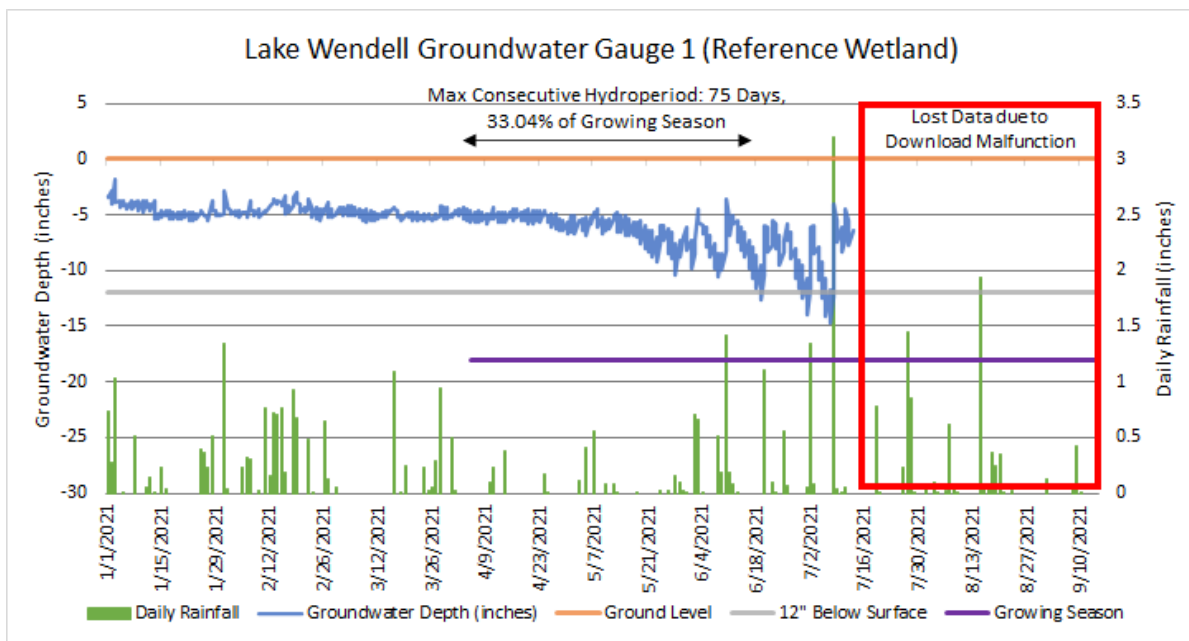
**Figure 4a: Hydrograph Data (pressure transducer)**

Jurisdictional stream flow documentation and monitoring of restored intermittent reaches is achieved by the installation of a flow gauge (continuous-read pressure transducer) within the thalweg of the channel towards the middle portion of the Reach R5 (Figure 1). Additionally, to determine if rainfall amounts are normal for the given year, precipitation data was obtained from CLAY Central Crops Research Station in Johnston County, approximately nine miles southwest of the site. The monitoring gauge documented the stream exhibited surface flow for 119 consecutive days from January 1st to April 29th, 2021 (see Figure 4). A gauge malfunction resulted in the loss of data from July 14th, 2021, to September 14th, 2021. The malfunctioning gauge was repaired on September 14<sup>th</sup>, 2021.

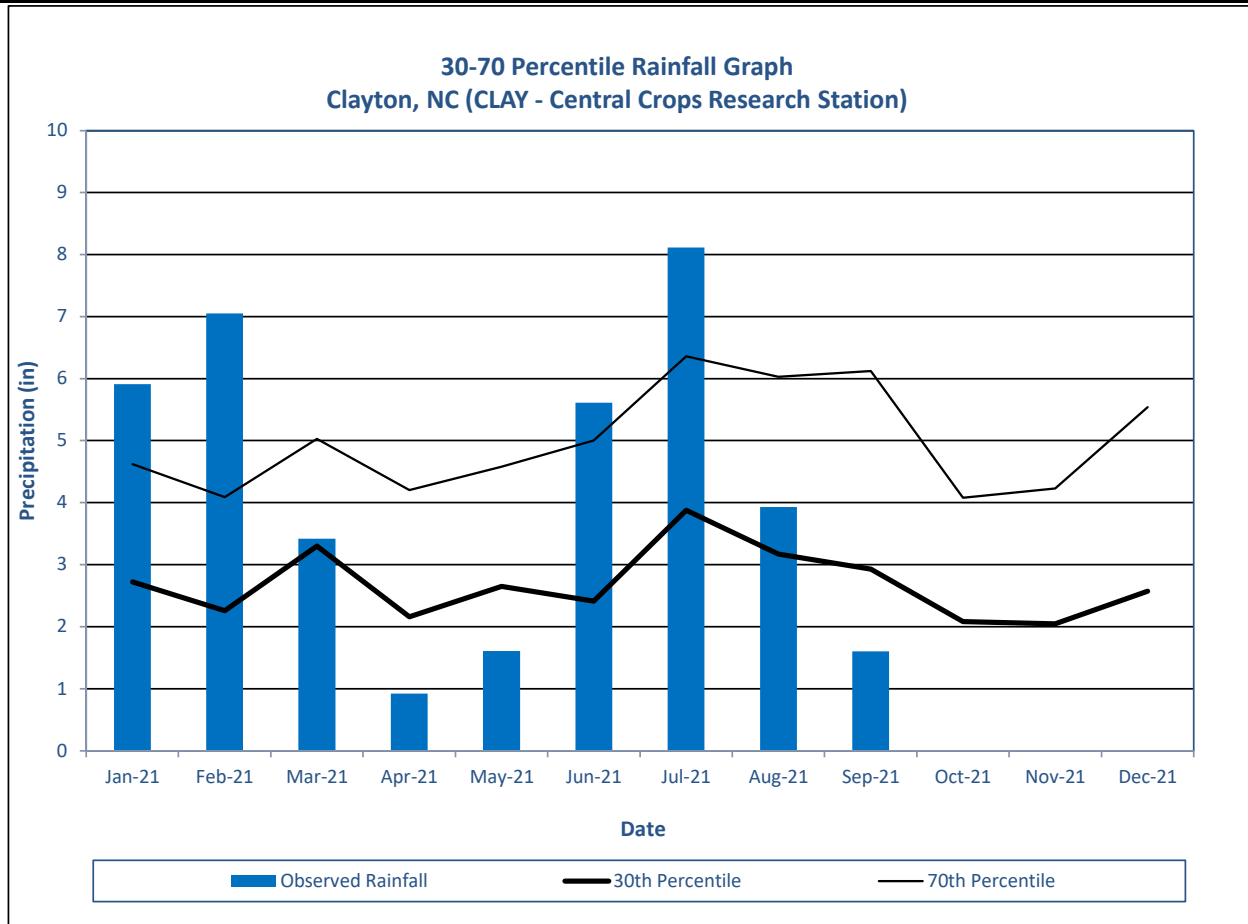
**Figure 5: Monthly Rainfall Data**  
**Lake Wendell Mitigation Project (NCDEQ DMS Project ID# 97081)**  
**MY4 2021**

- 4. DMS Comment: Update rain report for additional months if possible.** WLS Response: September rainfall data was added to Figure 5.
