MONITORING YEAR 1 ANNUAL REPORT FINAL

LAUREL VALLEY MITIGATION SITE

Burke County, NC
Catawba River Basin
HUC 03050101

LAUREL VALLEY MITIGATION SITE
Monitoring Year 1 Annual Report

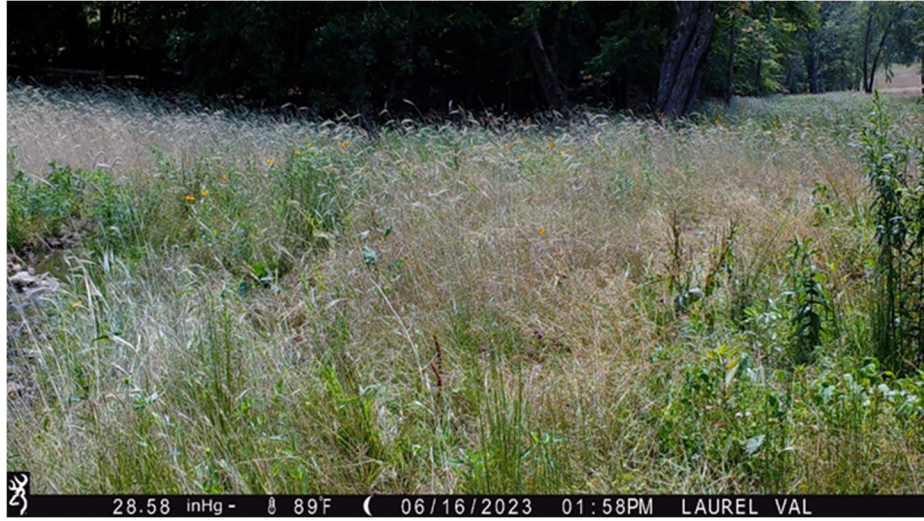
UT1 STA 219+75 – Trail camera (6/16/2023)

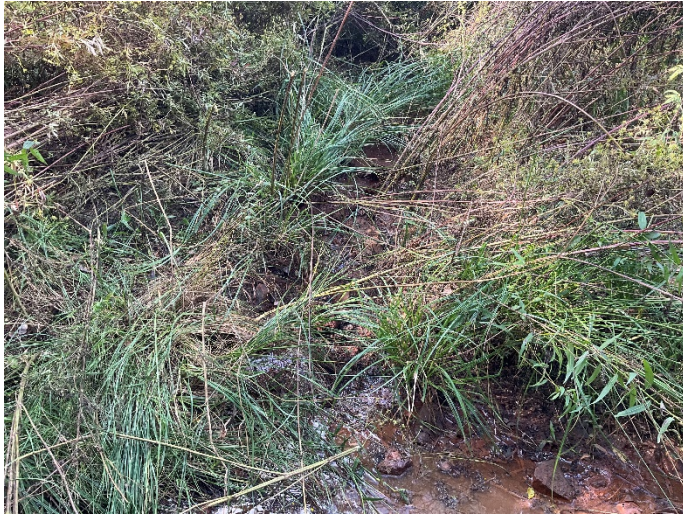
UT1 STA 206+96 – rock stabilization (9/22/2023)
