**FINAL  
MY1 (2022) MONITORING REPORT**

**LAUREL SPRINGS STREAM AND WETLAND MITIGATION SITE**

Avery County, North Carolina  
French Broad River Basin  
Cataloging Unit 06010108

DMS Project No. 100122  
Full Delivery Contract No. 7890  
DMS RFP No. 16-007725 (issued 11/13/18)  
USACE Action ID No. SAW-2019-00835  
DWR Project No. 2019-0865

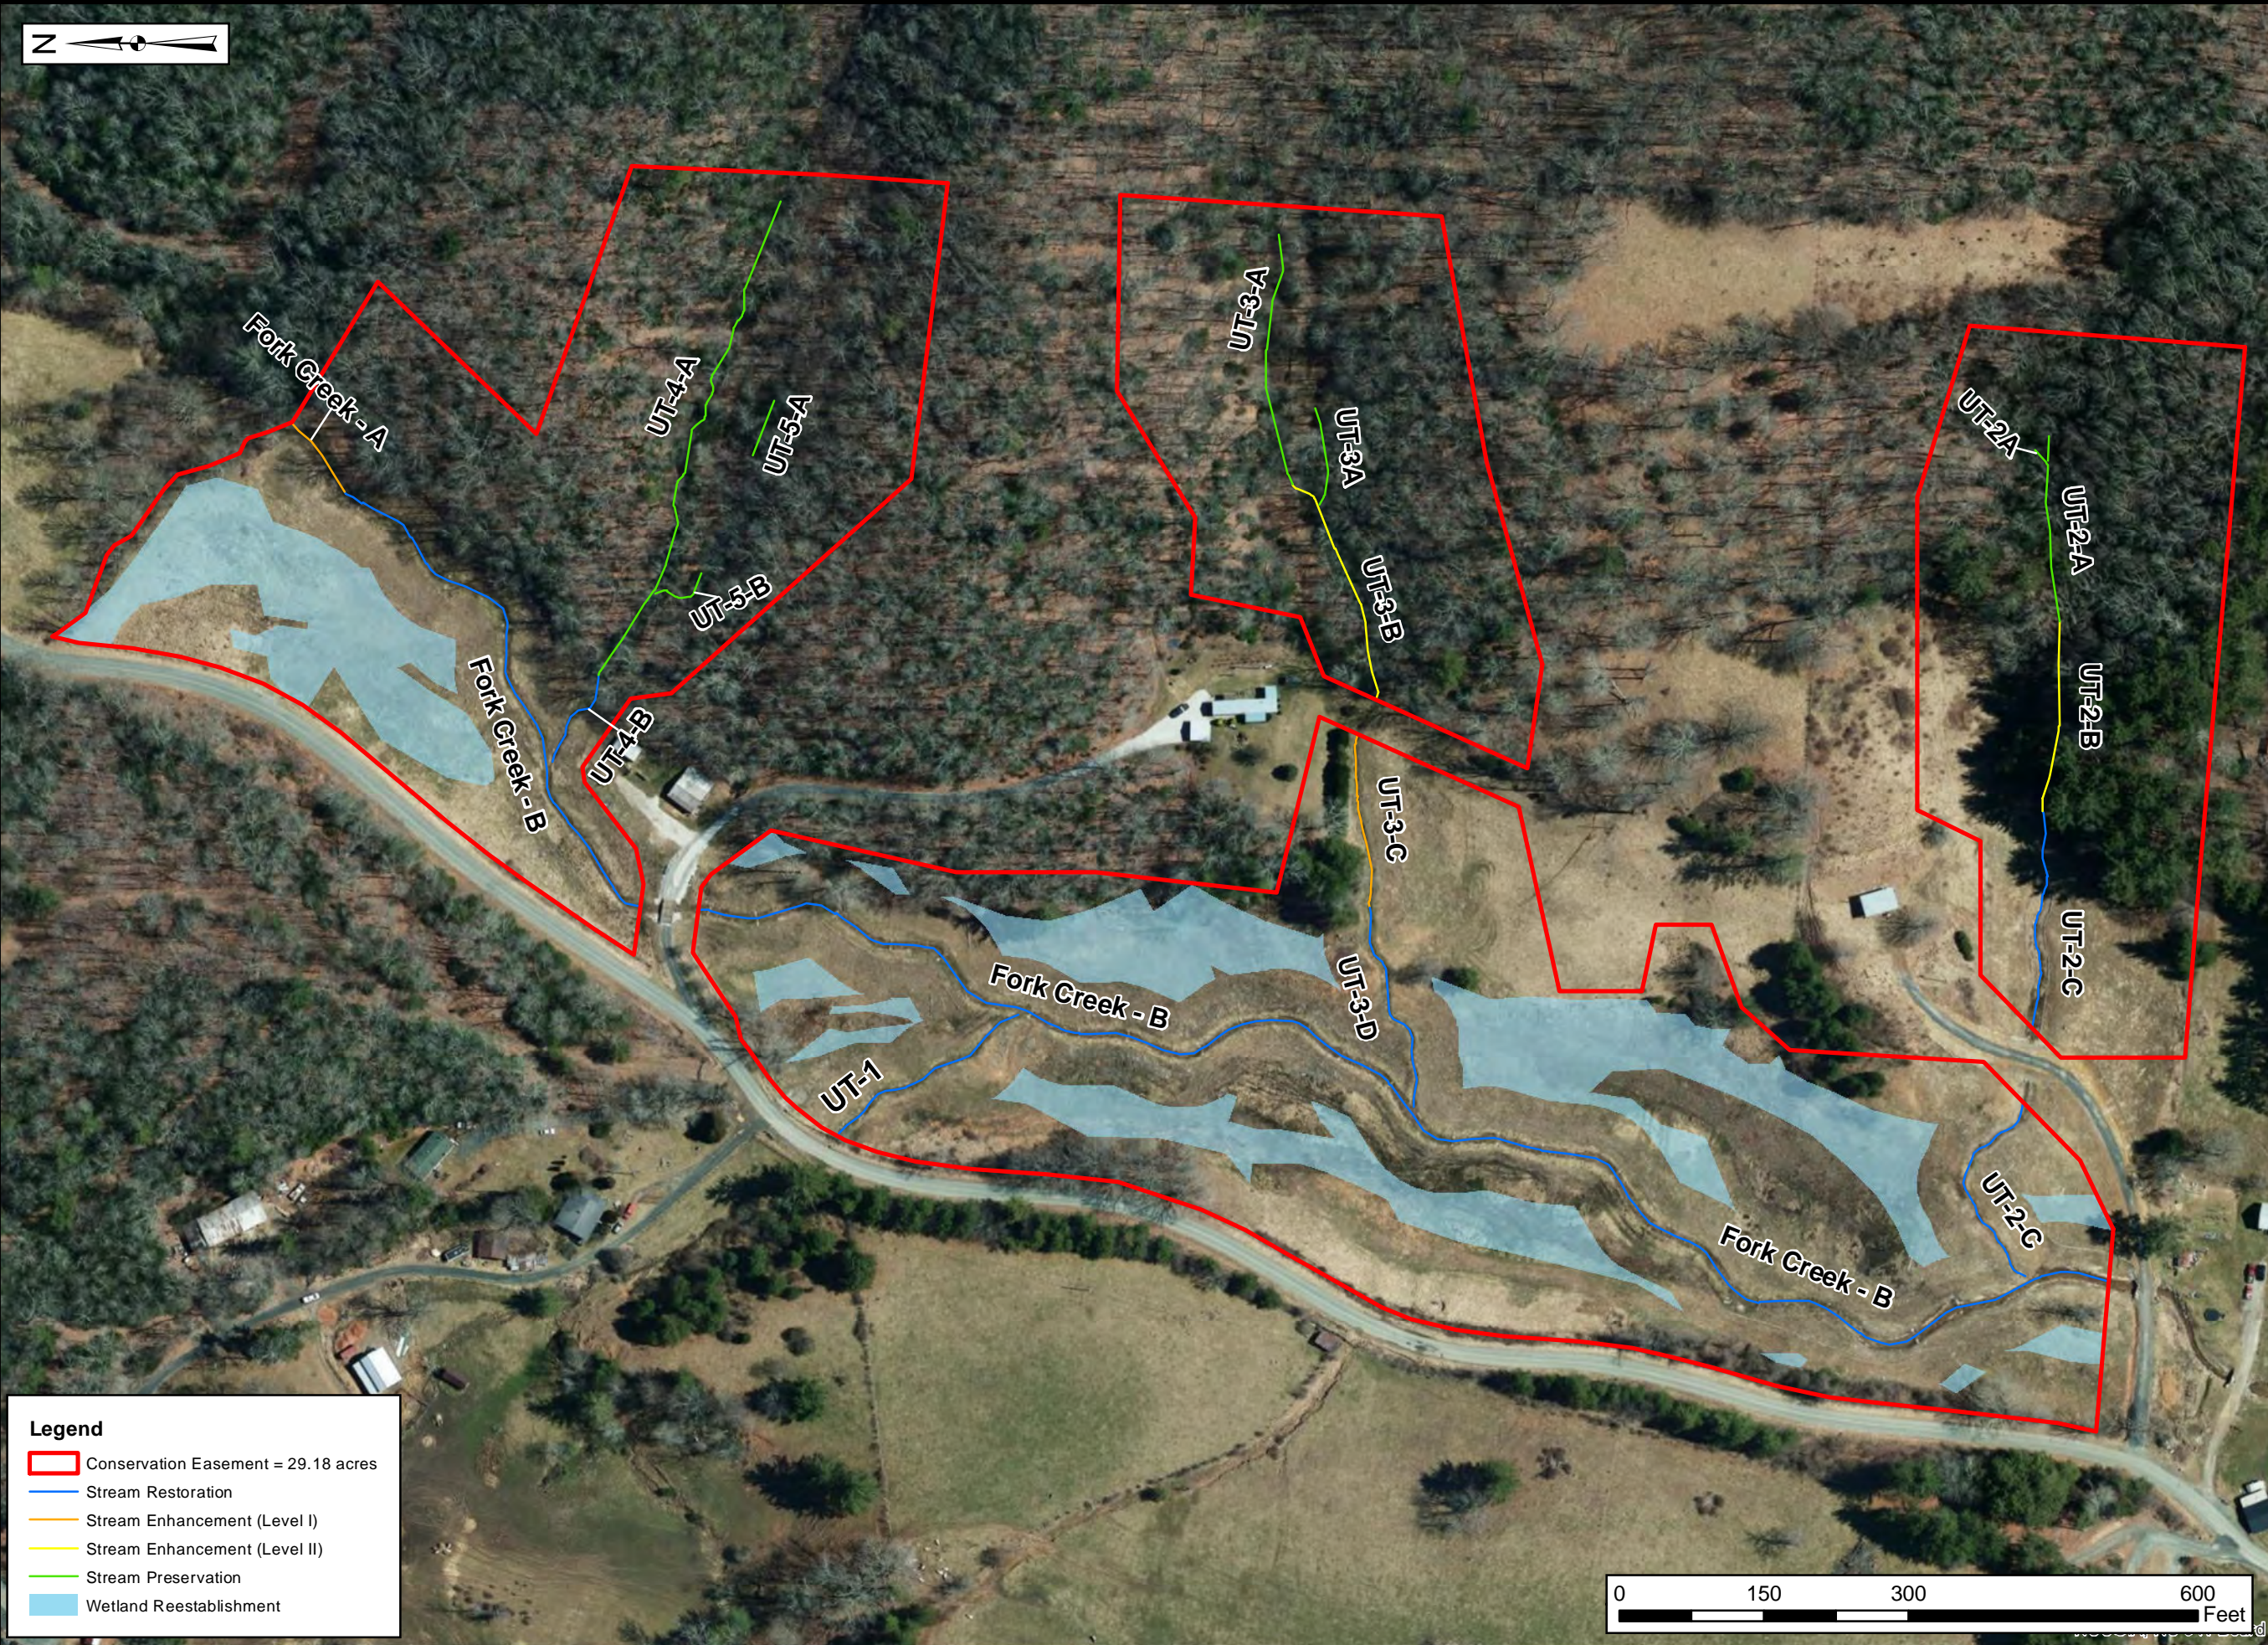
Figure 1. Current Conditions Plan View

- Observed Low Stem Density - 2023 Replant Areas
- Shed/Mowing Encroachment - 2023 Replant Areas

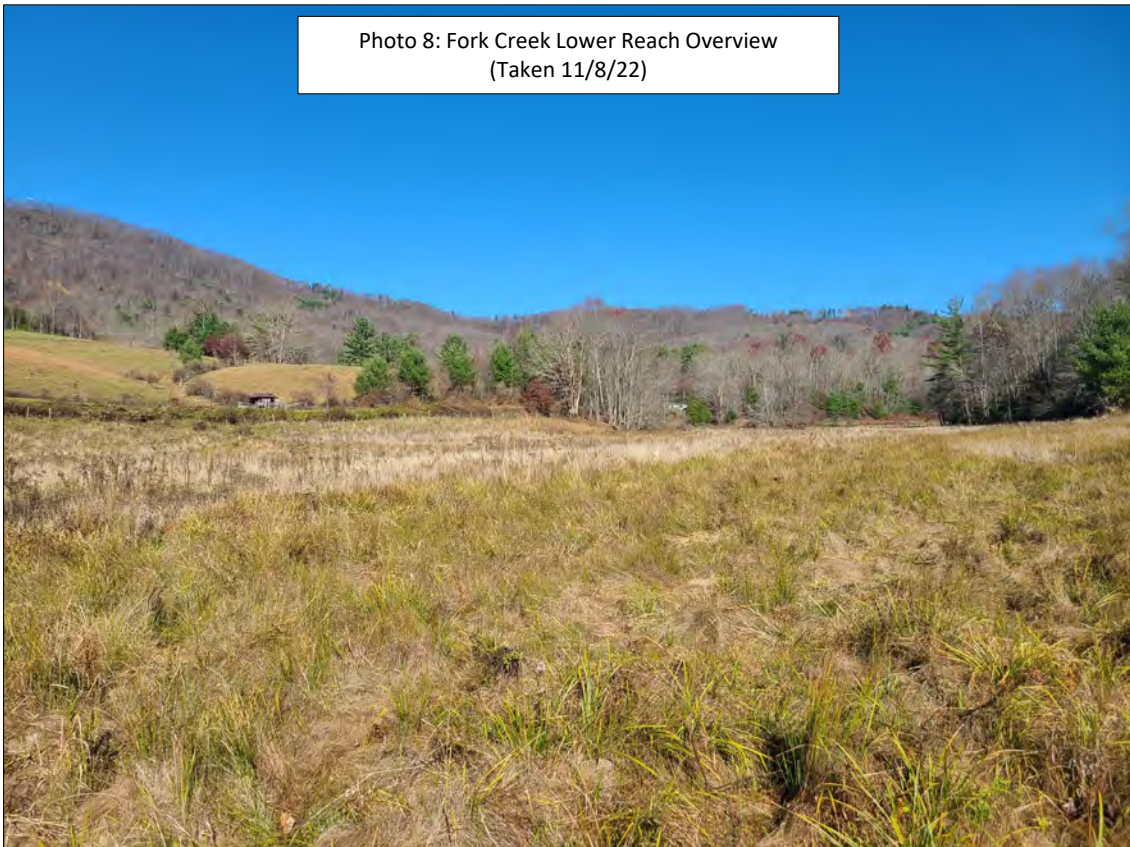
Photo 8: Fork Creek Lower Reach Overview  
(Taken 11/8/22)

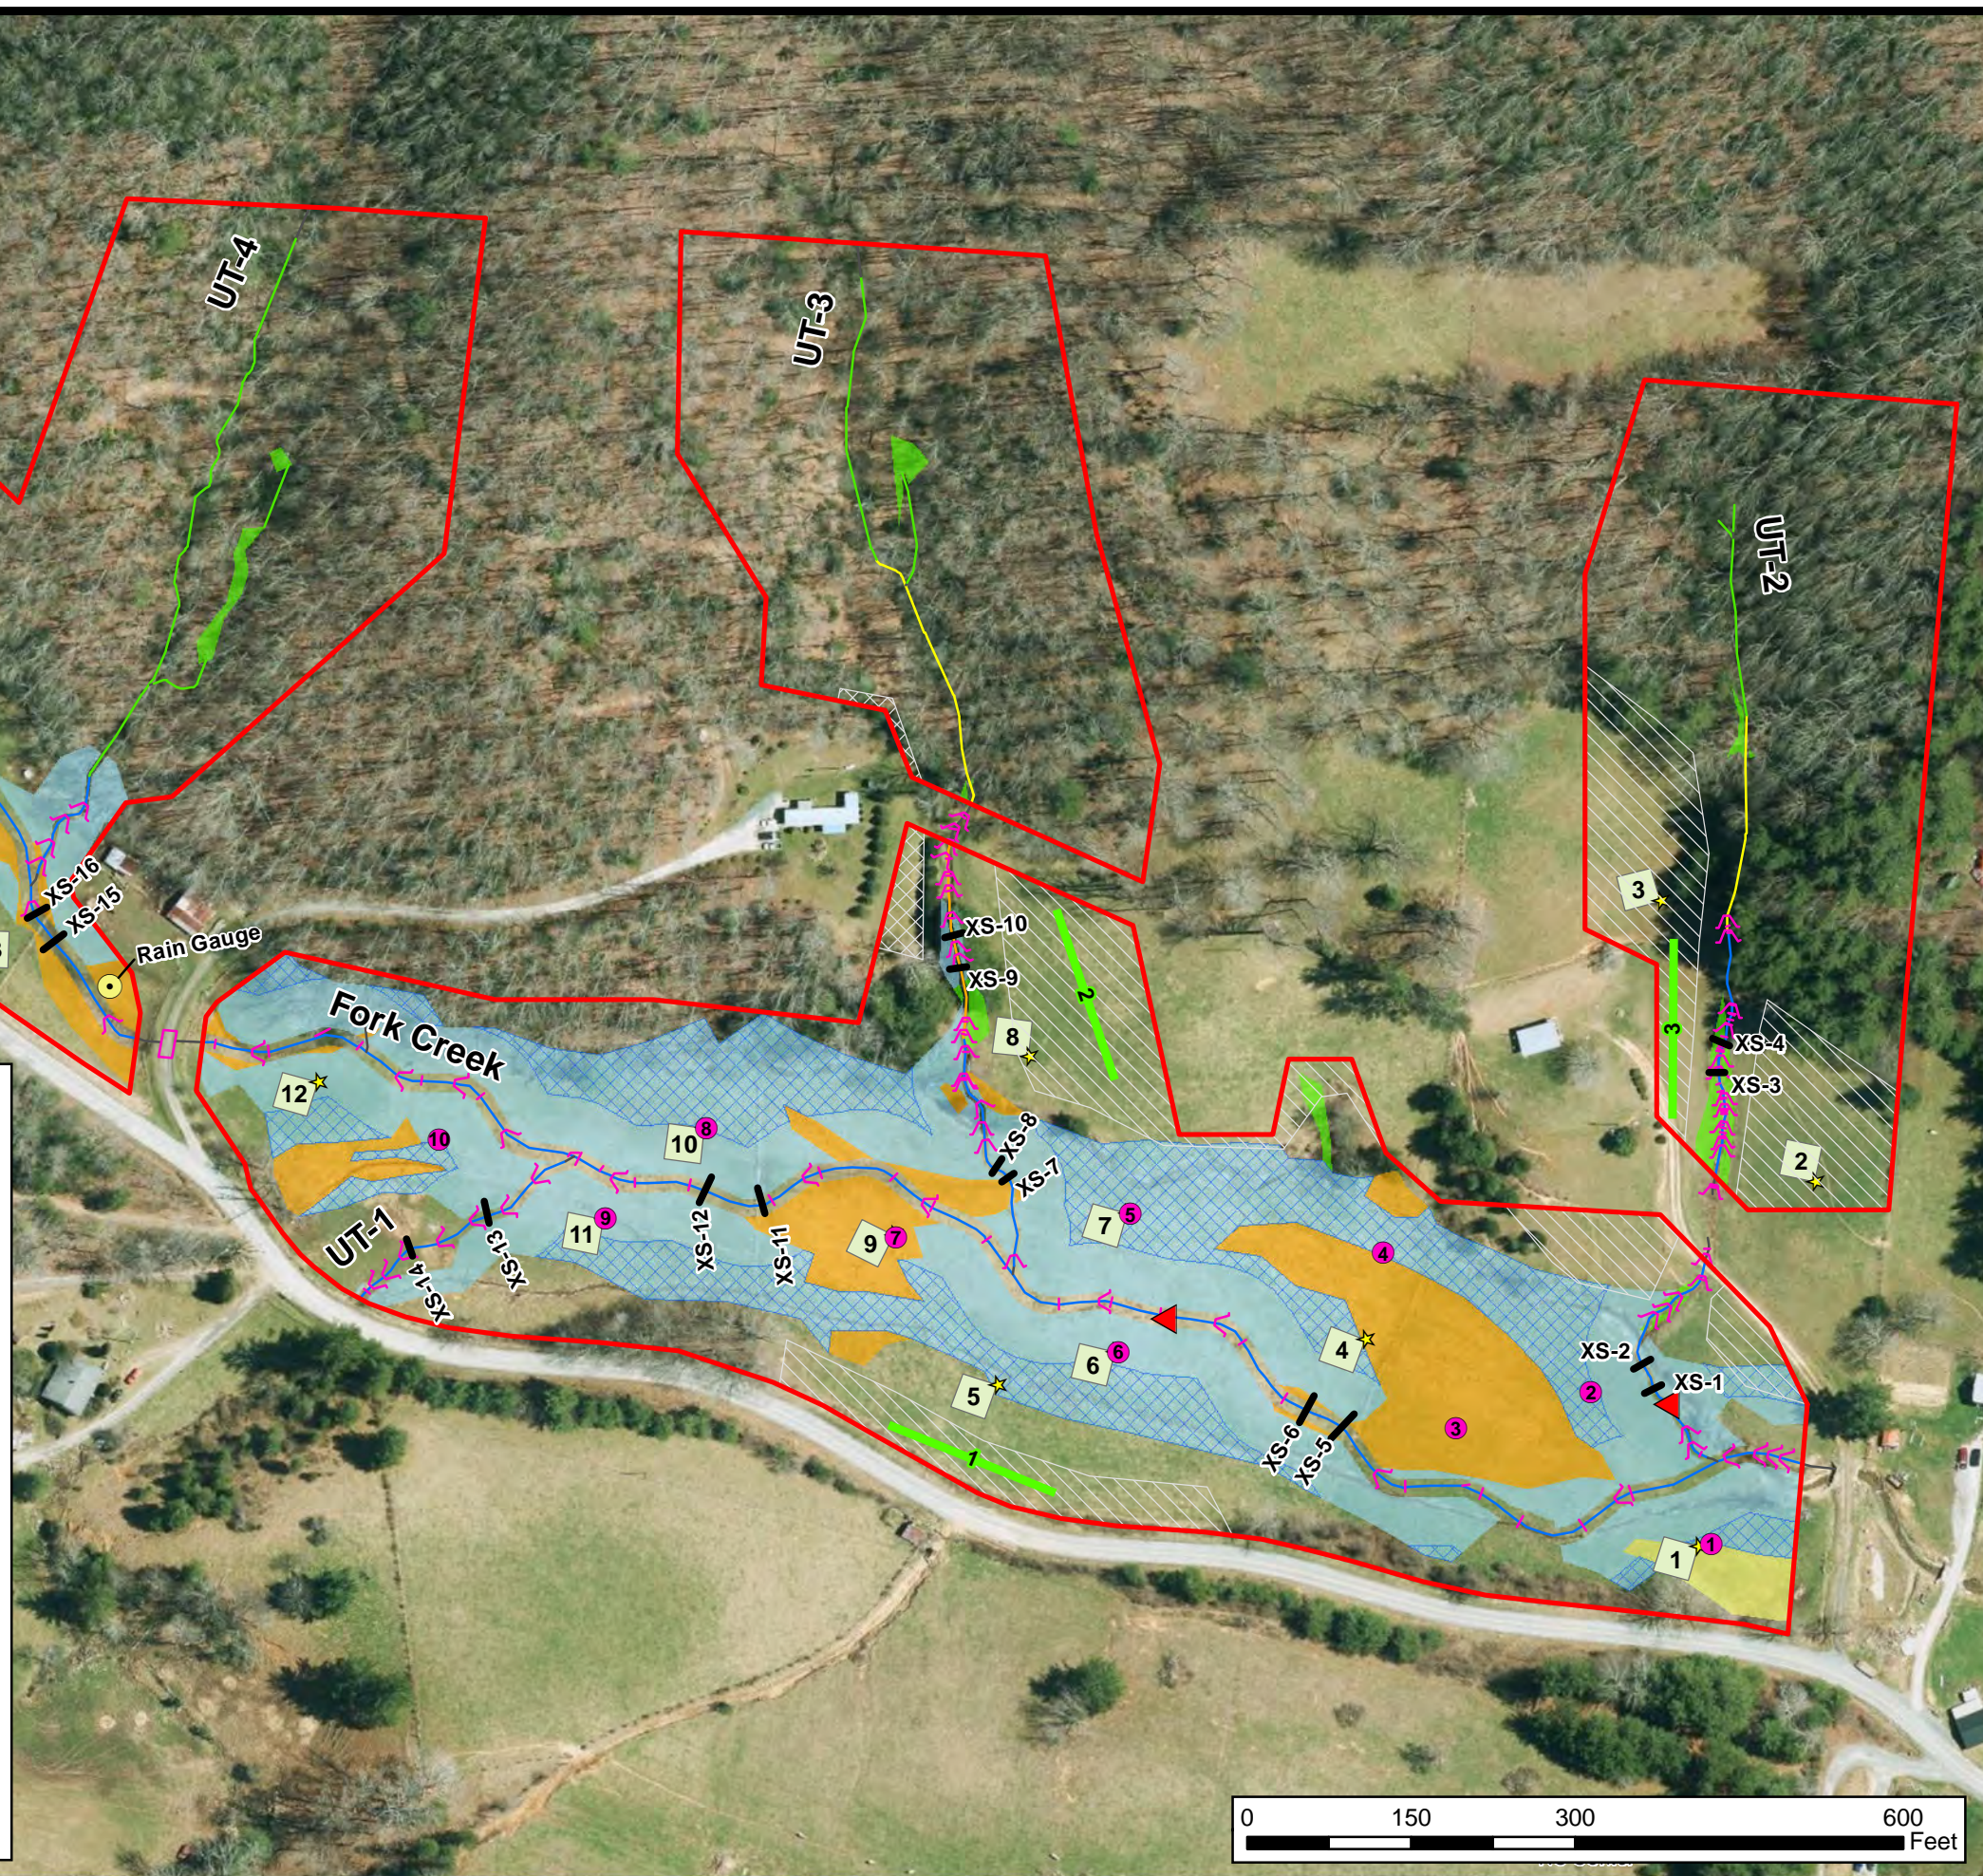
**CURRENT  
CONDITIONS  
PLAN VIEW**

During the 2022 growing season, Restoration Systems (RS) has observed areas of low stem densities at the Laurel Springs Mitigation Site (Site). Observed areas total 2.67 acres, which includes a 0.107-acre area of encroachment – see attached remedial planting figure. The encroachment area was partially due to a storage shed left within the easement used by the adjacent landowner. RS worked with the neighbor to remove the shed and cleared the area of all debris. Additionally, 6-inch treated fence posts were used to delineate the easement boundary in this area. A new shed was erected approximately 15 feet from the easement.

RS has ordered trees to replant 2.67 acres at a density of 670 stems per acre within observed low stem density areas, which includes the 0.107-acre area of encroachment. These areas are within the Acidic Cove Forest Association. The following species and quantities were secured for Q1-2023 planting.
