Lewis Creek Stream Restoration Henderson County, North Carolina

DMS Project #733
NCDEQ Contract #5631

MY – 05 Monitoring Report

Data Collected: September-November 2015
Submitted: December 2015

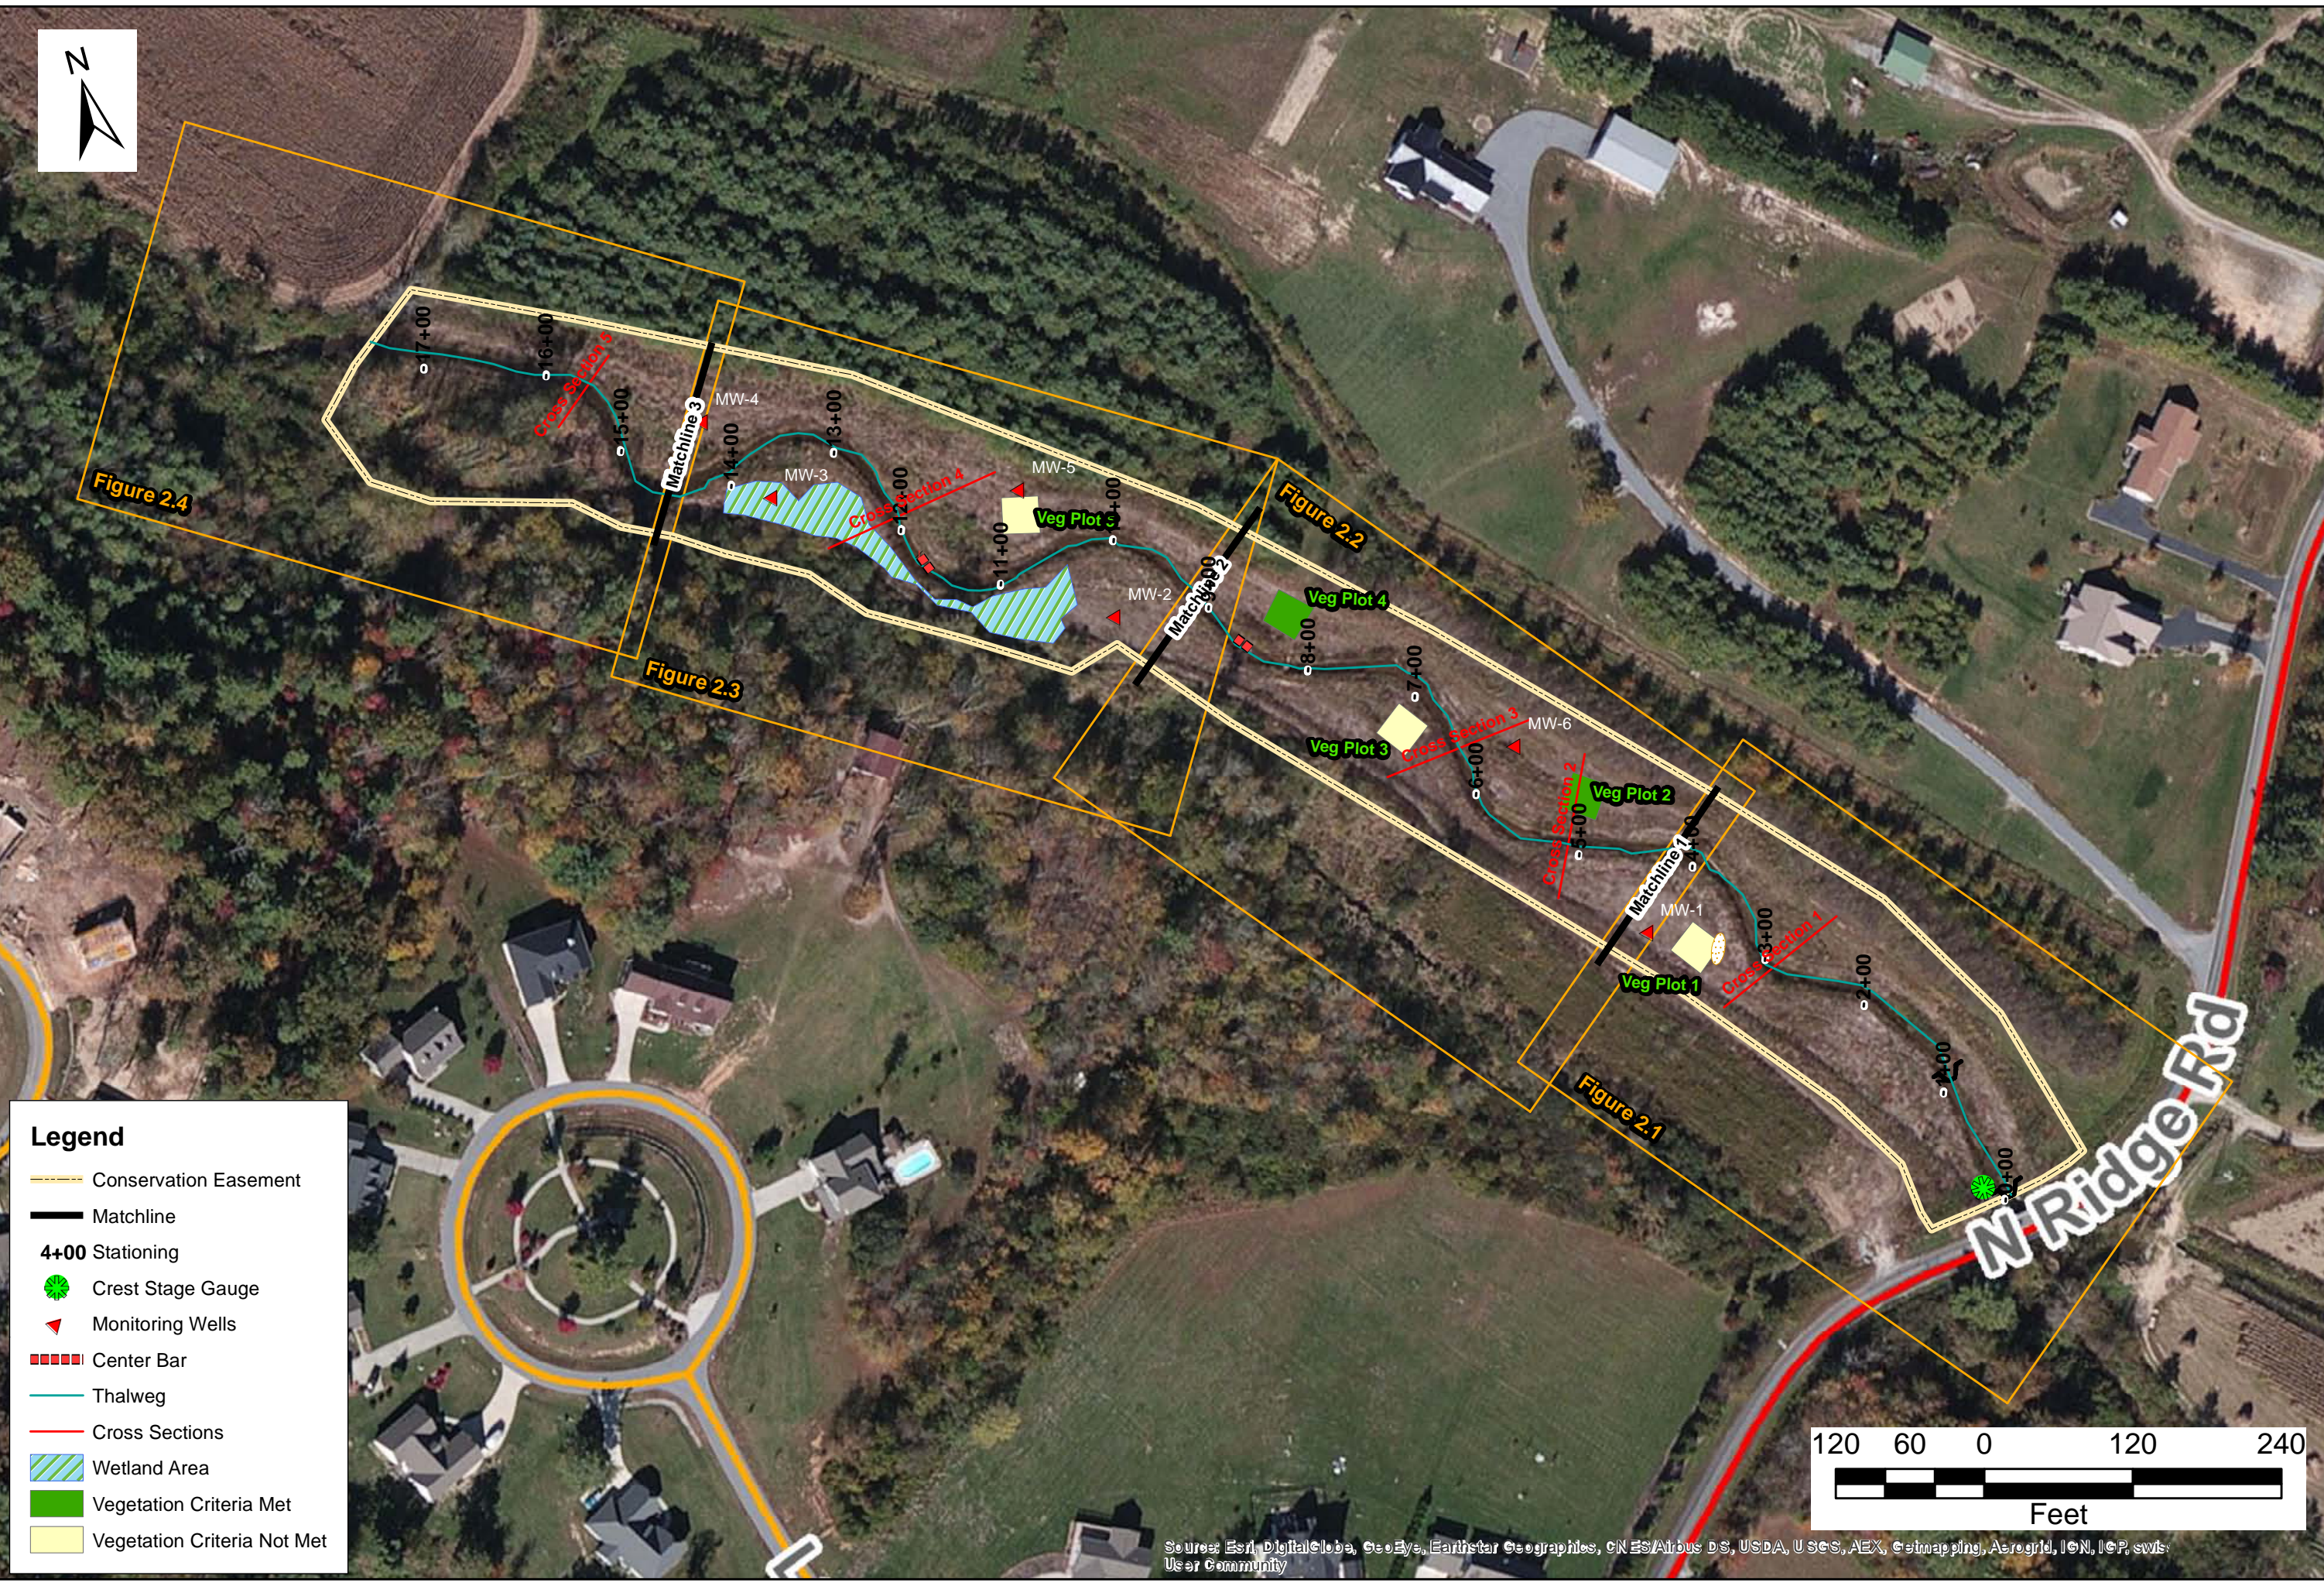
Figure 2
Overall

During our fall site visit in September, MMI observed evidence of an active beaver dam at approximately station 7+75 just upstream from VP-03 that was backing up water for roughly half

Several center bars persist in the stream channel and have been closely watched in all monitoring years. Larger bars occur at approximately Stations 8+50 and 11+50. Smaller center bars that had been observed downstream in past years were flooded this year due to the beaver activity. In general, these center bars are not a cause for concern as the streambank vegetation along these reaches is preventing lateral migration of the stream. The stream flows continue to be adequate to keep most in-stream vegetation from overtaking the stream channel even in summer months.
