# MONITORING YEAR 0 ANNUAL REPORT FINAL

## Liberty Rock Mitigation Site

Randolph County, NC  
Cape Fear River Basin  
HUC 03030003

DMS Project No. 100135  
NCDEQ Contract No. 7877-01  
DMS RFP No. 16-007877  
NCDWR Project No. 2020-0035 v1  
USACE Action ID Number 2020-00047

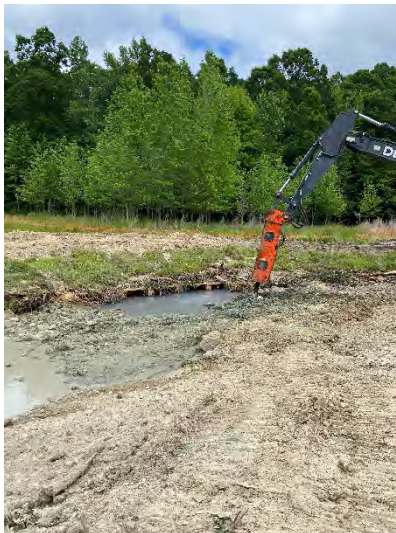
**Lunker Box Installation (8/04/2022)**

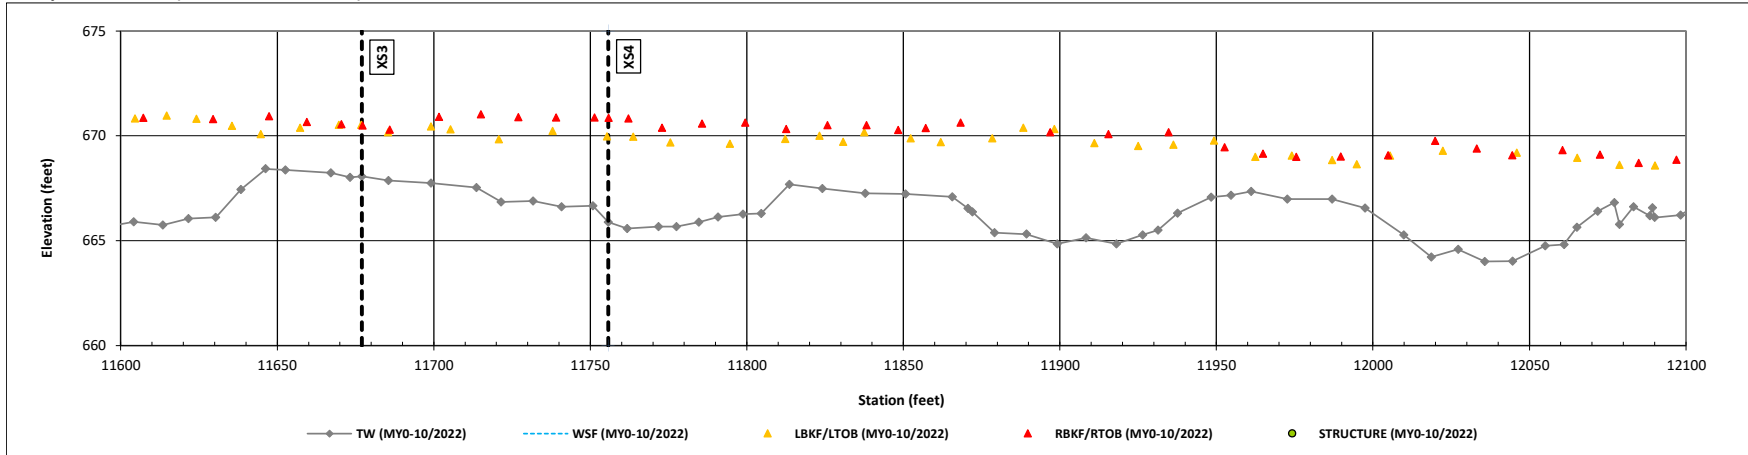
#### Rocky River Reach 1 (STA 116+00 to 121+00)

\*No water present in channel at the time of survey, water surface not shown.
