Lick Creek Stream Restoration Site MONITORING REPORT 2007 (Year 2)

Cataloging Unit: 0303004 EEP Contract #: D04013-1

December 7, 2007

Wolf Creek Engineering, PLLC
30 Ben Lippen School Rd.
Asheville, NC 28806

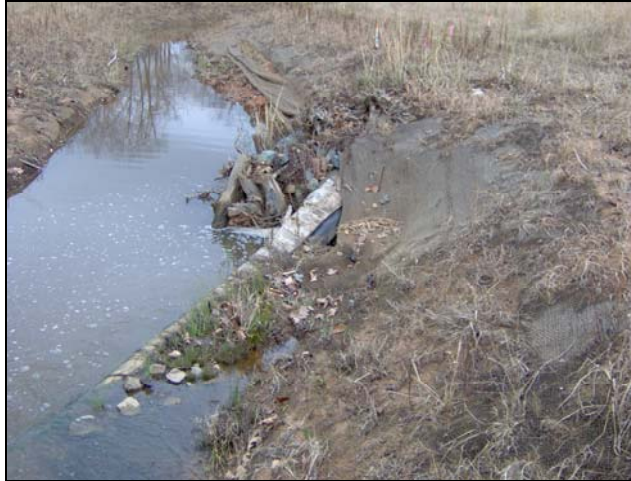
Piping at Log Vane on Lick Creek, STA 29+50 12/03/06
Photo No. 21

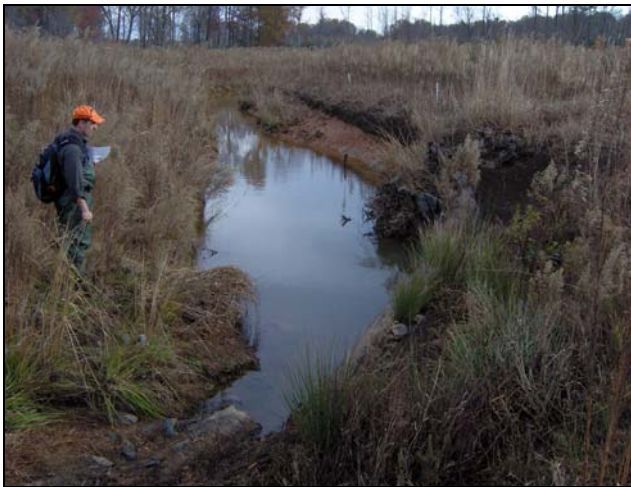
Piping at Log Vane on Lick Creek, STA 29+50 11/27/07
Photo No. 22

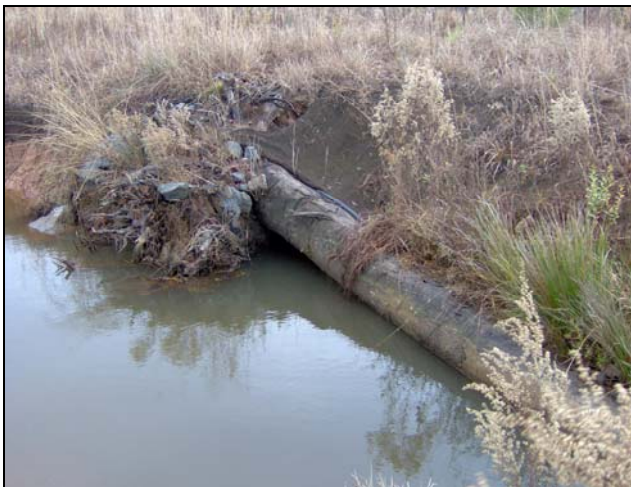
Piping at Log Vane on Lick Creek, STA 29+50 11/27/07
Photo No. 23
