Lick Creek Stream Restoration Site MONITORING REPORT 2010 (Year 5)

Cataloging Unit: 0303004 EEP Contract #: D04013-1

October 21, 2010

Wolf Creek Engineering, PLLC
51 North Knob Lane
Weaverville, NC 28787

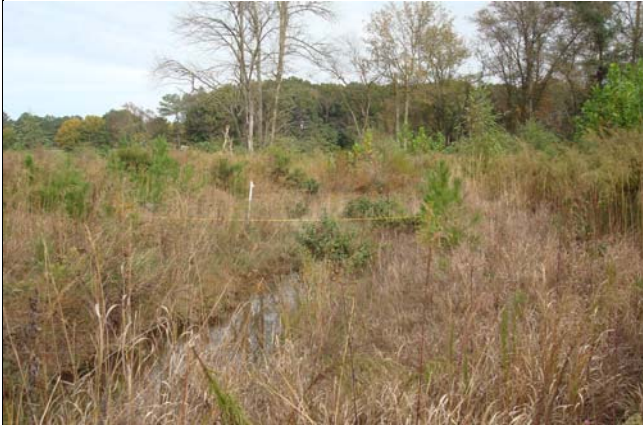
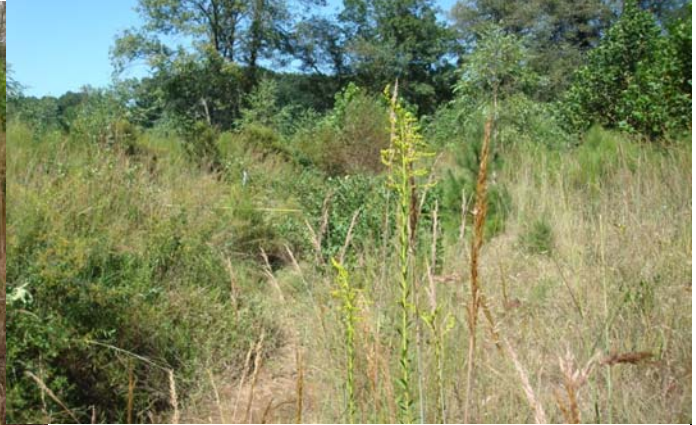
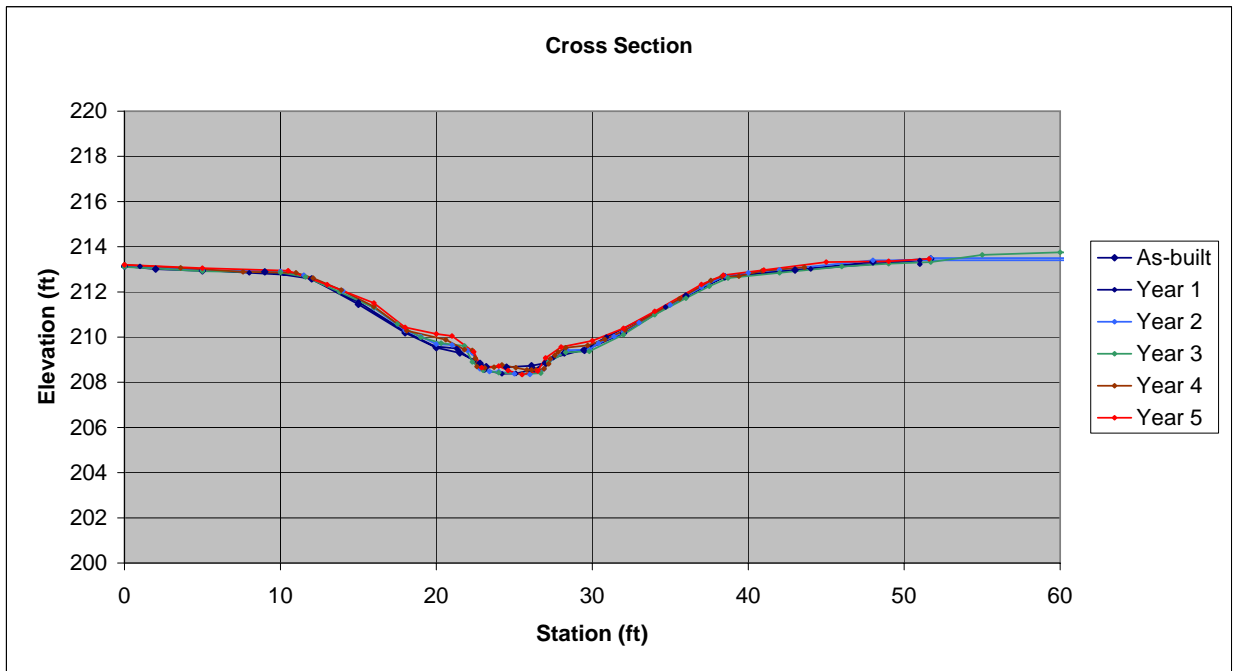
Cross Section No. 1

Reach 1 - Wallace Branch - Sta 12+80.7

As-Built		Year 1		Year 2		Year 3		Year 4		Year 5	
Date	5/4/06	Date	11/17/06	Date	11/26/07	Date	10/23/08	Date	10/26/09	Date	9/13/10
Area	60.5	Area	63.8	Area	62.7	Area	64.2	Area	64.2	Area	62.1
Bkf W	26.5	Bkf W	27	Bkf W	27	Bkf W	27.3	Bkf W	27.3	Bkf W	27.9
Dmean	2.3	Dmean	2.4	Dmean	2.3	Dmean	2.3	Dmean	2.4	Dmean	2.2
Dmax	3.9	Dmax	4.3	Dmax	4.4	Dmax	4.3	Dmax	4.3	Dmax	4.5
W/d	11.6	W/d	11.4	W/d	11.6	W/d	11.6	W/d	11.6	W/d	12.5

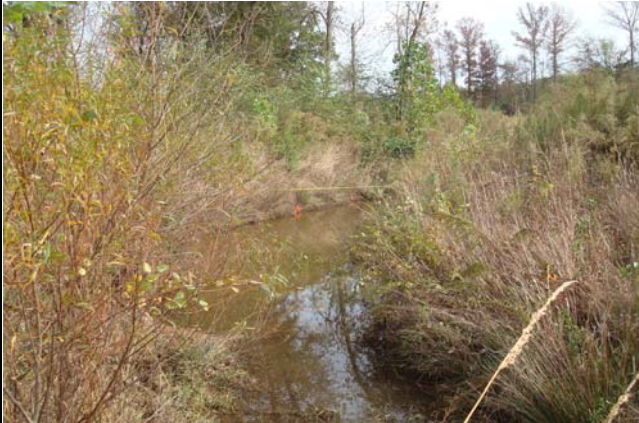
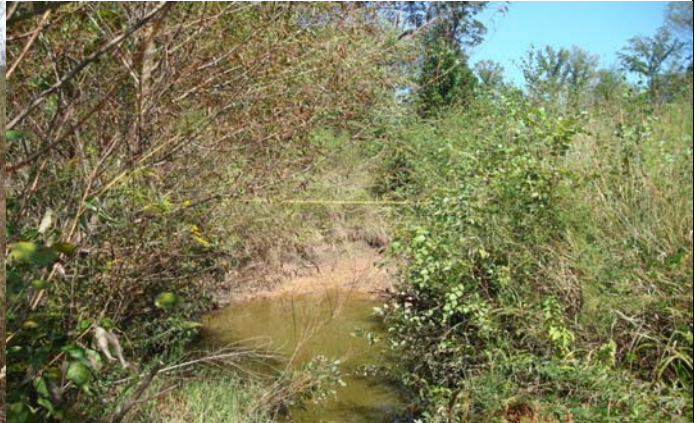
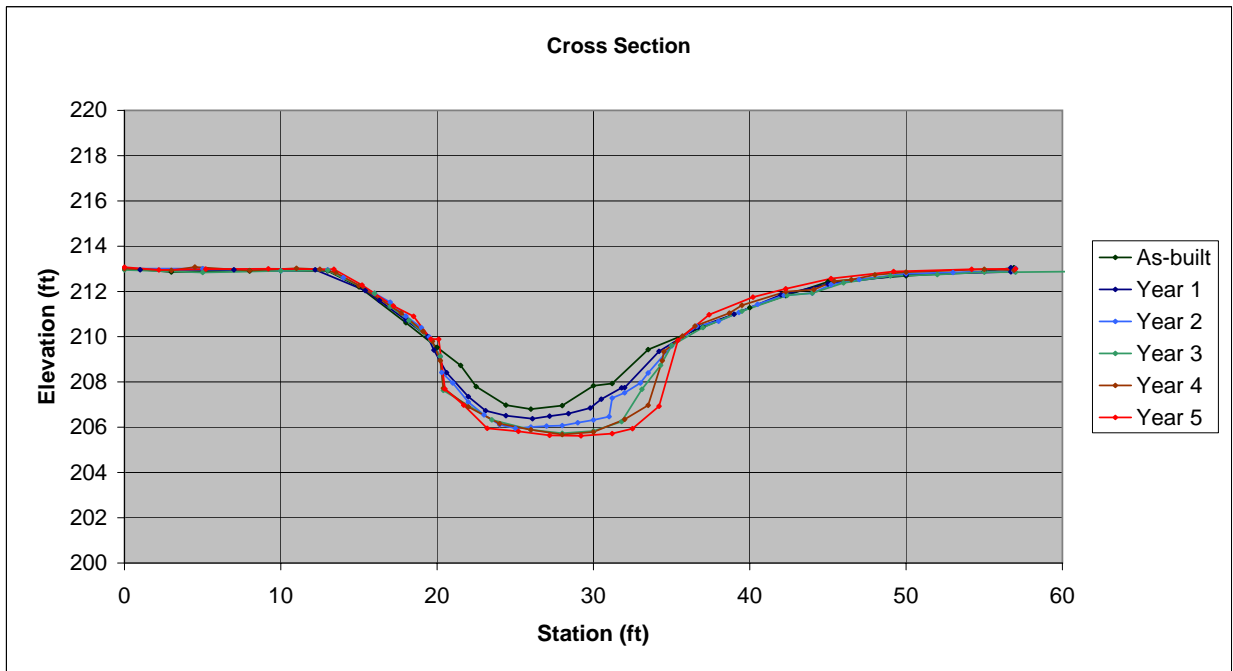
Lick Creek Stream Restoration Site
 Lee County, NC
 Cross Section No. 2 - Pool
 Reach 1 - Wallace Branch - Sta 13+74.5

As-Built		Year 1		Year 2		Year 3		Year 4		Year 5	
Date	5/4/06	Date	11/17/06	Date	11/26/07	Date	10/23/08	Date	10/26/09	Date	9/13/10
Area	69.2	Area	72.3	Area	83.5	Area	88.1	Area	91.6	Area	98.9
Bkf W	27.3	Bkf W	25.7	Bkf W	26.2	Bkf W	26.2	Bkf W	29.8	Bkf W	28.9
Dmean	2.5	Dmean	2.8	Dmean	3.2	Dmean	3.4	Dmean	3.1	Dmean	3.4
Dmax	5.0	Dmax	5.2	Dmax	5.9	Dmax	6.1	Dmax	6.3	Dmax	6.5
W/d	10.8	W/d	9.1	W/d	8.2	W/d	7.8	W/d	9.7	W/d	8.4

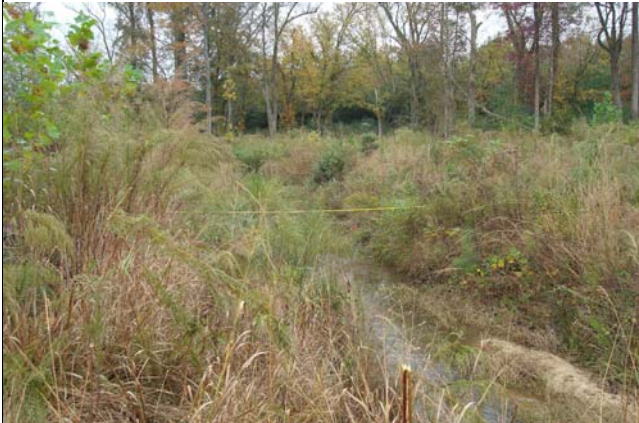
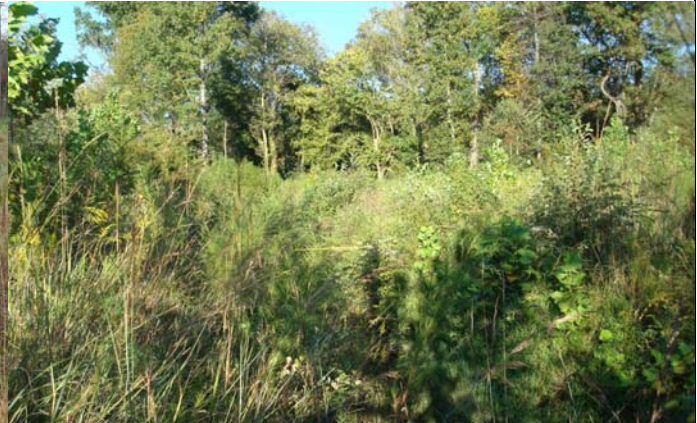
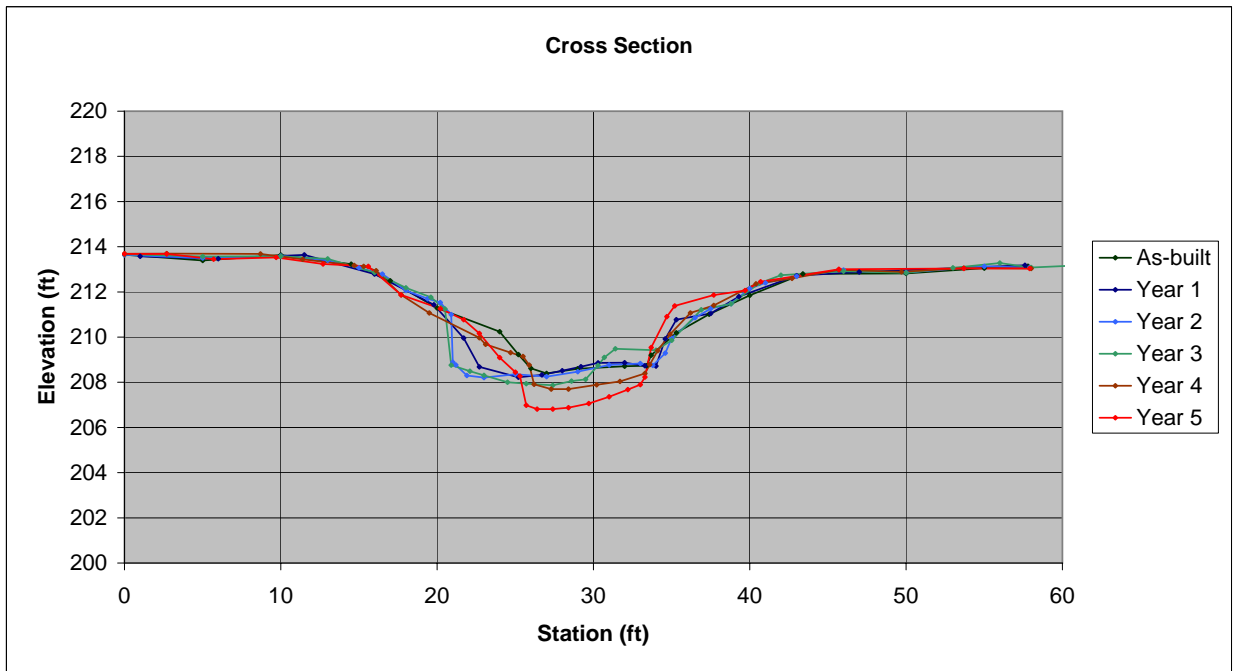
Cross Section No. 3 - Riffle

Reach 2 - Lick Creek - Sta 13+25.7

As-Built		Year 1		Year 2		Year 3		Year 4		Year 5	
Date	5/5/06	Date	11/17/06	Date	11/26/07	Date	10/23/08	Date	10/26/09	Date	9/13/10
Area	64.5	Area	68.0	Area	69.8	Area	69.4	Area	75.4	Area	83.4
Bkf W	28.9	Bkf W	27	Bkf W	26.4	Bkf W	26.4	Bkf W	29.6	Bkf W	30.1
Dmean	2.2	Dmean	2.5	Dmean	2.6	Dmean	2.6	Dmean	2.5	Dmean	2.8
Dmax	4.4	Dmax	4.5	Dmax	4.5	Dmax	4.8	Dmax	5.2	Dmax	6.3
W/d	13.0	W/d	10.7	W/d	10.0	W/d	10.0	W/d	11.6	W/d	10.9

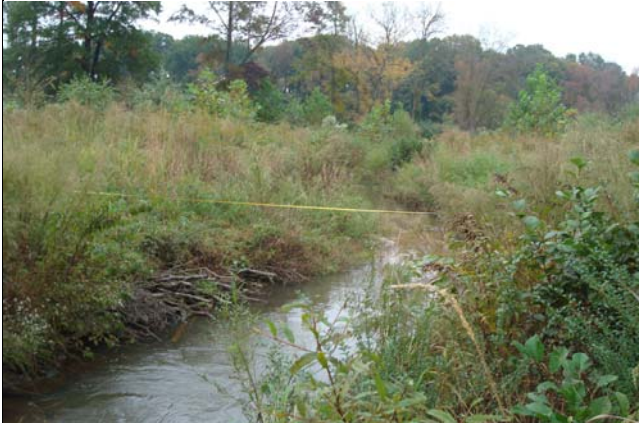
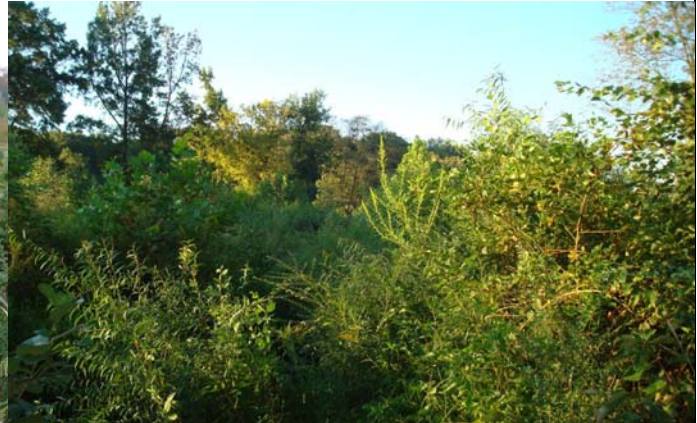
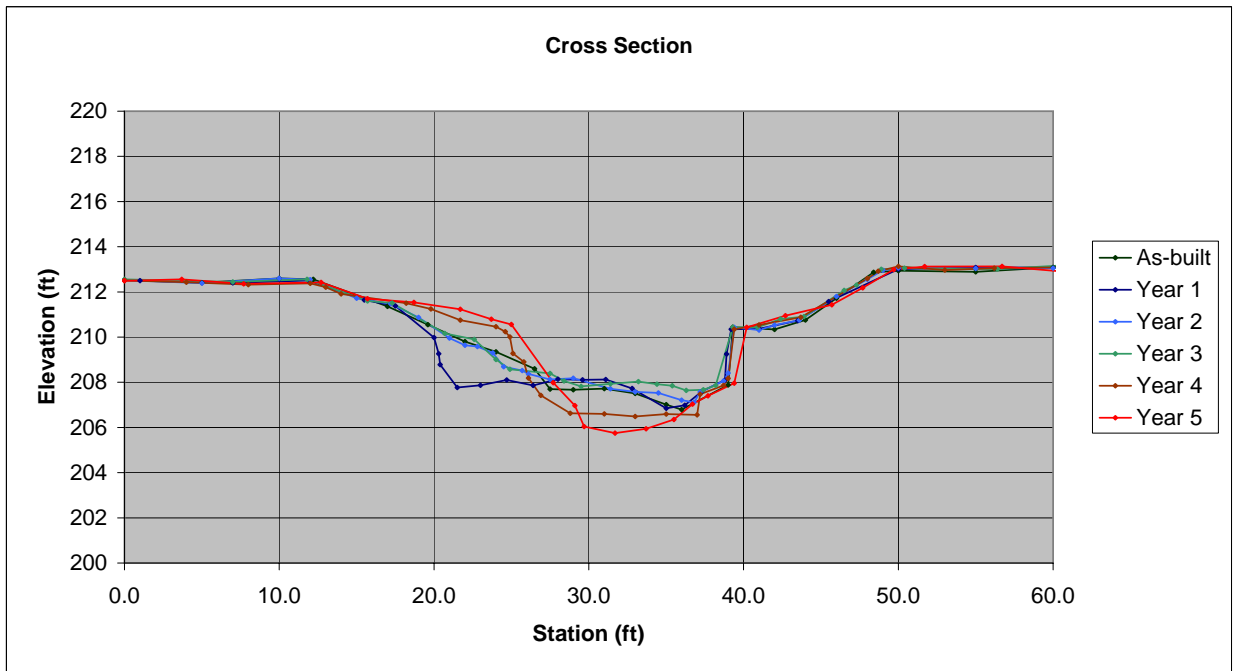
Cross Section No. 4 - Pool

Reach 2 - Lick Creek - Sta 15+79.4

As-Built		Year 1		Year 2		Year 3		Year 4		Year 5	
Date	5/5/06	Date	11/17/06	Date	11/26/07	Date	10/23/08	Date	10/26/09	Date	9/13/10
Area	105.2	Area	109.7	Area	102.9	Area	96.2	Area	100.0	Area	100.1
Bkf W	36.2	Bkf W	38.1	Bkf W	36	Bkf W	36	Bkf W	36	Bkf W	35
Dmean	2.9	Dmean	2.9	Dmean	2.9	Dmean	2.7	Dmean	2.8	Dmean	2.9
Dmax	5.8	Dmax	5.7	Dmax	5.4	Dmax	4.9	Dmax	5.9	Dmax	6.7
W/d	12.5	W/d	13.2	W/d	12.6	W/d	13.5	W/d	13.0	W/d	12.2

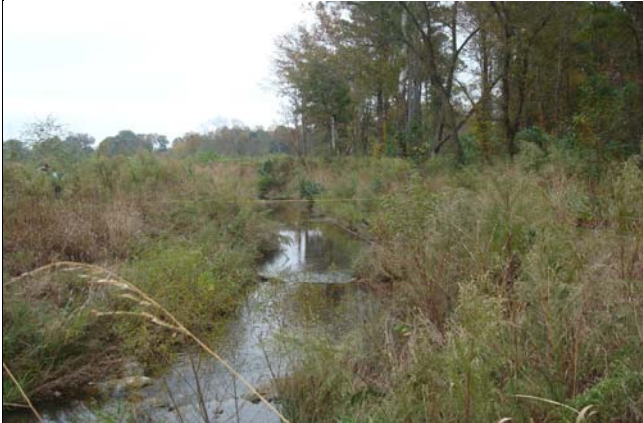
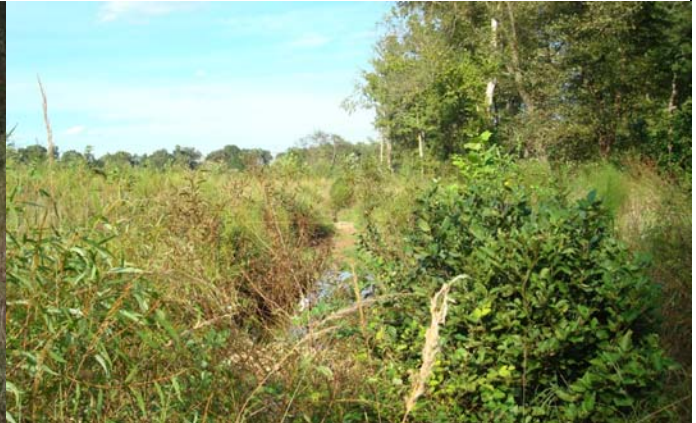
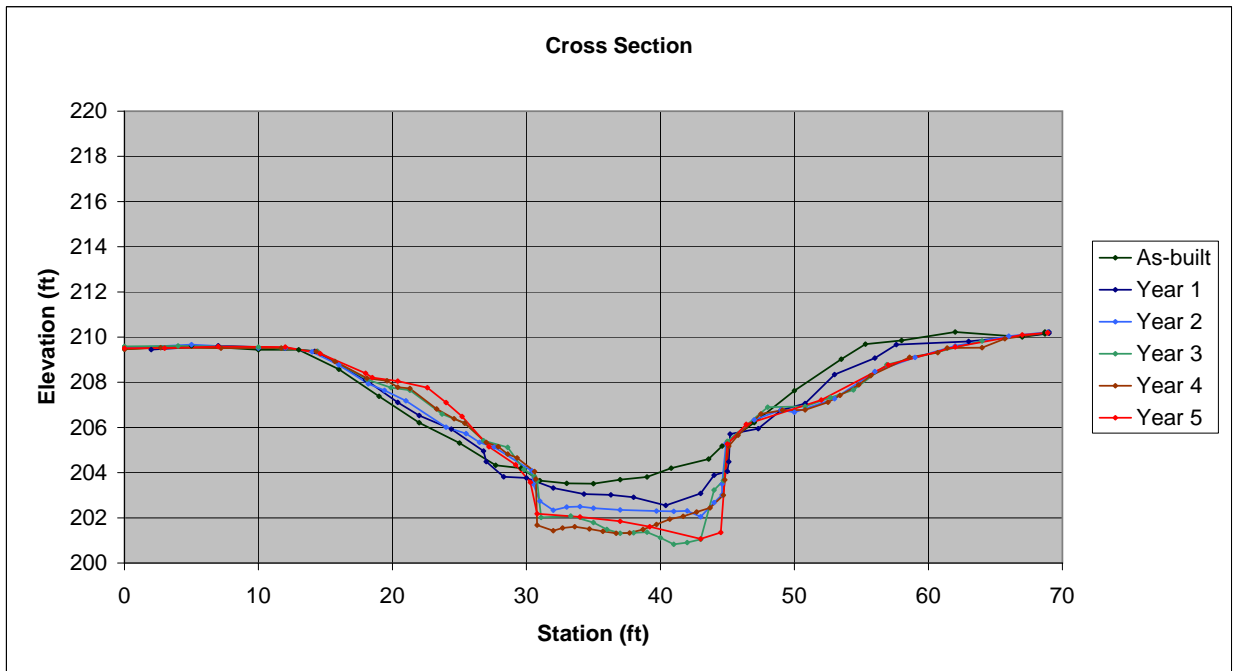
Cross Section No. 5 - Riffle

Reach 3 - Lick Creek - Sta 14+24.6

As-Built		Year 1		Year 2		Year 3		Year 4		Year 5	
Date	5/5/06	Date	11/17/06	Date	11/26/07	Date	10/24/08	Date	10/27/09	Date	9/14/10
Area	150.3	Area	162.1	Area	160.2	Area	164.0	Area	146.8	Area	170.7
Bkf W	42.3	Bkf W	43.4	Bkf W	44.5	Bkf W	44.5	Bkf W	44.3	Bkf W	47.4
Dmean	3.6	Dmean	3.7	Dmean	3.6	Dmean	3.7	Dmean	3.3	Dmean	3.6
Dmax	5.9	Dmax	6.8	Dmax	7.0	Dmax	8.3	Dmax	8.0	Dmax	8.2
W/d	11.9	W/d	11.6	W/d	12.4	W/d	12.1	W/d	13.4	W/d	13.2

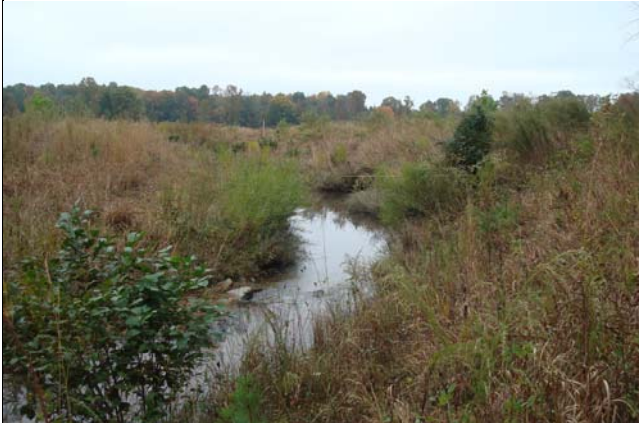
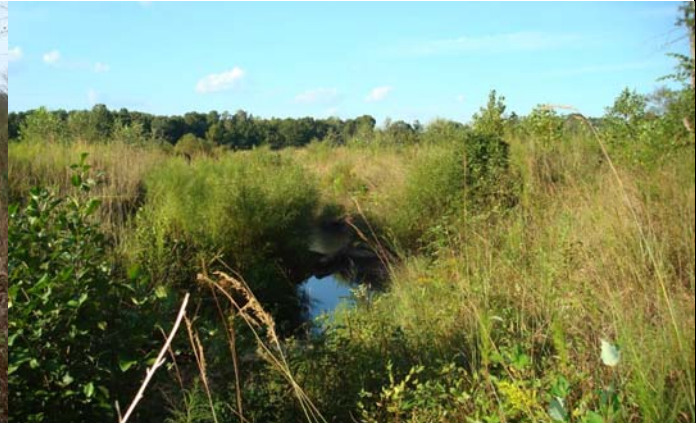
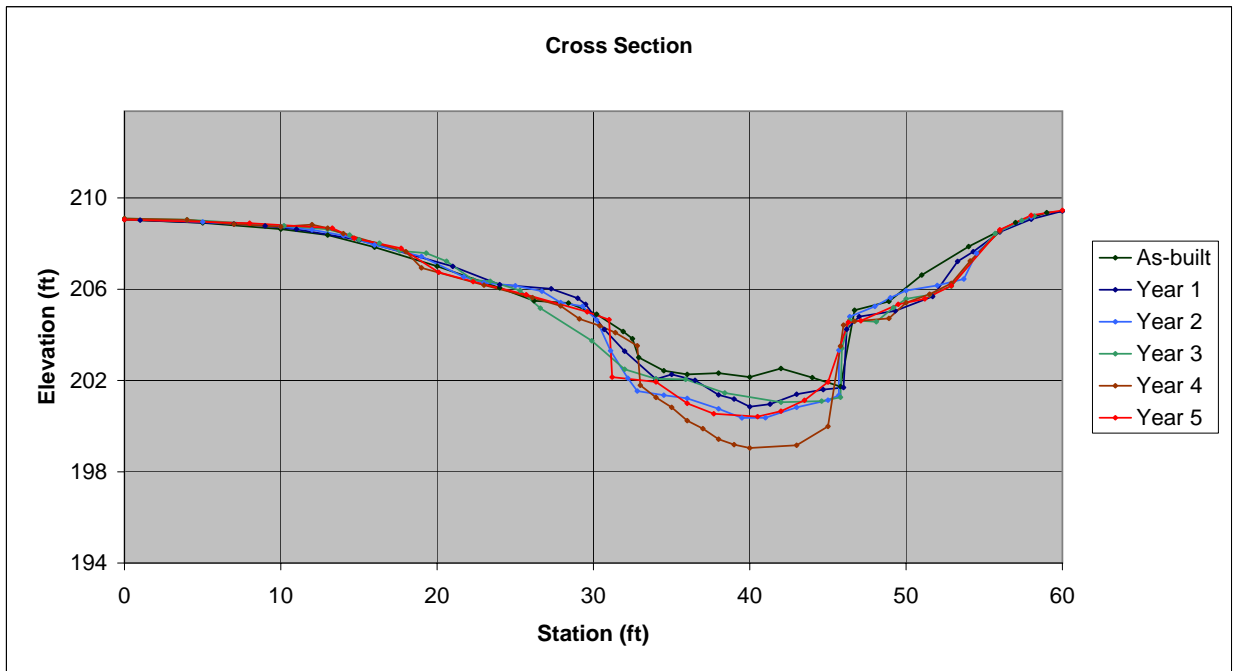
Cross Section No. 6 - Pool

Reach 3 - Lick Creek - Sta 15+53.8

As-Built		Year 1		Year 2		Year 3		Year 4		Year 5	
Date	5/5/06	Date	11/17/06	Date	11/26/07	Date	10/24/08	Date	10/27/09	Date	9/14/10
Area	140.7	Area	164.1	Area	170.9	Area	169.4	Area	186.1	Area	176.0
Bkf W	43	Bkf W	45	Bkf W	43	Bkf W	43	Bkf W	43	Bkf W	42.7
Dmean	3.3	Dmean	3.6	Dmean	4.0	Dmean	3.9	Dmean	4.3	Dmean	4.1
Dmax	6.7	Dmax	7.8	Dmax	8.3	Dmax	7.6	Dmax	9.6	Dmax	8.3
W/d	13.1	W/d	12.3	W/d	10.8	W/d	10.9	W/d	9.9	W/d	10.4

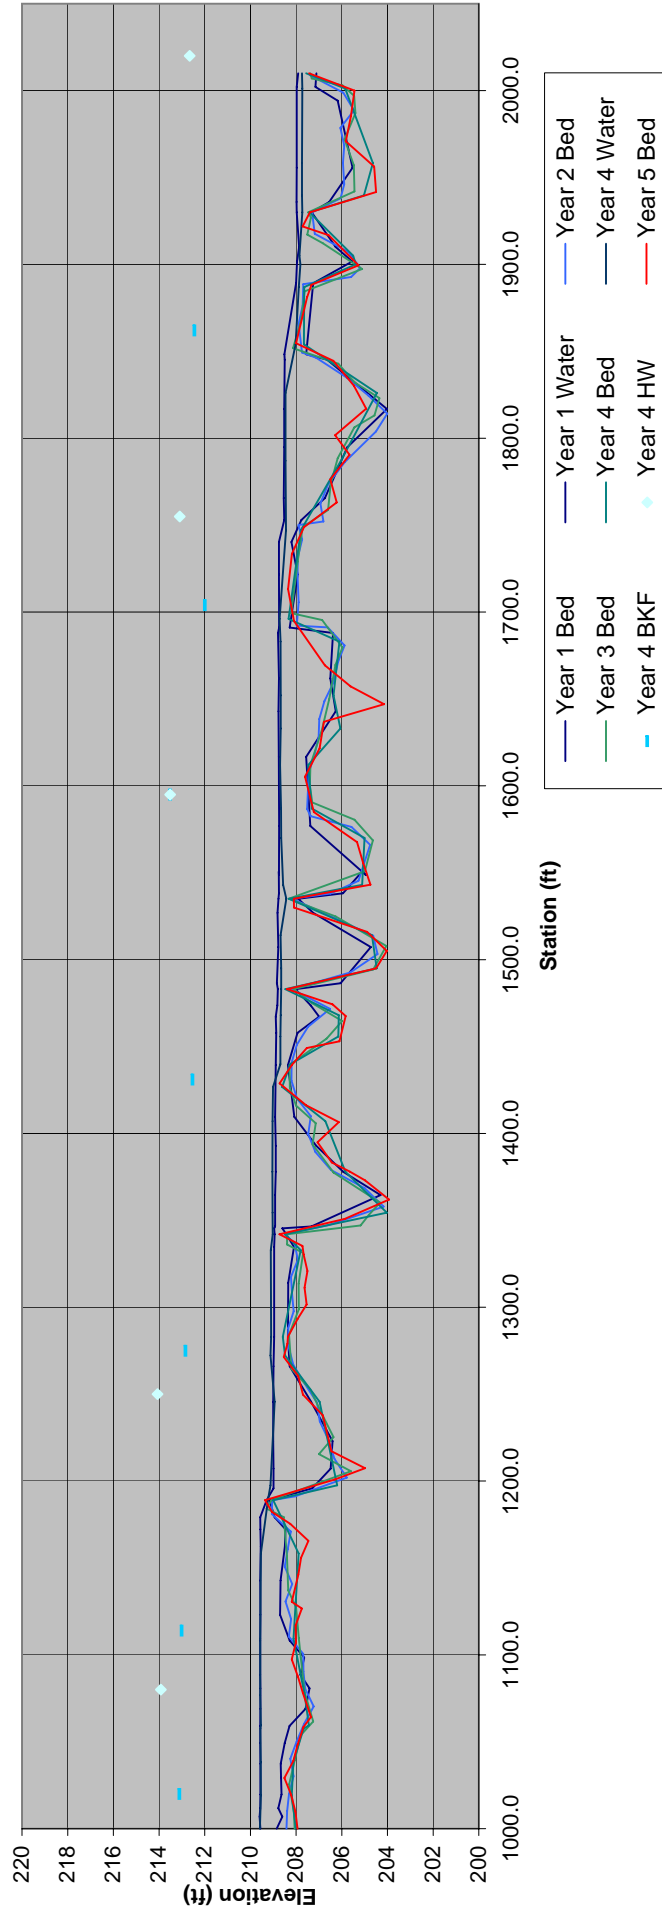
Profile Reach 1 - Wallace Branch

Re-survey of the permanent cross sections and profile reaches have shown some alterations in local bed elevations with the bed form and the channel pattern remaining consistent with the Year 4 condition. The riffle in monitoring Reach 1 shows nearly the same dimensions as Year 4. The riffle in monitoring Reach 2 is lower than the Year 4

bed elevation. Inspection of the bed profile indicates that this is a local bed feature and that the overall grade of the riffle is consistent with Year 4. The riffle in monitoring reach 3 indicates a shift in the thalweg but the max depth is consistent with Year 4. Inspection of the riffle profiles immediately downstream of these sections indicates that the riffle grade is stable. The pools were generally found to be deeper than the Year 4 condition which is probably related to the increase bank vegetation found throughout the Site and subsequent reduction in erosion. The pool locations relative to the pattern are consistent with previous surveys.
