# Annual Monitoring Report

## Little Pine Creek II

### Monitoring Year 2 of 7

NCDMS Project No. 856

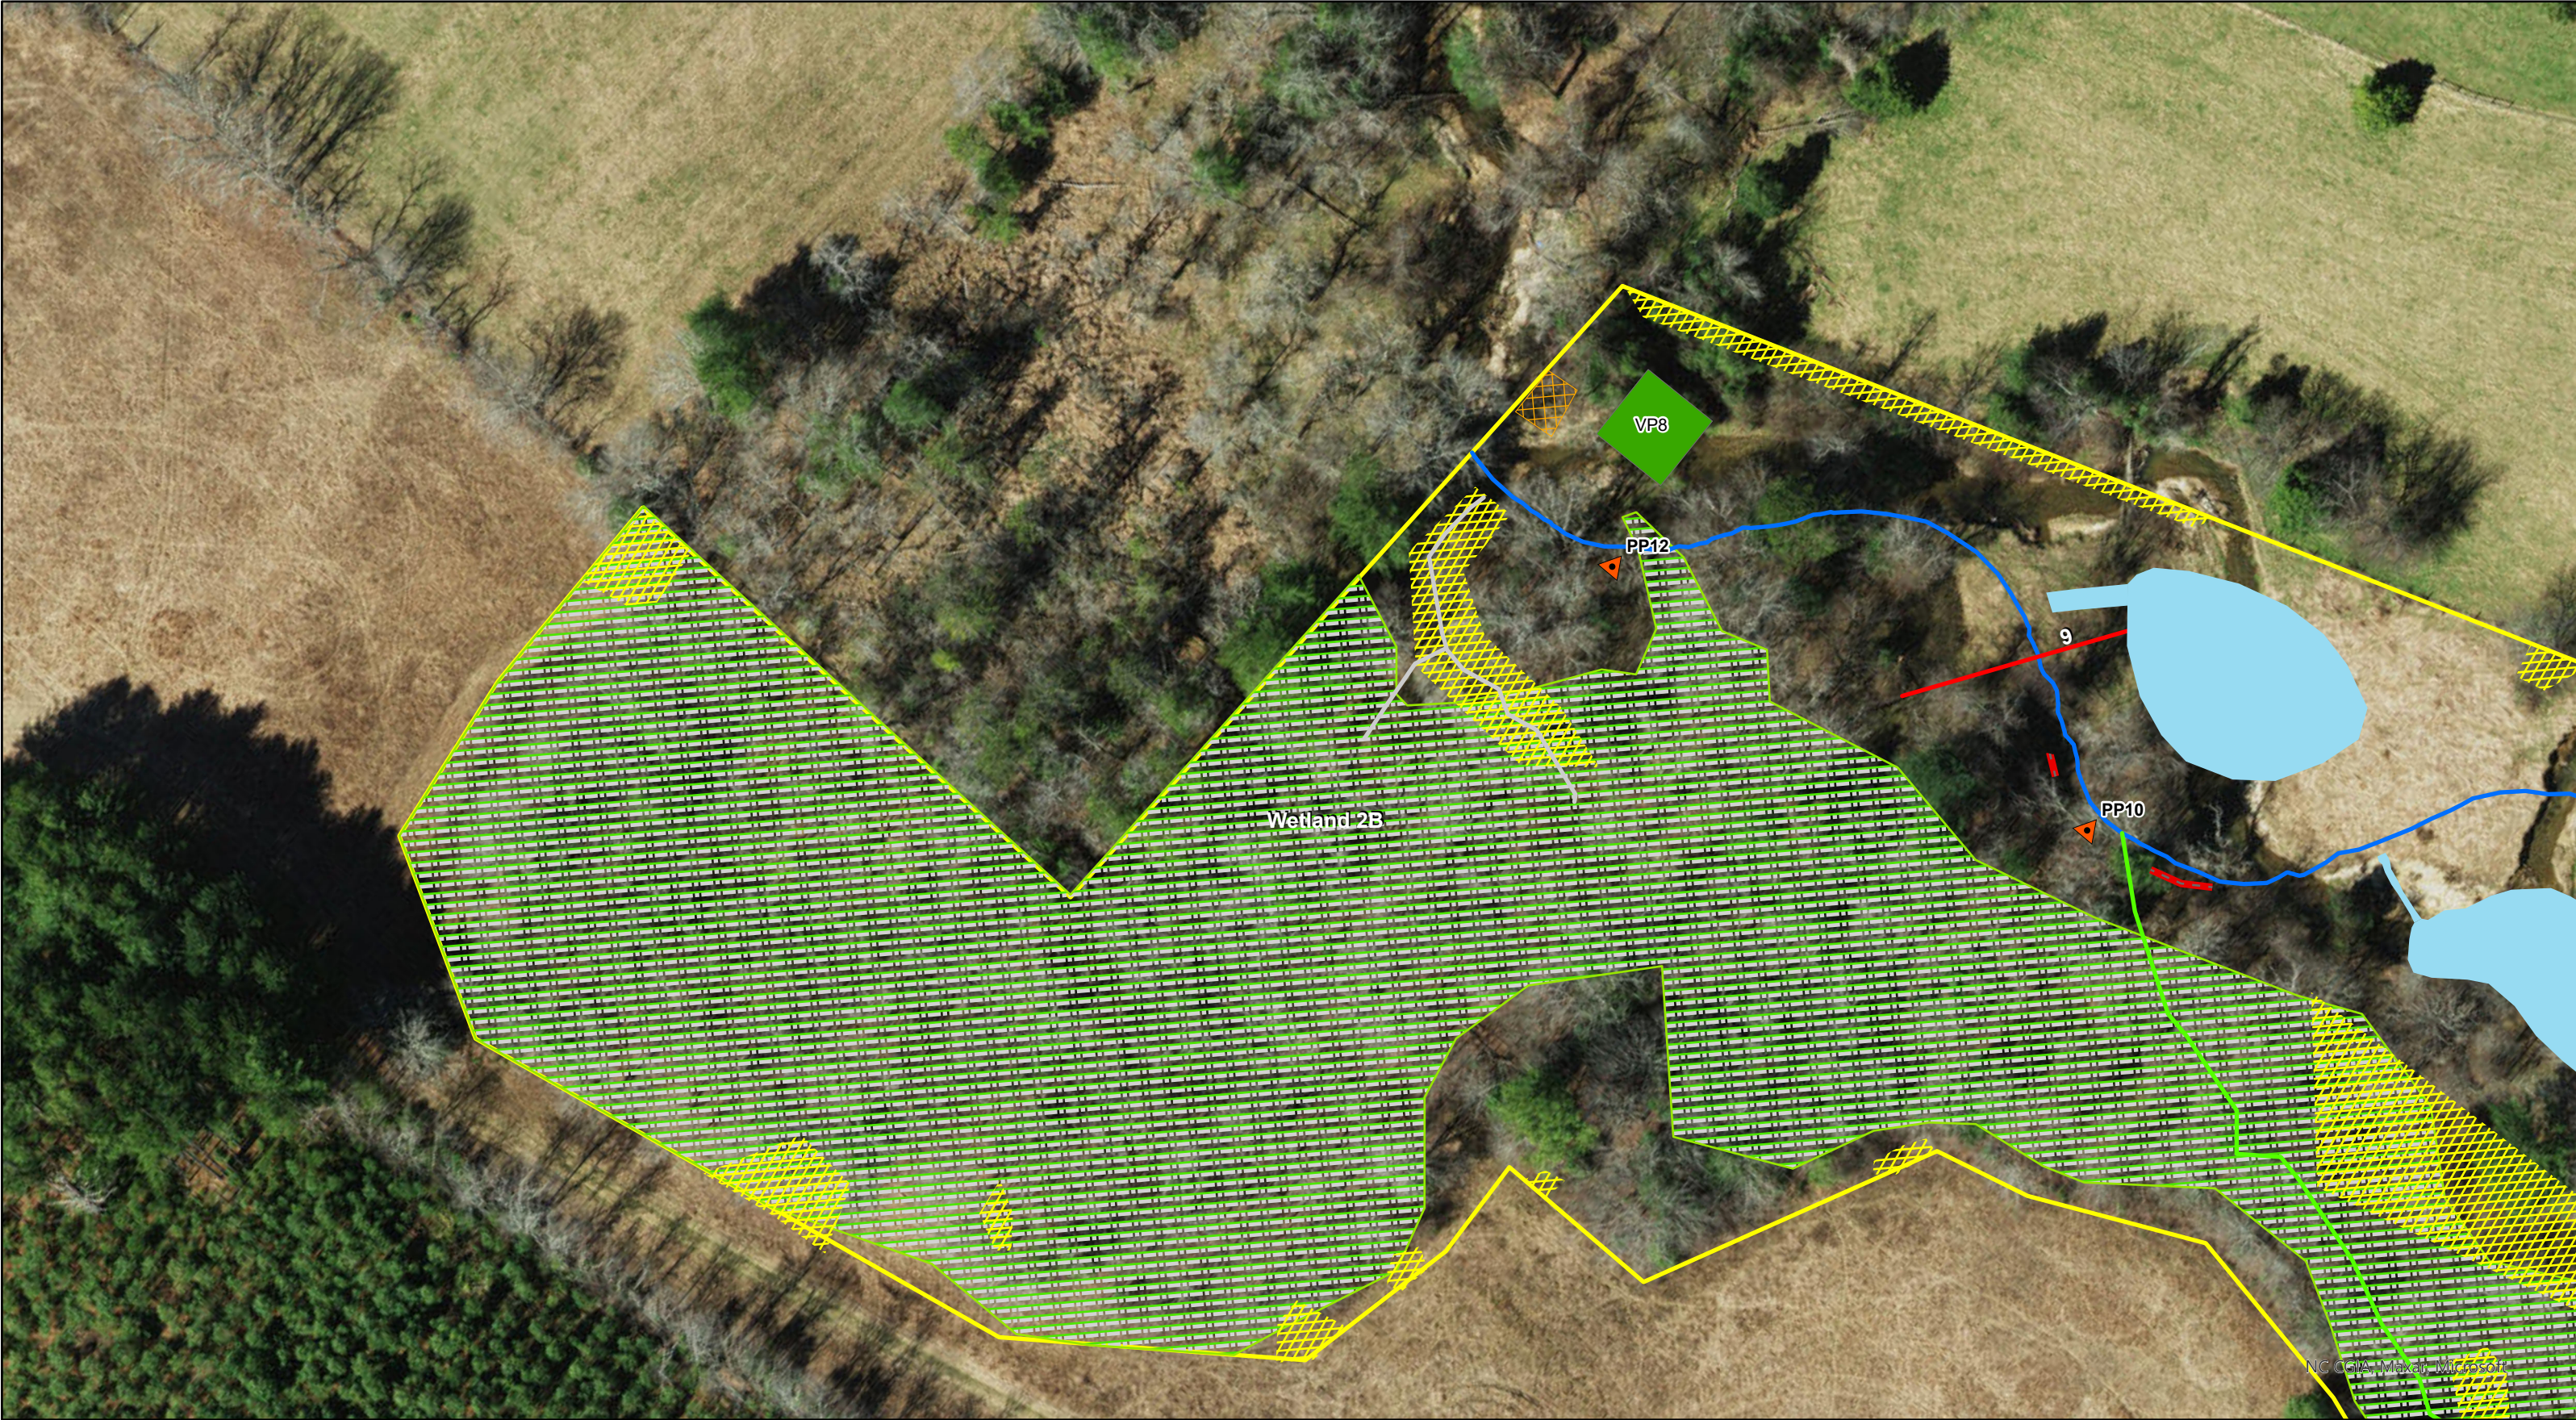
Integrated CCPV  
 MY2  
 Little Pine Creek II  
 Alleghany County, NC  
 Sheet 3 of 3

Three areas of low stem density were identified in MY2. The first area of concern is overbank scour located mid-reach at STA 112+00 has some vegetation reestablishment but was still considered a problem area in MY2. The second area was located adjacent to Veg Plot 7 and is an area of poor soil with limited ground cover establishment. The third area called out in MY2 is located at Station 124+50, the downstream boundary of the project and is an area of bank scour with sparse vegetation (Table 6 and CCPV, Appendix B). An area noted in MY1 between Cross-sections 3 and 5 continues to receive overbank deposition but impacts to existing planted stems seem to be less in MY2. Thus, this area was removed from the areas of concern. These areas will continue to be monitored in future site visits for further signs of instability.

Vegetation problem areas continue to be restricted to the immediate floodplain of Little Pine Creek Some of the low stem density areas noted in MY0 and MY1 are still present, particularly within the channel belt width on Reach 2A (Table 6 and CCPV, Appendix B).

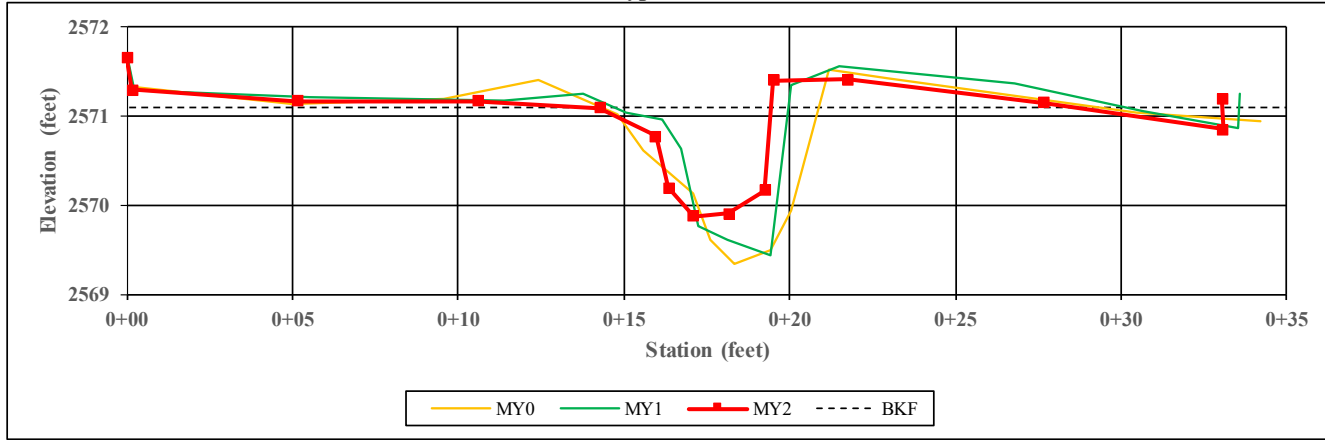
Project Name: LPC II  
 Reach Name: Trib C

CHANNEL DIMENSIONS SUMMARY	MY0	MY1	MY2	MY3	MY4	MY5	MY6	MY7
Bankful Width (ft)	8.7	4.3	2.2	-	-	-	-	-
Floodprone Width (ft)	40.0	40.0	40.0	-	-	-	-	-
Bankfull Mean Depth (ft)	1.0	0.9	1.0	-	-	-	-	-
Bankfull Max Depth (ft)	2.1	1.6	1.2	-	-	-	-	-
Bankfull Cross-Sectional Area (ft <sup>2</sup> )	8.7	3.7	2.3	-	-	-	-	-
Width/Depth Ratio	8.7	5.0	2.1	-	-	-	-	-
Entrenchment Ratio	4.6	9.3	18.1	-	-	-	-	-
Bank Height Ratio	1.0	0.7	0.3	-	-	-	-	-

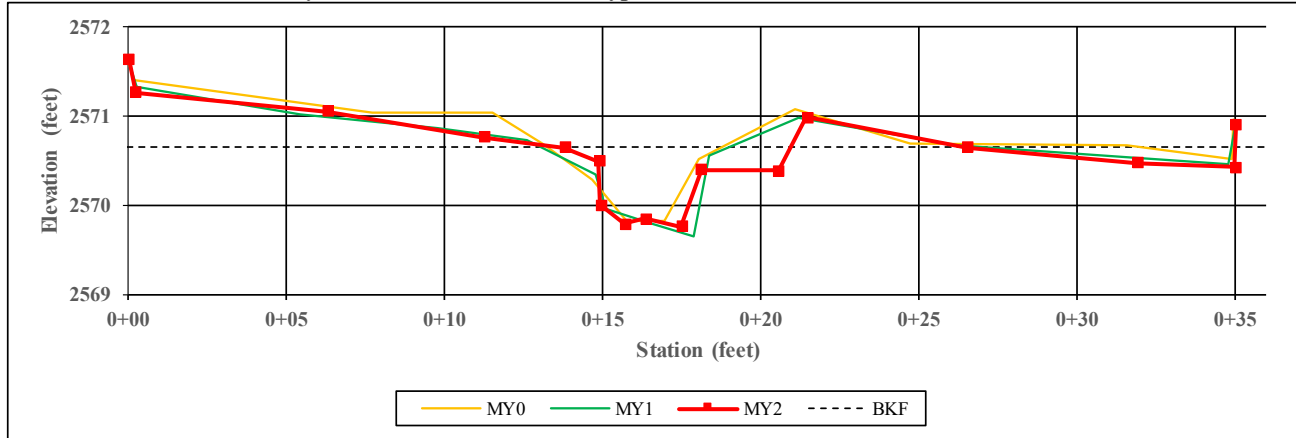
**Project Name:** LPC II  
**Reach Name:** Tributary C

CHANNEL DIMENSIONS SUMMARY	MY0	MY1	MY2	MY3	MY4	MY5	MY6	MY7
Bankful Width (ft)	9.3	5.4	5.7	-	-	-	-	-
Floodprone Width (ft)	40.0	40.0	40.0	-	-	-	-	-
Bankfull Mean Depth (ft)	0.6	0.6	0.5	-	-	-	-	-
Bankfull Max Depth (ft)	1.2	1.0	0.9	-	-	-	-	-
Bankfull Cross-Sectional Area (ft <sup>2</sup> )	5.3	3.2	3.1	-	-	-	-	-
Width/Depth Ratio	16.4	9.3	10.5	-	-	-	-	-
Entrenchment Ratio	4.3	7.4	7.1	-	-	-	-	-
Bank Height Ratio	1.0	1.0	0.7	-	-	-	-	-

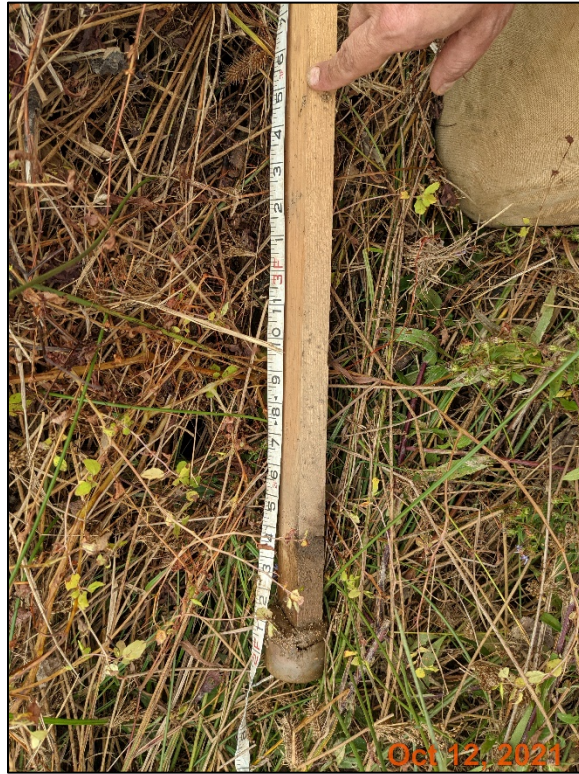
4. Tributary B Crest Gage.
