Annual Monitoring Report

Little Pine Creek II

Monitoring Year 3 of 7

NCDMS Project No. 856

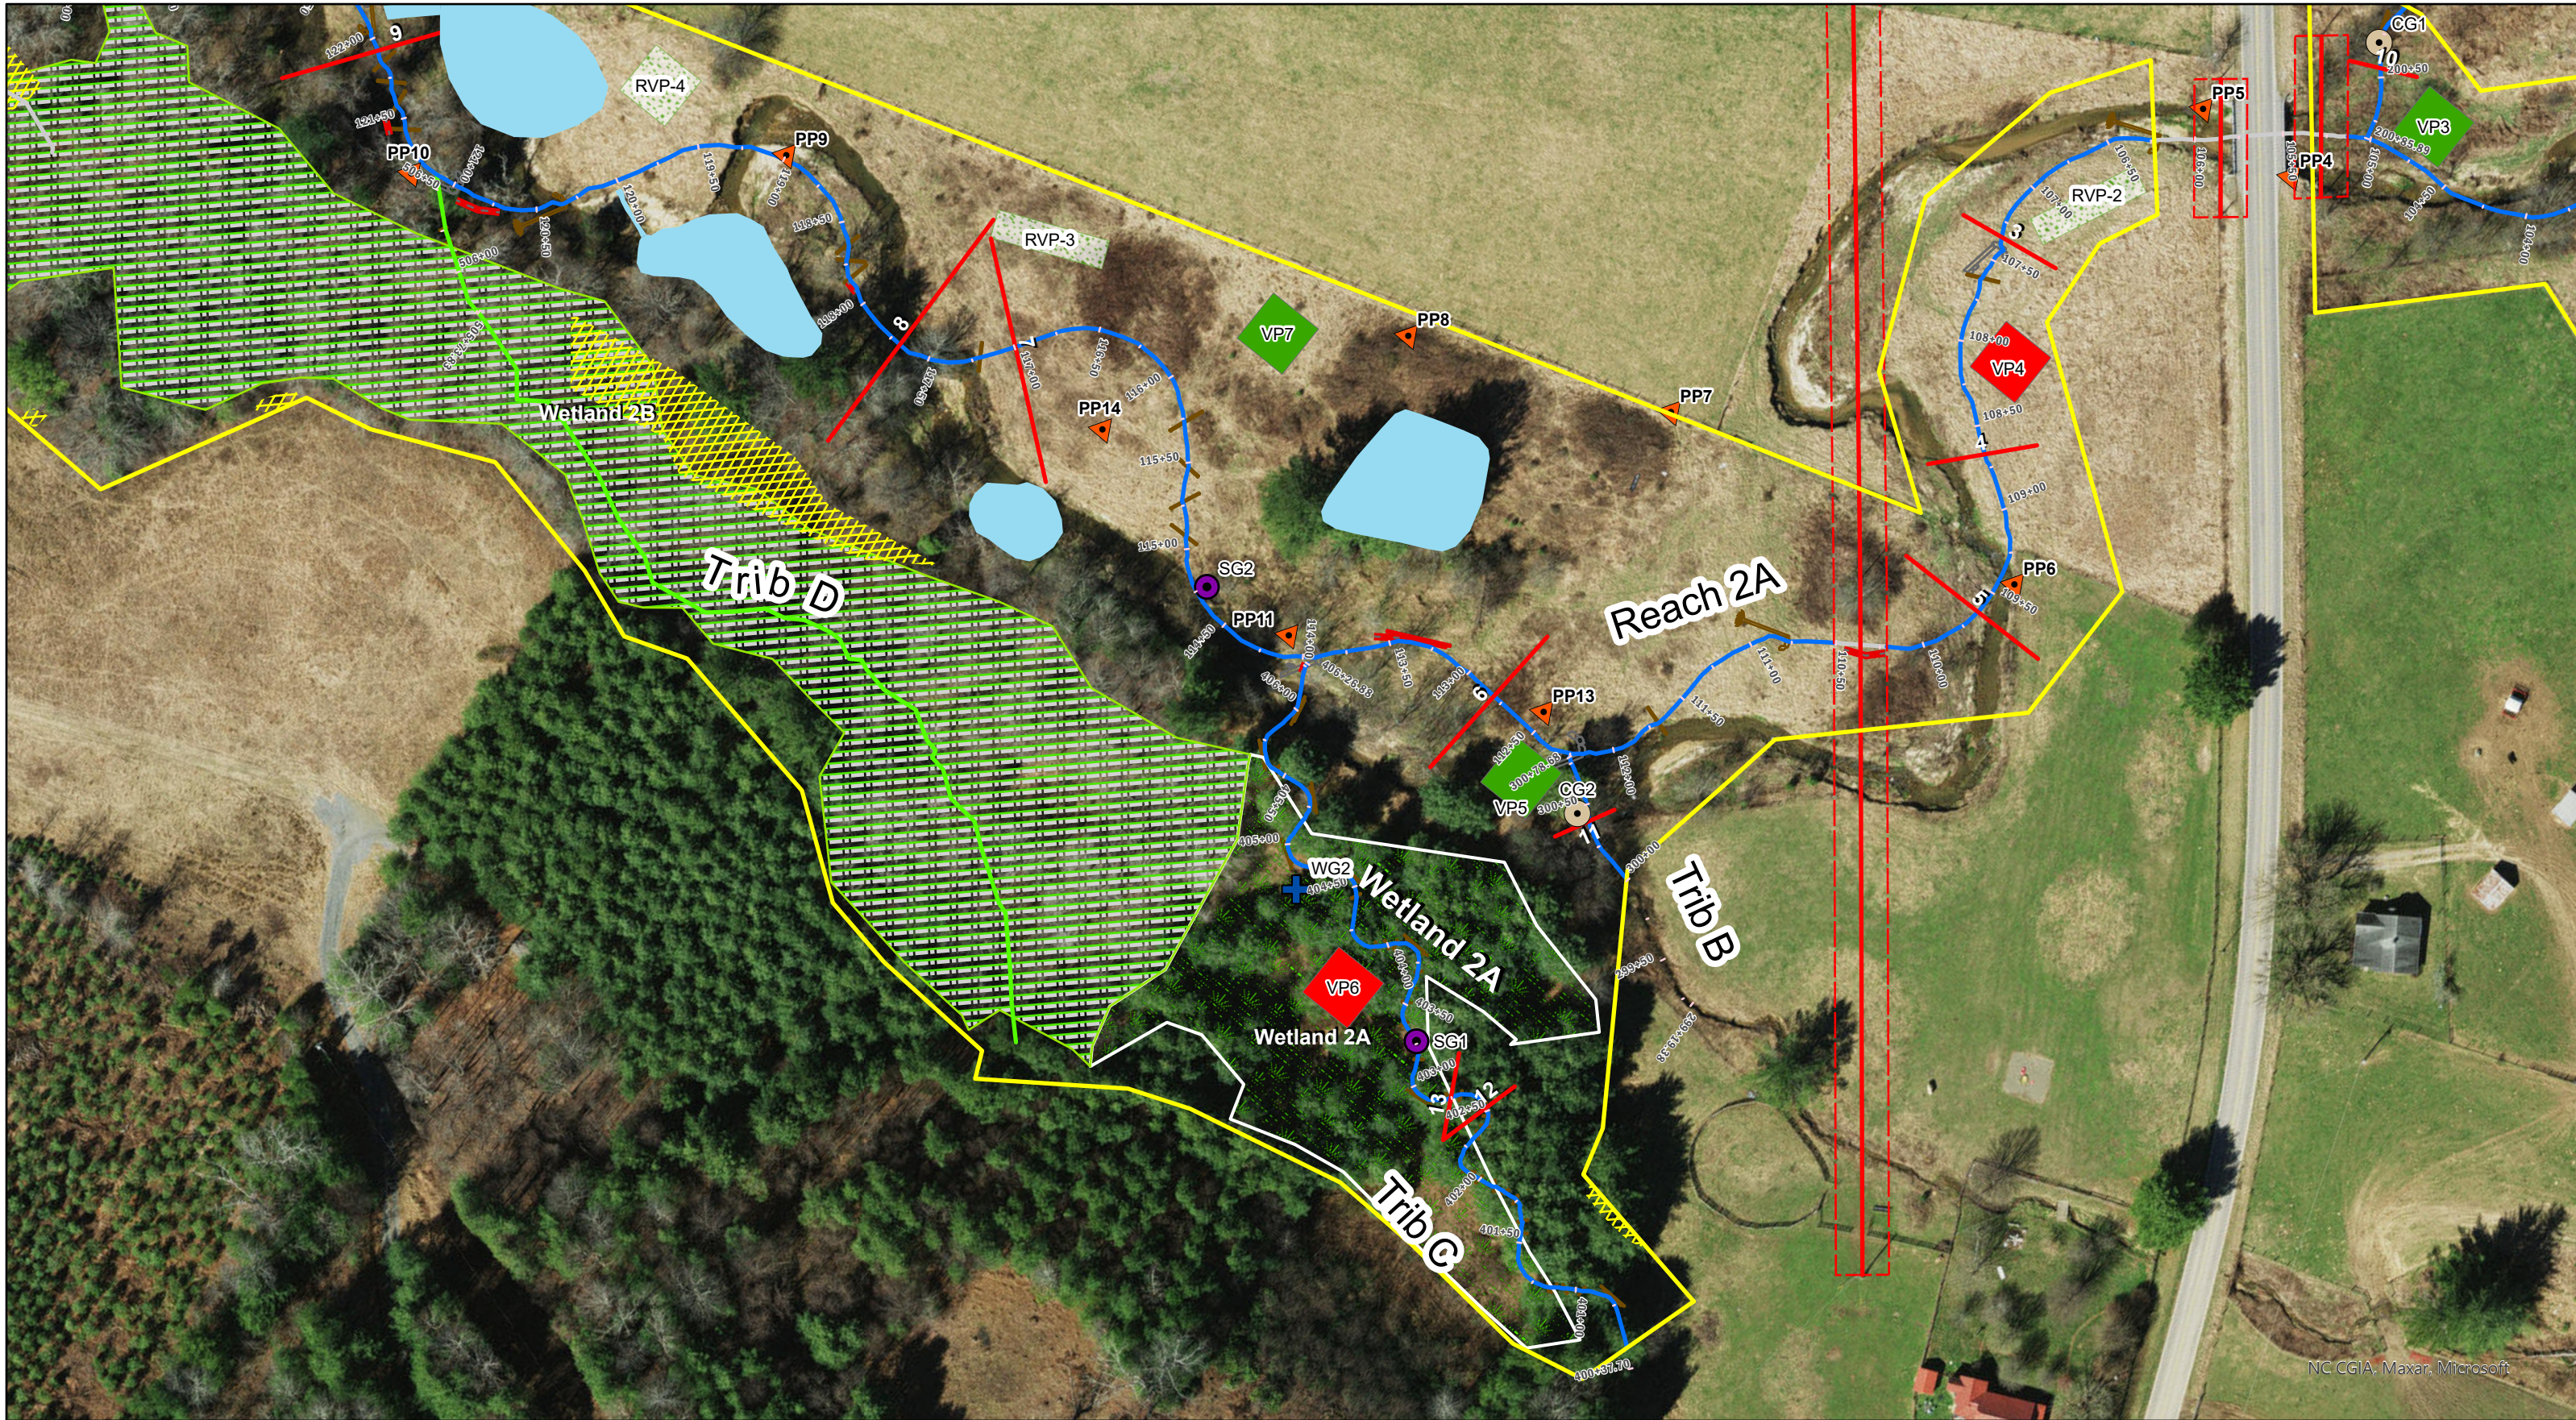
CCPV MY3
Little Pine Creek II
Alleghany County, NC

One exposed structure (113+30) and 6 areas of bank scour or slumping (100+10, 110+20, 118+00, 121+00, 121+75, and 406+26) were identified at the LPC II Project in MY3. At Stations 113+30 - 113+60 the toe logs of an outer bend structure have been exposed and there is an area of bank slump immediately downstream. Bank scour noted at Stations 100+10 and 110+20 were identified in MY2 and have neither improved nor worsened in MY3. At Station 118+00 the outside bend has notable scour and bank slump. The second area of instability (Station 121+00) has a similar amount of scour along the outer bend leading to the confluence with Trib D. At the final problem area (Stations 121+75) in Reach 2b, the bank at the first set of log-drop structures has a significant amount of scour. A concentrated area of scour was noted on the left descending bank at the confluence of Trib C and the LPCII Reach 2A/B (CCPV and Table 5, Appendix B). The site will continue to be monitored for signs of instability.

Division of mitigation services has plans to initiate focused stream problem area repair and limited supplemental planting in 2023.
