Year 2 Monitoring Report

LITTLE SEBASTIAN SITE

NCDMS Project # 100027 (Contract # 7187) | RFP 16-006993 (Issued 9/16/2016)
USACE Action ID: SAW-2017-01507 | DWR Project # 2017-1041

Surry County, North Carolina
Yadkin River Basin
HUC 03040101

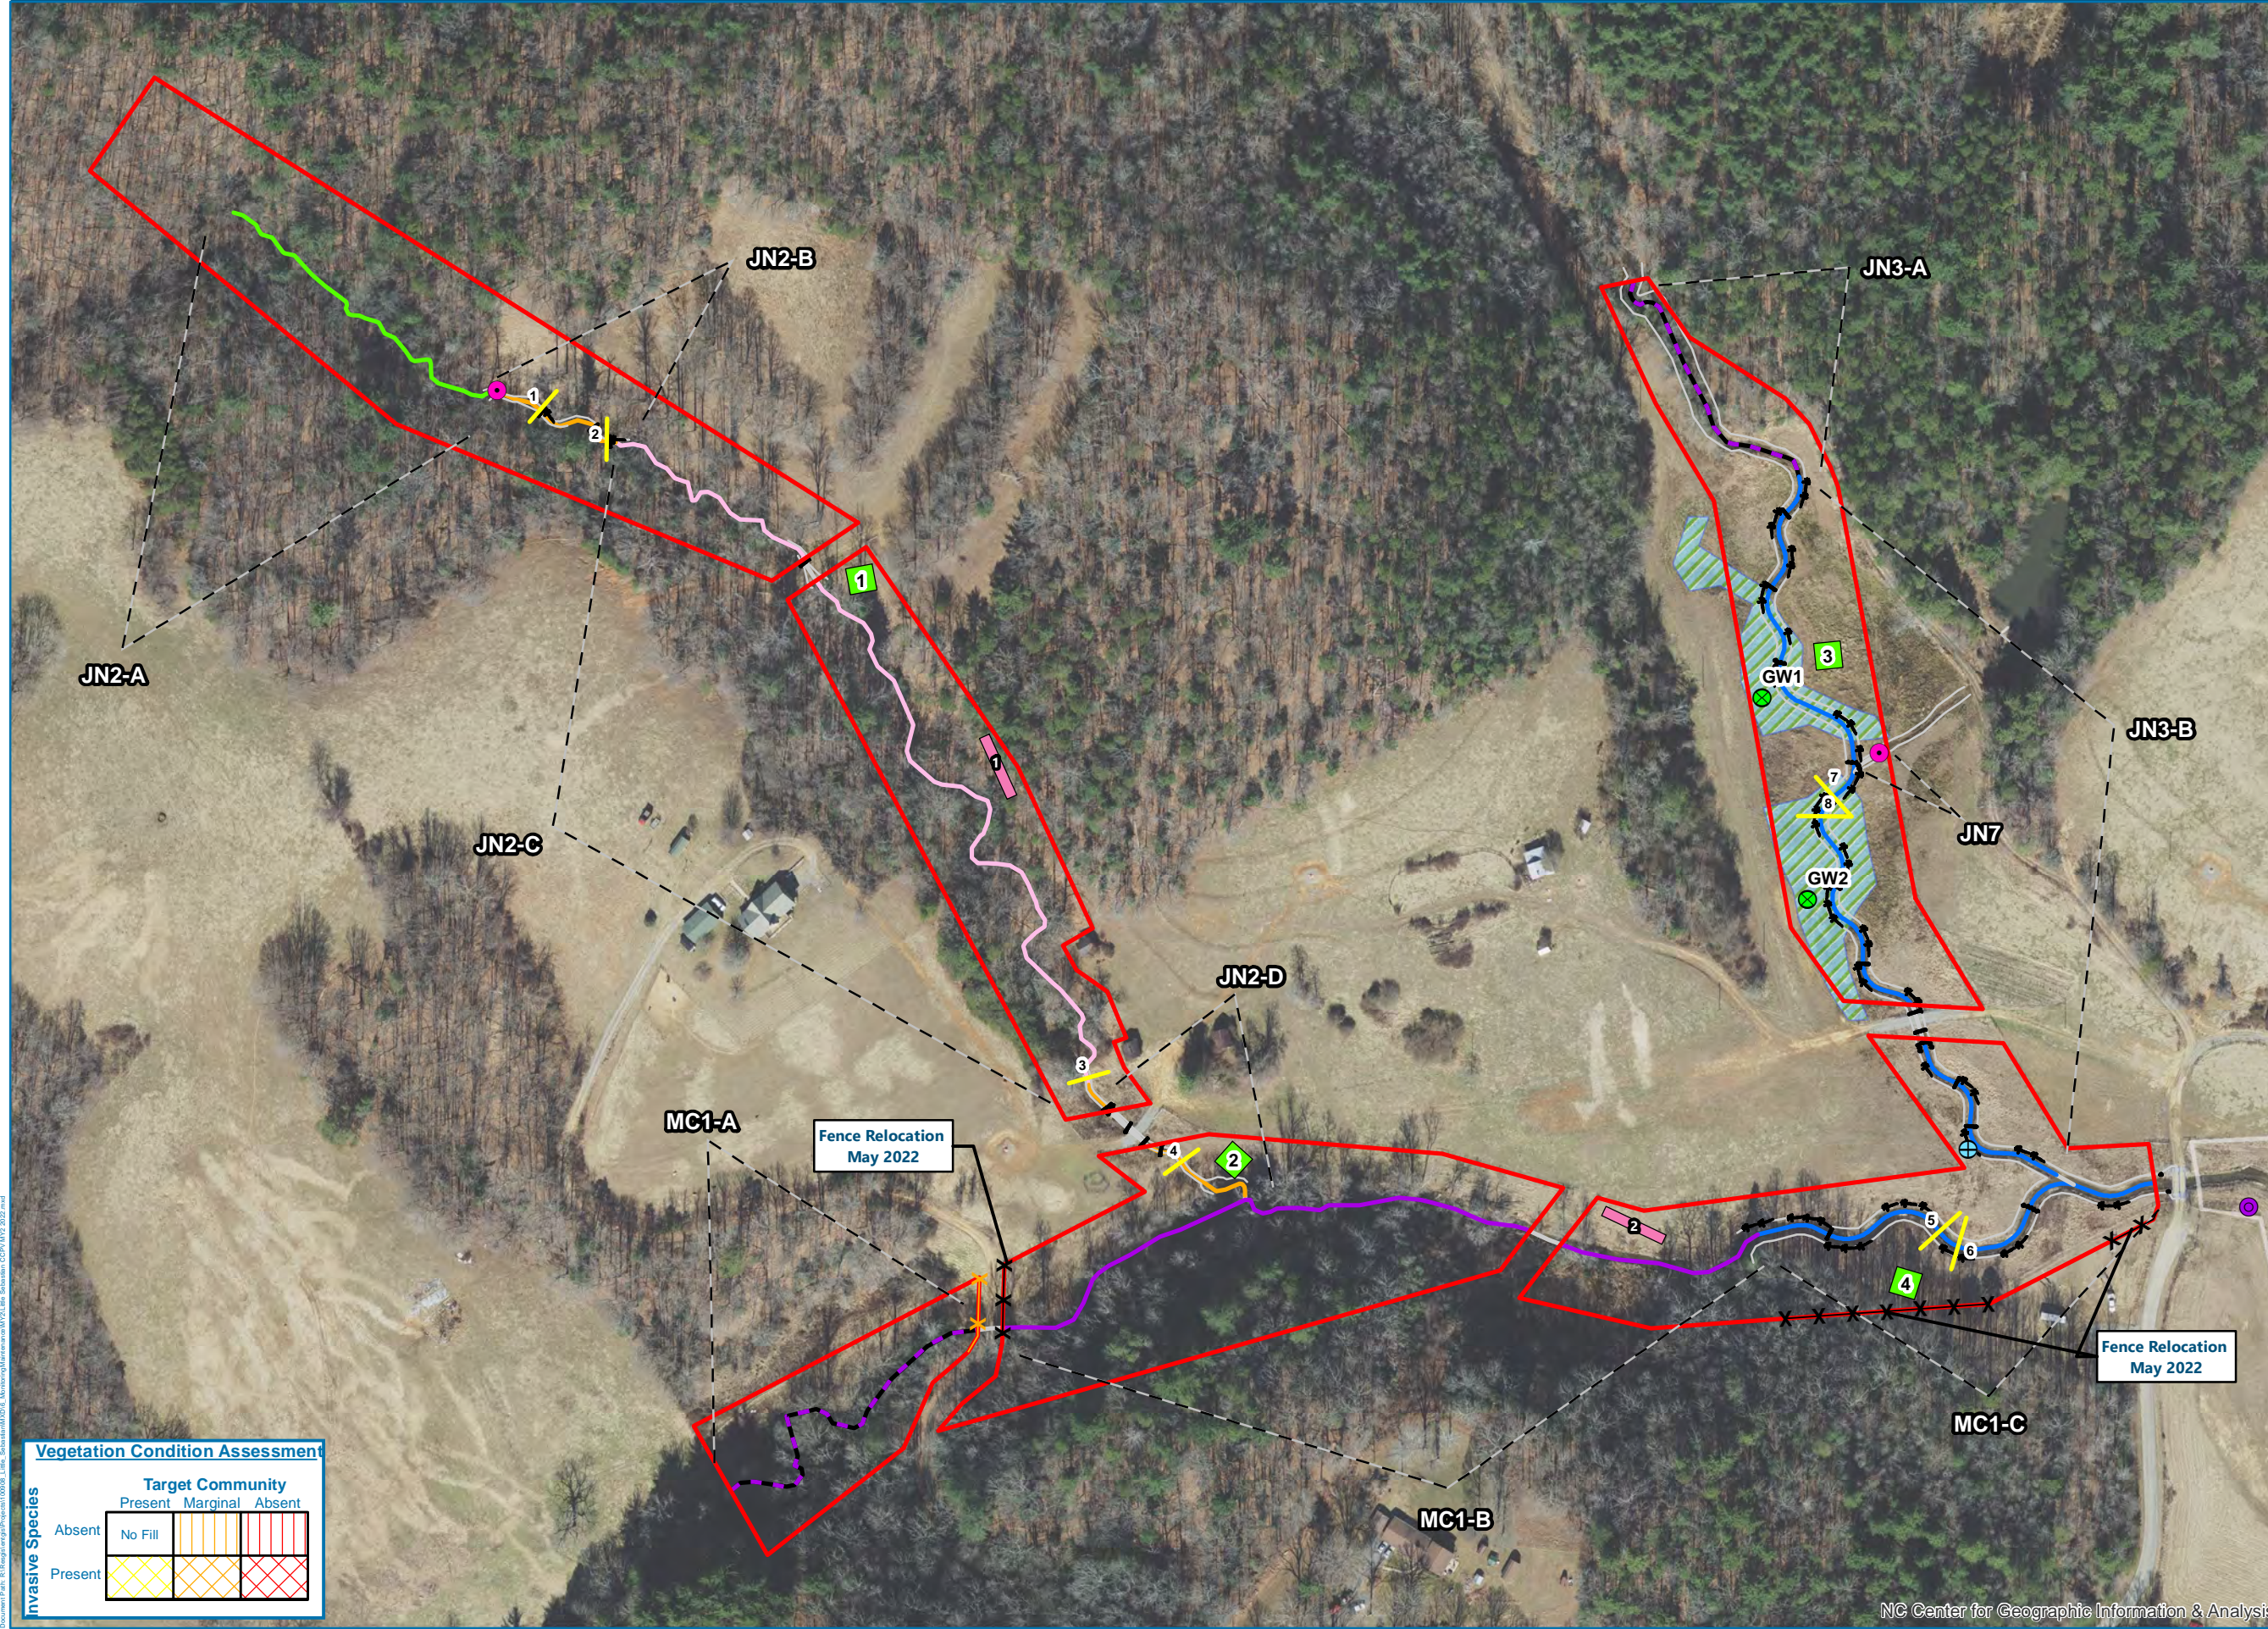
Current Conditions
Plan View

"Two areas of mowing encroachment along the eastern boundary of the Project, adjacent to BS1, were observed during Year 2 monitoring. The mowing has resulted in two areas of low stem density; one is 0.49 acres and the other is 0.34 acres. This roughly 0.83-acre area will be replanted with native container trees, chosen in reference to the original planting list (Appendix C) and based on supply availability, during this dormant season. Additional signage and horse tape (in areas where visibility between markers may be limited) will be installed along this side of the easement to mark a clear boundary to prevent further mowing."

CCPV Maps – Figure 2: A steep stream bank was observed on MC3-B/ MC3-C near the crossing during the last DMS monitoring site visit (2021). Please confirm that the bank continues to remain stable.

This bank continues to remain stable.

The encroachment will be resolved with the landowner by placing clear easement markers, signage, and horse tape where necessary, in the impacted areas. If further encroachment is observed in the future, a formal letter will be sent to the landowner.

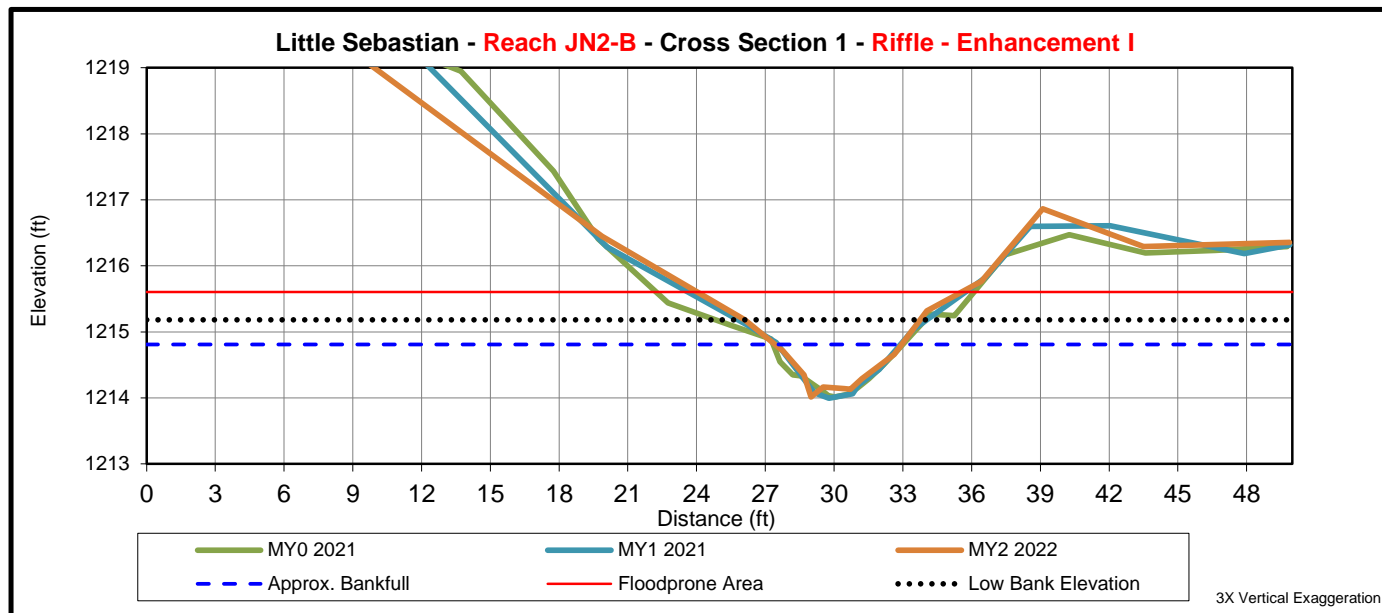
Cross Section 1 (Riffle)						
	Base	MY1	MY2	MY3	MY5	MY7	MY+
Bankfull Elevation (ft) - Based on AB-XSA¹	1214.7	1214.8	1214.8				
Bankfull Width (ft) ¹	5.4	5.1	5.5				
Floodprone Width (ft) ¹	13.1	11.2	11.5				
Bankfull Max Depth (ft) ²	0.7	1.0	1.2				
Low Bank Elevation (ft)	1214.74	1215.0	1215.2				
Bankfull Cross Sectional Area (ft ²) ²	2.4	4.1	4.9				
Bankfull Entrenchment Ratio ¹	2.4	2.2	2.1				
Bankfull Bank Height Ratio ¹	1.0	1.4	1.5

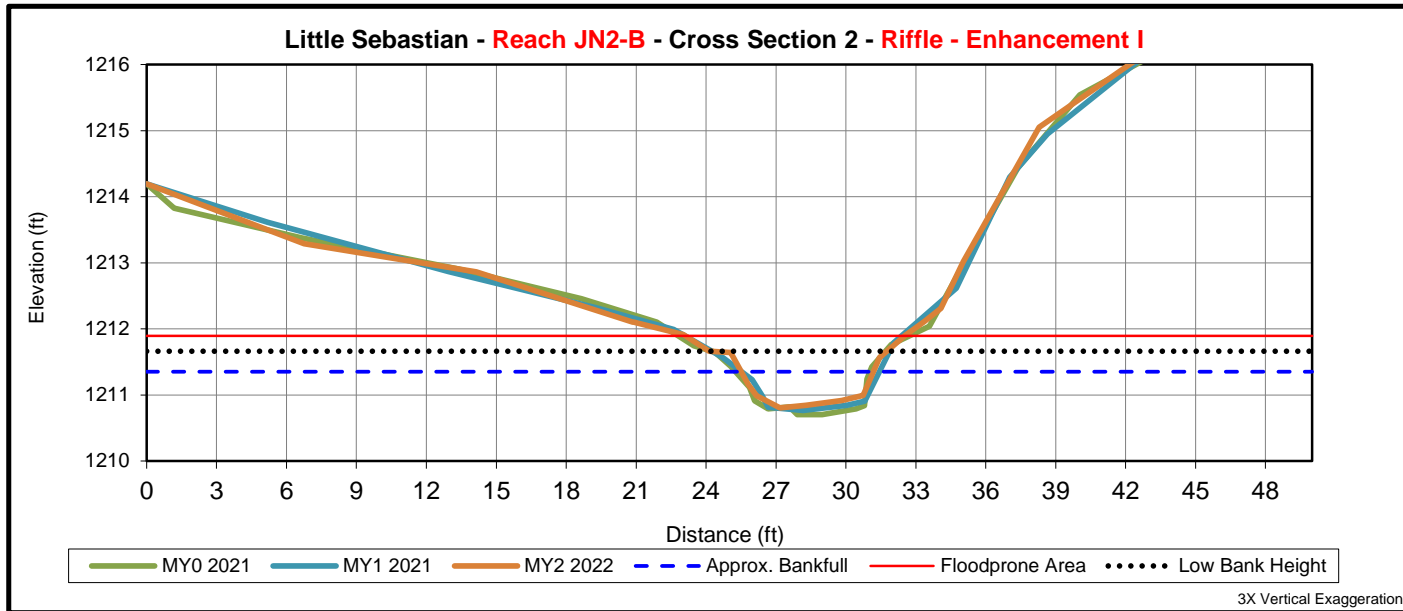
Cross Section 2 (Riffle)						
	Base	MY1	MY2	MY3	MY5	MY7	MY+
Bankfull Elevation (ft) - Based on AB-XSA¹	1211.2	1211.3	1211.4				
Bankfull Width (ft) ¹	5.4	5.6	5.7				
Floodprone Width (ft) ¹	8.7	8.8	9.4				
Bankfull Max Depth (ft) ²	0.5	0.8	0.9				
Low Bank Elevation (ft)	1211.2	1211.6	1211.7				
Bankfull Cross Sectional Area (ft ²) ²	2.3	4.1	4.3				
Bankfull Entrenchment Ratio ¹	1.6	1.6	1.7				
Bankfull Bank Height Ratio ¹	1.0	1.5	1.6
