Year 3 Monitoring Report

LITTLE SEBASTIAN SITE

NCDMS Project # 100027 (Contract # 7187) | RFP 16-006993 (Issued 9/16/2016)
USACE Action ID: SAW-2017-01507 | DWR Project # 2017-1041

Surry County, North Carolina
Yadkin River Basin
HUC 03040101

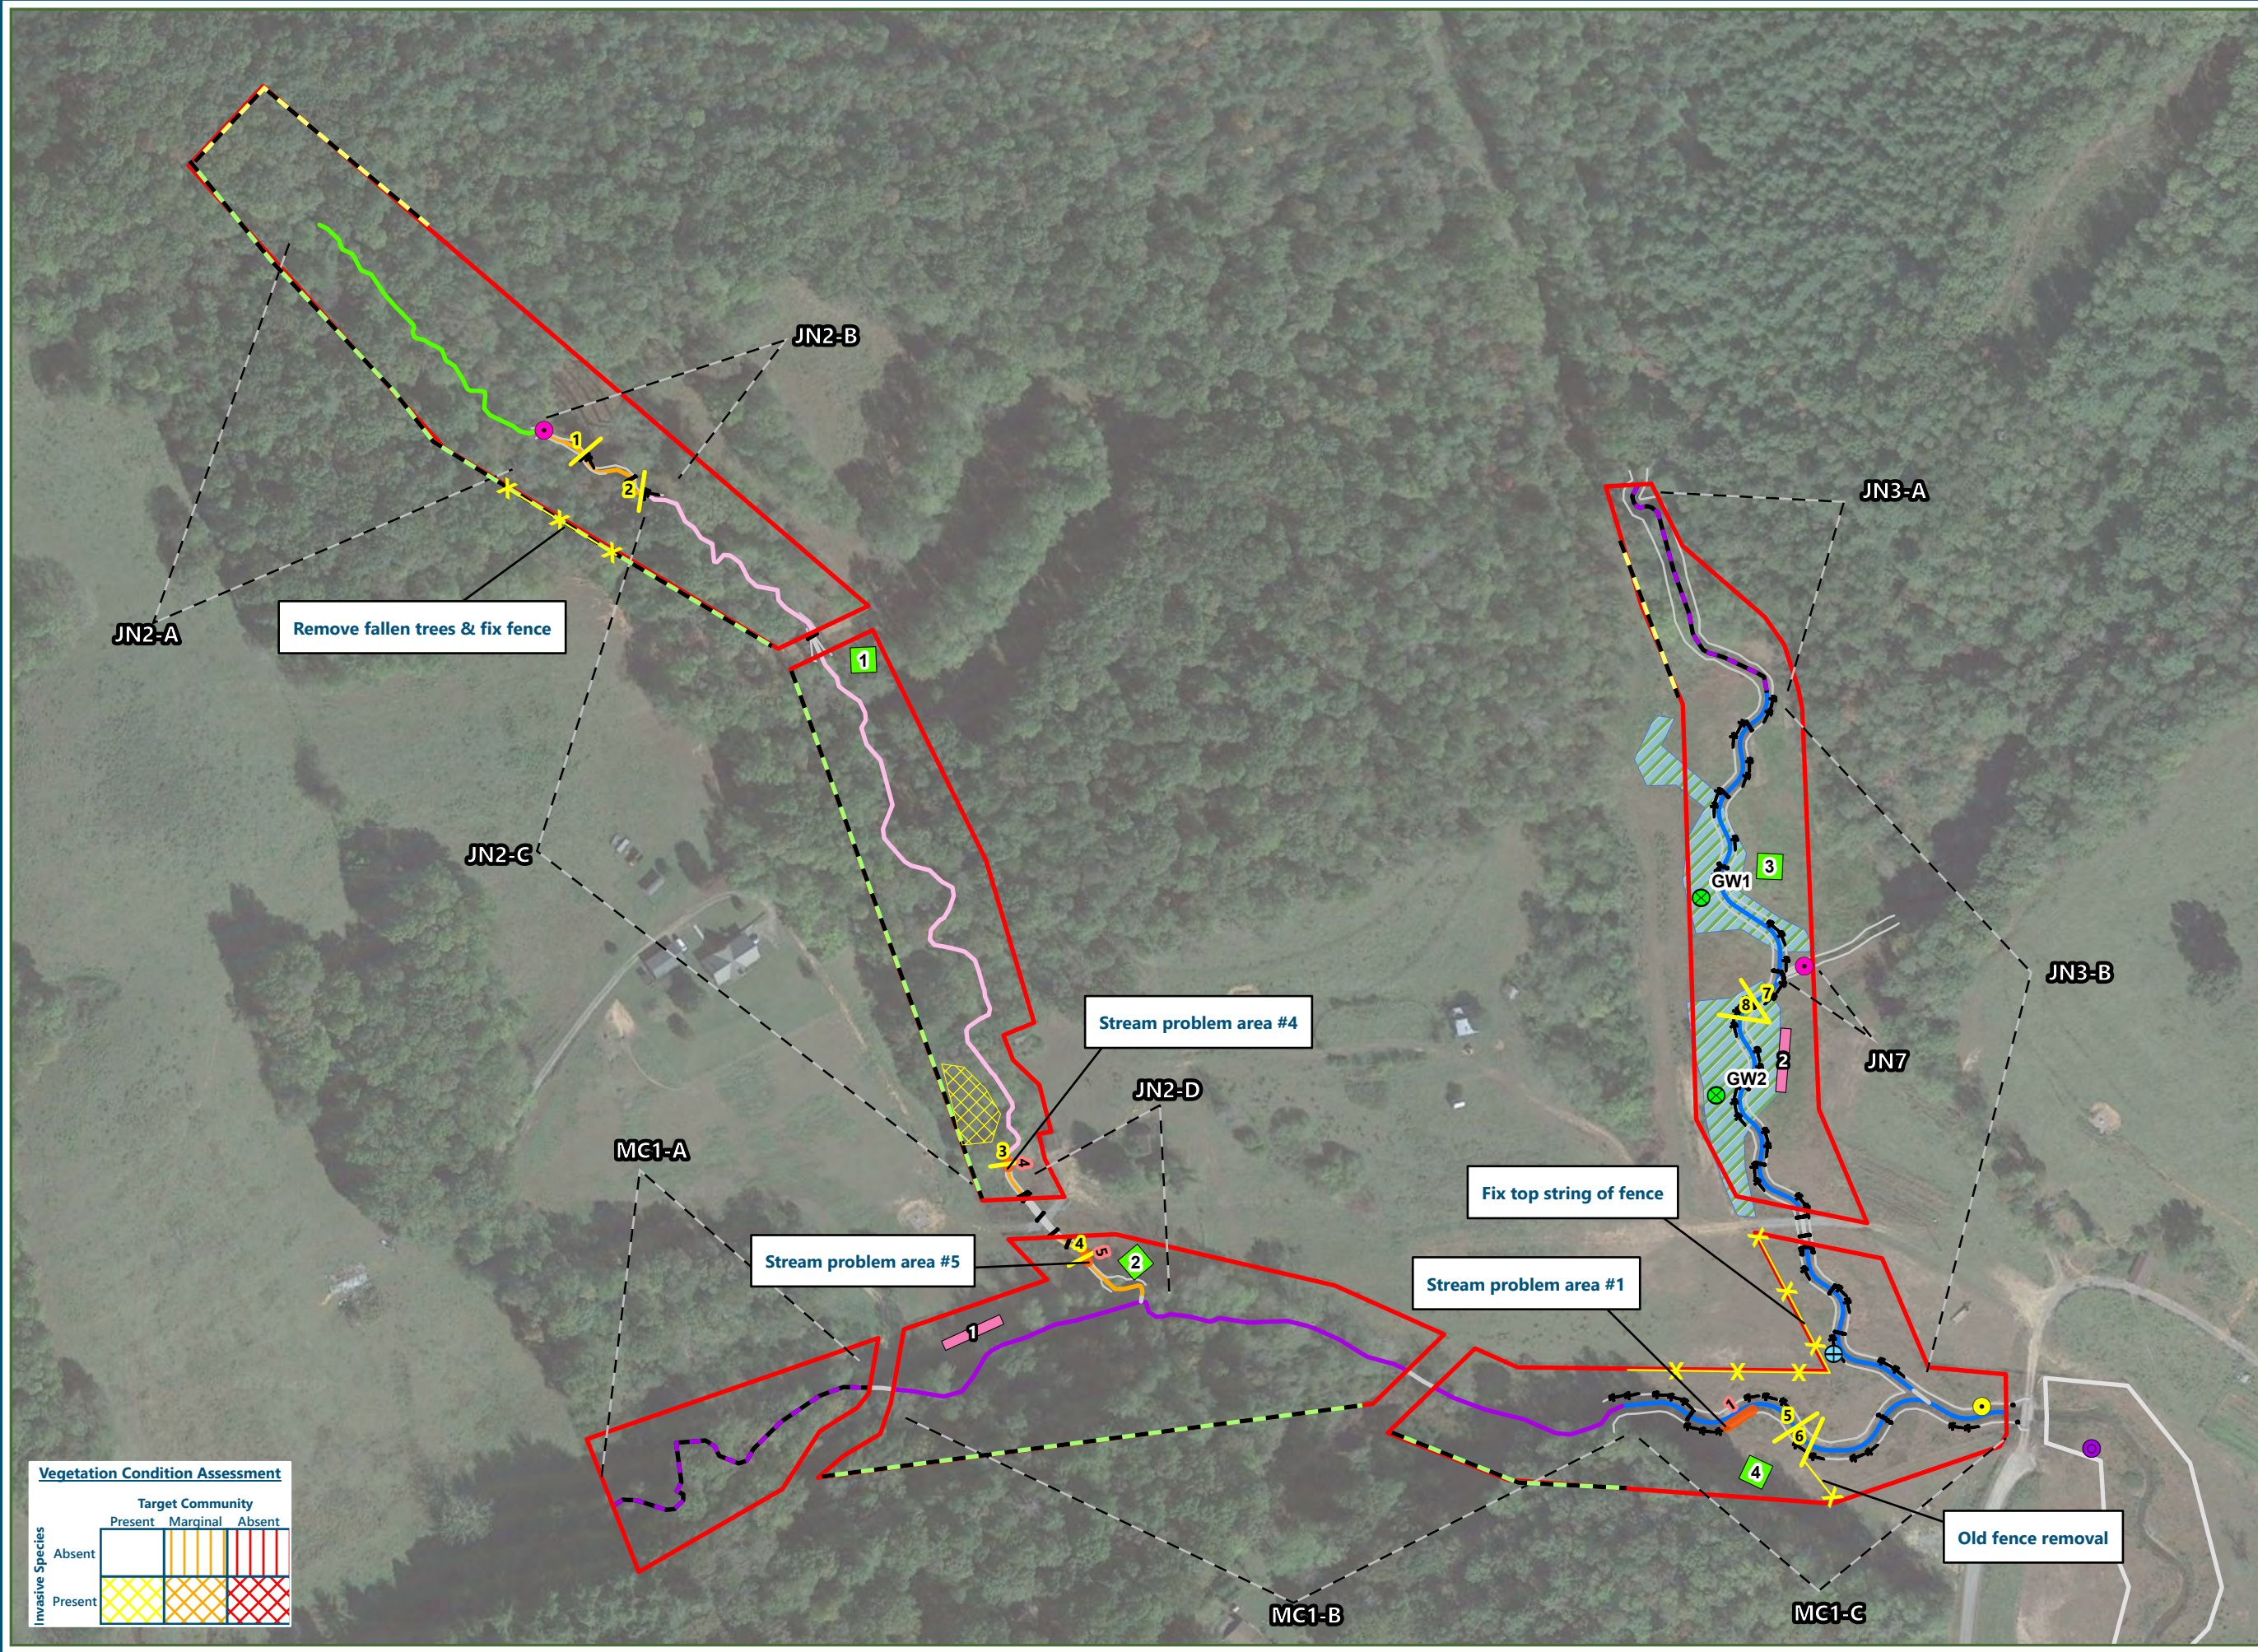
Figure 2
Current Conditions Plan View

9. Section 1.7 Monitoring Performance (MY3) _Stream Geomorphology: An area of erosion is noted at Right Bank Erosion BS1-C and mapped on the CCPV, and “caused by a failed log sill causing the stream flow to erode away at the right bank”. It is noted that matting and live staking will be completed to stabilize this area in early 2024; however, the photo shows a vertical, eroding bank. Is RES confident that matting and staking can rectify and stabilize the apparently actively eroding bank? Please review and discuss in the report text.

10. Section 1.7 Monitoring Performance (MY3) _Stream Geomorphology: An area of erosion is noted at Right Bank Erosion MC1-C and mapped on the CCPV, and “caused by a brush toe failing during a major storm event”; however, a photo of this area was not included. Is this an area RES also intends to address with matting and live staking, and is RES confident that this approach will stabilize the area? Does RES have an idea which storm event caused this? Please add additional information in the report text to detail the project issue and proposed resolution. The photo of the brush toe failure was previously mislabeled with the wrong reach and has been updated. The CCPV and report now also refer to the stream problem areas by station numbers. RES can not confirm what storm event caused the brush tow to fail but feels confident that the matting, packing with coir logs, and live staking will stabilize the area.

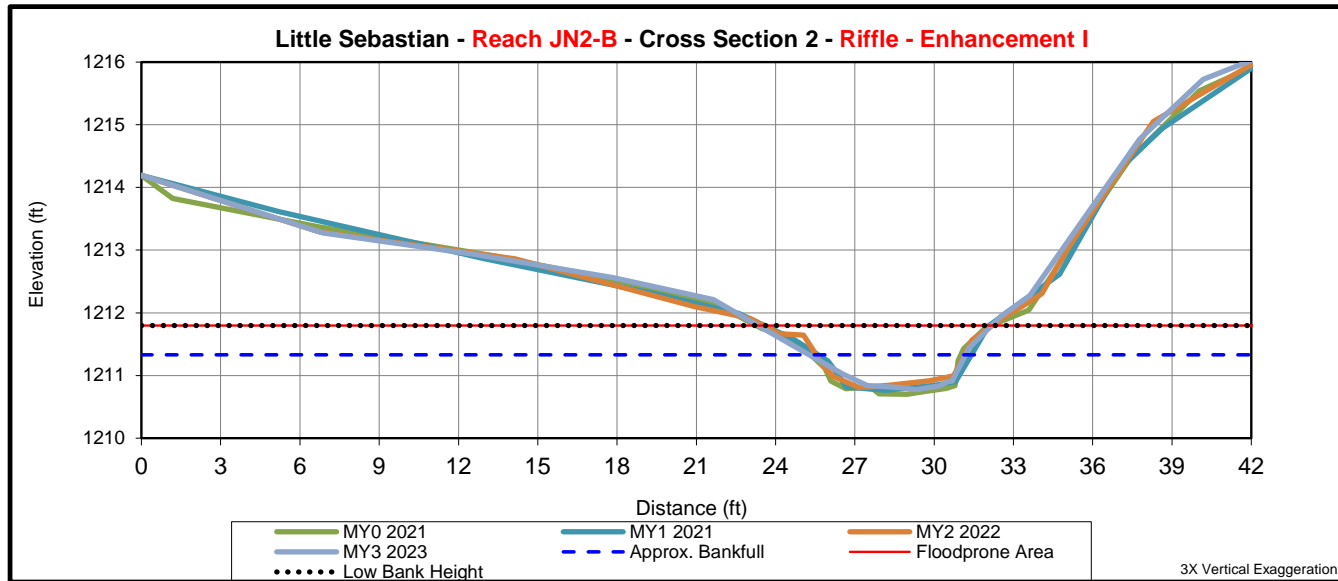
Cross Section 2 (Riffle)						
	Base	MY1	MY2	MY3	MY5	MY7	MY+
Bankfull Elevation (ft) - Based on AB-XSA¹	1211.2	1211.3	1211.4	1211.3			
Bankfull Width (ft) ¹	5.4	5.6	5.7	5.9			
Floodprone Width (ft) ¹	8.7	8.8	9.4	9.4			
Bankfull Max Depth (ft) ²	0.5	0.8	0.9	1.0			
Low Bank Elevation (ft)	1211.2	1211.6	1211.7	1211.8			
Bankfull Cross Sectional Area (ft ²) ²	2.3	4.1	4.3	5.7			
Bankfull Entrenchment Ratio ¹	1.6	1.6	1.7	1.6			
Bankfull Bank Height Ratio ¹	1.0	1.5	1.6	1.8

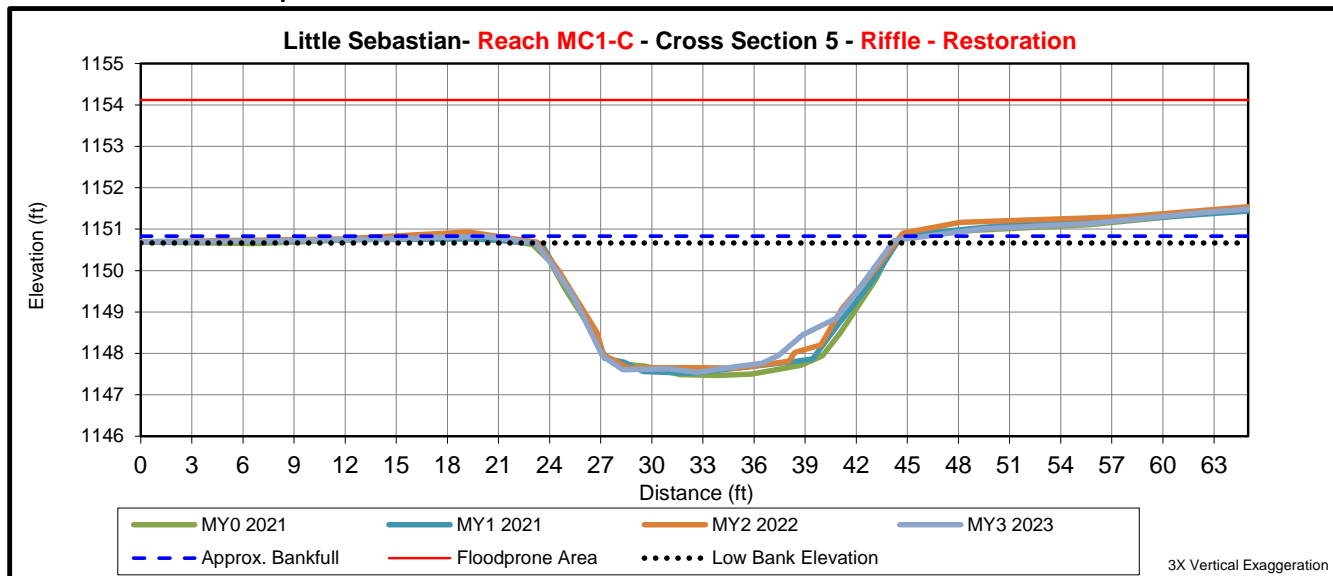
Cross Section 5 (Riffle)						
	Base	MY1	MY2	MY3	MY5	MY7	MY+
Bankfull Elevation (ft) - Based on AB-XSA¹	1150.6	1150.7	1150.8	1150.8			
Bankfull Width (ft) ¹	21.3	21.0	21.3	21.1			
Floodprone Width (ft) ¹	>64.9	>65.1	>65	>65			
Bankfull Max Depth (ft) ²	3.2	3.1	3.0	3.1			
Low Bank Elevation (ft)	1150.6	1150.6	1150.7	1150.7			
Bankfull Cross Sectional Area (ft ²) ²	49.8	48.2	47.2	46.3			
Bankfull Entrenchment Ratio ¹	>3.0	>3.1	>3.1	>3.1			
Bankfull Bank Height Ratio ¹	1.0	1.0	1.0	0.9

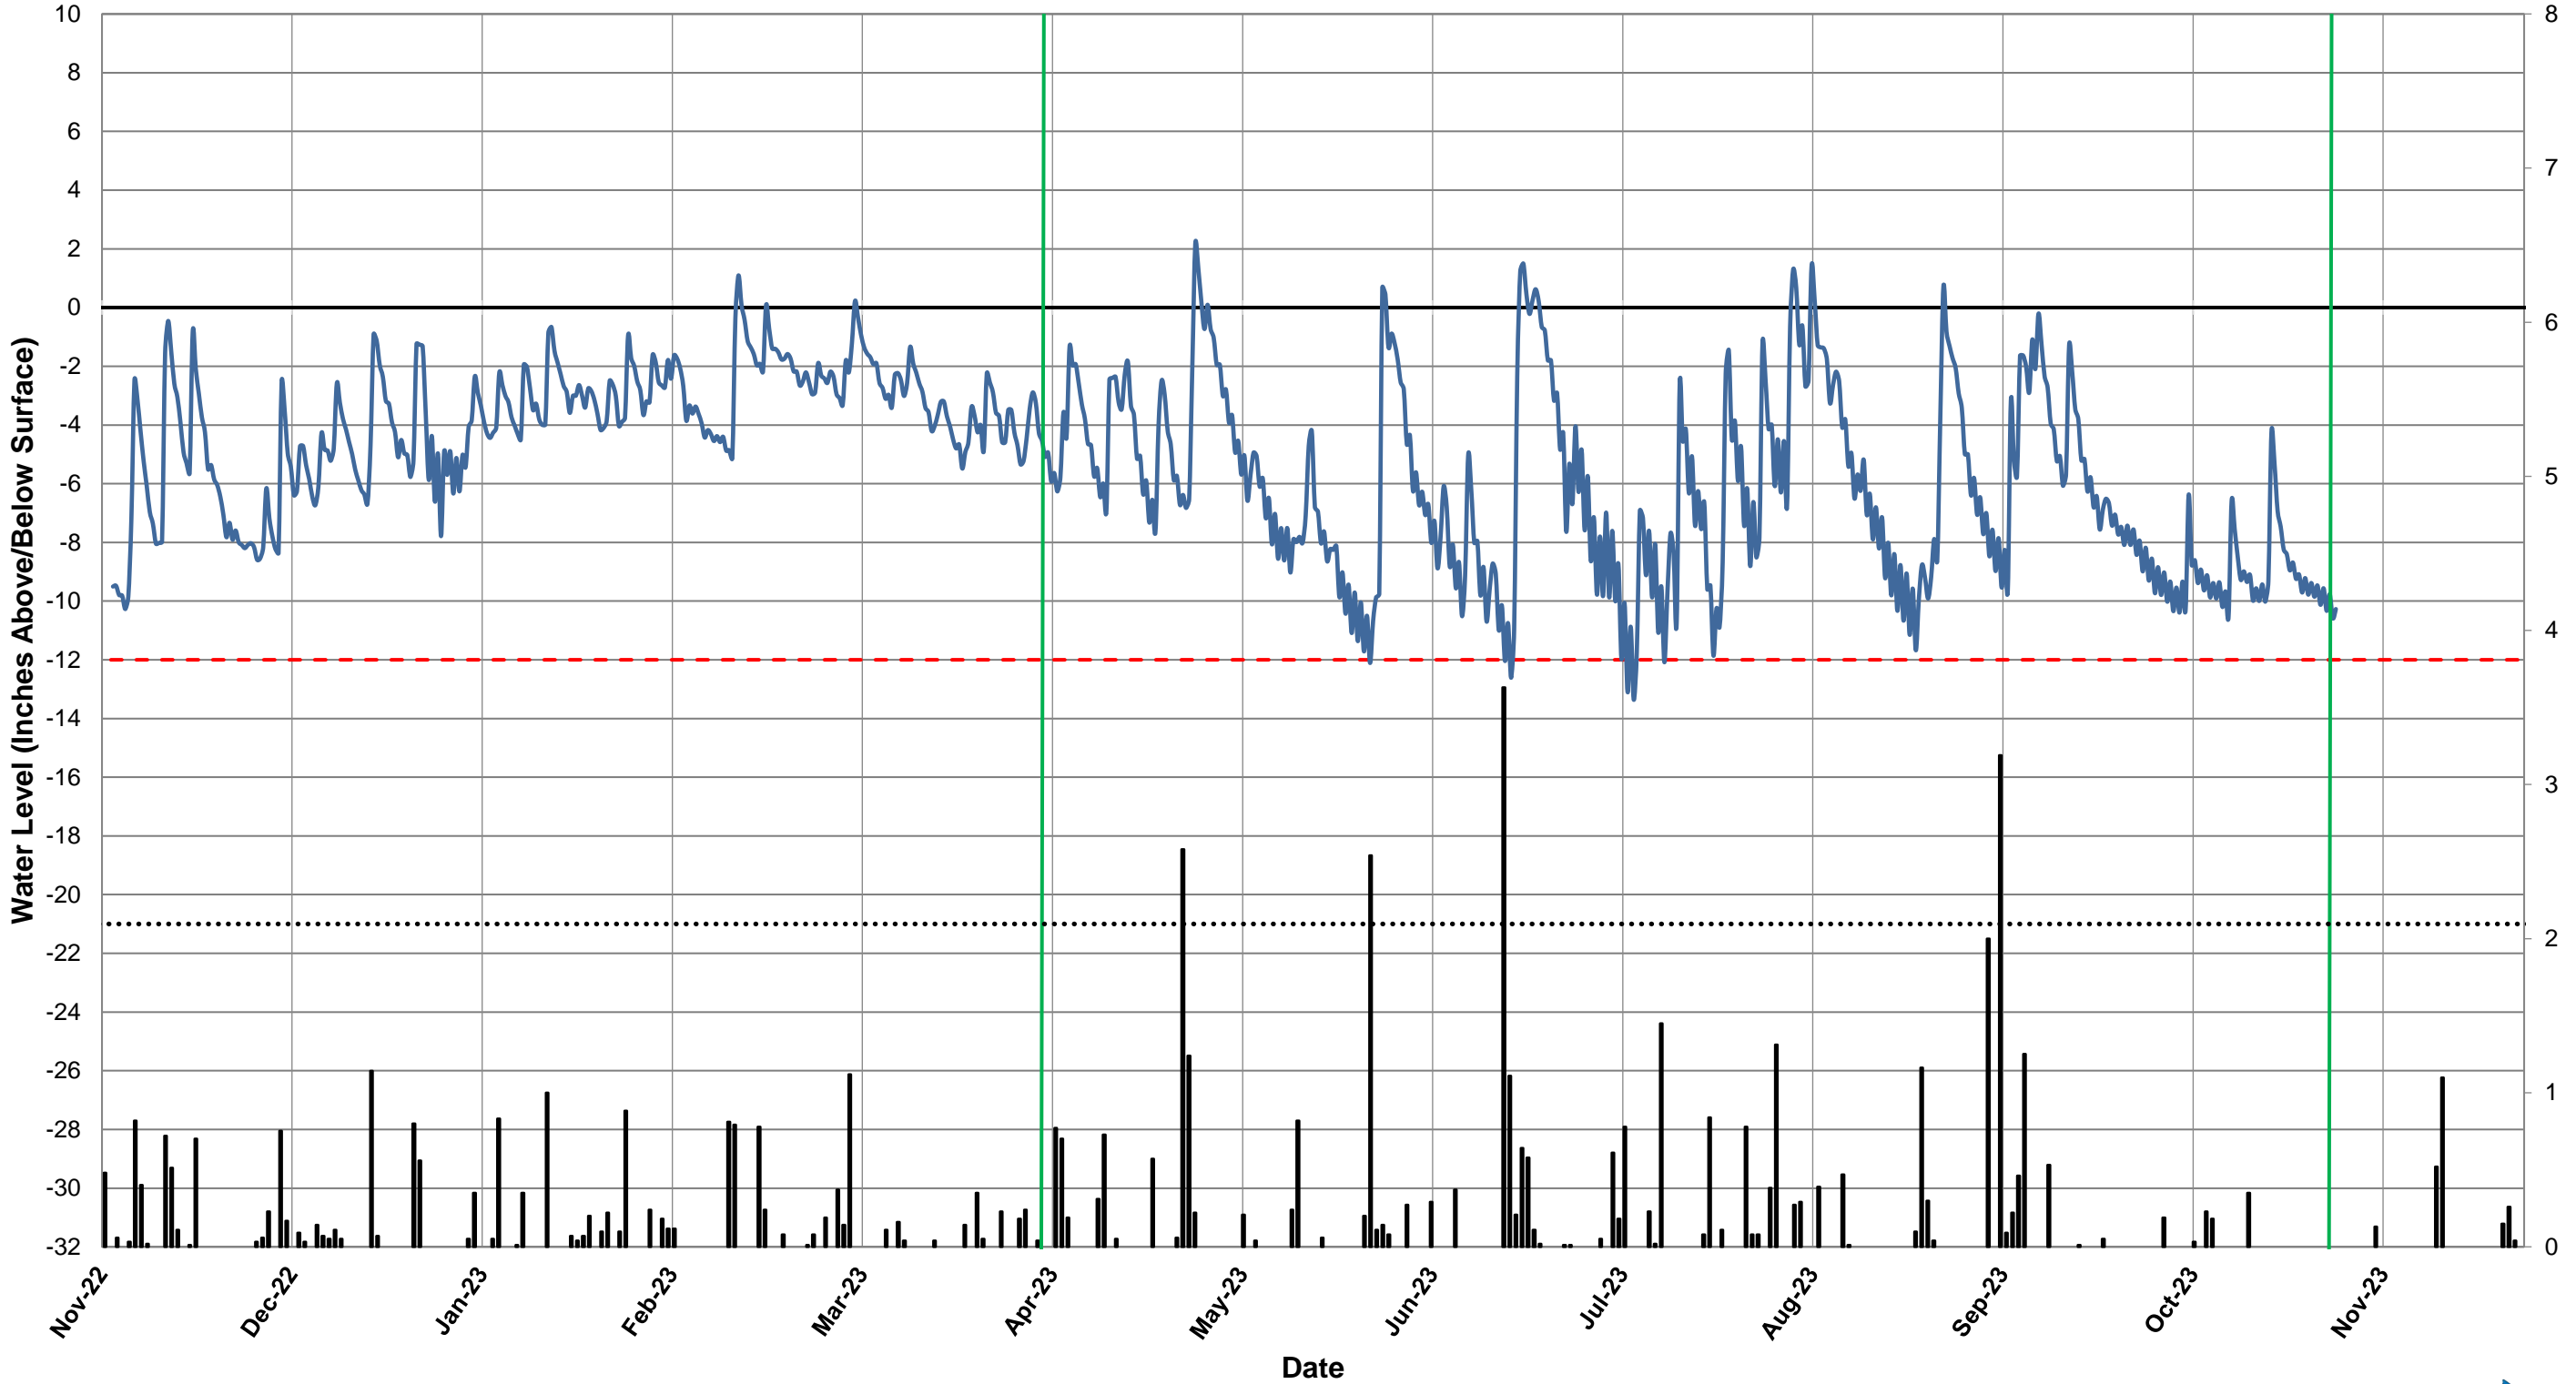
MY3 Little Sebastian GW1

210 Consecutive Days of Hydrology
04/03/2023 - 10/30/2023

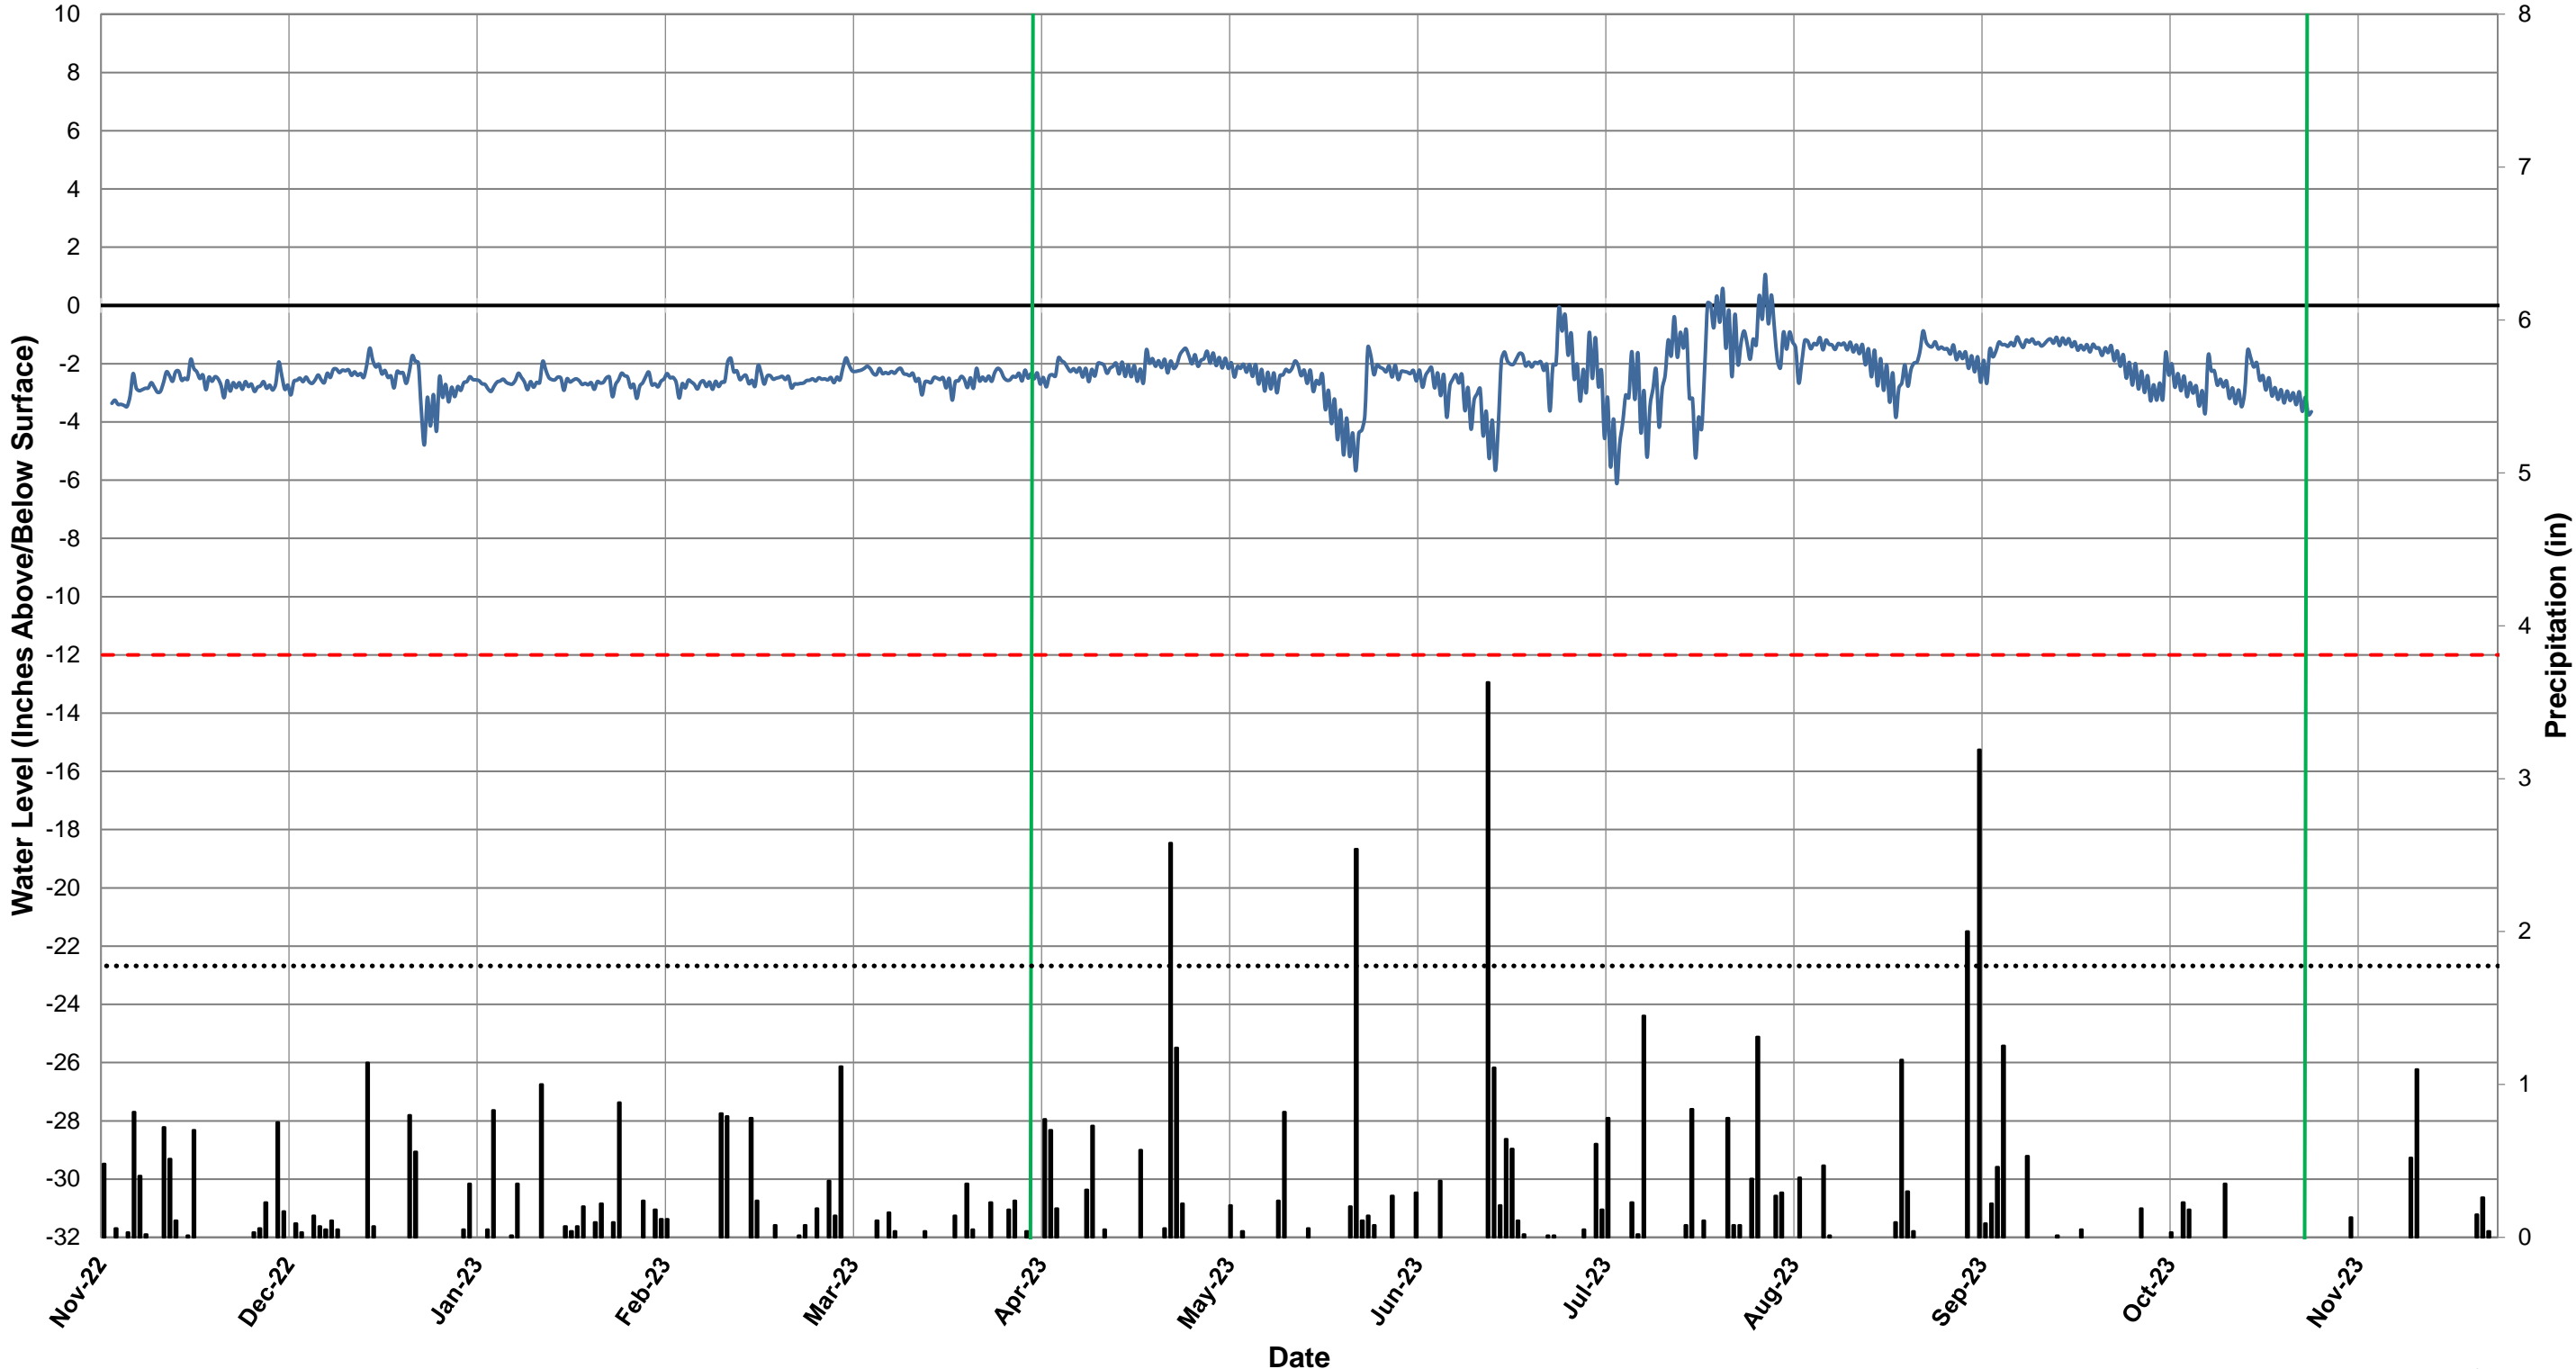
MY3 Little Sebastian GW2

210 Consecutive Days of Hydrology
04/03/2023 - 10/30/2023
