# Little Alamance Creek (Burlington Park) Stream Restoration 2013 Monitoring Report Monitoring Year 2 of 5

Alamance County, NC  
Cape Fear River Basin  
Cataloging Unit: 03030002  
NCEEP Project Number: 92372  
NCEEP Contract Number: 4998

**FINAL** – 2013 Monitoring Report – Year 2 of 5

**Prepared by:**  
**EEE Consulting, Inc.**  
601 Cascade Pointe Lane, Suite 101  
Cary, NC 27513

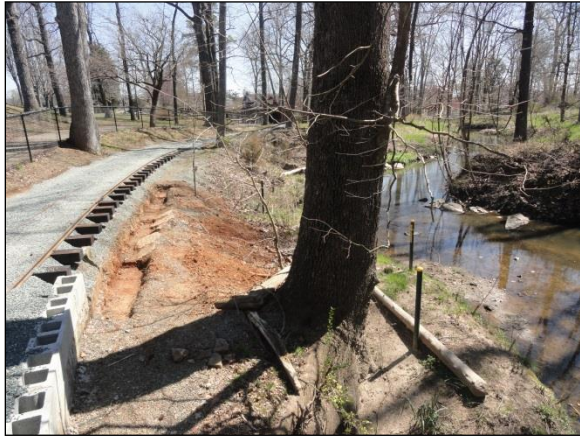
Photo Station 1, rail line at bollard 172, facing east; April 3, 2013

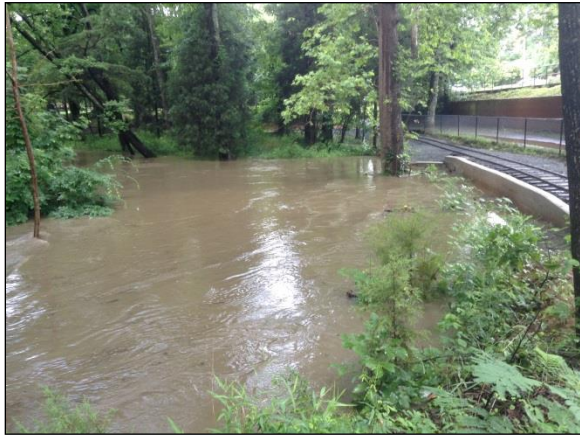
View of Rail Road at PS1  
July 3, 2013

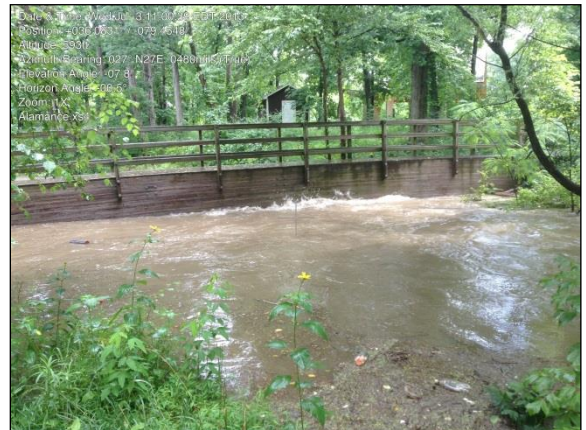
View of Bridge at XS 4  
July 3, 2013

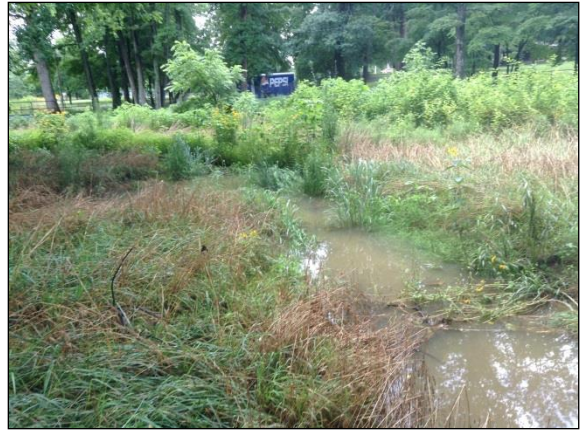
View from PS 2, level spreader  
July 3, 2013
