**Little Alamance Creek (Burlington Park) Stream Restoration
2015 Monitoring Report
Monitoring Year 4 of 5**

**Alamance County, NC
Cape Fear River Basin
Cataloging Unit: 03030002
NCDMS Project Number: 92372
NCDMS Contract Number: 4998**

Final – 2015 Monitoring Report – Year 4 of 5

Prepared by:
EEE Consulting, Inc.
601 Cascade Pointe Lane, Suite 101
Cary, NC 27513

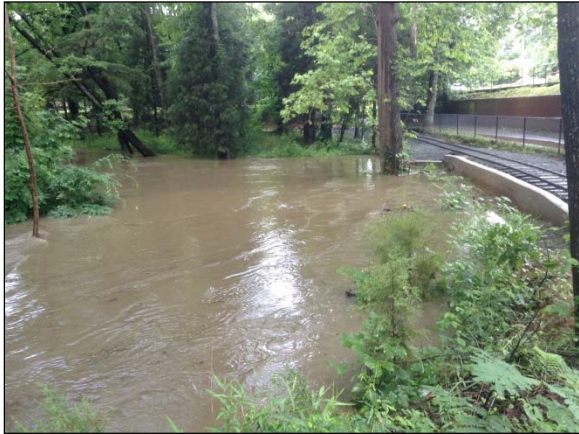
View of Rail Road at PS1
July 3, 2013

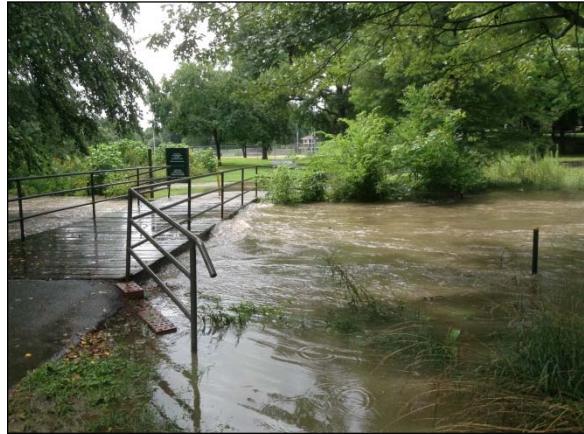
Bridge at XS 5
July 3, 2013

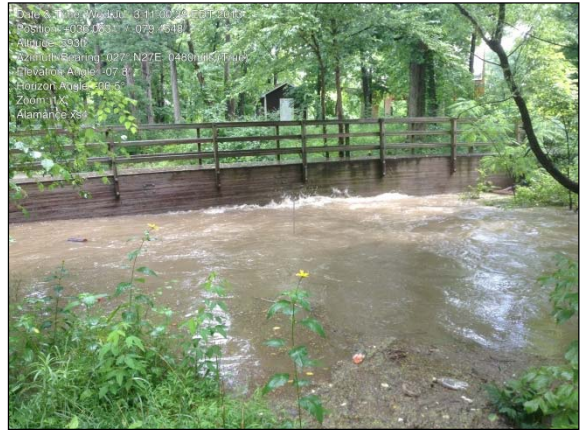
View of Bridge at XS 4
July 3, 2013

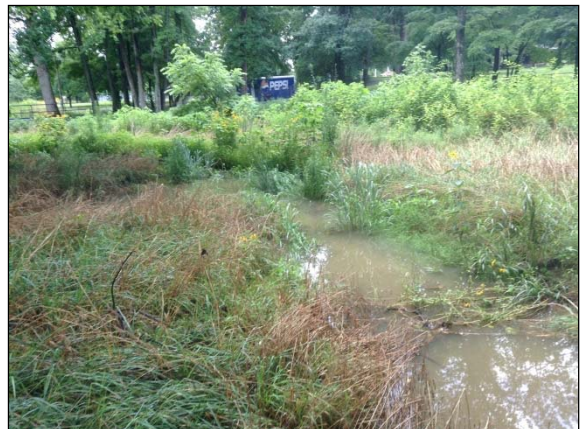
View from PS 2, level spreader
July 3, 2013
