**Little Alamance Creek (Burlington Park) Stream Restoration
2016 Monitoring Report
Monitoring Year 5 of 5**

**Alamance County, NC
Cape Fear River Basin
Cataloging Unit: 03030002
NCDMS Project Number: 92372
NCDMS Contract Number: 4998**

Final – 2016 Monitoring Report – Year 5 of 5

Prepared by:
EEE Consulting, Inc.
601 Cascade Pointe Lane, Suite 101
Cary, NC 27513

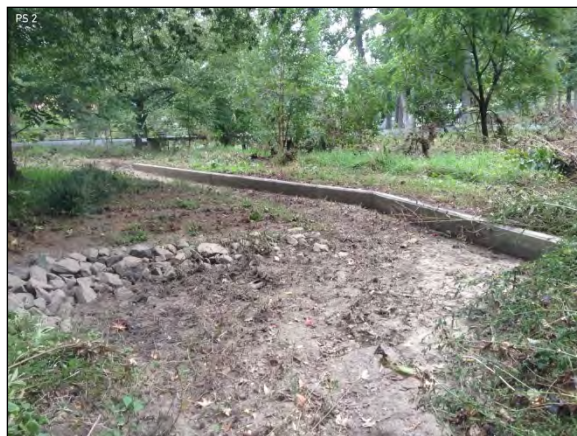
Photo Station 2, level spreader at bollard 410, facing east: April 3, 2013

Photo Station 2, level spreader at bollard 410, facing east: October 15, 2013

Photo Station 2, level spreader at bollard 410, facing east: September 30, 2014

Photo Station 2, level spreader at bollard 410, facing east: September 3, 2015

Photo Station 2, level spreader at bollard 410, facing east: October 5, 2016

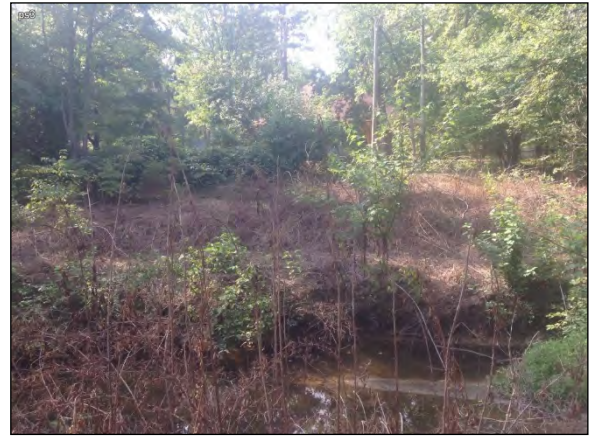
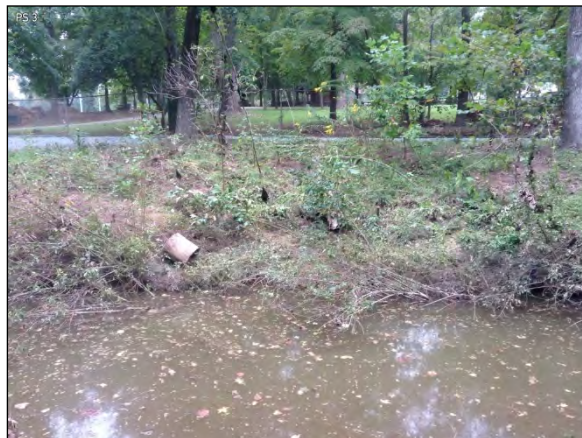
Photo Station 3, rail line discharge, facing south:
April 3, 2013

Photo Station 3, rail line discharge, facing south:
October 15, 2013

Photo Station 3, rail line discharge, facing south:
September 30, 2014

Photo Station 3, rail line discharge, facing south:
September 3, 2015

Photo Station 3, rail line discharge, facing south:
October 5, 2016

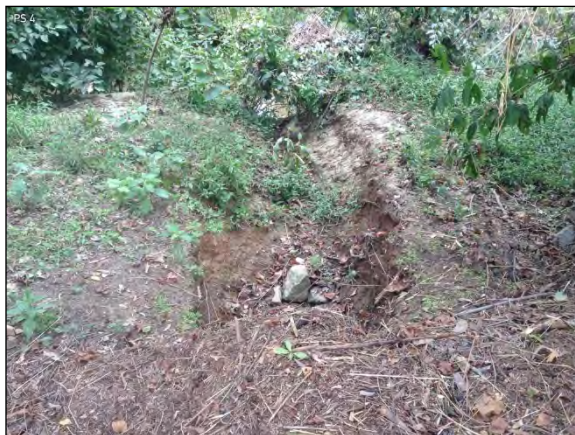
Photo Station 4, discharge at bollard 312, facing west:
April 3, 2013

Photo Station 4, discharge at bollard 312, facing west:
October 15, 2013

Photo Station 4, discharge at bollard 312, facing west:
September 30, 2014

Photo Station 4, discharge at bollard 312, facing west:
September 3, 2015

Photo Station 4, discharge at bollard 312, facing west:
October 5, 2016

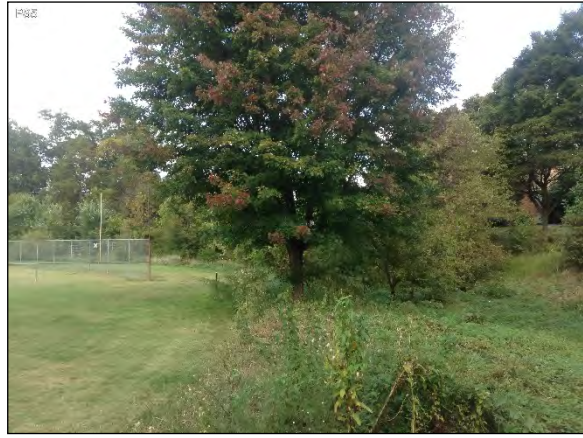
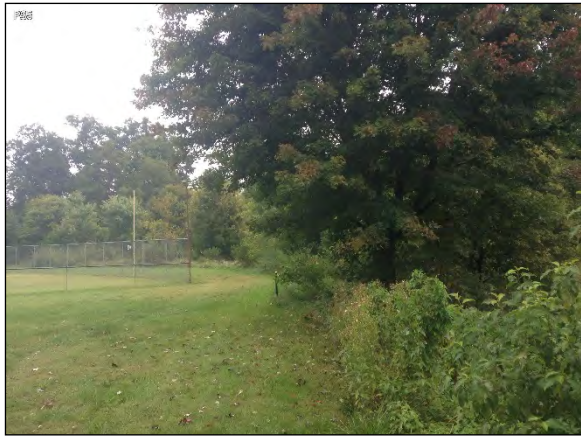
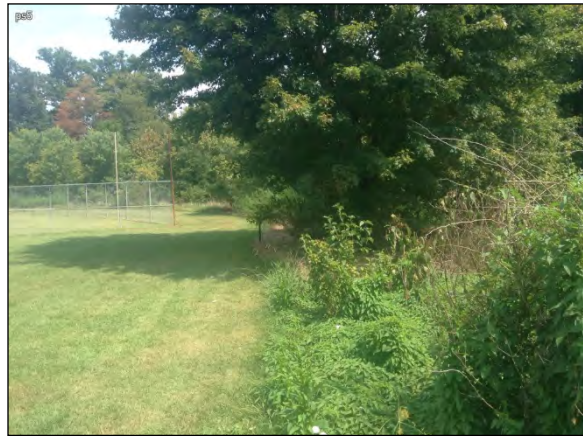
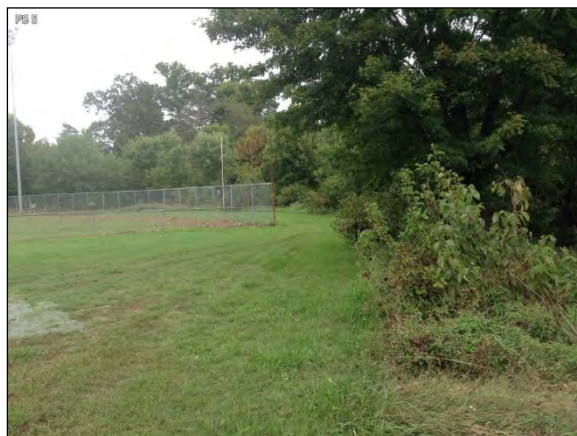
Photo Station 5, view of easement facing northwest:
April 3, 2013

Photo Station 5, view of easement facing northwest:
October 15, 2013

Photo Station 5, facing northwest:
September 30, 2014

Photo Station 5, facing northwest:
September 3, 2015

Photo Station 5, view of easement facing northwest:
October 5, 2016

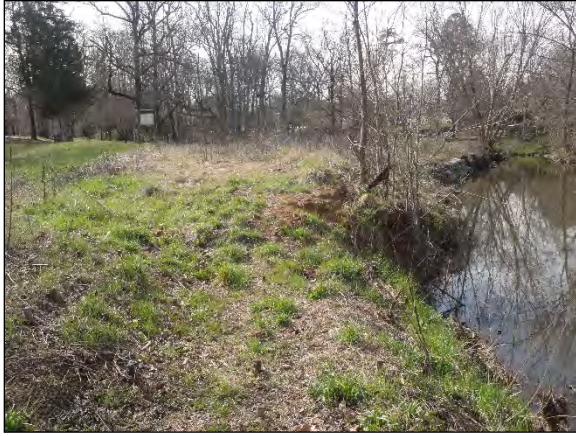
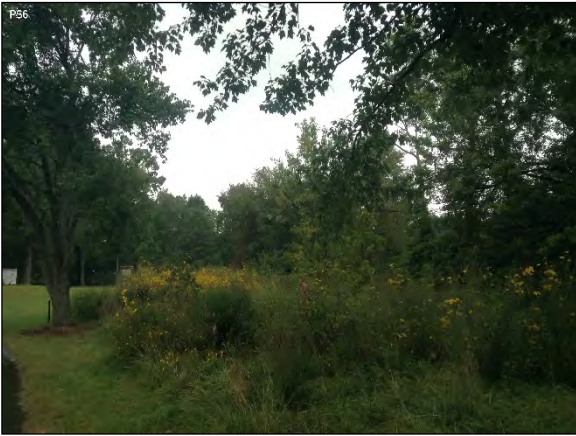
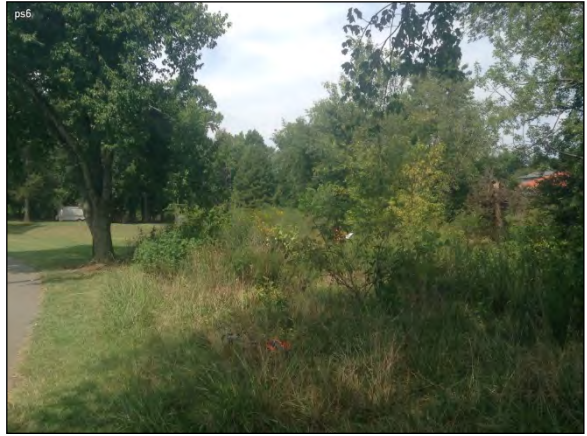
Photo Station 6, VP 7 at bollard 401:
April 3, 2013

Photo Station 6, VP 7 at bollard 401:
October 15, 2013

Photo Station 6, VP 7 at bollard 401:
September 30, 2014

Photo Station 6, VP 7 at bollard 401:
September 3, 2015

Photo Station 6, VP 7 at bollard 401:
October 5, 2016

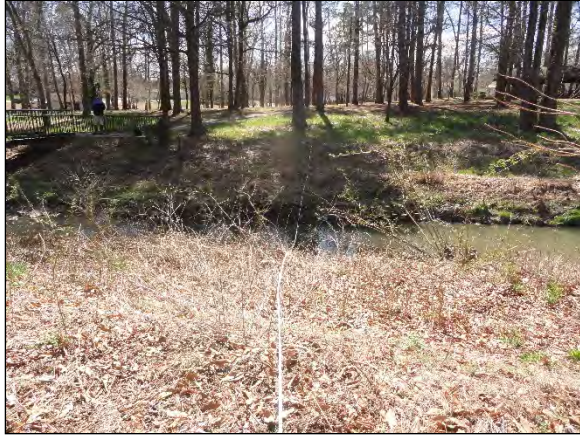
Photo Station 7, XS 1, facing right bank:
April 3, 2013

Photo Station 7, XS 1, facing right bank:
October 15, 2013

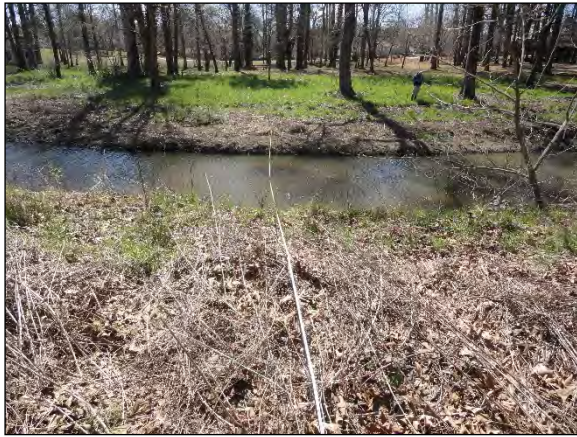
Photo Station 7, XS 1, facing right bank:
March 31, 2016

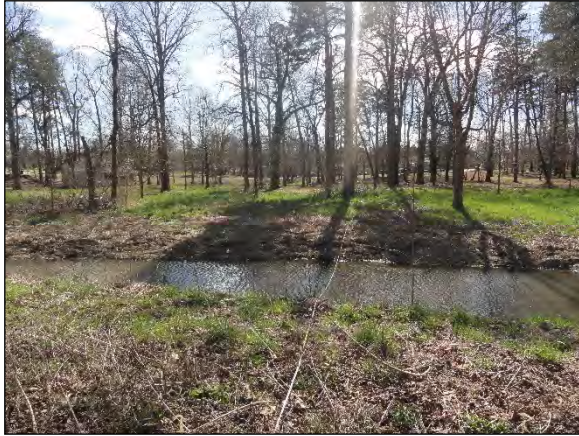
Photo Station 8, XS 2, facing right bank:
March 31, 2016

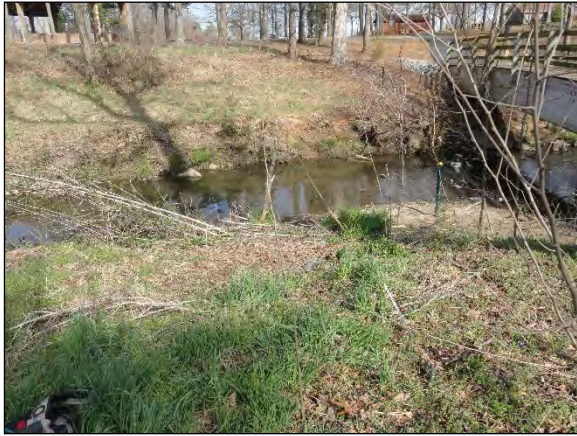
Photo Station 9, XS 3, facing right bank:
March 31, 2016

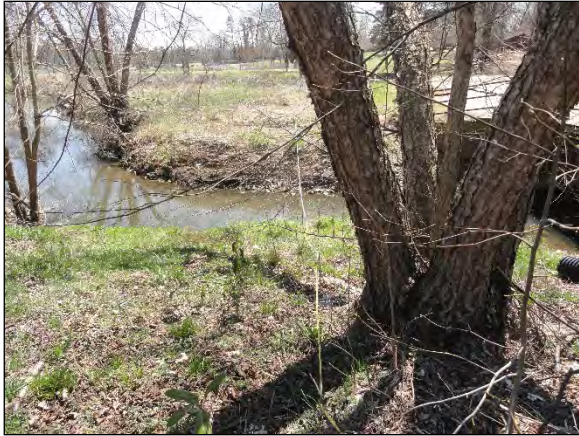
Photo Station 10, XS 4, facing right bank:
March 31, 2016

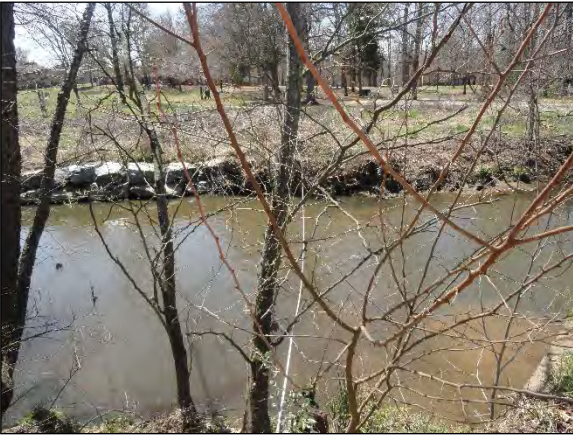
Photo Station 11, XS 5, facing right bank:
March 31, 2016

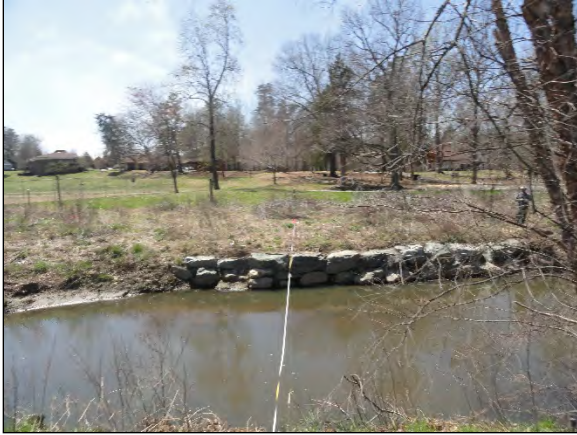
Photo Station 12, XS 6, facing right bank:
March 31, 2016

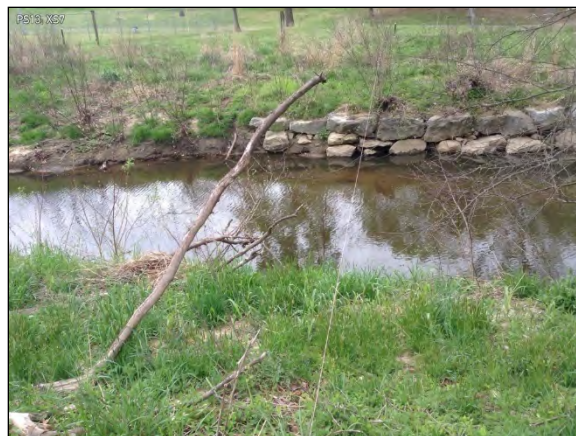
Photo Station 13, XS 7, facing right bank:
September 3, 2015

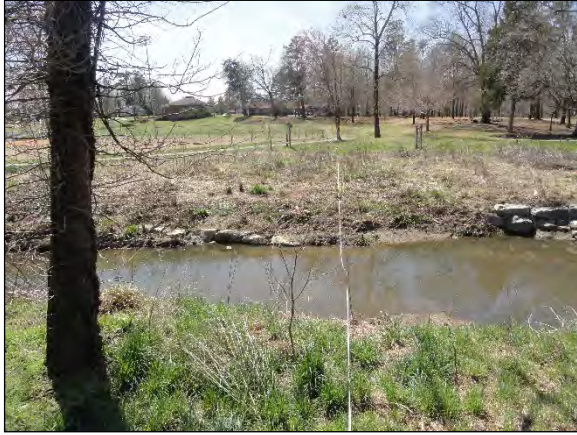
Photo Station 13, XS 7, facing right bank:
March 31, 2016

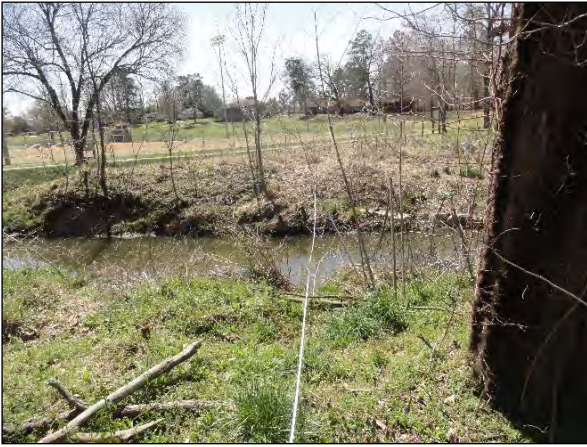
Photo Station 14, XS 8, facing right bank:
March 31, 2016

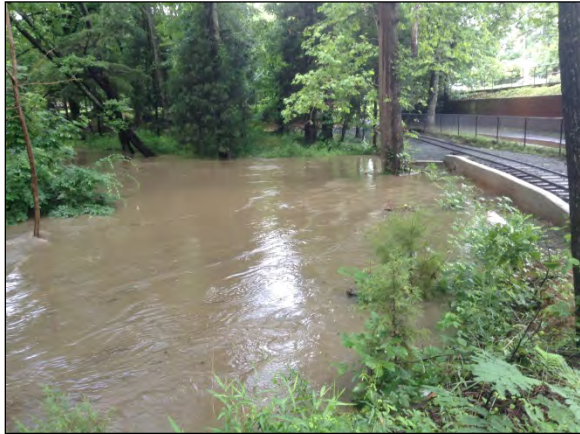
View of Rail Road at PS1
July 3, 2013

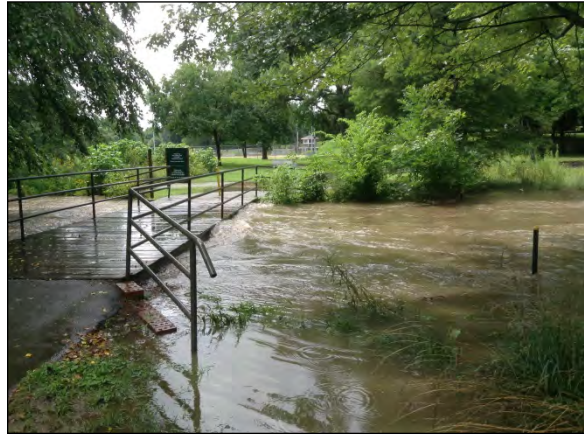
Bridge at XS 5
July 3, 2013

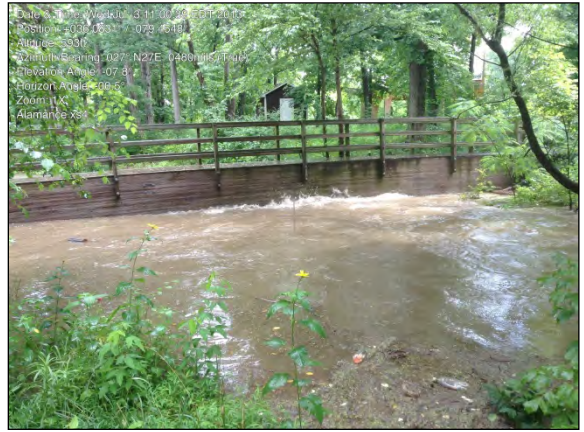
View of Bridge at XS 4
July 3, 2013

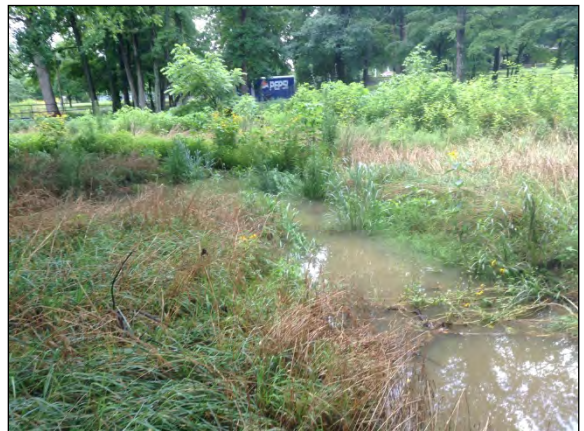
View from PS 2, level spreader
July 3, 2013

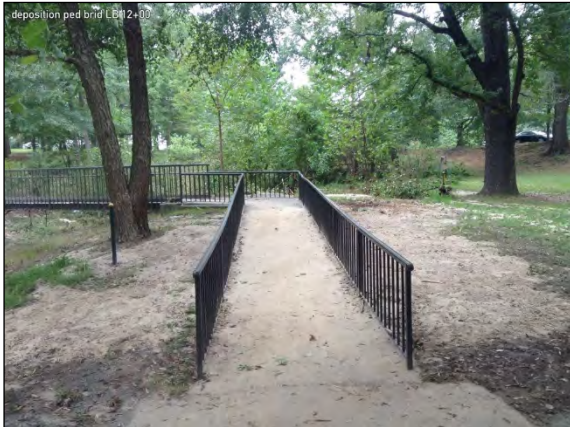
Alluvial deposition from flooding on the pedestrian bridge at XS1.

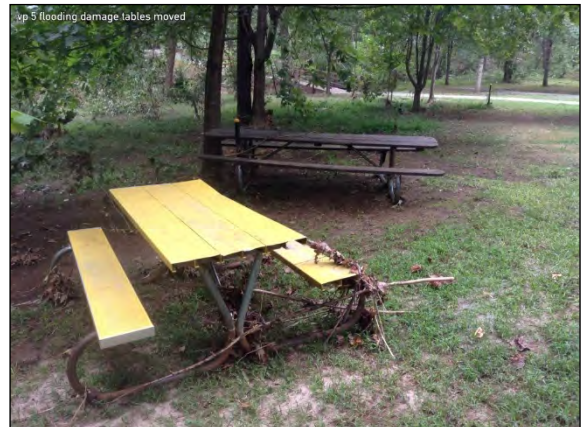
Wreck line from flooding on picnic tables near VP5. Tables were moved by flood waters.

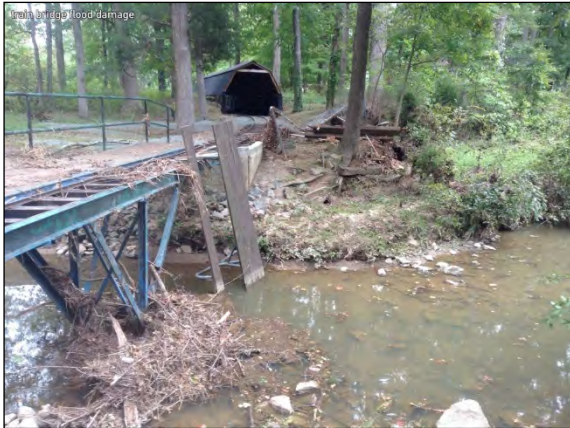
Wreck line and debris from flooding including a picnic table at the train bridge closest to VP5.

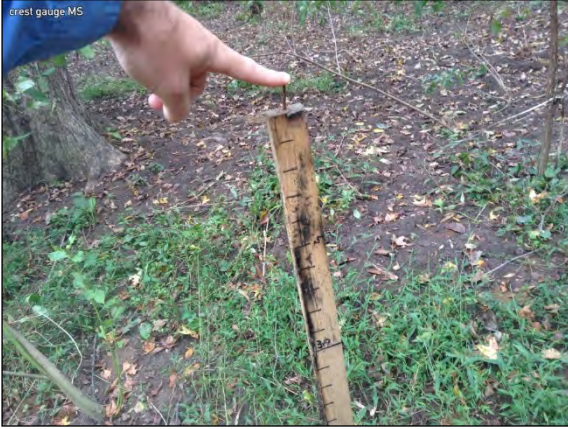
Crest gauge, main stem. Cork overtopped gauge.
October 5, 2016

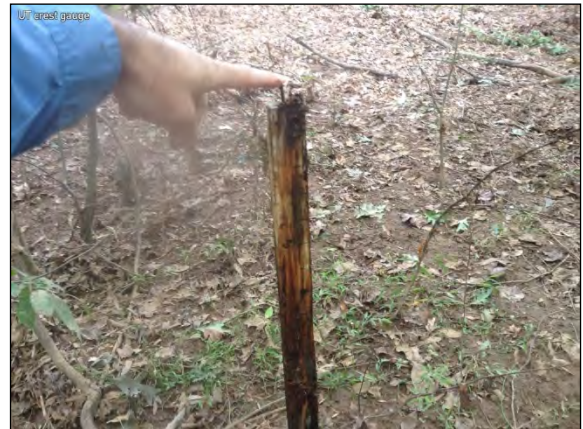
Crest gauge, UT. Cork overtopped gauge.
October 5, 2016
