**Little Beaver Creek
Stream Restoration
Wake County, North Carolina
Year 1 Monitoring Report**

Monitoring Year: 2007
Measurement Year 1
As-Built Date 2005
NCEEP Project Number 221

February 2008

**LITTLE BEAVER CREEK STREAM RESTORATION
YEAR 1 MONITORING REPORT**

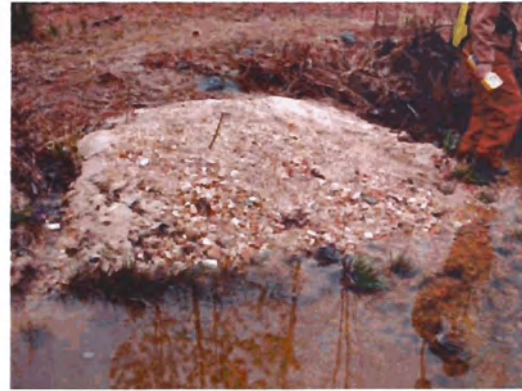
SPA 6. Deposition in mid point of curve. Sta. 15+27.

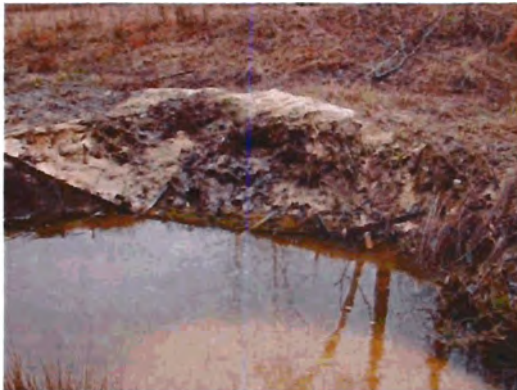
SPA 11. Coir matting dislodged. Sta. 21+91.

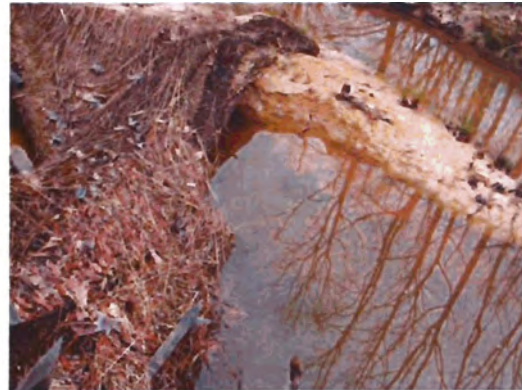
SPA 15. Point bar chute cutoff (C33). Sta. 26+00.

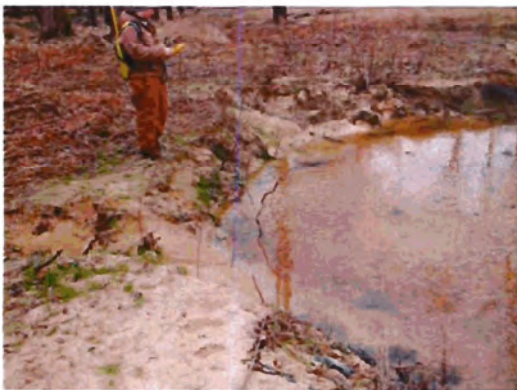
SPA 17. Aggradation in pool. Sta. 26+78.

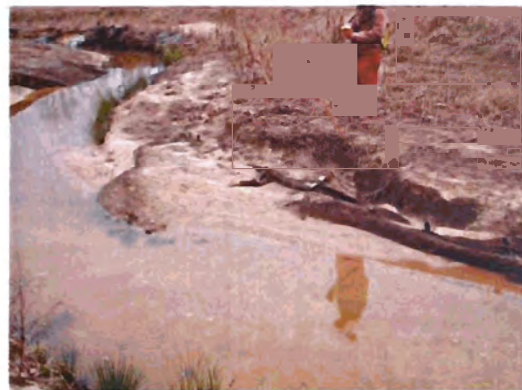
SPA 21. **Bankfull** bench collapse. Sta. 35+37.

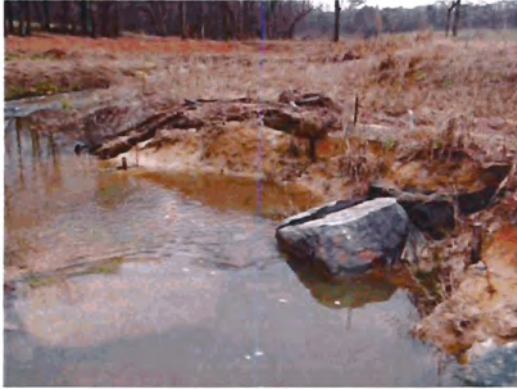
SPA. 22. Right bank scour around structure. Sta. 36+14.

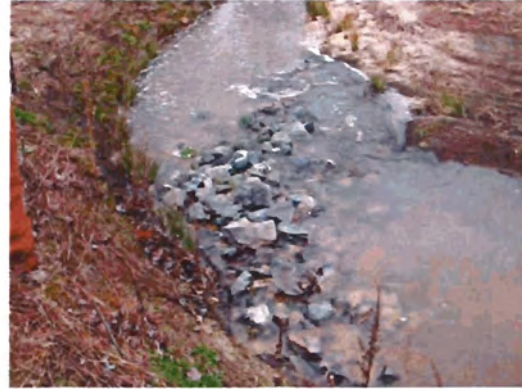
SPA 23. Riprap transverse bar formation. Sta. 36+45.
