Little Beaver Creek Stream and Wetland Restoration Site

2008 Annual Monitoring Report- (Year 2)

Wake County
EEP Project No. 221
Design Firm: Earth Tech

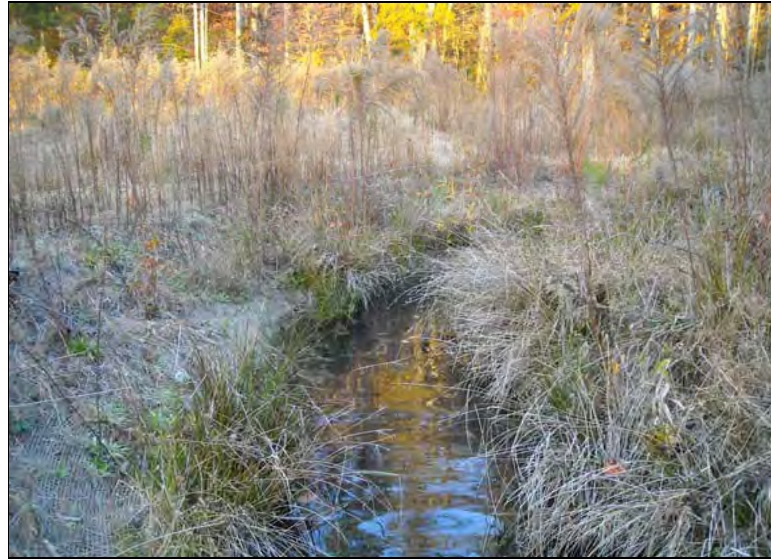
Photo of XS-1, Sta 11+25 looking in the upstream direction

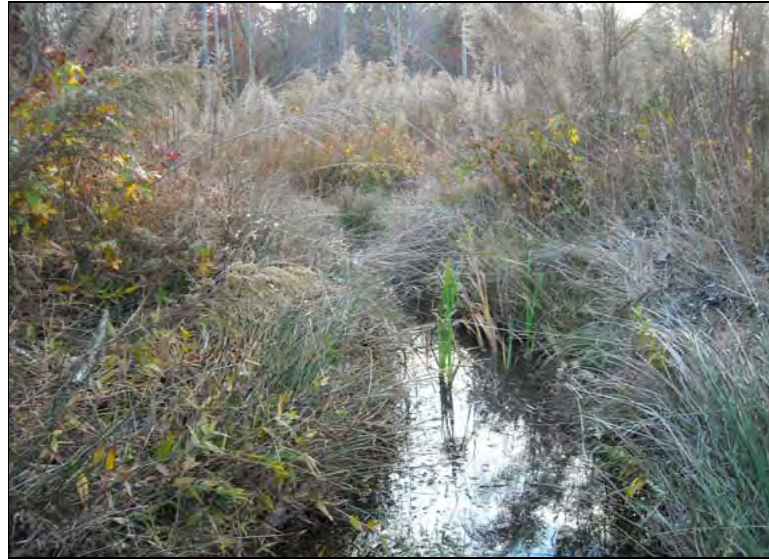
Cross Section 2 Station 14+85 Pool

Photo of XS-2, Sta 14+85 looking in the downstream direction
