**Little Beaver Creek (EEP #221)
Stream and Wetland Restoration Site
2013 Annual Monitoring Report (MY4)**

**Wake County
EEP Project No. 221
Design Firm: Earthtech
Construction Completed February 2007
Construction Repairs Completed May 2013**

September 2014

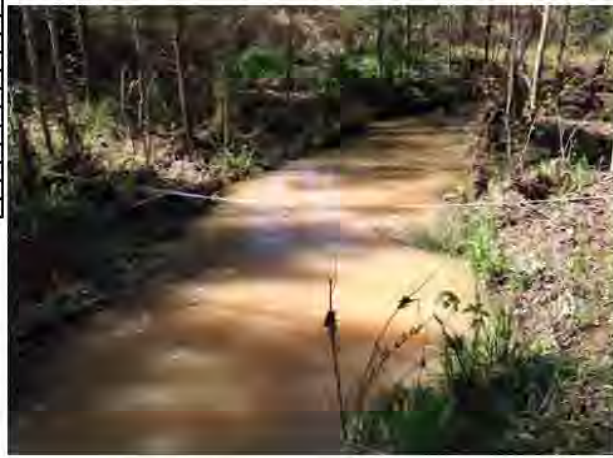
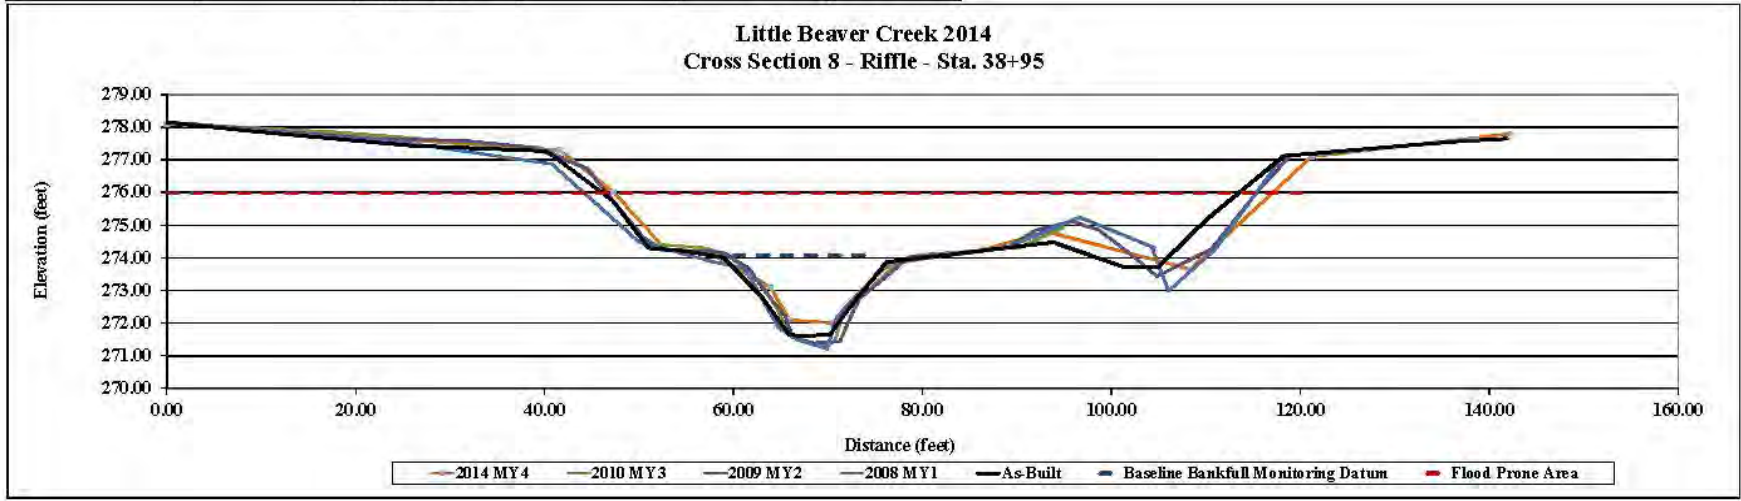
Project Name: Little Beaver Creek, MY4
 Watershed:
 Cross Section: T1
 Drainage Area: NA
 Date: Mar-14
 Crew: Boggs, Stafford

Photo of Cross-Section T1 - Pool - Looking Upstream

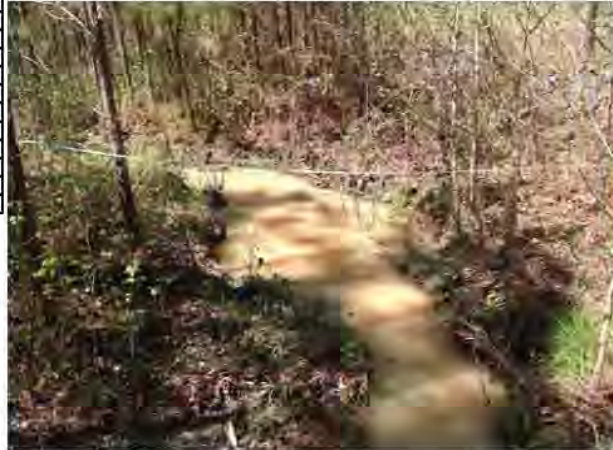
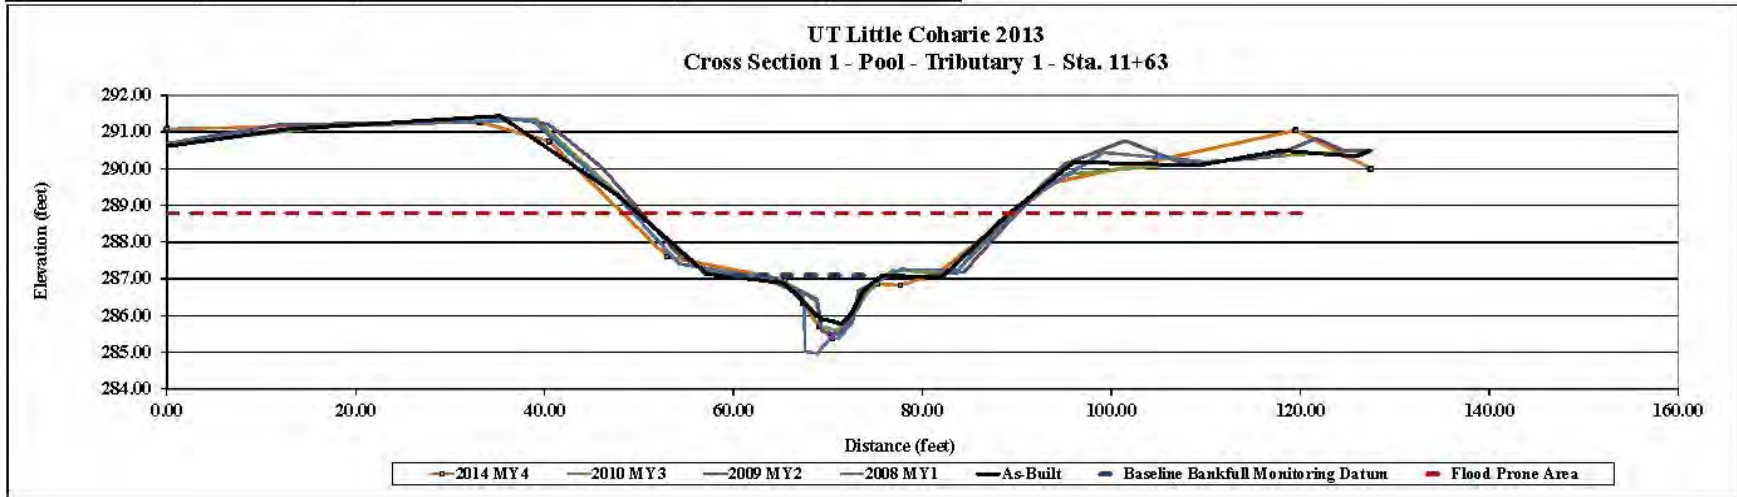
Project Name: Little Beaver Creek, MY4
 Watershed:
 Cross Section: T2
 Drainage Area: NA
 Date: Mar-14
 Crew: Boggs, Stafford

Photo of Cross-Section T2 - Pool - Looking Upstream
