**Monitoring Report  
Year 3  
FINAL  
Little Buffalo Creek Stream Mitigation Project**

*NCDEQ-DMS Project Number: 94147  
Contract Number: 2029  
USACE Permit Action ID: 2014-00386  
DWR Permit: 14-0129  
Cabarrus County*

**Data collection: September/November 2017  
Draft Submitted: December 2017  
Final Submitted: February 2018**

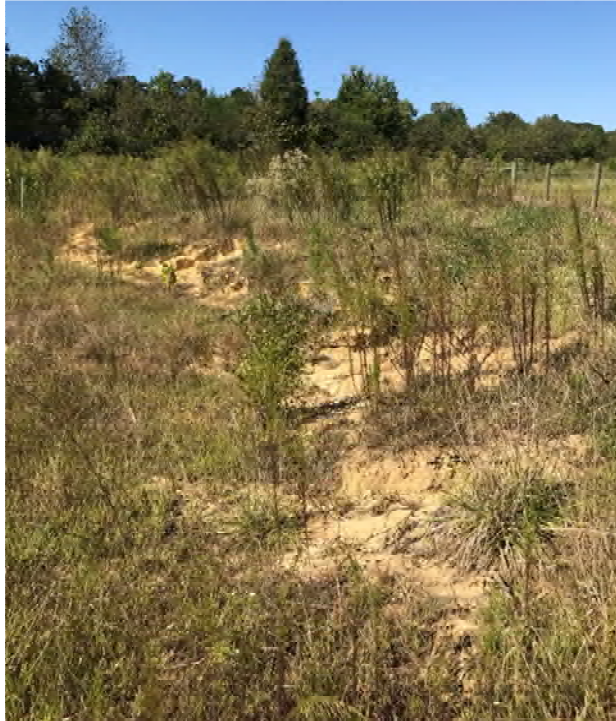
Bare spots and eroding slopes on outskirts of floodplain in reach 1

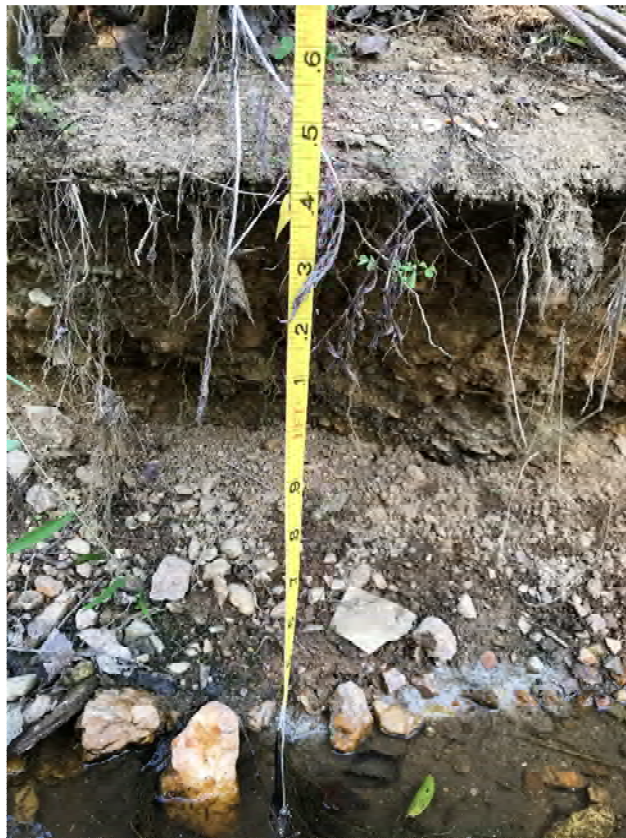
Undercut along the left interior channel bank in restoration area of reach 3

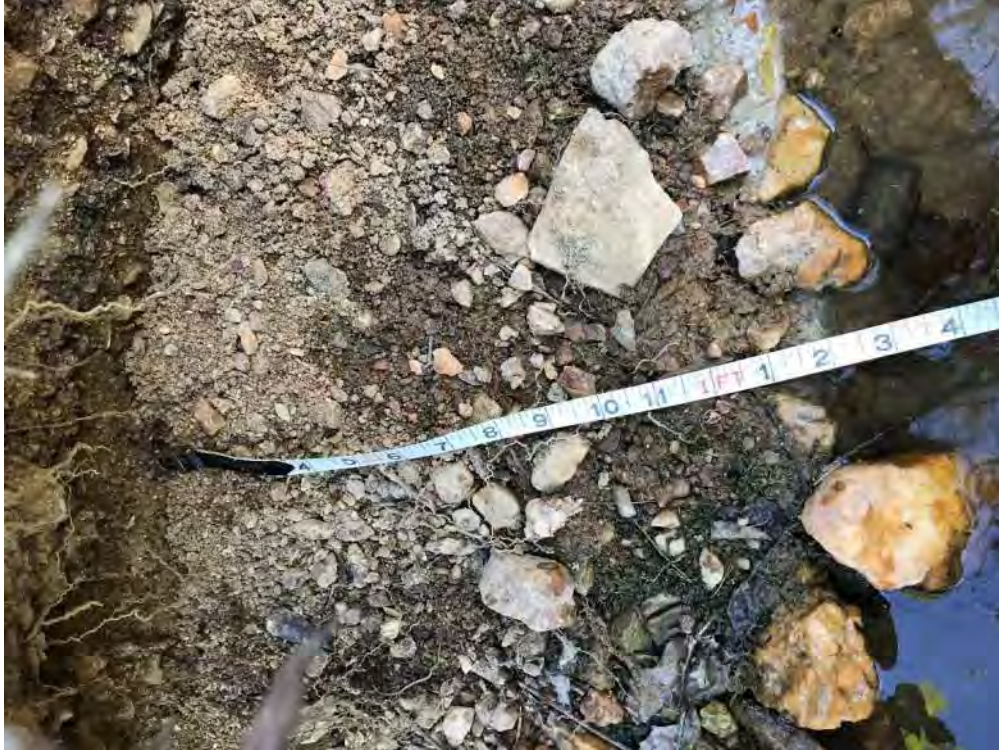
Undercut along the left interior channel bank in restoration area of reach 3

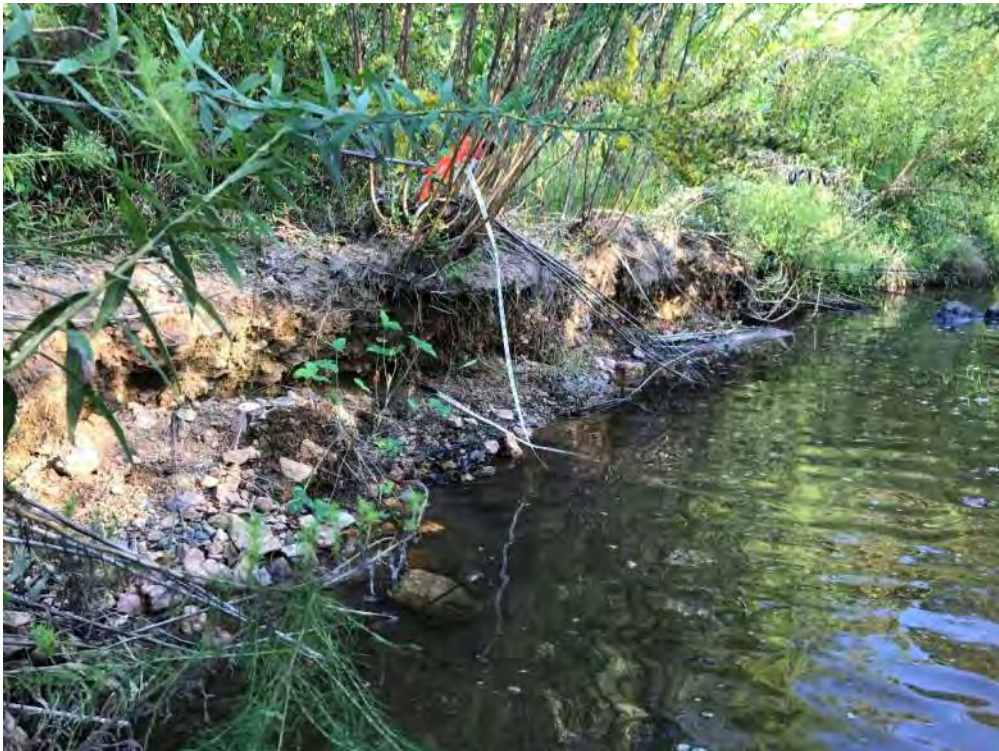
Undercut along the left interior channel bank in restoration area of reach 3

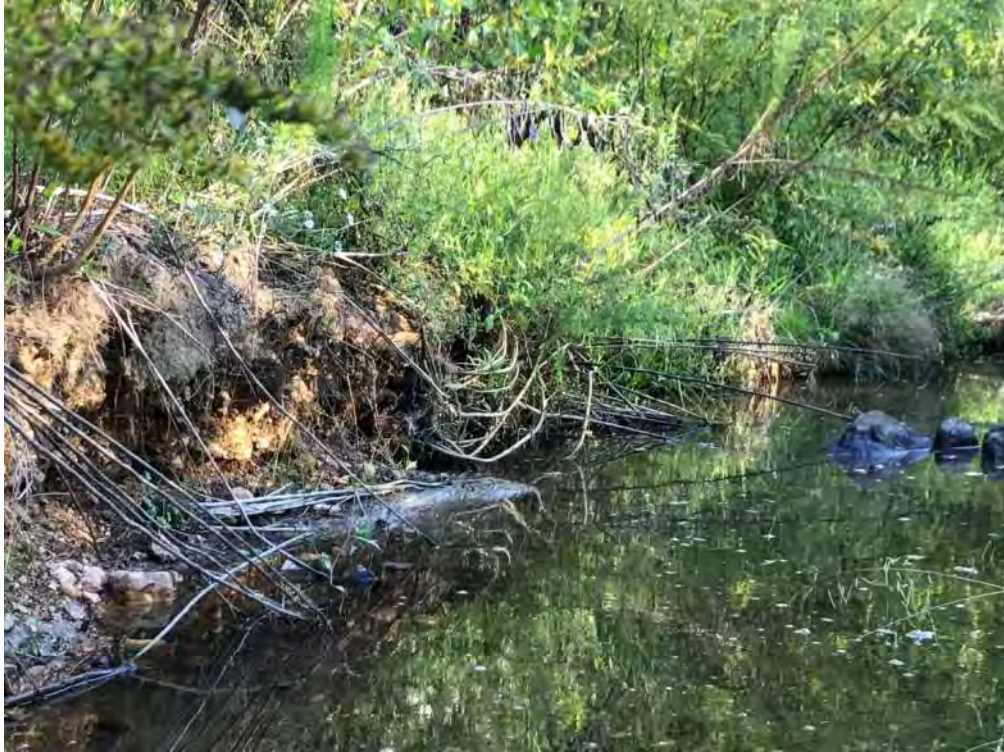
Undercut along the left interior channel bank in restoration area of reach 3

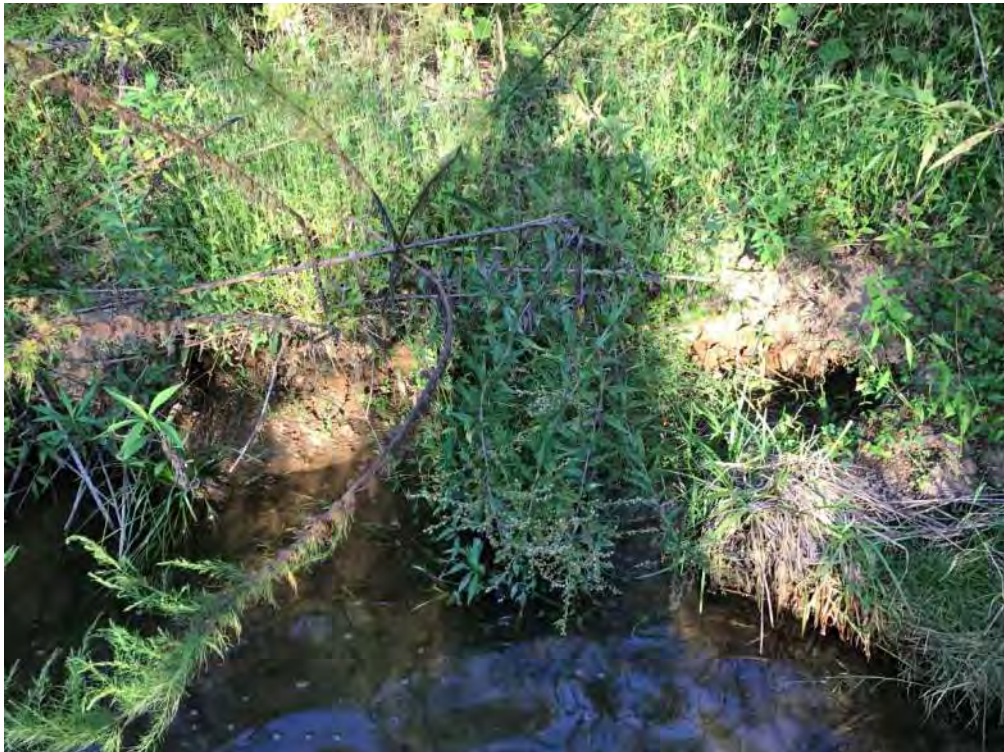
Undercut along the left interior channel bank in restoration area of reach 3

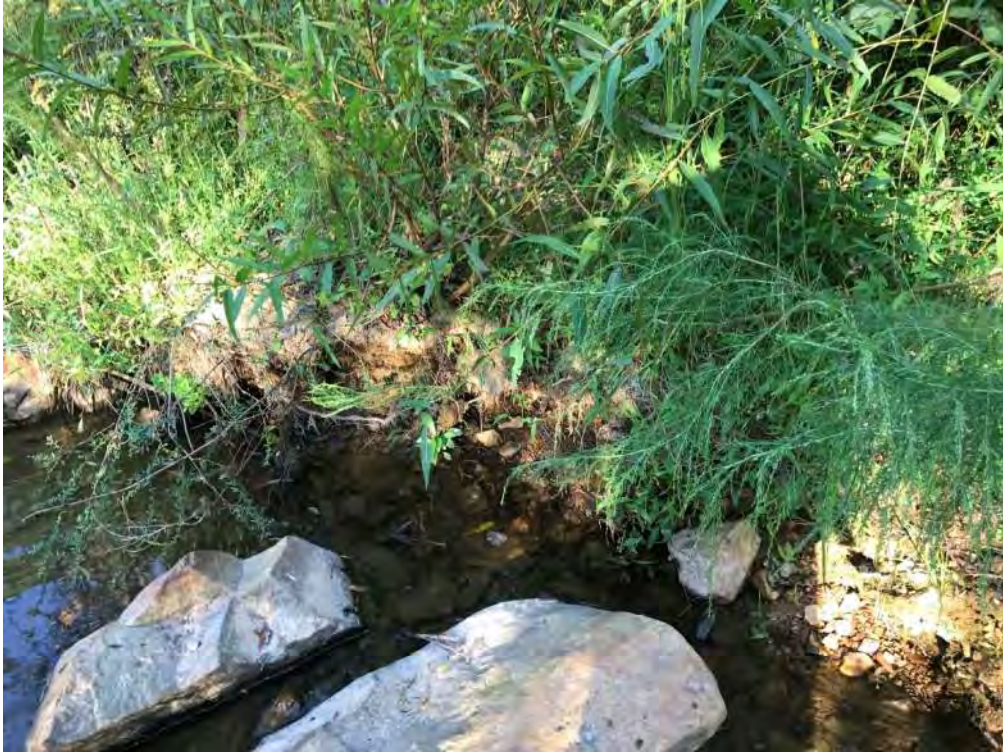
Undercut along the left interior channel bank in restoration area of reach 3

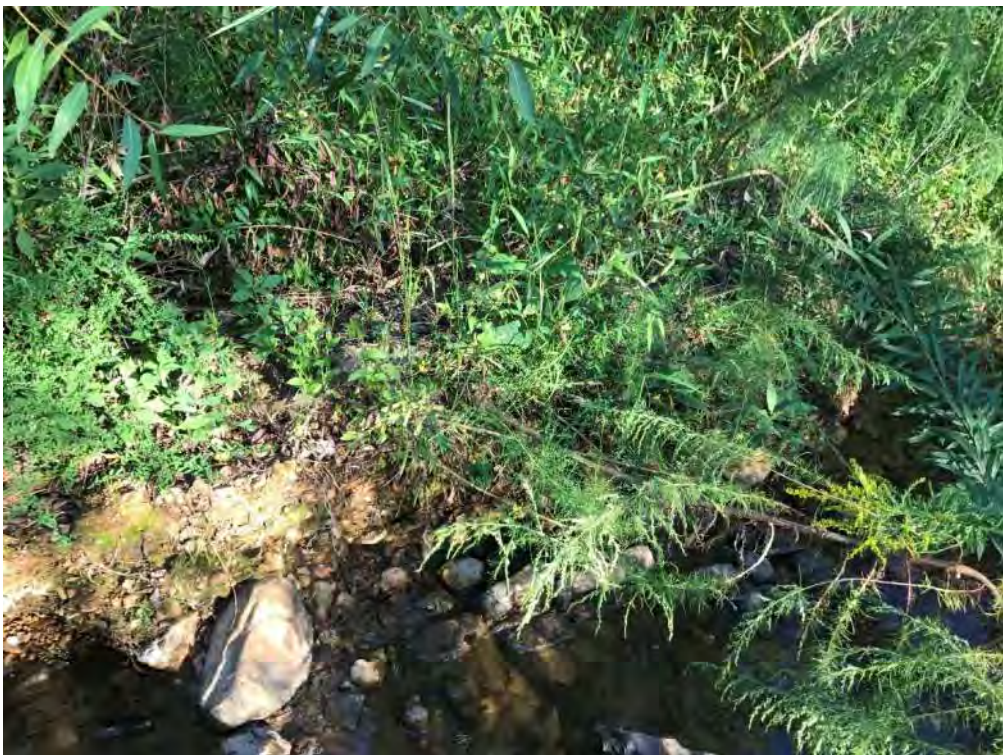
Undercut along the left interior channel bank in restoration area of reach 3

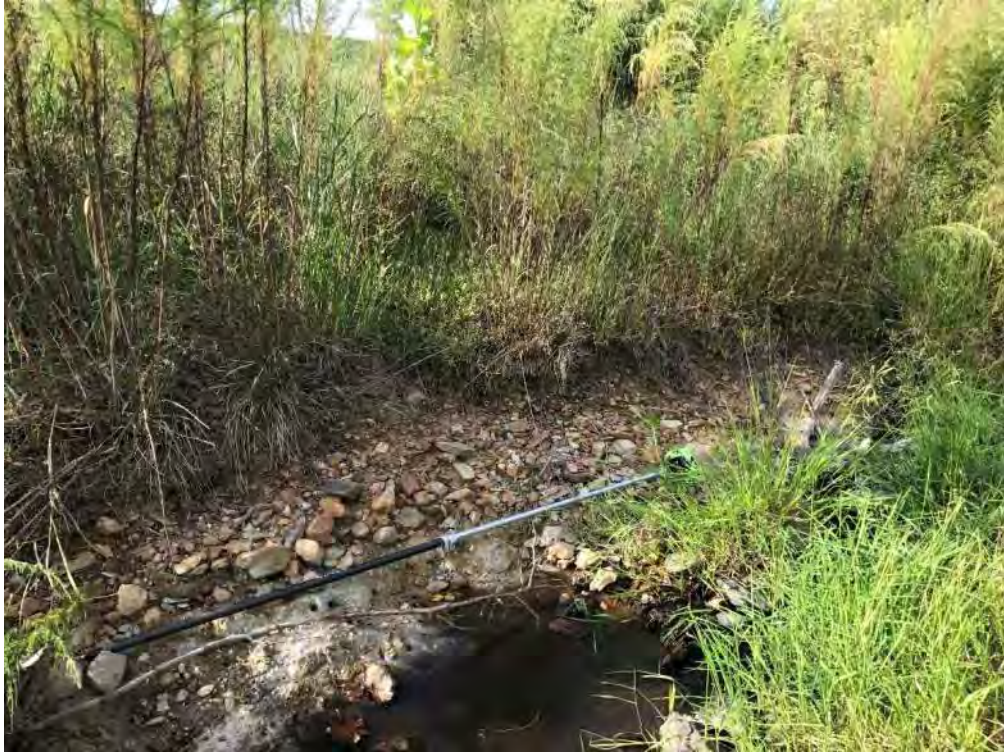
15 foot bank scour along the right bank in restoration area of reach 4

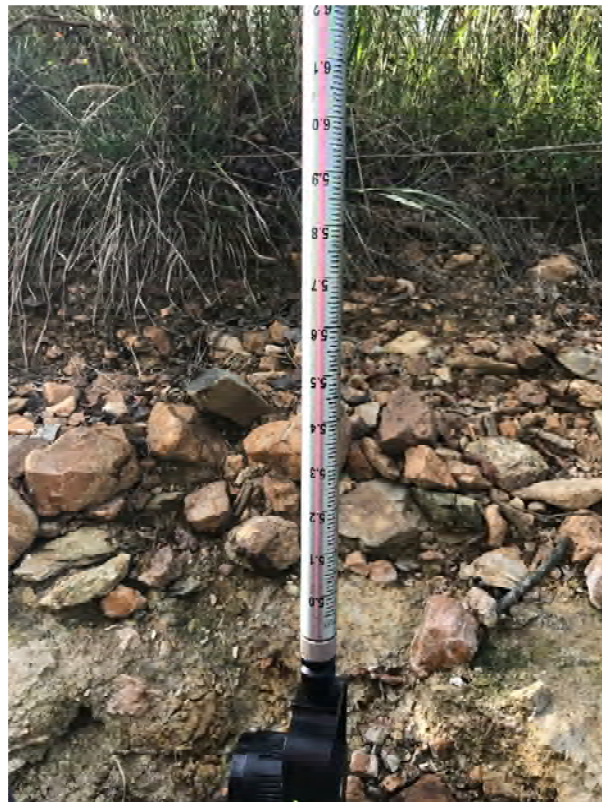
15 foot bank scour along the right Bank in restoration area of reach 4

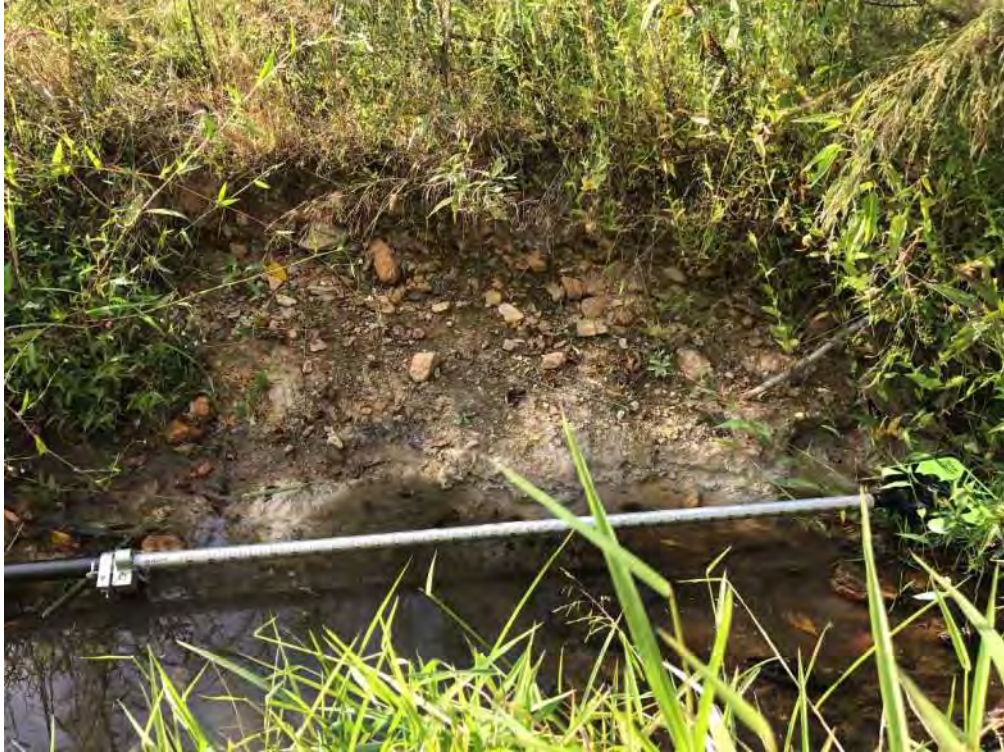
6 foot bank scour along the right bank in restoration area of reach 4

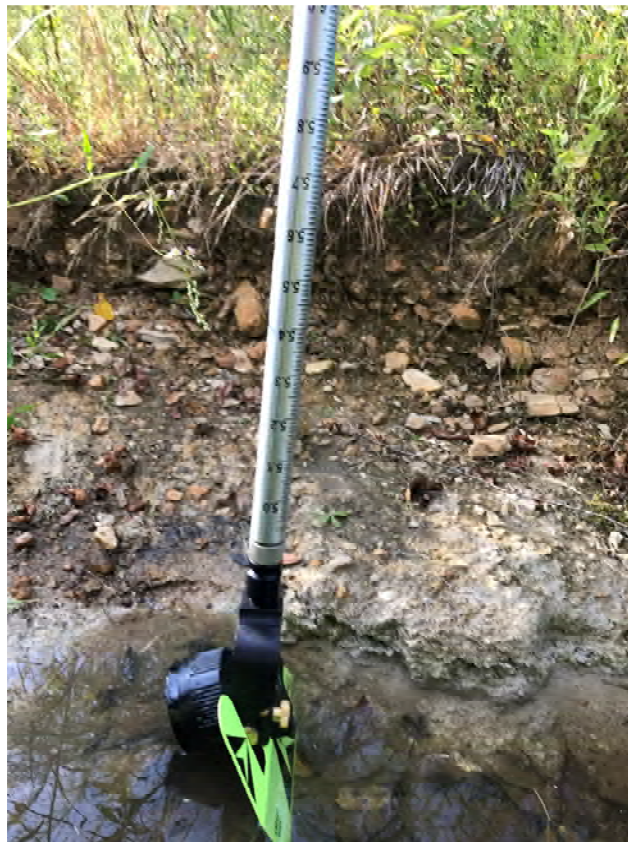
6 foot bank scour along the right bank in restoration area of reach 4

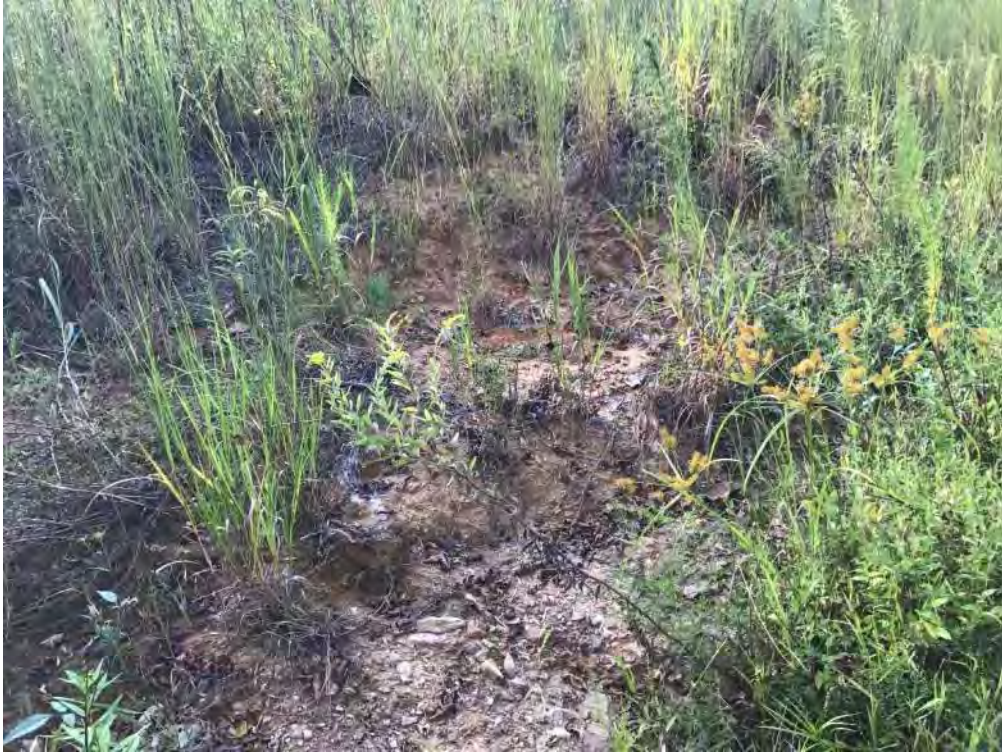
Poor vegetation coverage along right upper bank of restoration area in reach 4

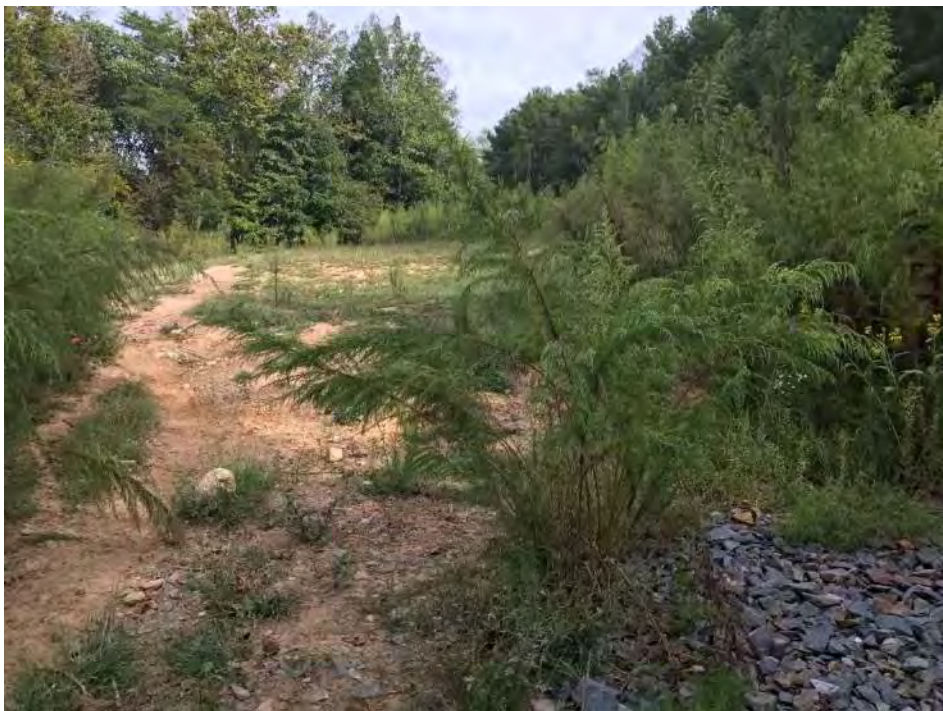
Gates open at cattle crossing along Little Buffalo Creek. Area not being maintained by owners.

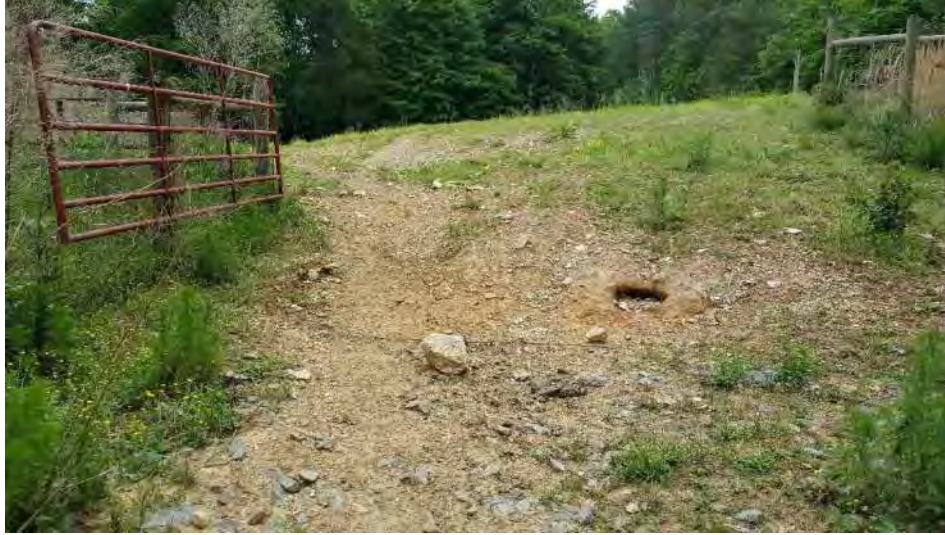
Gates open at cattle crossing along Little Buffalo Creek. Area not being maintained by owners.

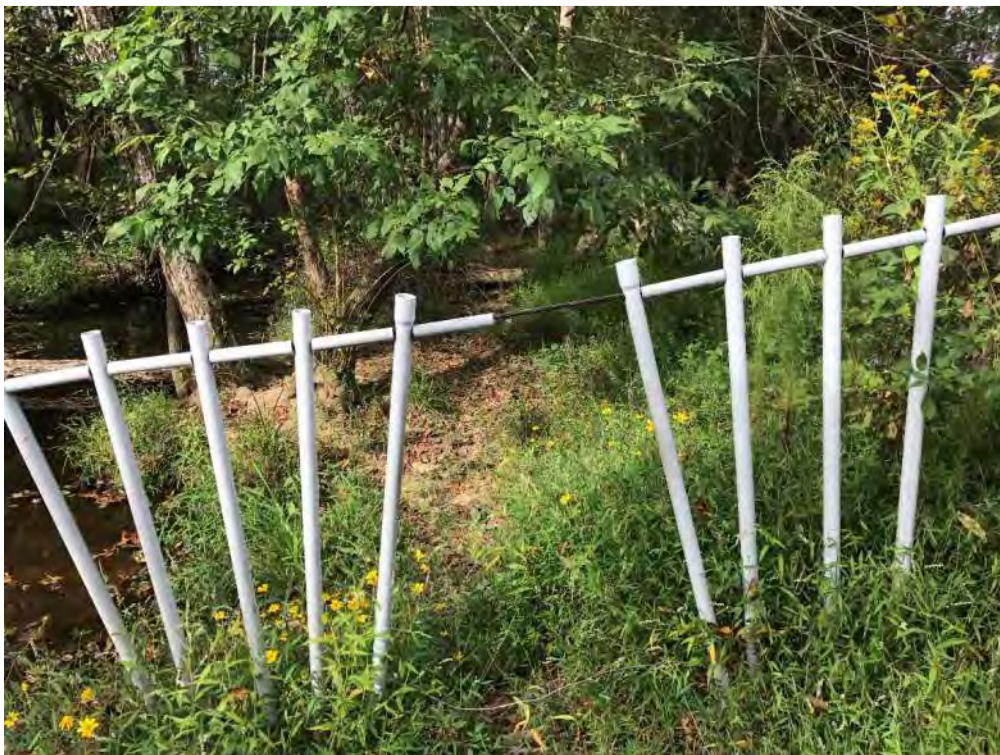
Cattle crossing opening in flood gate, with no electric power. Not being maintained by owners.

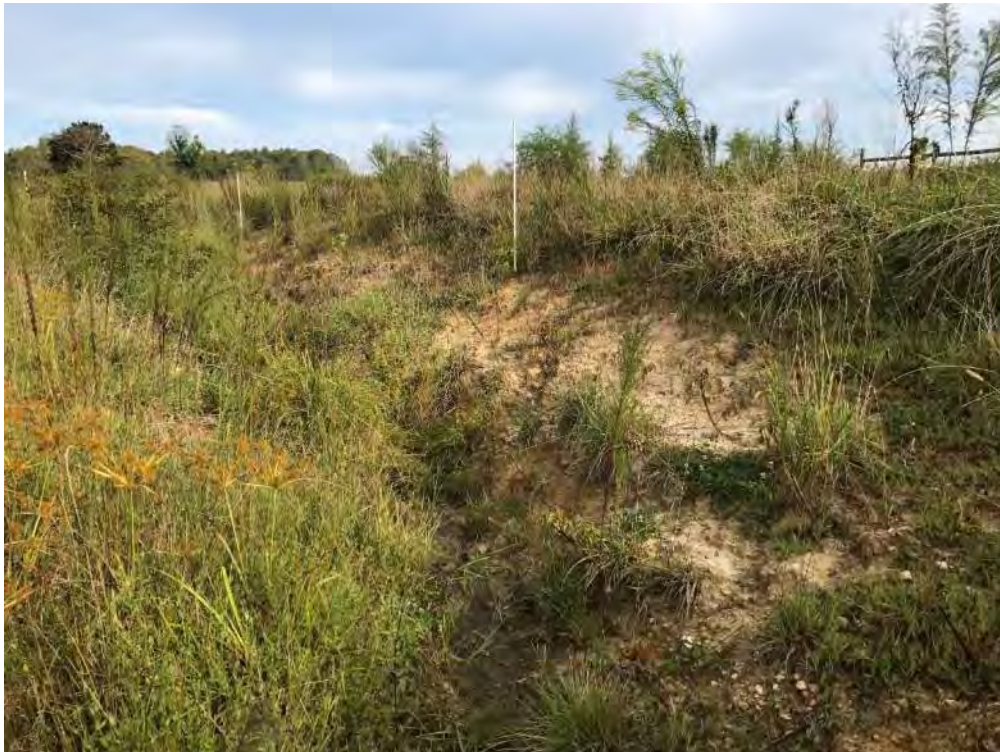
Poor vegetation along portion of left bank in UT3

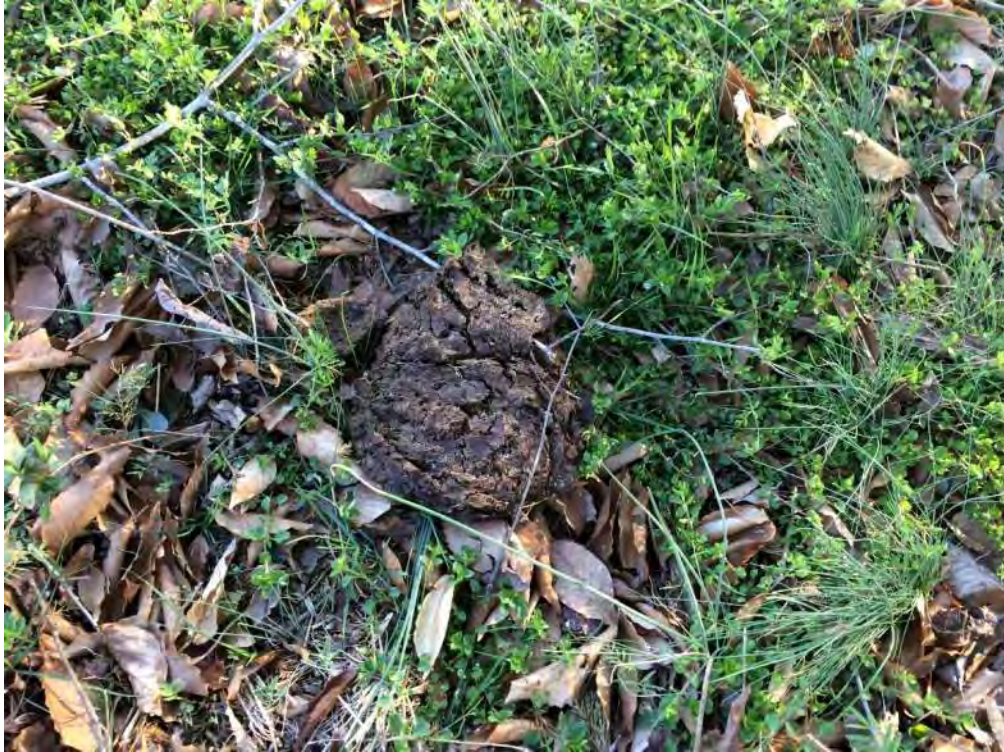
Fresh cow pies between UT3 and UT4. Likely getting in by cattle crossing.

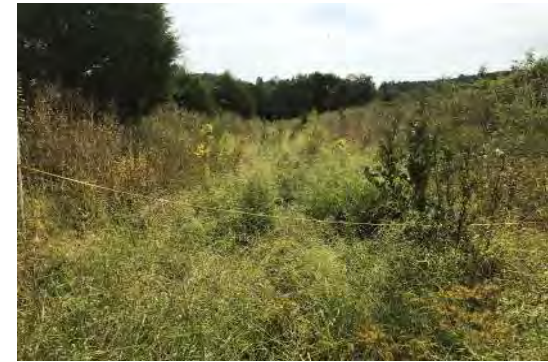
Station and description 1802.03 UT3-2R Looking Upstream

Note: No visual water surface during MY 3 survey

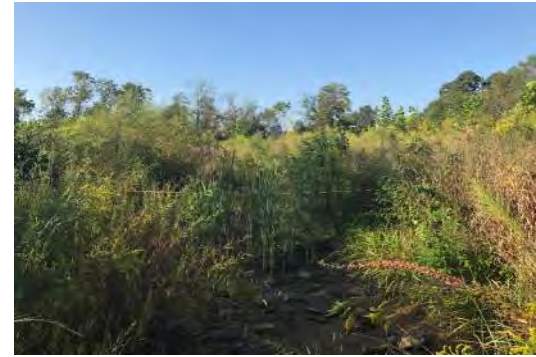
Station and description 1345.64 UT7-1R Looking Upstream

Note: UT 7 was dry during MY 3 survey

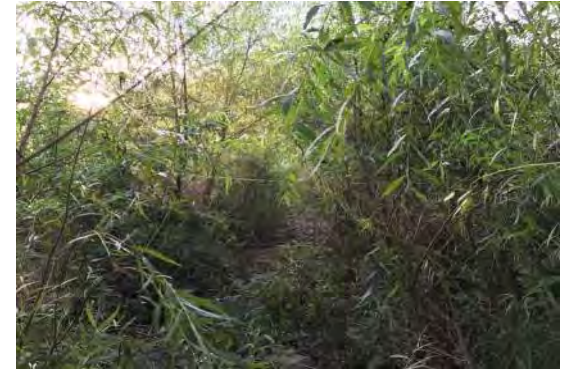
1846.19 UT7-2R Looking Downstream

Note: UT 7 was dry during MY 3 survey

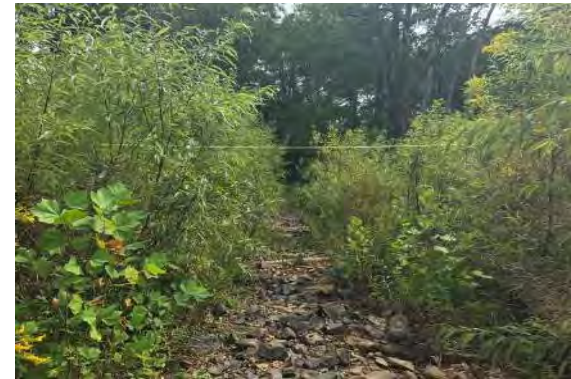
2019.70 UT7-STP1 Looking Downstream

Note: UT 7 was dry during MY 3 survey

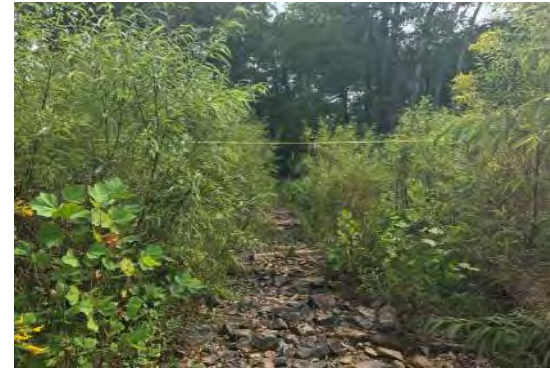
2077.52 UT7-STP2 Looking Downstream

Note: UT 7 was dry during MY 3 survey
