**Monitoring Report
Year 4
FINAL**

Little Buffalo Creek Stream Mitigation Project

*NCDEQ-DMS Project Number: 94147
Contract Number: 2029
USACE Permit Action ID: 2014-00386
DWR Permit: 14-0129
Cabarrus County*

**Data collection: September/October/November 2018
Draft Submitted: January 2019
Final Submitted: March 2019**

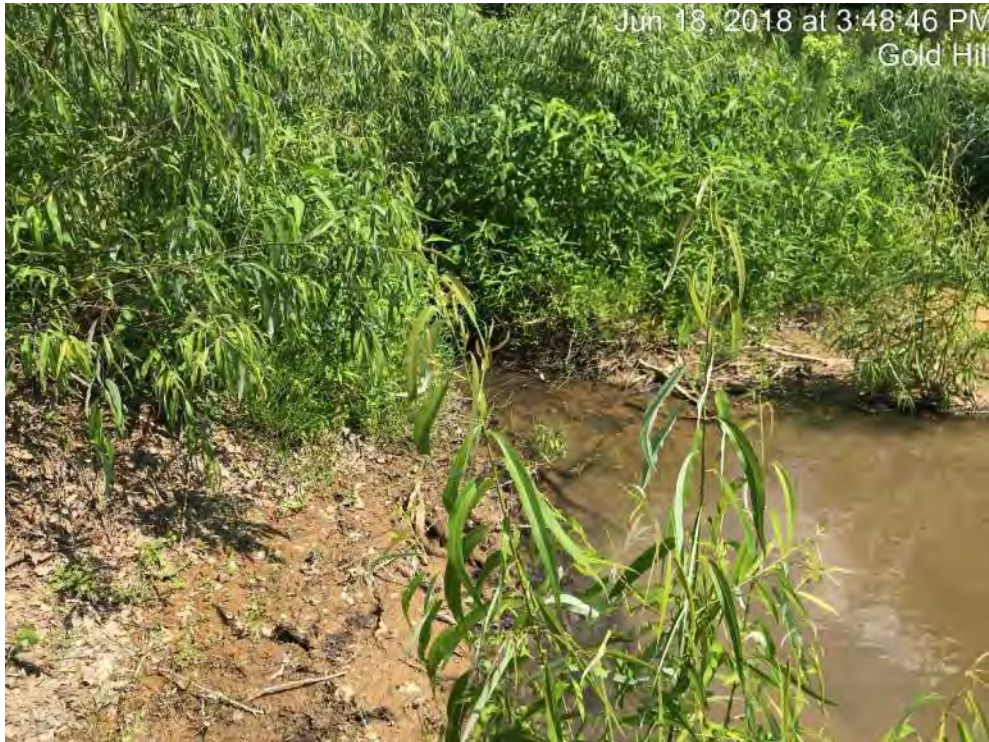
Reach 1 before beaver dam clearing work taken in June 2018

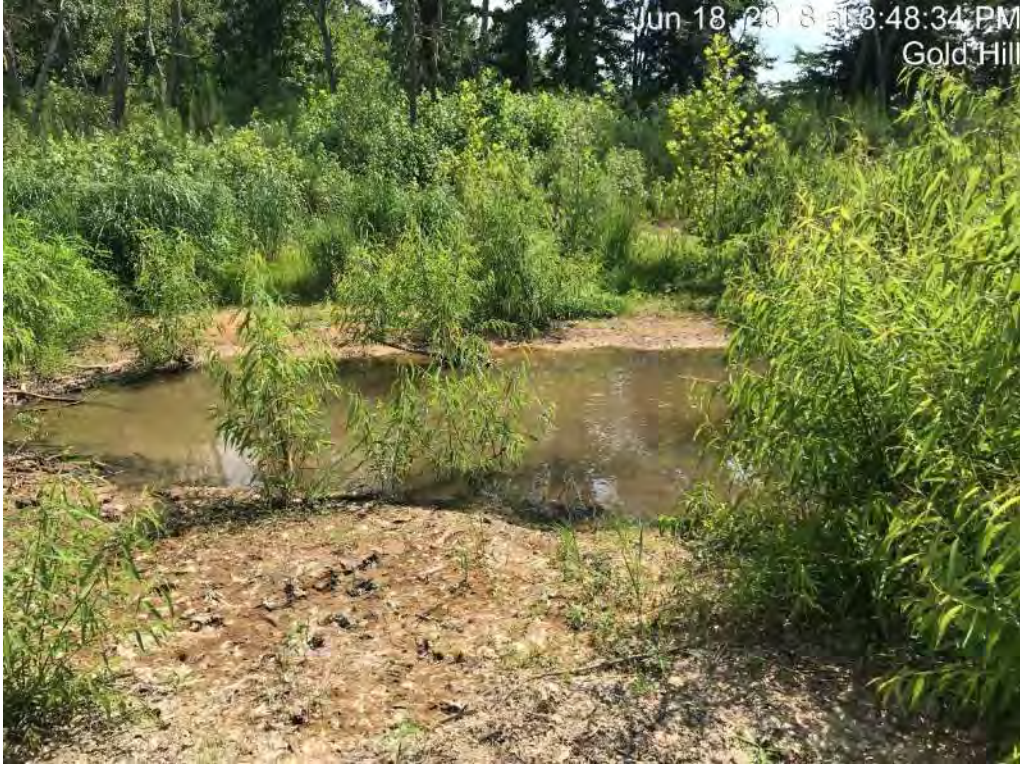
Beaver dam in restoration area of Reach 1

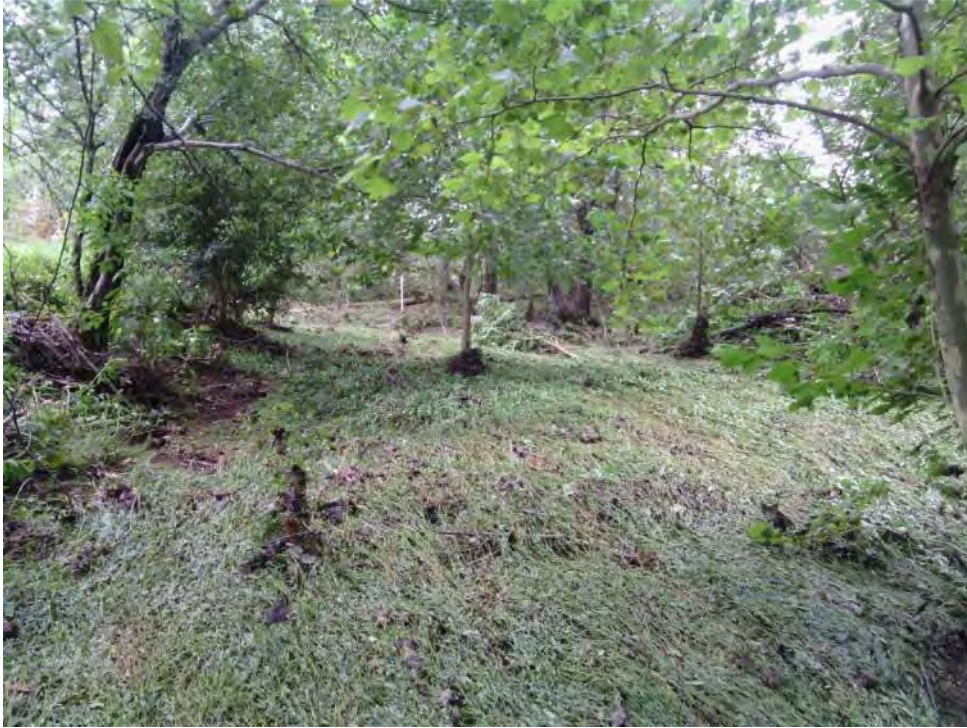
Significant Flow in Reach 1, herbaceous vegetation bent over in floodplain
Photo taken in September 2018

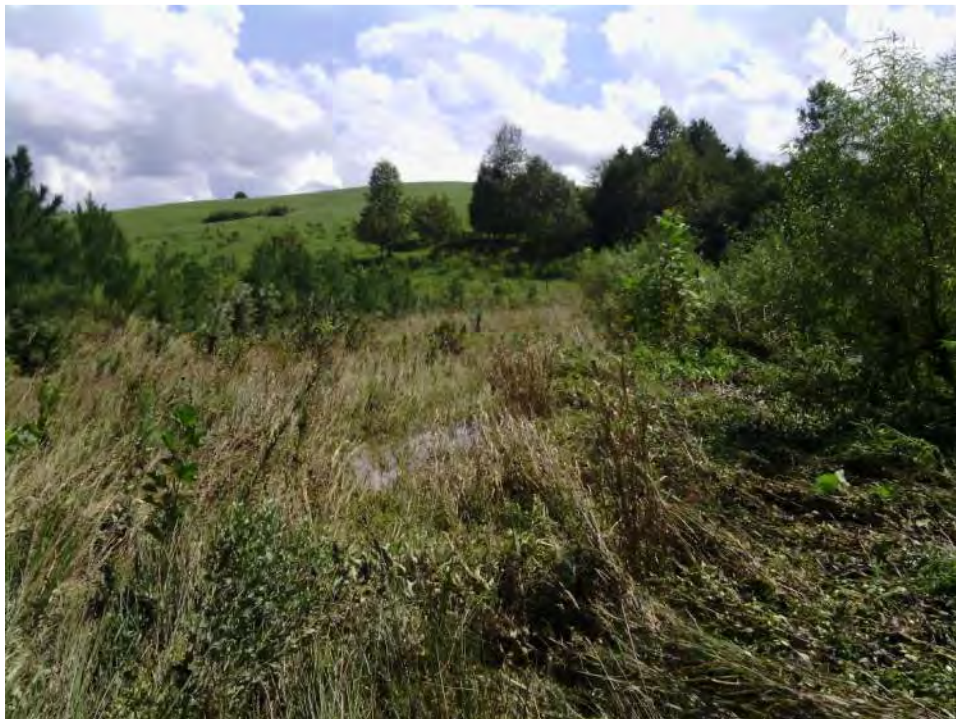
Significant Flow in outskirts of Reach 1, vegetation bent over in floodplain
Photo taken in September 2018

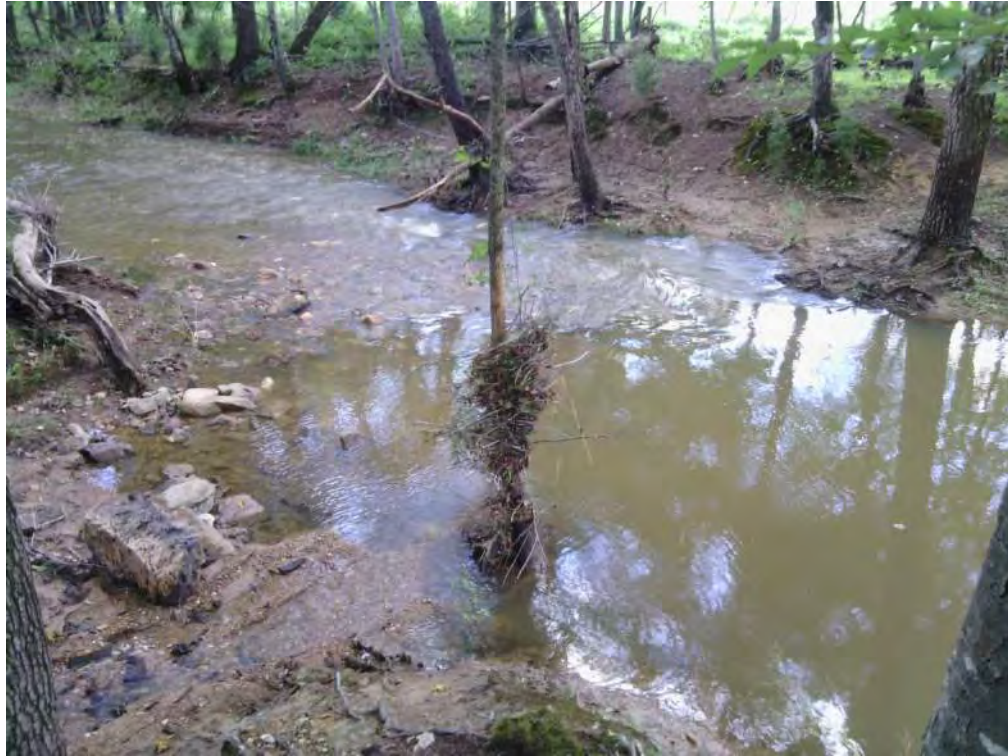
Wrack line indicating high water levels
Photo take in September 2018

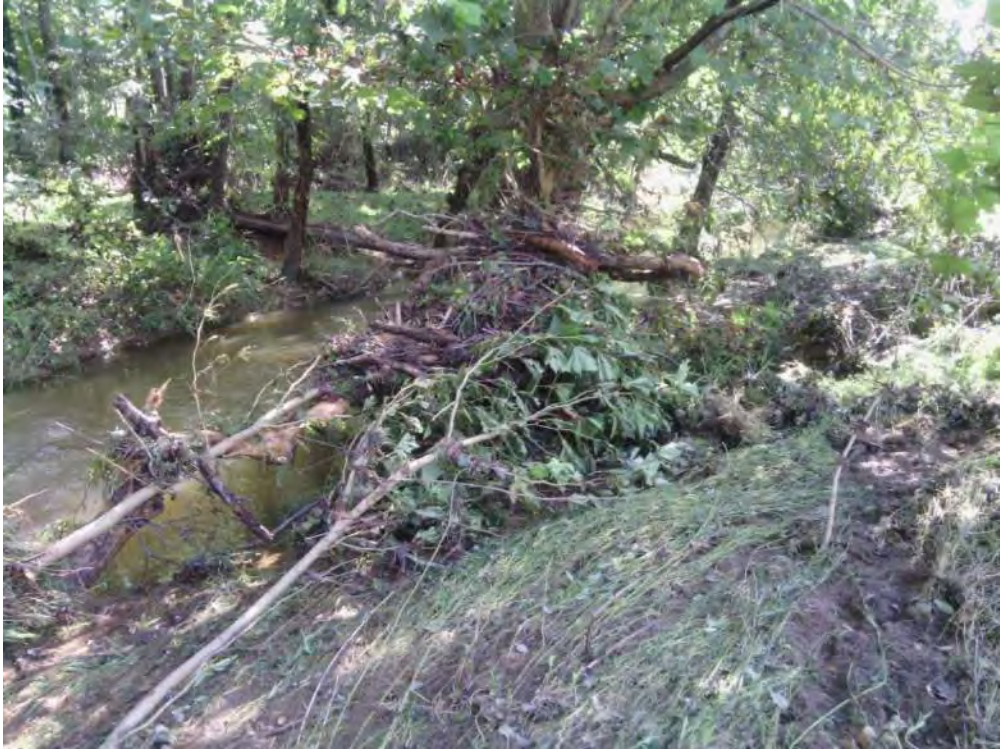
More Debris from Hurricane event in Reach 2

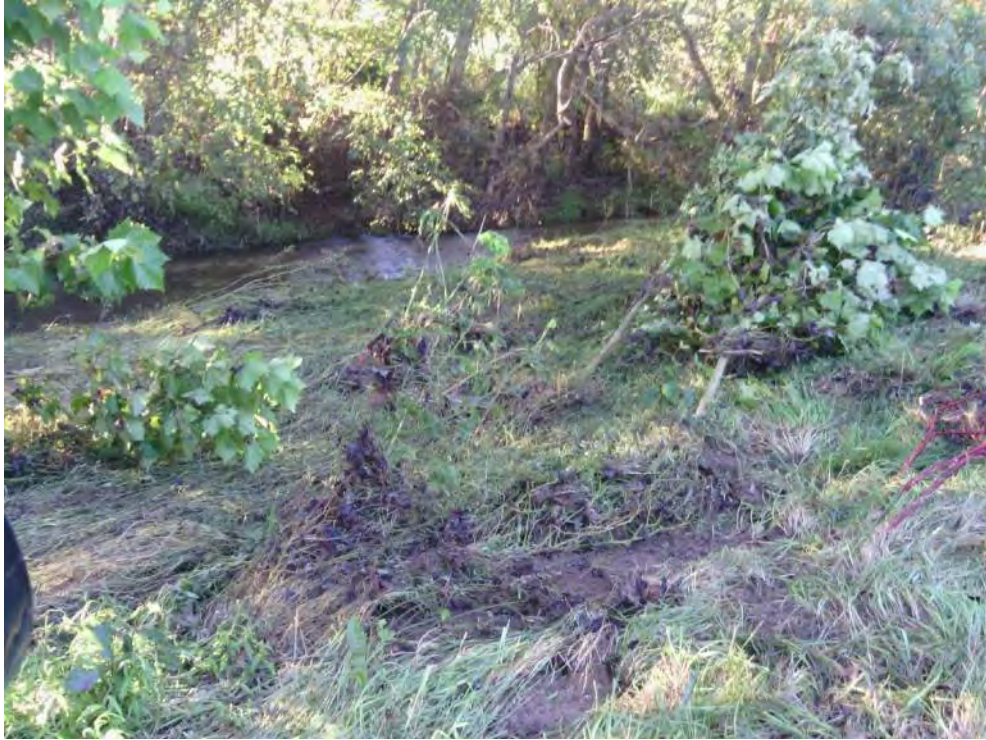
Evidence of Significant flow event on Reach 2 bank

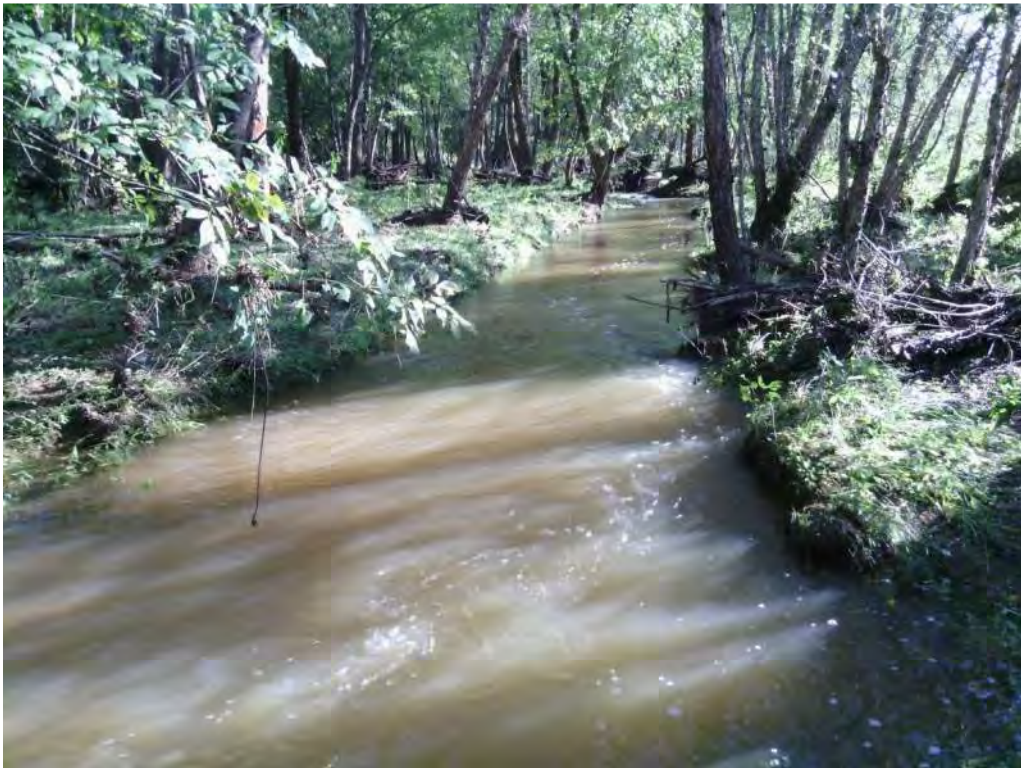
Flow debris in floodplain in Reach 5

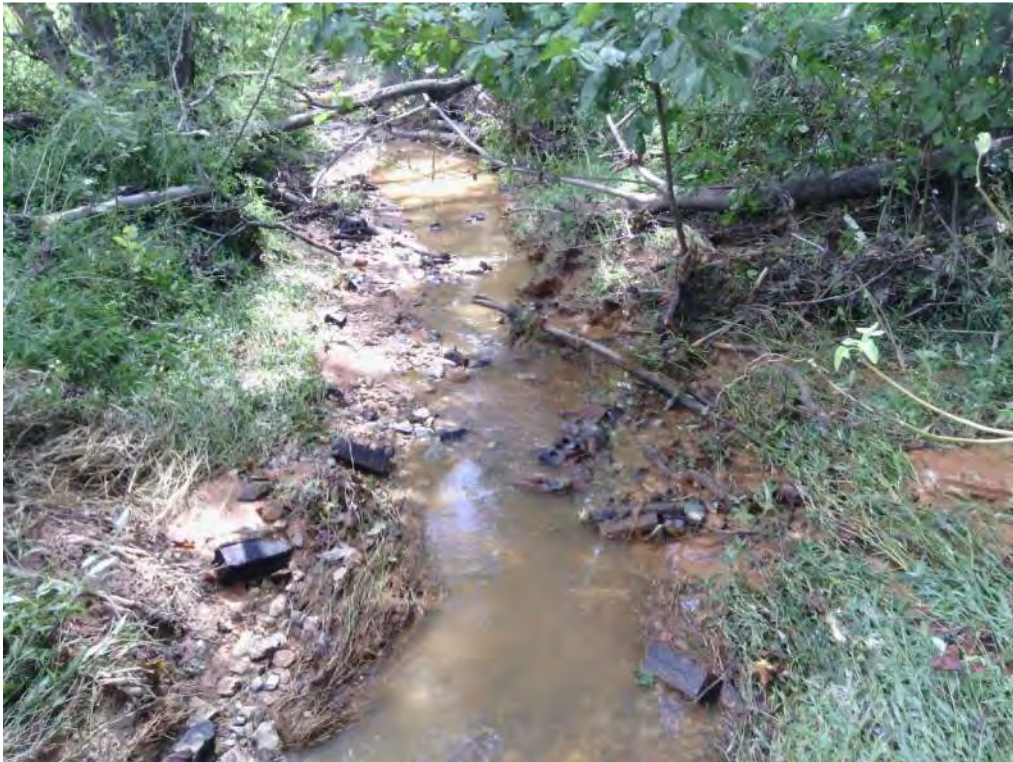
Debris settled in floodplain of UT2

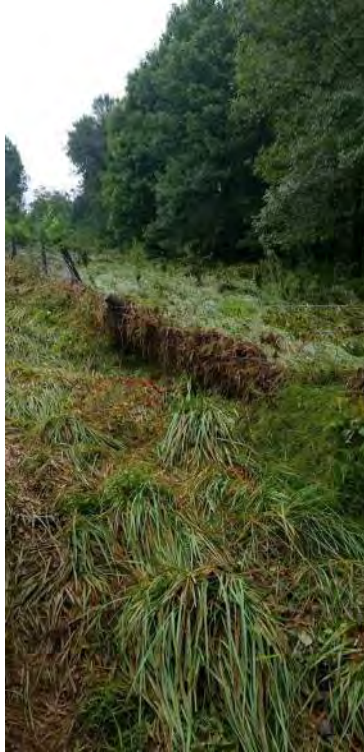
Bent vegetation into easement fence from hurricane

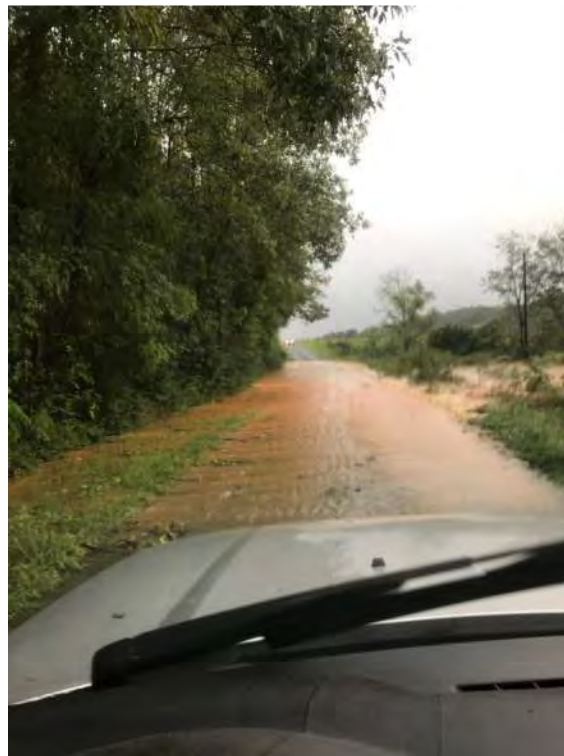
Flooding over old mine road at UT7

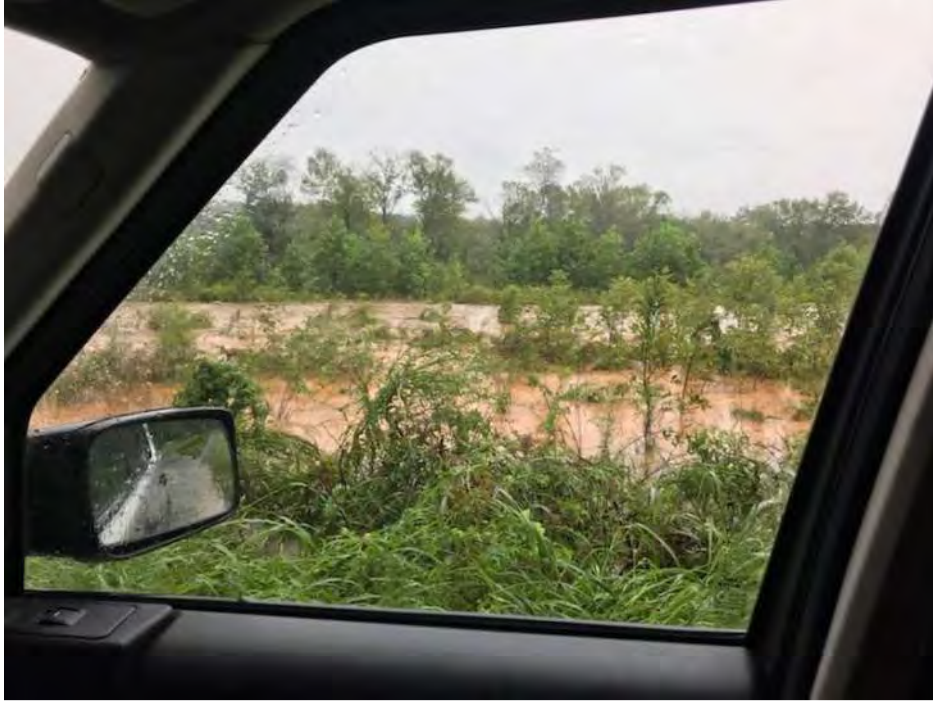
Flooding at UT7 during Hurricane

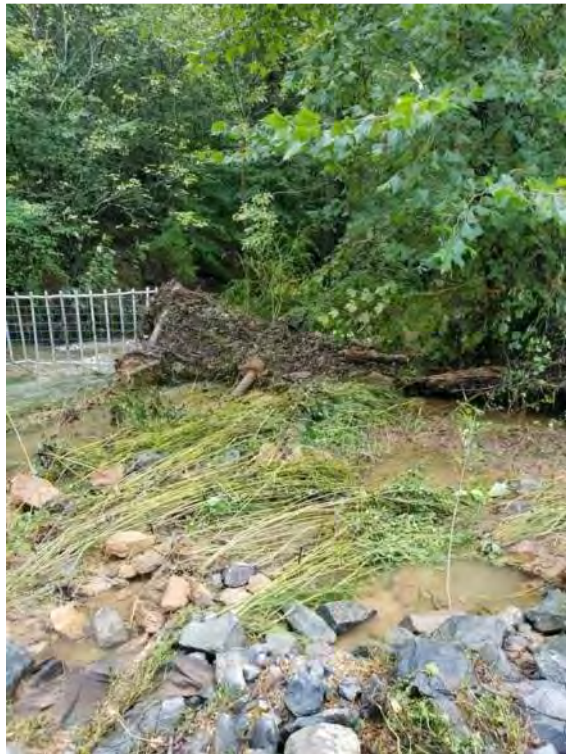
Wreck line at cattle crossing from Hurricane

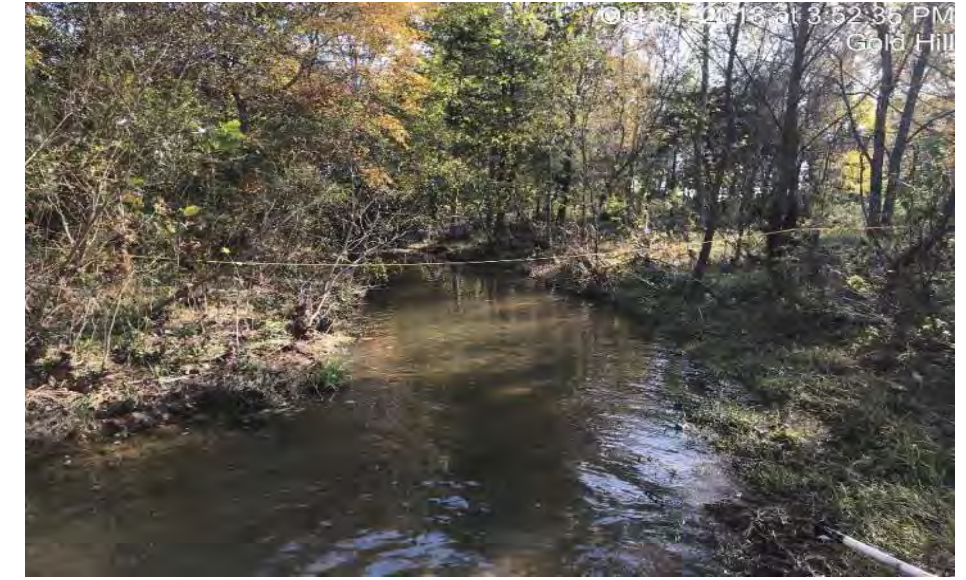
River Basin:	Yadkin-Pee Dee River
Watershed:	Little Buffalo Creek
XS ID:	MS-2P
Drainage Area (sq mi):	2.82
Date:	10/31/2018
Field Crew:	Matthew Holthaus, Alston Willard, Louis Berger

Station and description 5008.51 MS-2P Looking Upstream

5008.51 MS-2P Looking Downstream

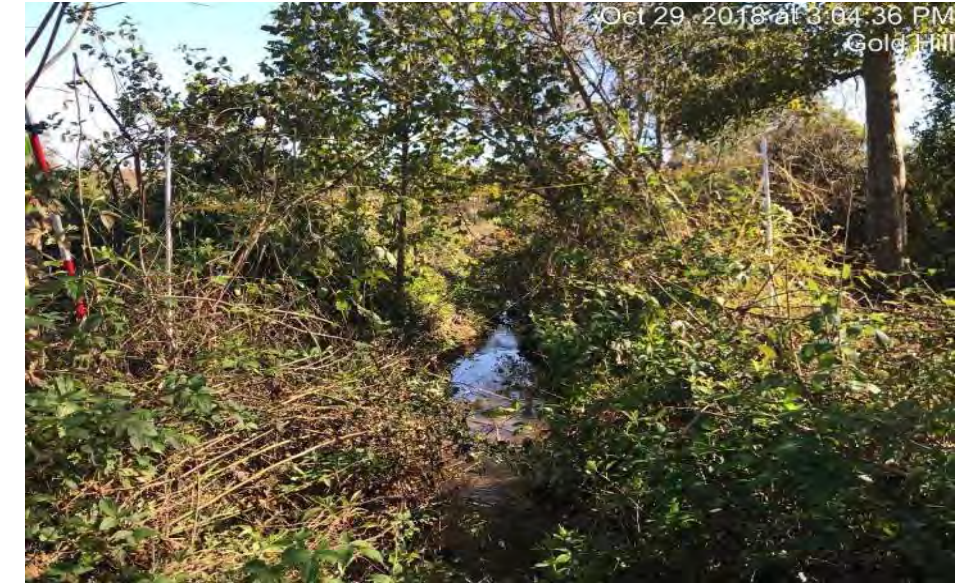
River Basin:	Yadkin-Pee Dee River
Watershed:	Little Buffalo Creek
XS ID:	UT2-1R
Drainage Area (sq mi):	0.3
Date:	10/29/2018
Field Crew:	Matthew Holthaus, Alston Willard, Louis Berger

Station and description 1391.34 UT2-1R Looking Upstream

1391.34 UT2-1R Looking Downstream

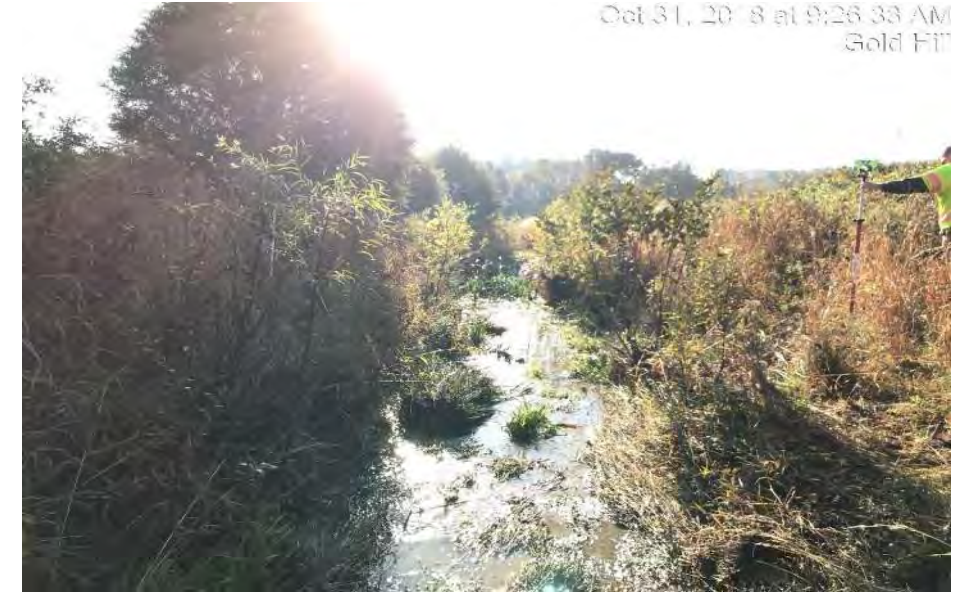
River Basin:	Yadkin-Pee Dee River
Watershed:	Little Buffalo Creek
XS ID:	UT3-2R
Drainage Area (sq mi):	0.097
Date:	10/31/2018
Field Crew:	Matthew Holthaus, Alston Willard, Louis Berger

Station and description 1802.03 UT3-2R Looking Upstream

1802.03 UT3-2R Looking Downstream

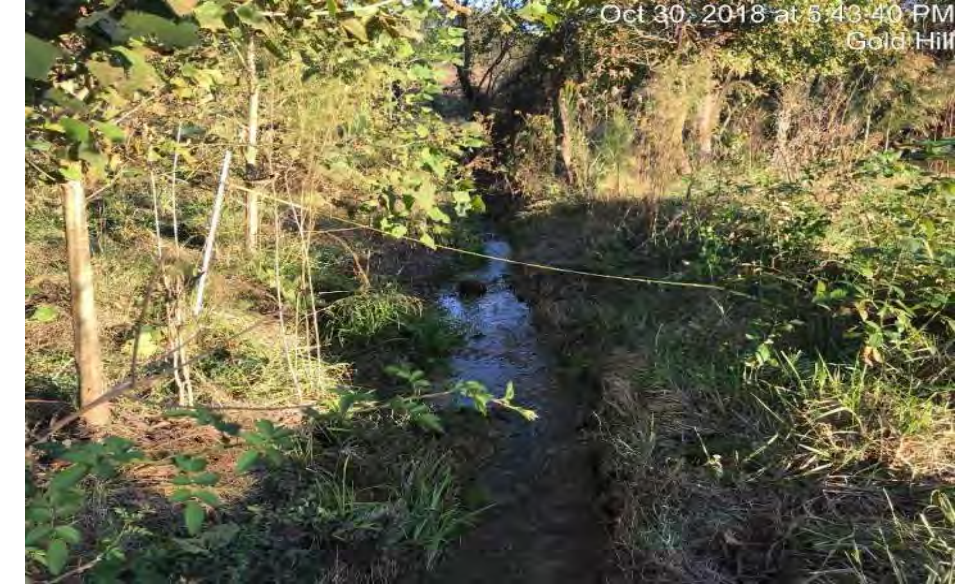
River Basin:	Yadkin-Pee Dee River
Watershed:	Little Buffalo Creek
XS ID:	UT3-3R
Drainage Area (sq mi):	0.097
Date:	10/30/2018
Field Crew:	Matthew Holthaus, Alston Willard, Louis Berger

Station and description 2426.03 UT3-3R Looking Upstream

2426.03 UT3-3R Looking Downstream

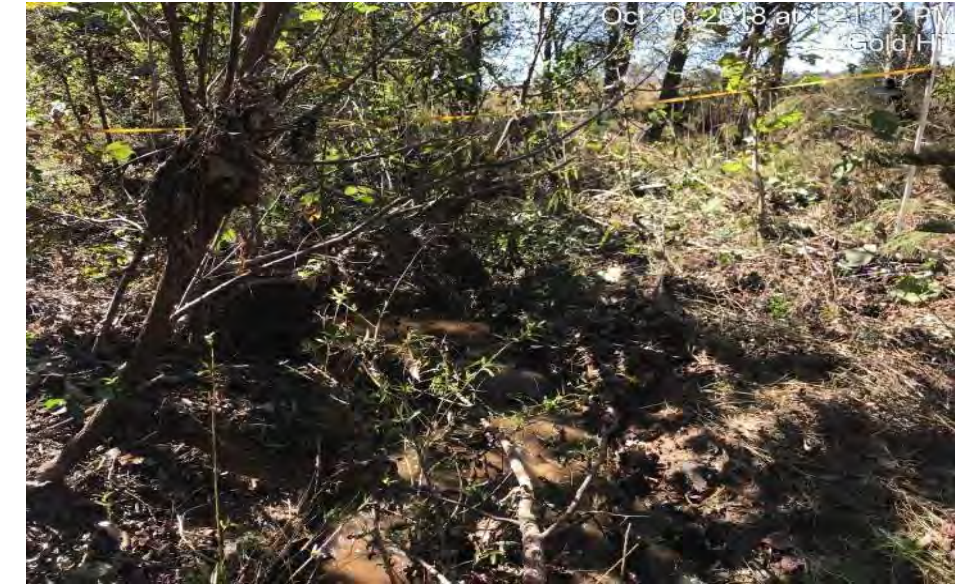
River Basin:	Yadkin-Pee Dee River
Watershed:	Little Buffalo Creek
XS ID:	UT4-1R
Drainage Area (sq mi):	0.4
Date:	10/30/2018
Field Crew:	Matthew Holthaus, Alston Willard, Louis Berger

Station and description 1727.36 UT4-1R Looking Upstream

1727.36 UT4-1R Looking Downstream
