**Monitoring Report
Year 5
FINAL**

Little Buffalo Creek Stream Mitigation Project

*NCDEQ-DMS Project Number: 94147
Contract Number: 2029
USACE Permit Action ID: 2014-00386
DWR Permit: 14-0129
Cabarrus County*

**Data collection: October 2019-January 2020
Draft Submitted: February 2020
Final Submitted: March 2020**

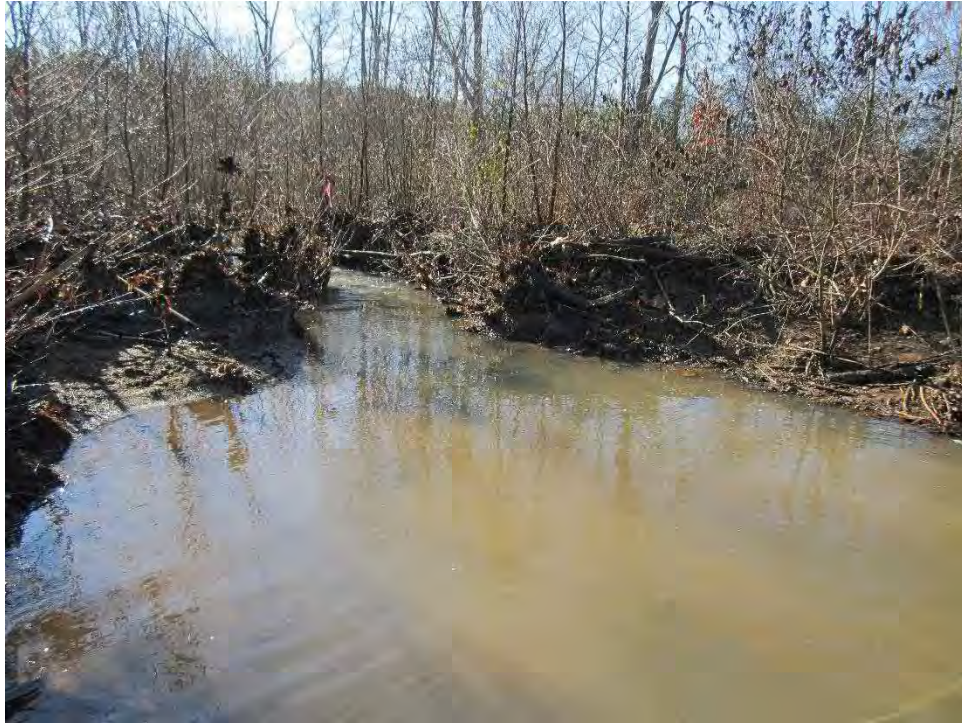
Photo taken in January 2020, view towards UT7 beaver dam location (pink flagging) that was removed in December 2019

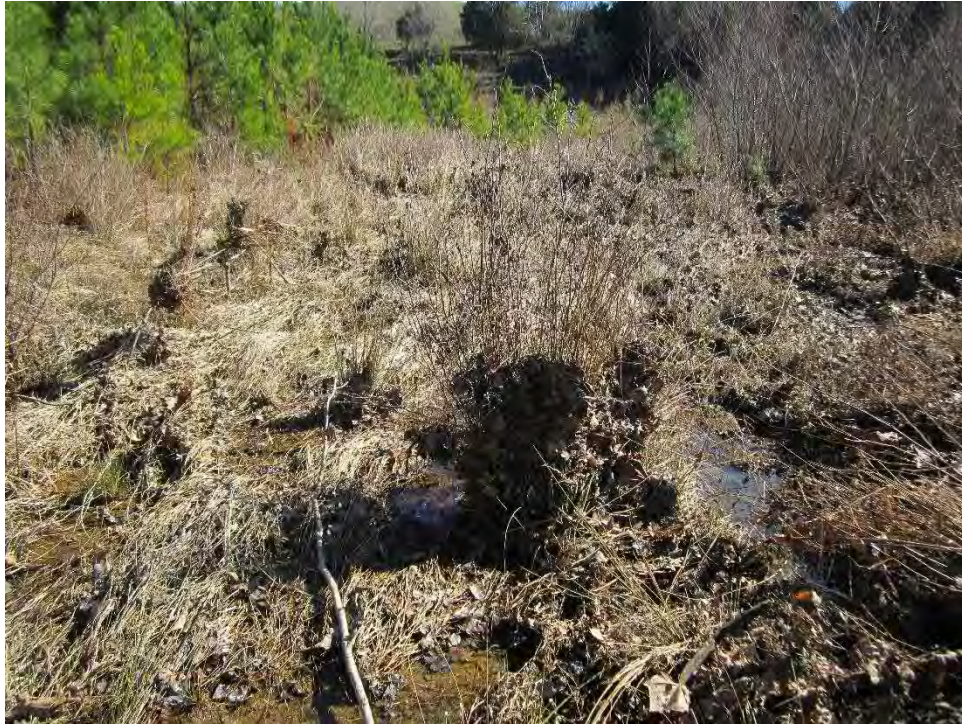
Flattened vegetation and drift lines in vegetation monitoring plot 11

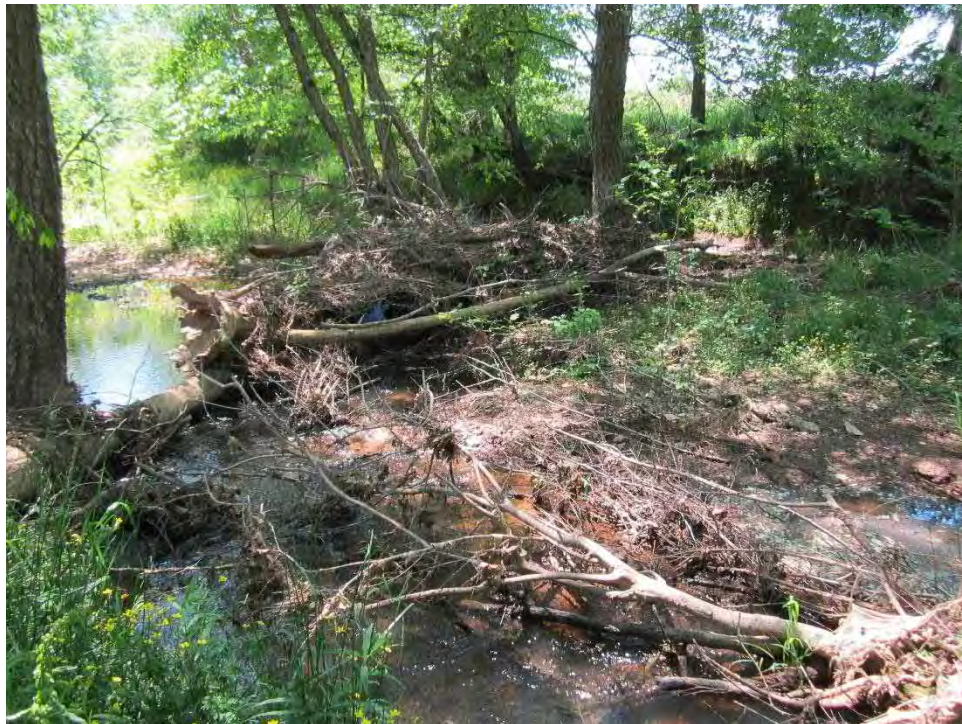
Dropped debris in Reach 4 just upstream of Gauge 5

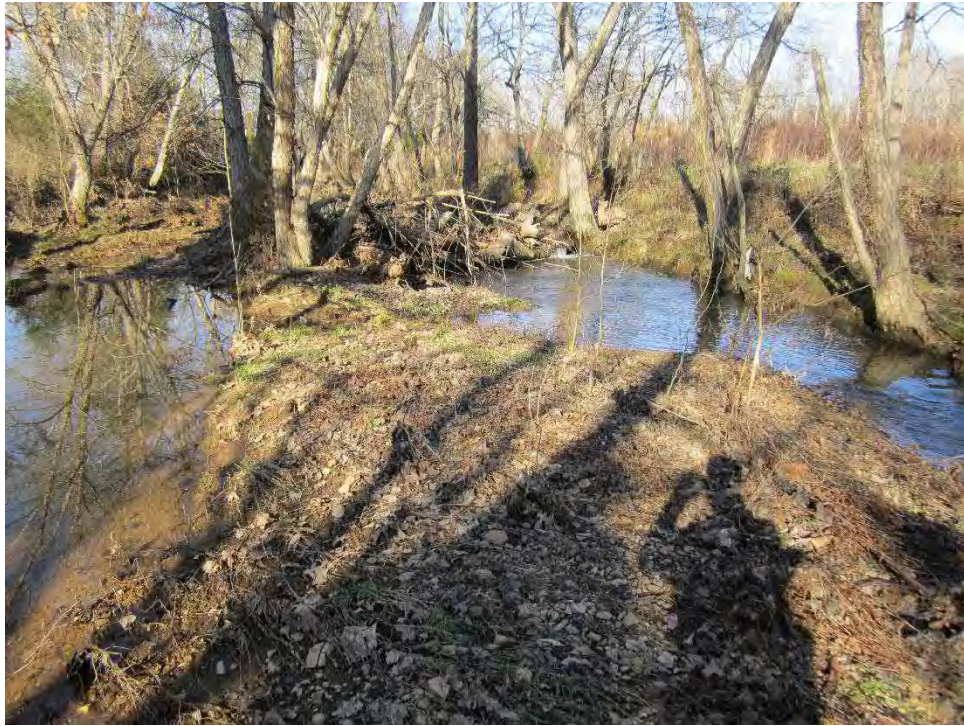
Debris jam and flattened vegetation in Reach 4

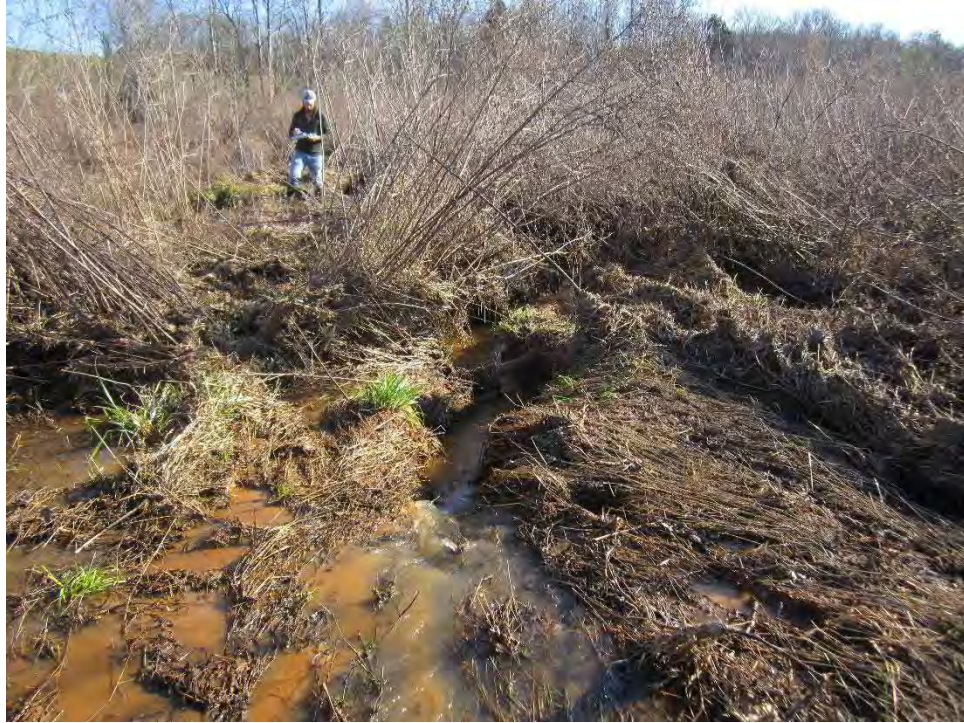
Small headcut in UT2 near Station 16+85 (January 2020)

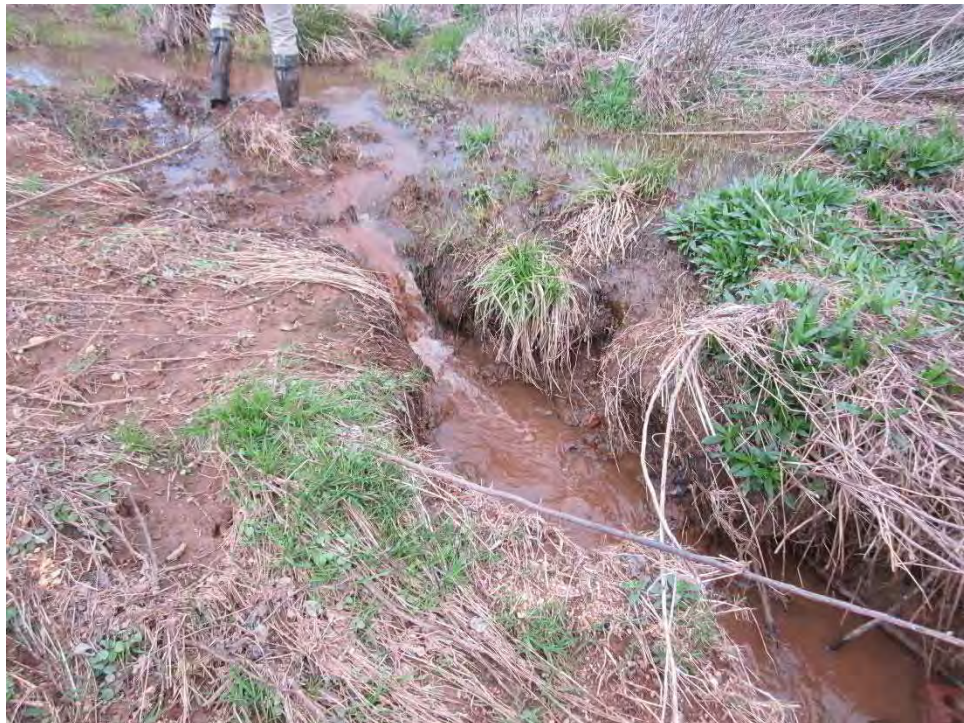
Headcut in UT2 near Station 16+95 (March 2020)

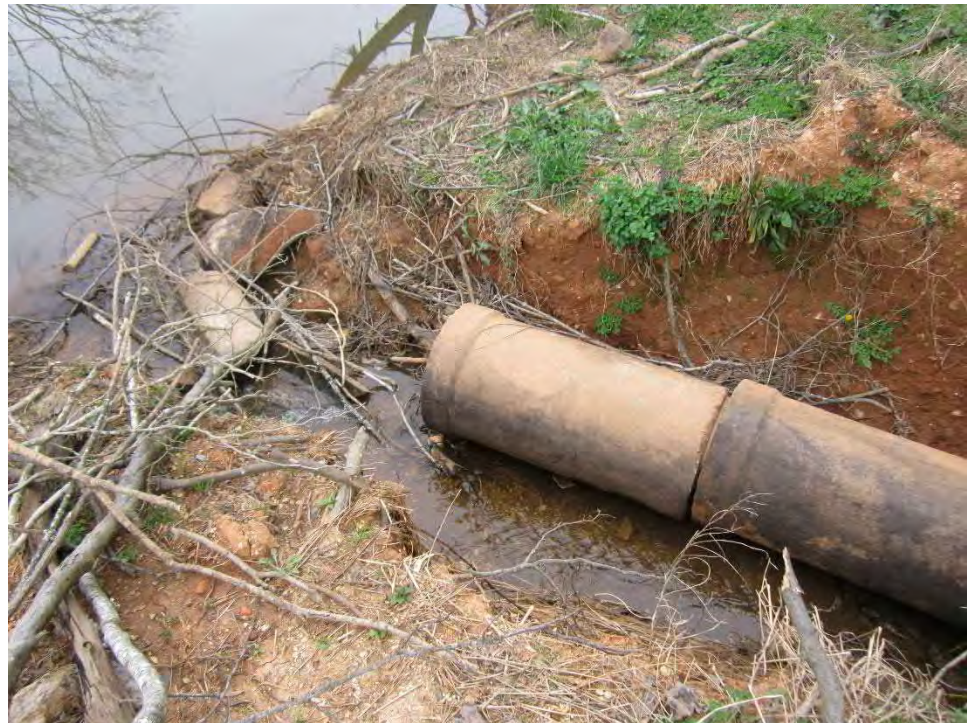
Dam blowout around existing concrete outlet pipe (US end of UT2)

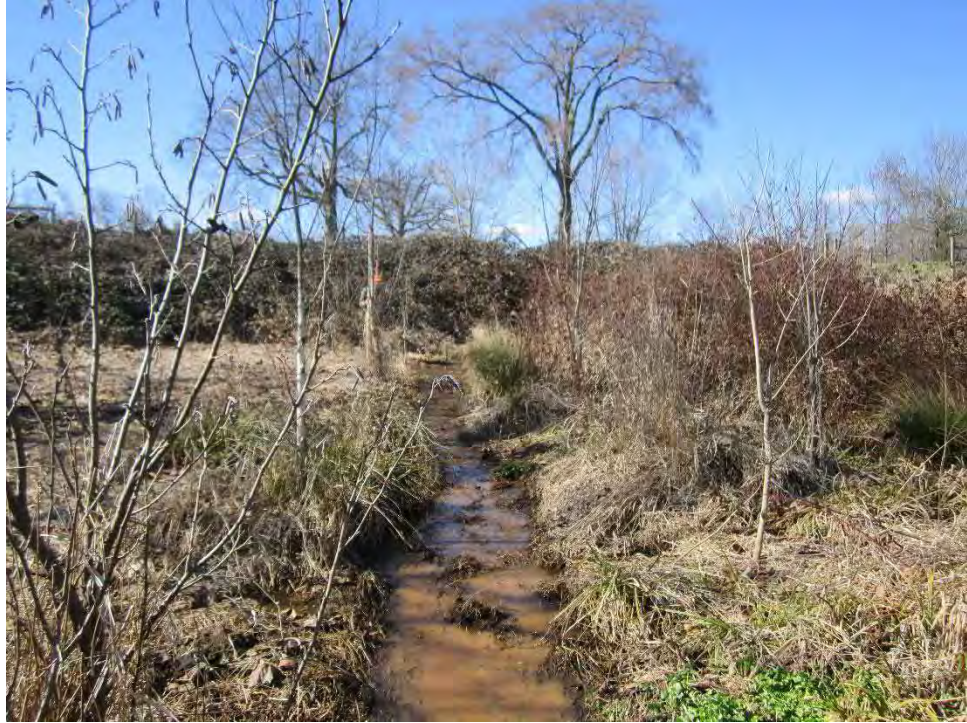
Section 1.5.2 - Stream Assessment: In the report text, please indicate the approximate stream stations where the former beaver dams were located. Based on a review of the draft report, it appears that WSP does not currently consider the previous aggradation (linear wetlands) on UT 2 and UT3 a project issue. Please confirm in the comment response letter. If aggradation (linear wetlands) are still considered a project issue, please update the report text and edit the CCPV (Figures 3 & 4) to more clearly indicate the sections of UT 2 and UT3 that are considered linear wetlands and the sections considered stream channel.

UT3 near Station 11+00 showing channel in January 2020

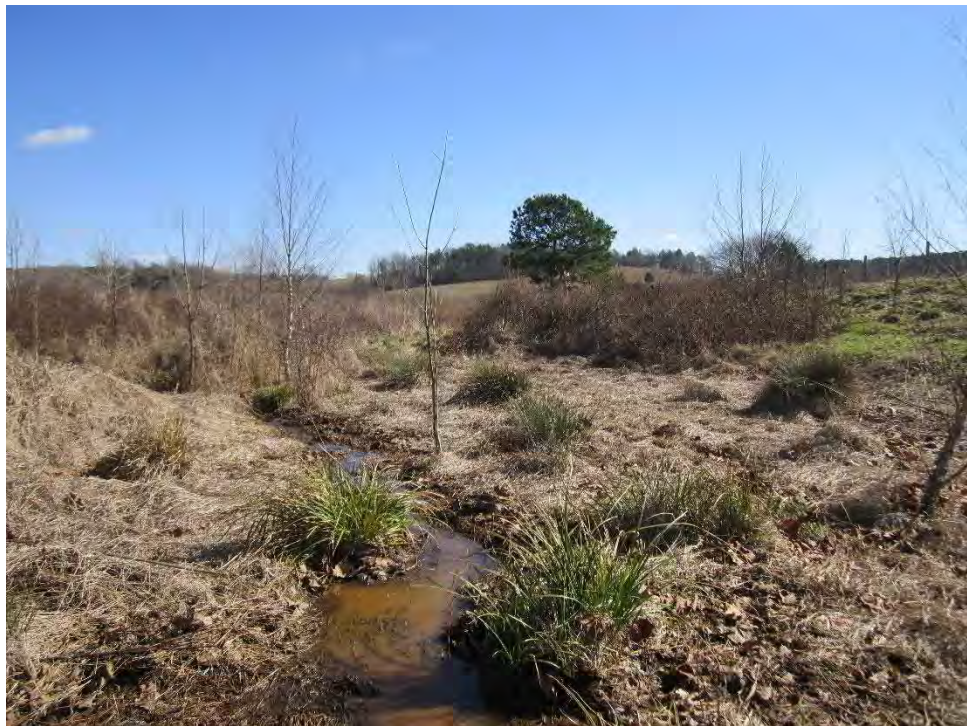
UT3 in near Station 11+50 showing channel in January 2020
