**LITTLE GRASSY CREEK PROJECT**  
**ANNUAL MONITORING REPORT FOR 2008 (YEAR 1)**

**EEP Project #224**

**February 2009**

**Michael Baker Engineering, Inc.**  
6500 Regency Parkway  
Suite 200  
Cary, North Carolina 27516  
Phone: 919.463.5498  
Fax: 919.463.5490

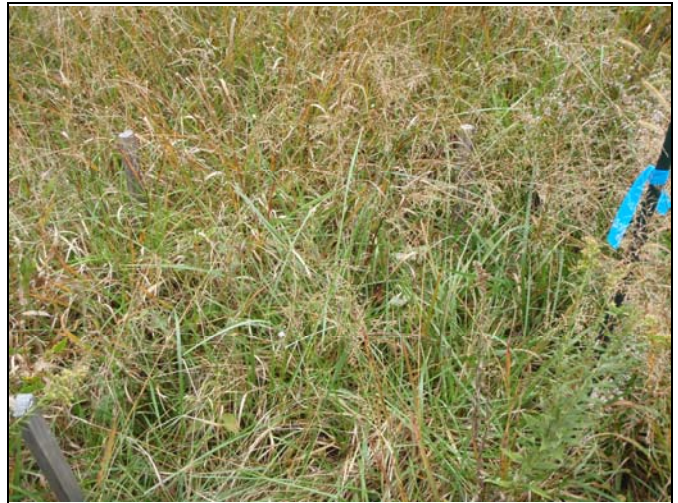
Herbaceous Vegetation Plot 6 – 10/10/2008

<b>Little Grassy Creek Restoration Site: EEP No. 224</b>			
<b>Feature/Issue</b>	<b>Station # / Range</b>	<b>Probable Cause</b>	<b>Photo</b>
Low denisty - 202 stems/acre	See Plan Sheets	Heavy <i>Rubus spp.</i> within plot boundaries	VP6 10/10/2008

Tables A.1. through A.5. in Appendix A present vegetation metadata, vegetation vigor, vegetation damage and stem count data of the monitoring stations at the end of the Year 1 monitoring period. Data from the Year 1 monitoring event of the seven vegetation plots showed a range of 202 to 728 stems per acre. Data for Year 1 showed that the Site exhibited an average of 497 stems per acre. Based on these results, plots 1, 2, 3, 4, 5, and 7 are on track to meet the interim success criteria of 320 stems per acre at the end of monitoring Year 5. The density for plot 6 was 202 stems per acre, and the plot will need to be replanted in winter/spring 2009.
