# **Annual Monitoring Report**

## **Little Pine Creek II**

### **Monitoring Year 1 of 7**

NCDMS Project No. 856

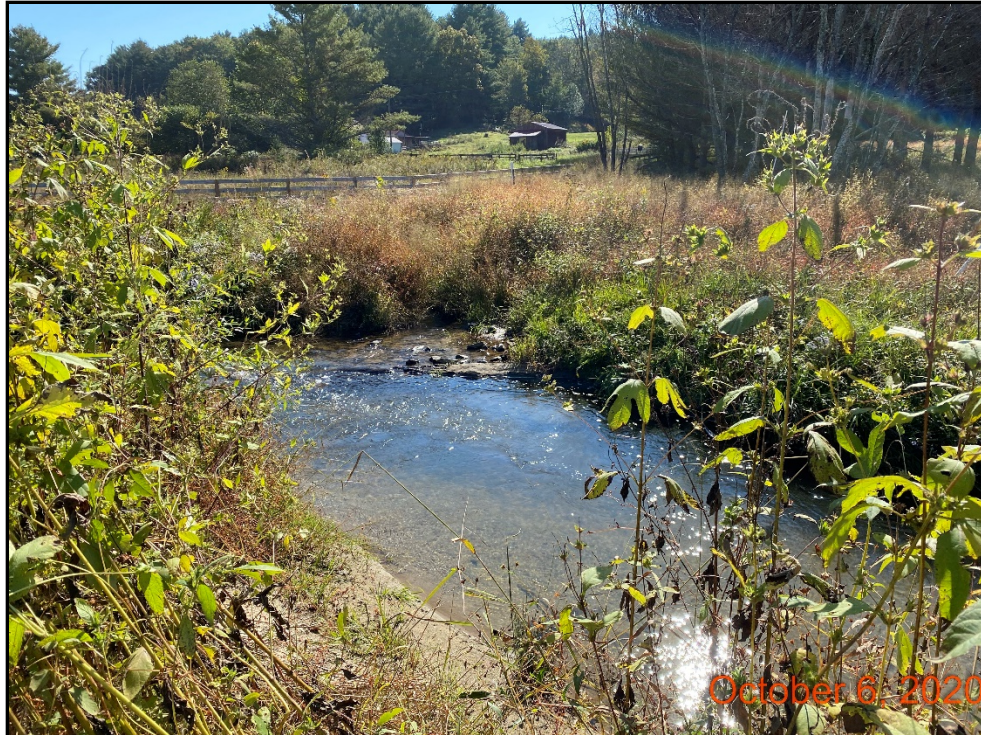
Little Pine Creek II – Permanent Photo Station 13a  
Confluence with Trib B

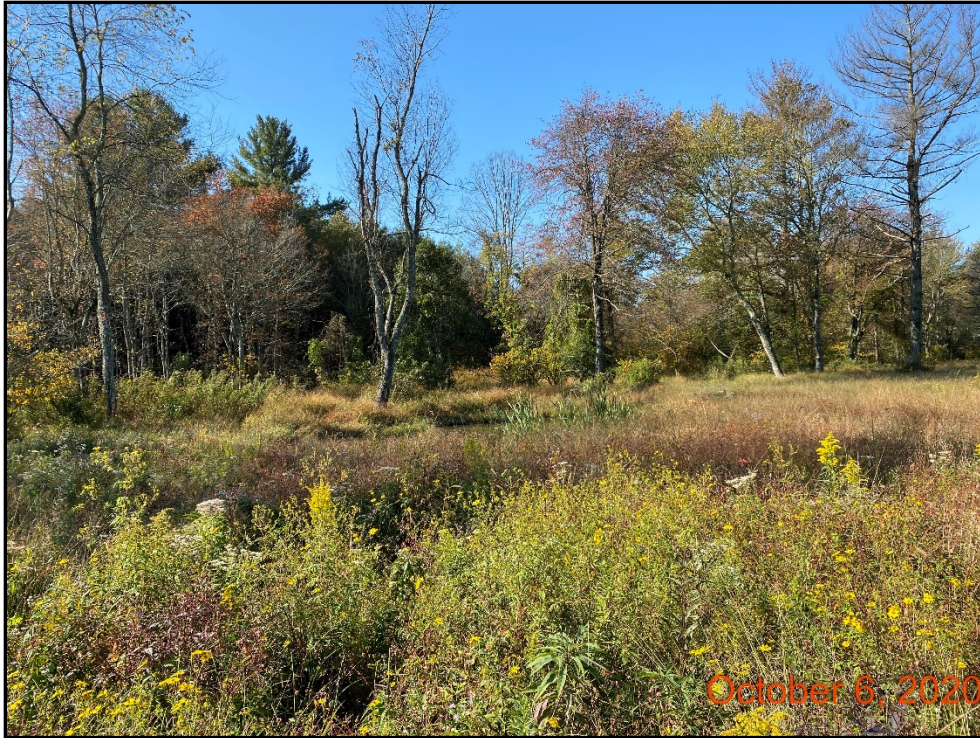
Little Pine Creek II – Permanent Photo Station 14a  
Looking at floodplain pool
