MONITORING YEAR 7 ANNUAL/CLOSEOUT REPORT

LITTLE PINE III STREAM AND WETLAND RESTORATION PROJECT

Alleghany County, NC
NCDEQ Contract 6844
DMS Project Number 94903
DWR # 14-0041
USACE Action ID 2012-01299

Data Collection Period: August - December 2022
Draft Submission Date: January 26, 2023
Final Submission Date: February 23, 2023

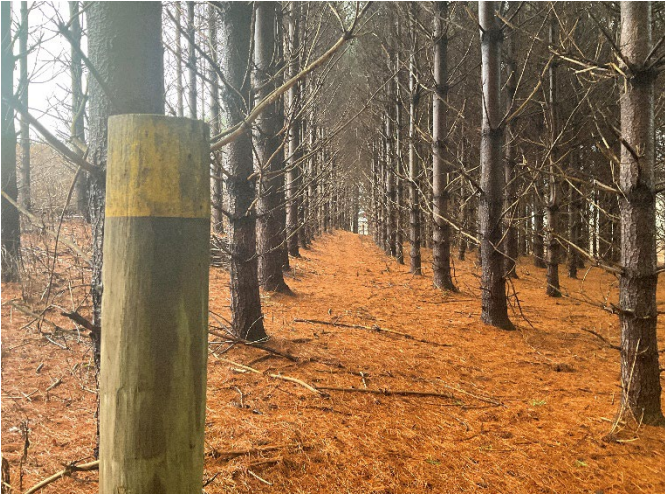
Conservation Easement Corner – Located south of Wetland HH, logging well outside of easement, looking northwest (12/7/2022)

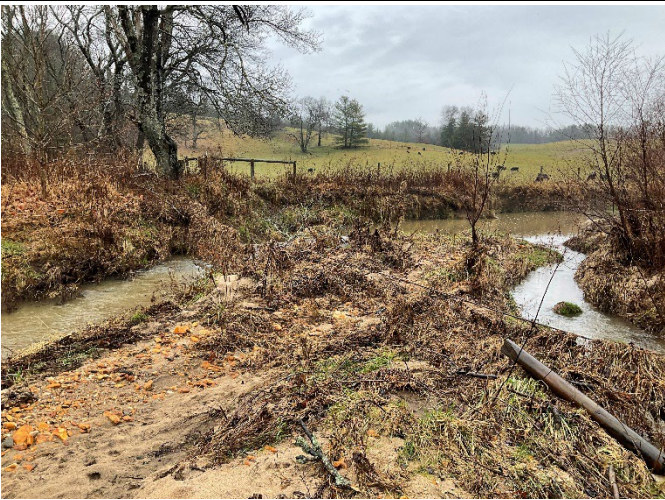
Conservation Easement Boundary – Located at the start of Little Pine Creek, fencing down across the stream, looking east (12/7/2022)

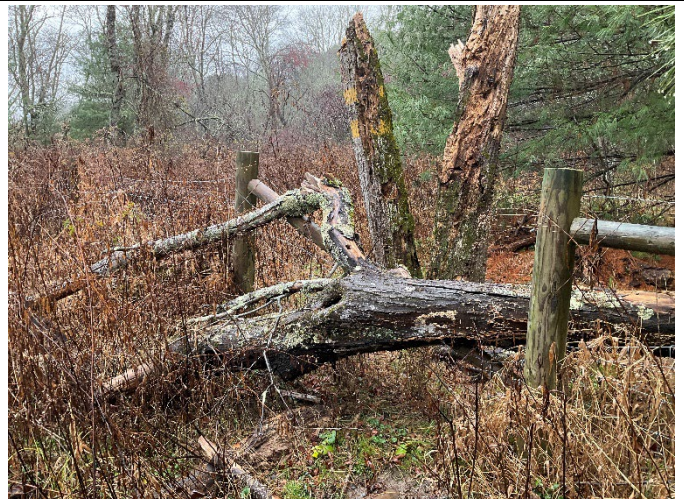
Conservation Easement Boundary – Located north of XS1 on Little Pine Creek, tree down on fence line, looking north (12/7/2022)

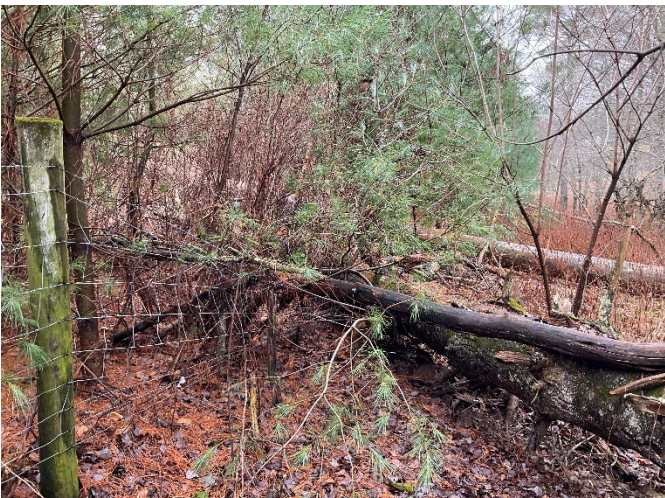
Conservation Easement Boundary – Located south of PP31 on UT2B, tree down on fence line, looking southwest (12/7/2022)

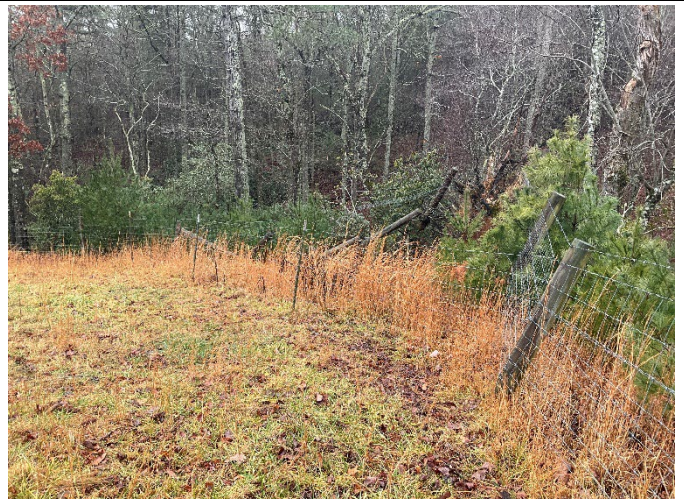
Conservation Easement Corner – Located south of UT2A/UT3 confluence, fenced to avoid tree down at corner, looking west (12/7/2022)

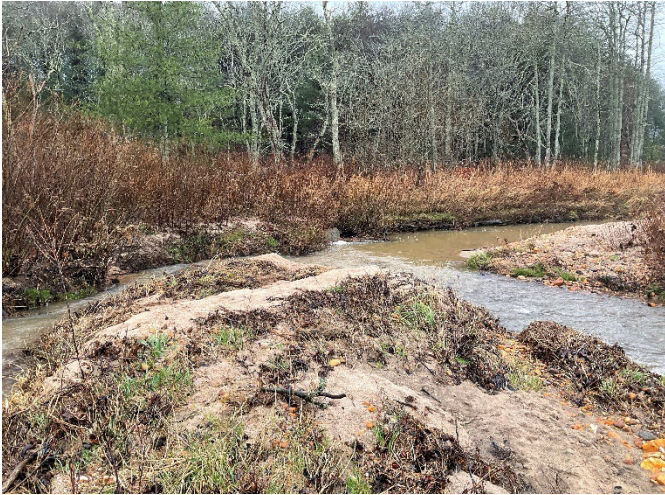
LPC Reach 1 STA 100+00 – Mid channel sediment bar at the start of project, looking downstream (12/7/2022)

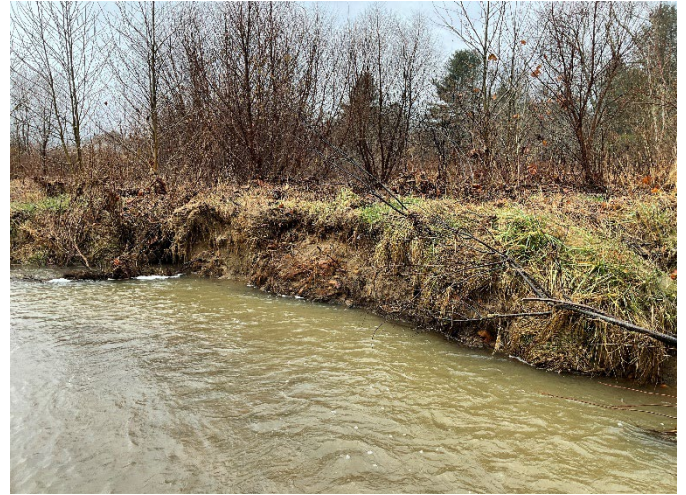
LPC Reach 1 STA 108+00 – Right bank scour, looking downstream (12/7/2022)

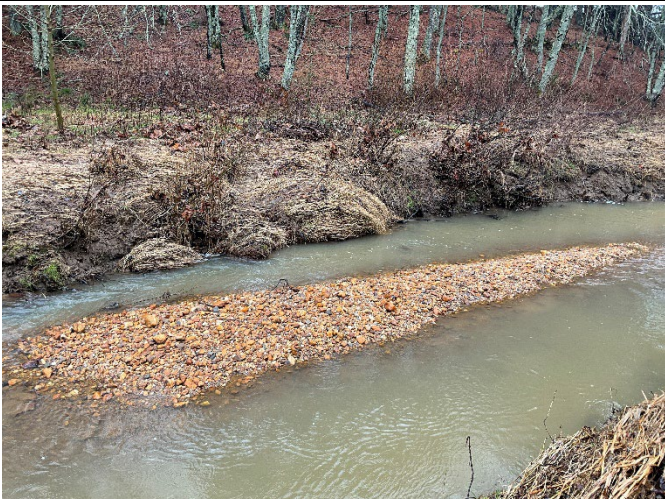
LPC Reach 1 STA 112+50 – Mid channel sediment bar, looking downstream (12/7/2022)

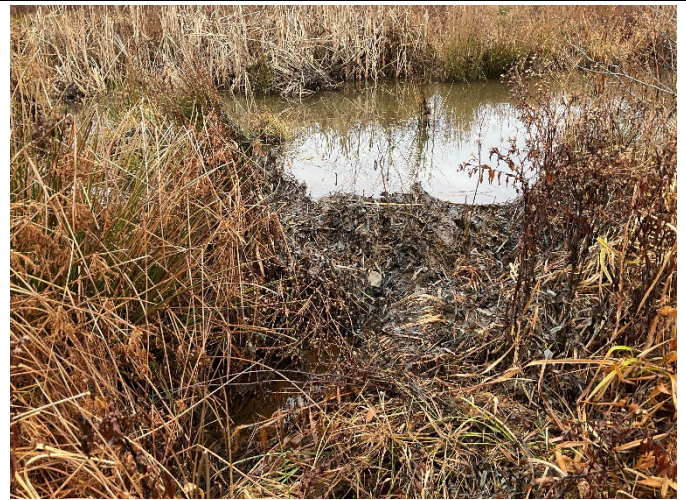
UT1 STA 204+40 – Small beaver dam on UT1, looking upstream (12/7/2022)

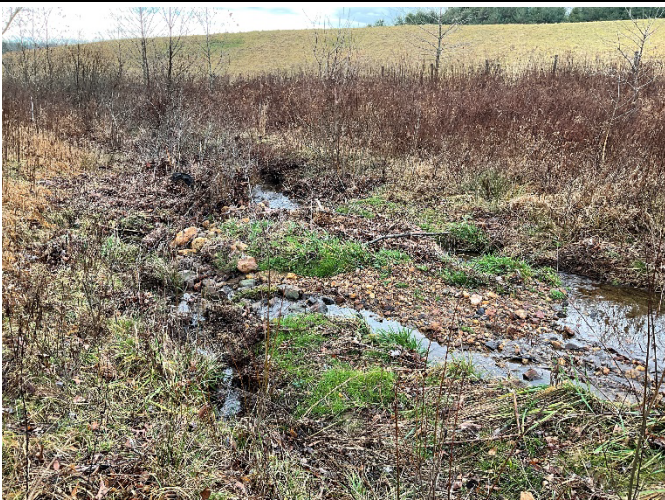
UT2 Reach 2 STA 333+50 – Mid channel sediment bar, looking downstream (12/7/2022)

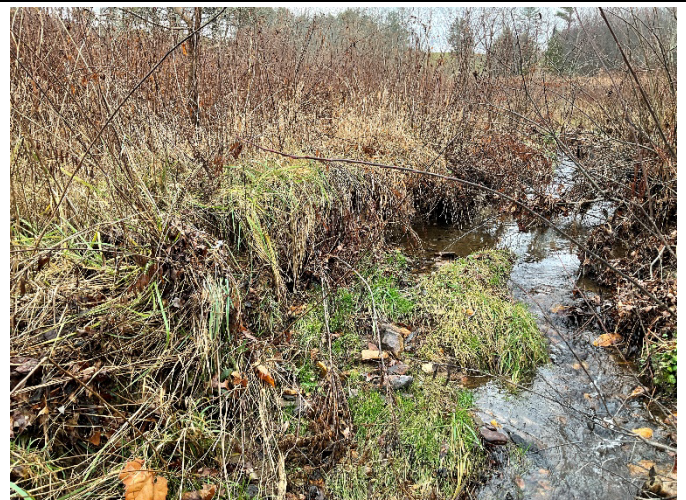
UT2 Reach 2 STA 334+10 – Right bank scour, looking upstream (12/7/2022)

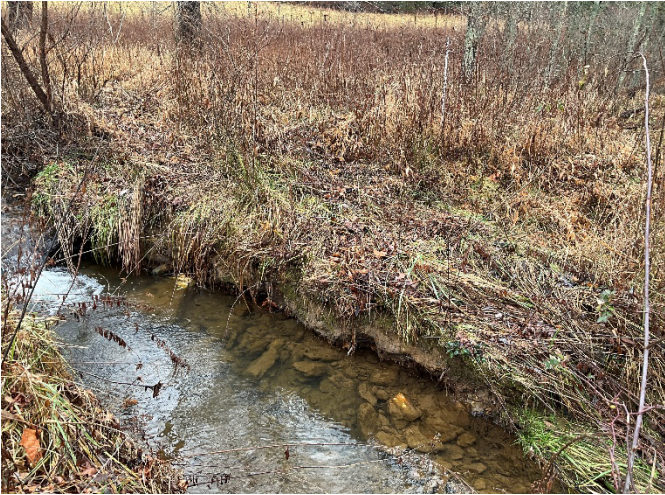
UT2 Reach 2 STA 334+40 – Left bank scour, looking upstream (12/7/2022)

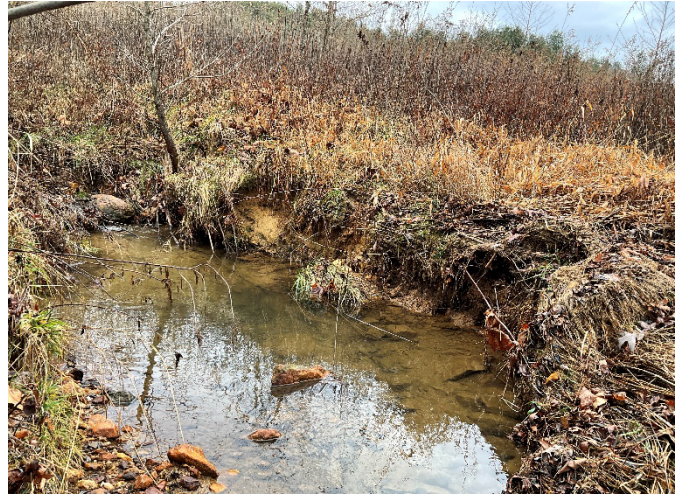
UT2 Reach 2 STA 336+40 – Left bank scour, looking upstream (12/7/2022)

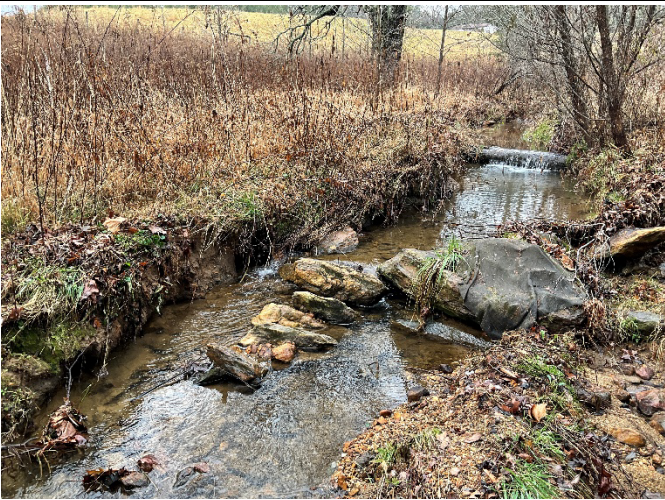
UT2 Reach 2 STA 337+50 – Right bank scour around rock vane structure, looking upstream (12/7/2022)

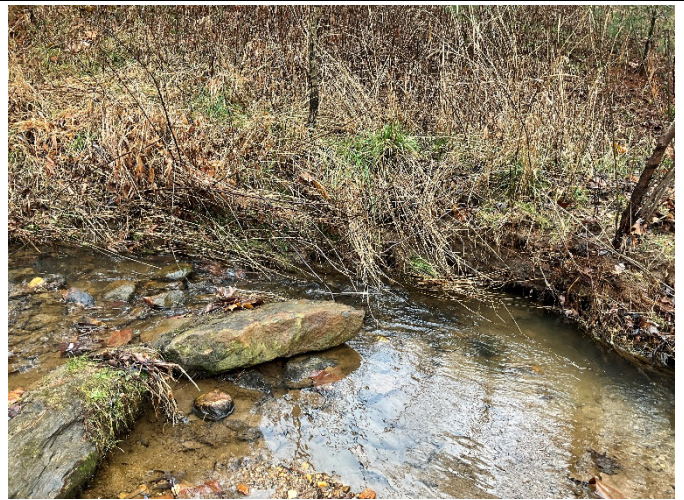
UT2 Reach 2 STA 338+00 – Left bank scour, looking at left bank (12/7/2022)

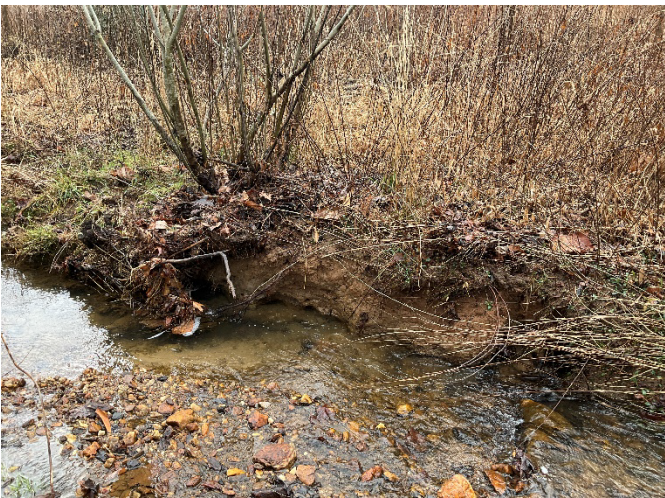
UT2 Reach 2 STA 338+30 – Right bank scour, looking at right bank (12/7/2022)

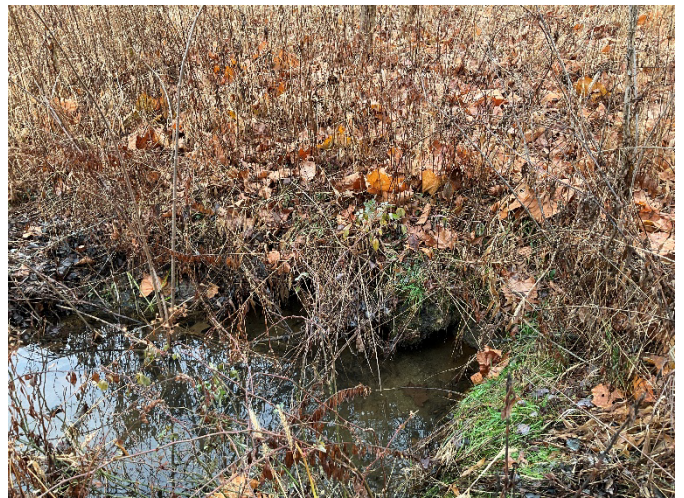
UT2B STA 504+20 – Right bank scour, looking at right bank (12/7/2022)

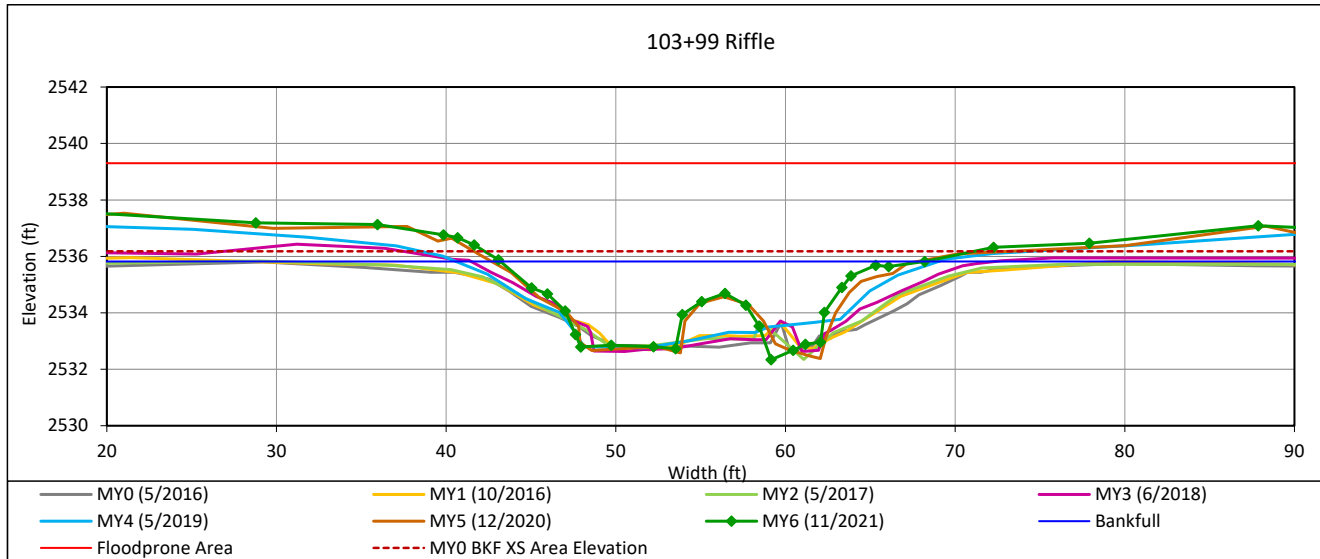
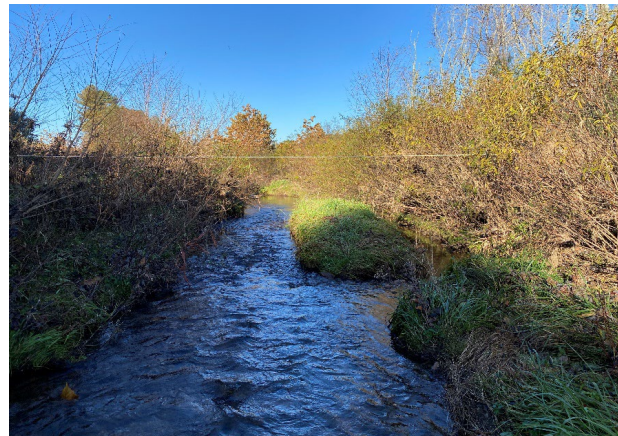
Cross Section 1- Little Pine Reach 1

44.3	x-section area (ft.sq.)
25.0	width (ft)
1.8	mean depth (ft)
3.5	max depth (ft)
29.5	wetted perimeter (ft)
1.5	hydraulic radius (ft)
14.1	width-depth ratio
105.5	W flood prone area (ft)
4.2	entrenchment ratio
0.9	low bank height ratio

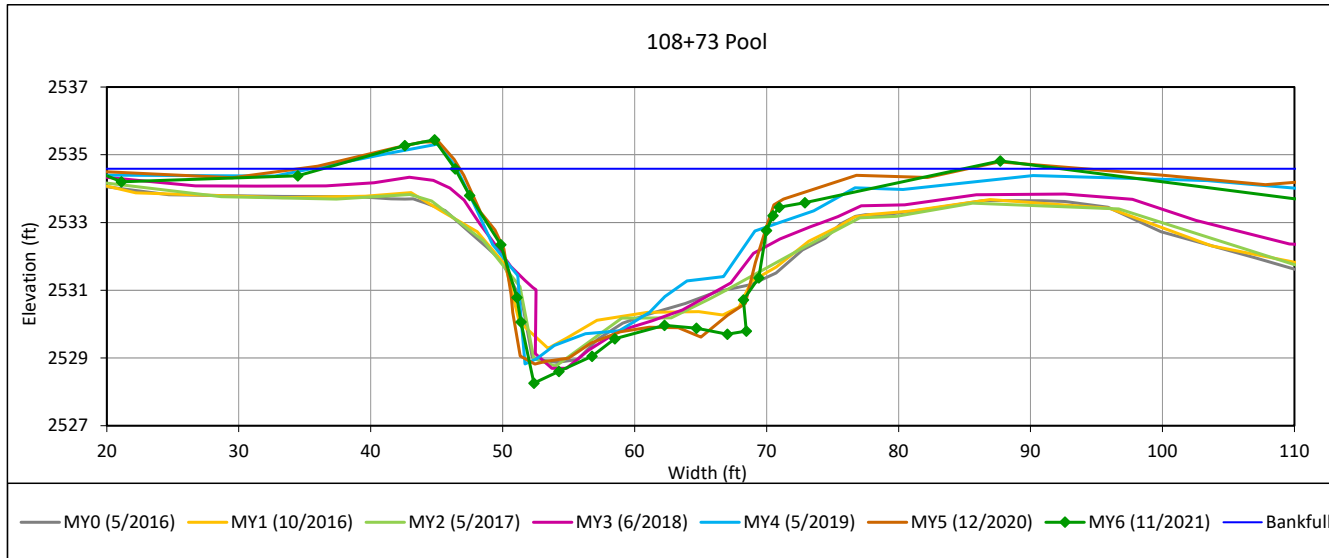
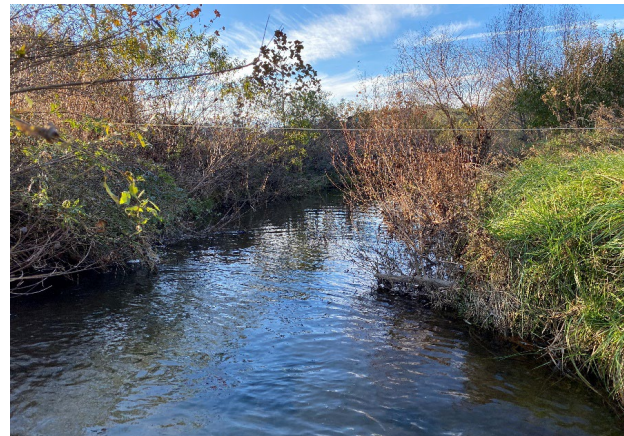
Cross Section 2- Little Pine Reach 1

103.2	x-section area (ft.sq.)
24.6	width (ft)
4.2	mean depth (ft)
6.3	max depth (ft)
30.2	wetted perimeter (ft)
3.4	hydraulic radius (ft)
5.8	width-depth ratio

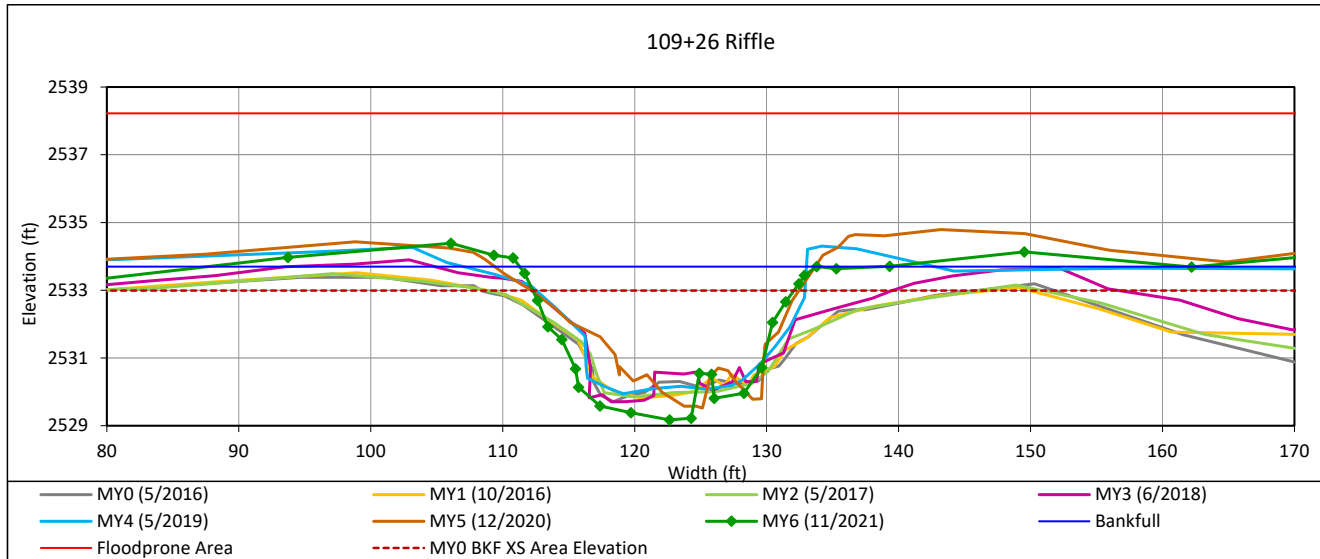
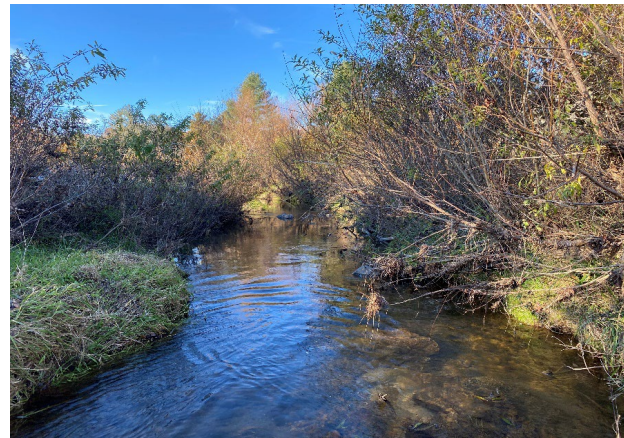
Cross Section 3- Little Pine Reach 1

67.0	x-section area (ft.sq.)
22.5	width (ft)
3.0	mean depth (ft)
4.5	max depth (ft)
26.7	wetted perimeter (ft)
2.5	hydraulic radius (ft)
7.6	width-depth ratio
214.1	W flood prone area (ft)
9.5	entrenchment ratio
1.2	low bank height ratio

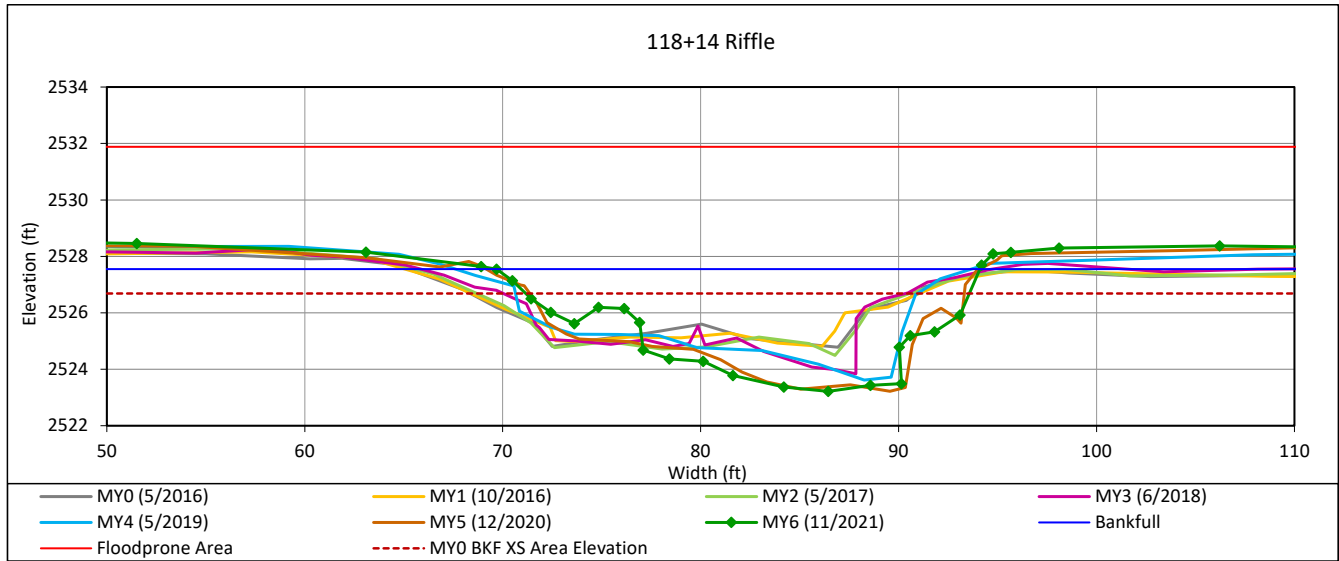
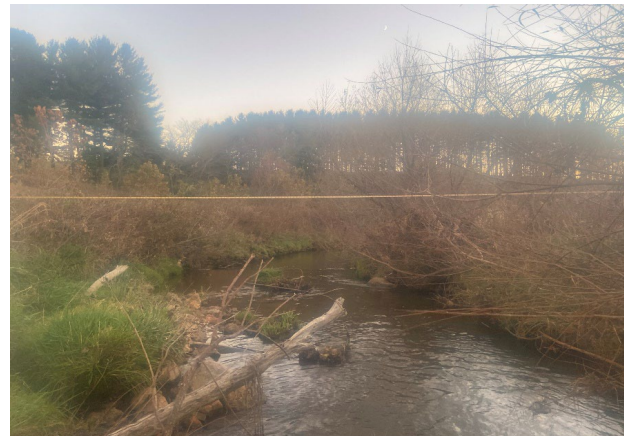
Cross Section 4 - Little Pine Reach 2a

66.8	x-section area (ft.sq.)
24.4	width (ft)
2.7	mean depth (ft)
4.3	max depth (ft)
28.7	wetted perimeter (ft)
2.3	hydraulic radius (ft)
8.9	width-depth ratio
188.7	W flood prone area (ft)
7.7	entrenchment ratio
1.2	low bank height ratio

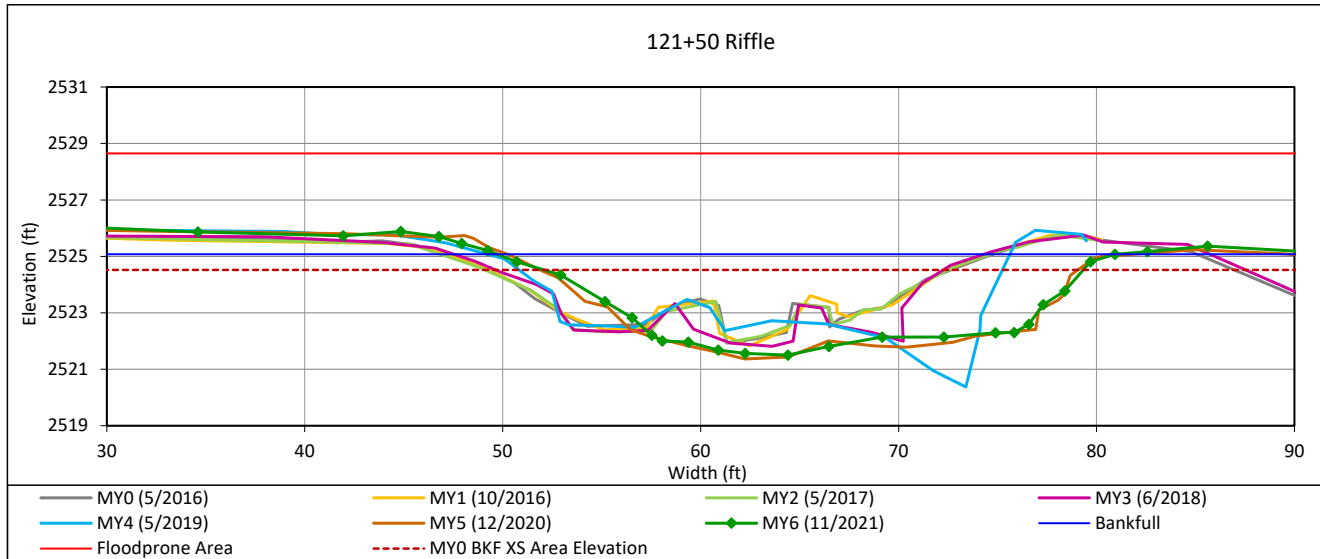
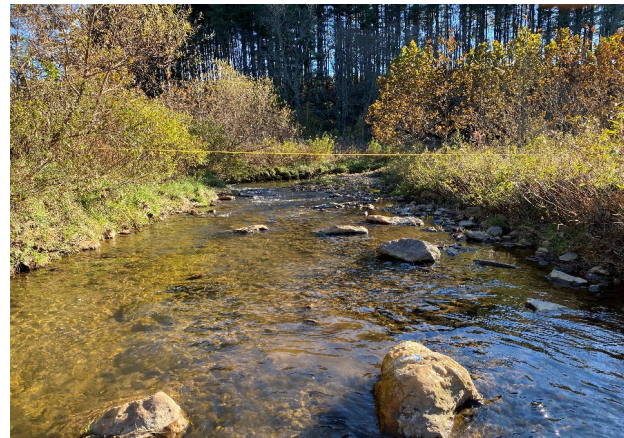
Cross Section 5- Little Pine Reach 2a

73.1	x-section area (ft.sq.)
31.2	width (ft)
2.3	mean depth (ft)
3.6	max depth (ft)
32.7	wetted perimeter (ft)
2.2	hydraulic radius (ft)
13.3	width-depth ratio
93.1	W flood prone area (ft)
3.0	entrenchment ratio
1.2	low bank height ratio

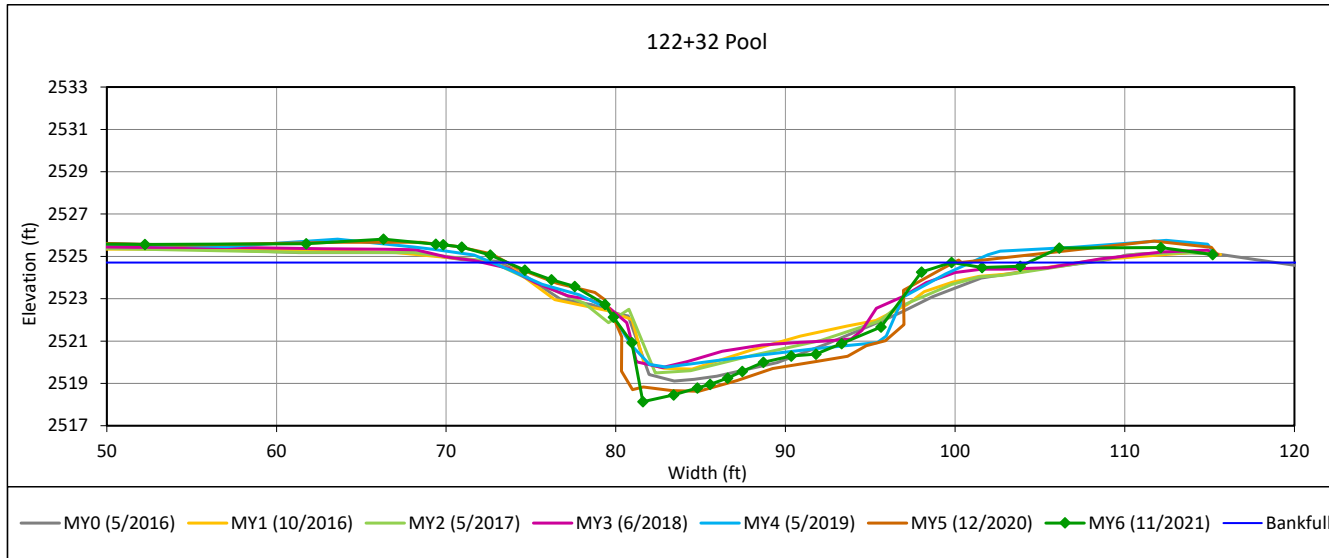
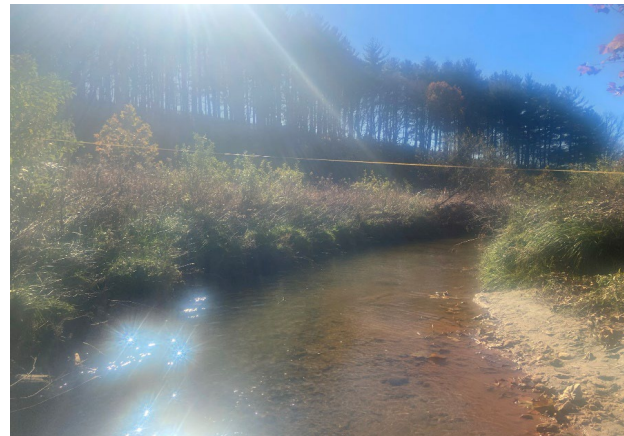
Cross Section 6- Little Pine Reach 2a

86.8	x-section area (ft.sq.)
26.2	width (ft)
3.3	mean depth (ft)
6.6	max depth (ft)
31.2	wetted perimeter (ft)
2.8	hydraulic radius (ft)
7.9	width-depth ratio

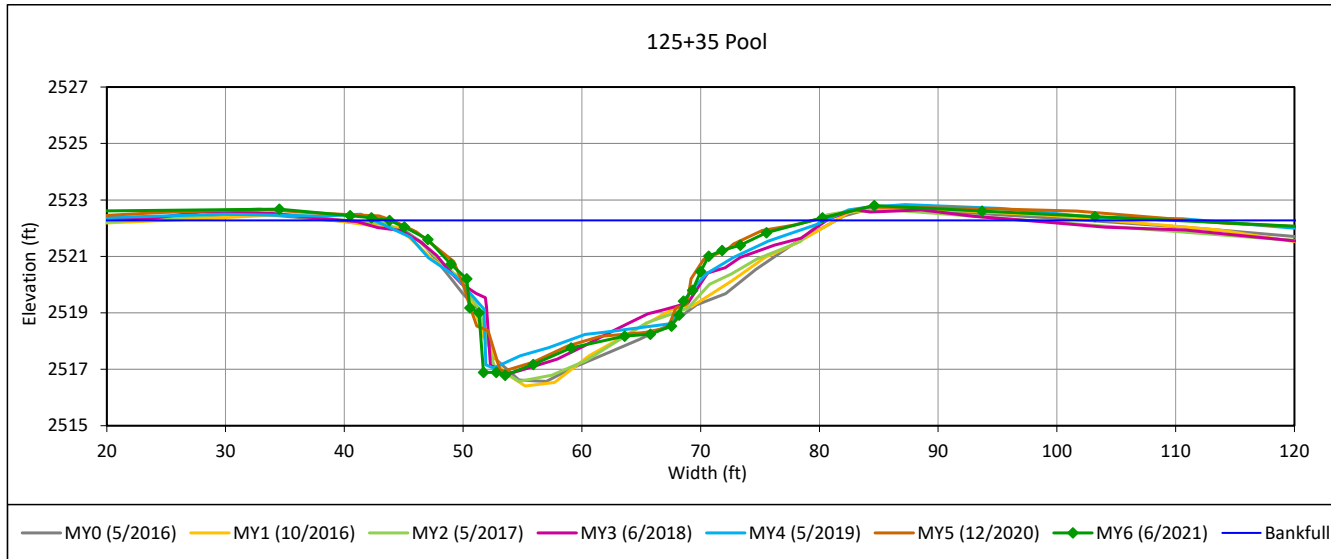
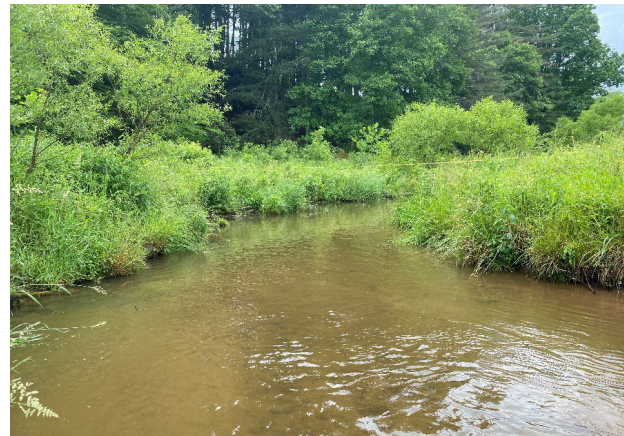
Cross Section 7 - Little Pine Reach 2b

94.0	x-section area (ft.sq.)
29.5	width (ft)
3.2	mean depth (ft)
5.5	max depth (ft)
33.6	wetted perimeter (ft)
2.8	hydraulic radius (ft)
9.3	width-depth ratio

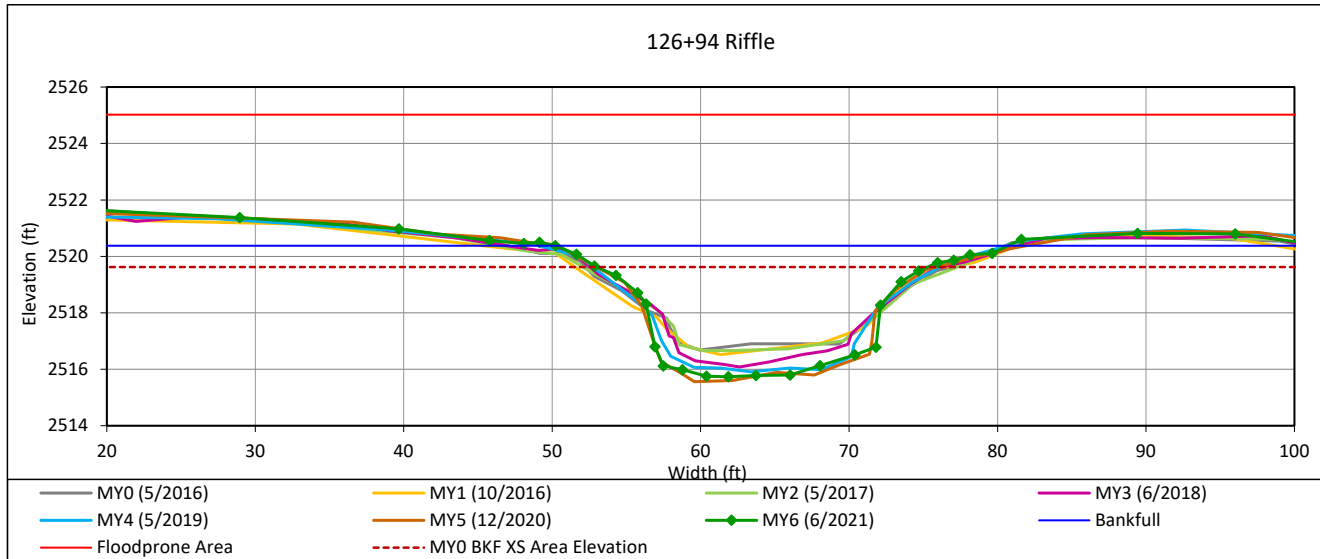
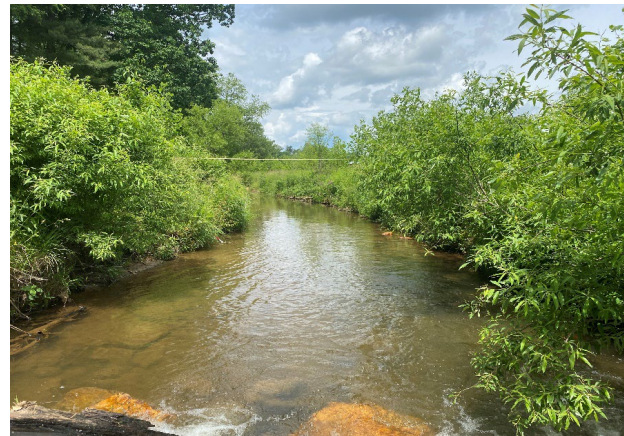
Cross Section 8 - Little Pine Reach 2b

77.7	x-section area (ft.sq.)
26.8	width (ft)
2.9	mean depth (ft)
4.6	max depth (ft)
30.2	wetted perimeter (ft)
2.6	hydraulic radius (ft)
9.3	width-depth ratio
121.4	W flood prone area (ft)
4.5	entrenchment ratio
1.2	low bank height ratio

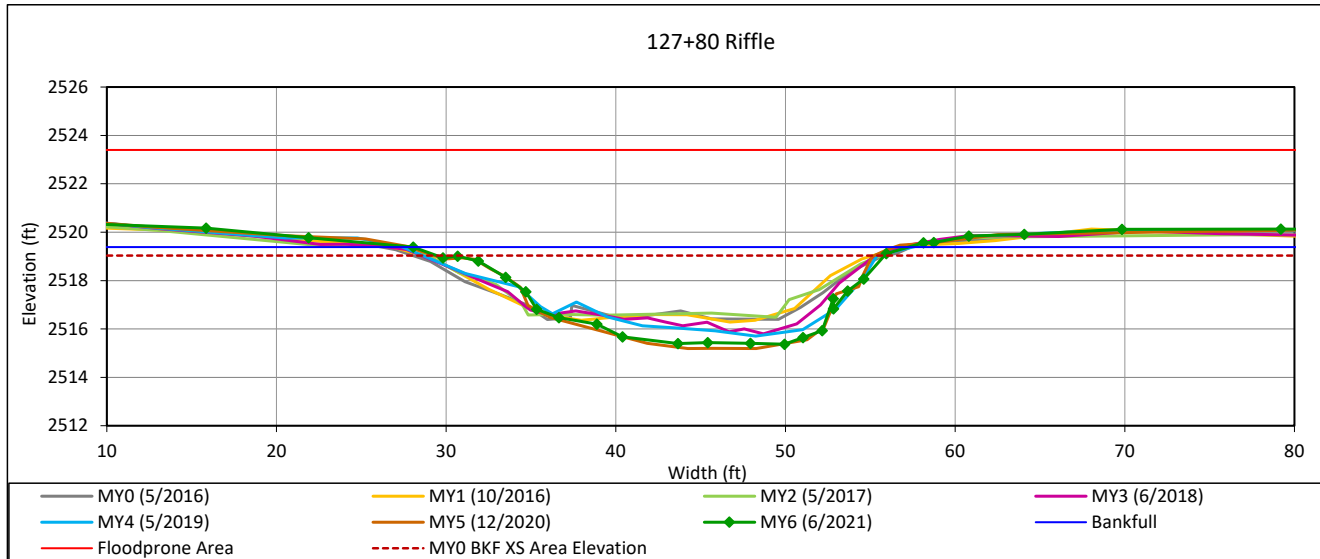
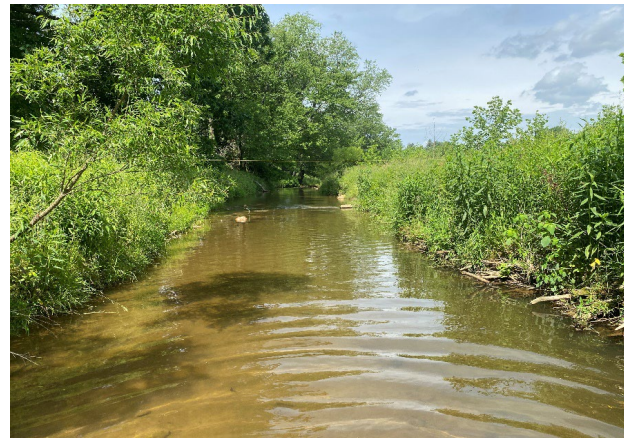
Cross Section 9 - Little Pine Reach 2b

73.9	x-section area (ft.sq.)
29.2	width (ft)
2.5	mean depth (ft)
4.0	max depth (ft)
32.1	wetted perimeter (ft)
2.3	hydraulic radius (ft)
11.5	width-depth ratio
110.0	W flood prone area (ft)
3.8	entrenchment ratio
1.1	low bank height ratio

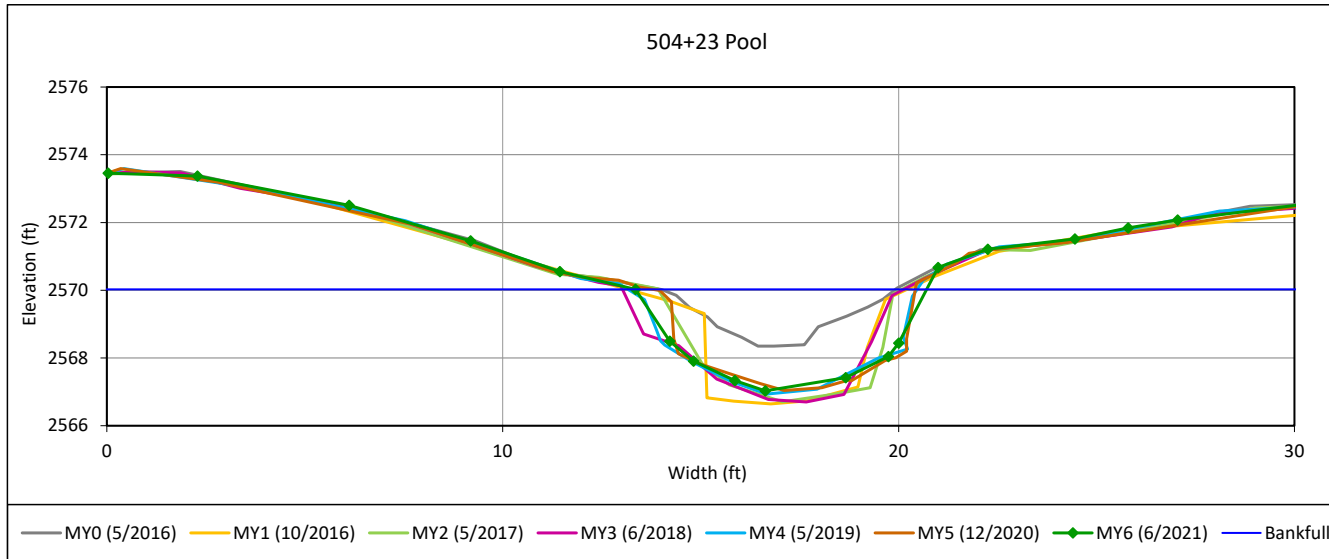
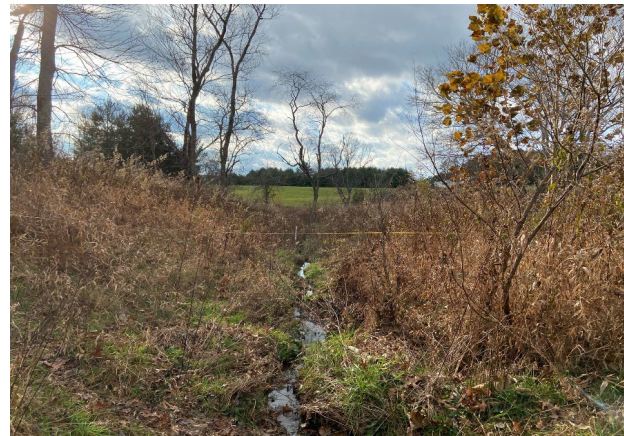
Cross Section 10 - UT2b

15.6	x-section area (ft.sq.)
7.4	width (ft)
2.1	mean depth (ft)
3.0	max depth (ft)
10.1	wetted perimeter (ft)
1.5	hydraulic radius (ft)
3.5	width-depth ratio

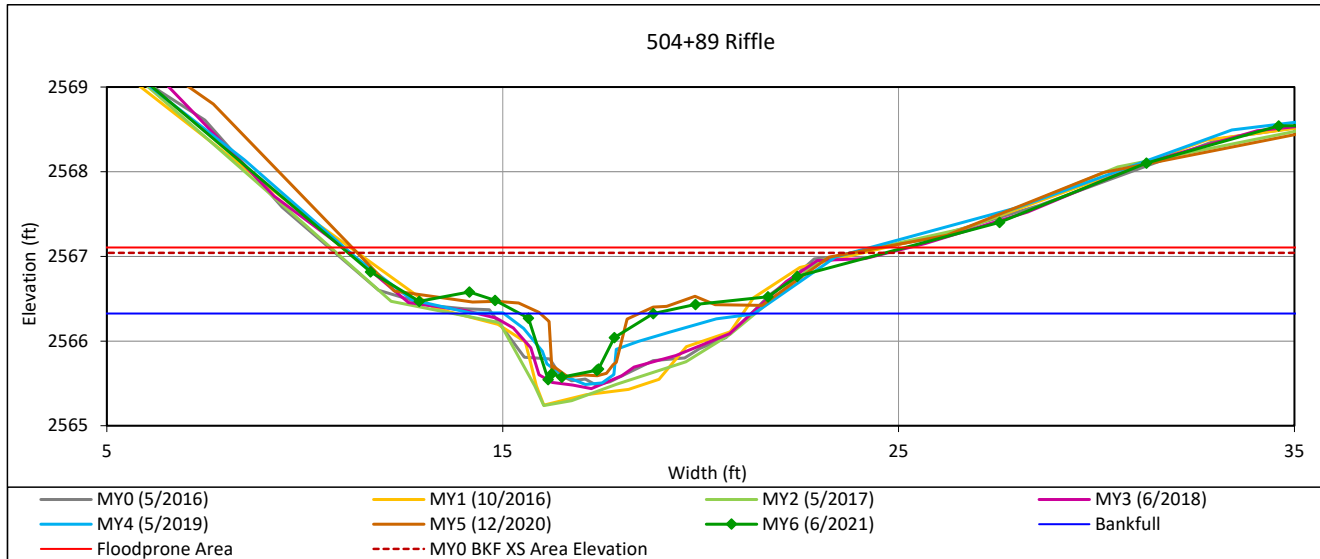
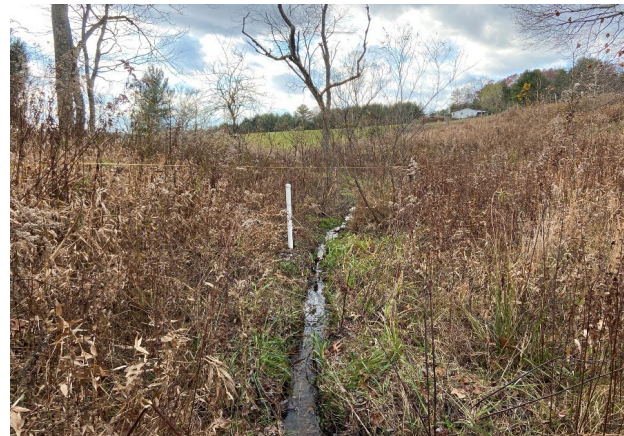
Cross Section 11 - UT2b

1.4	x-section area (ft.sq.)
3.4	width (ft)
0.4	mean depth (ft)
0.8	max depth (ft)
4.0	wetted perimeter (ft)
0.4	hydraulic radius (ft)
7.8	width-depth ratio
14.2	W flood prone area (ft)
4.2	entrenchment ratio
0.5	low bank height ratio

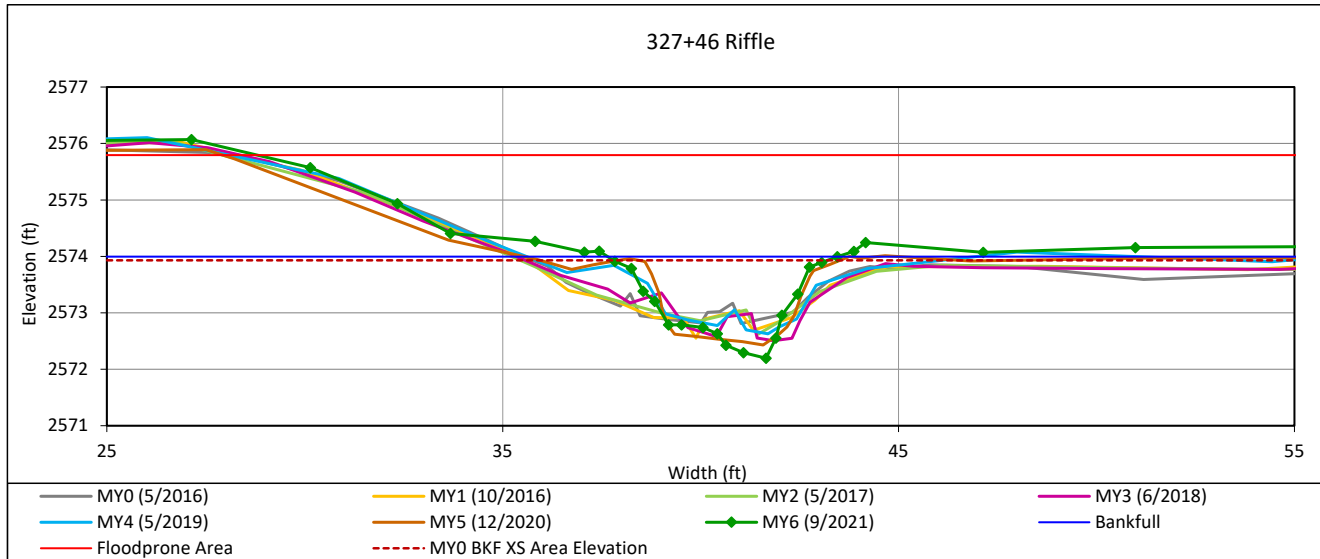
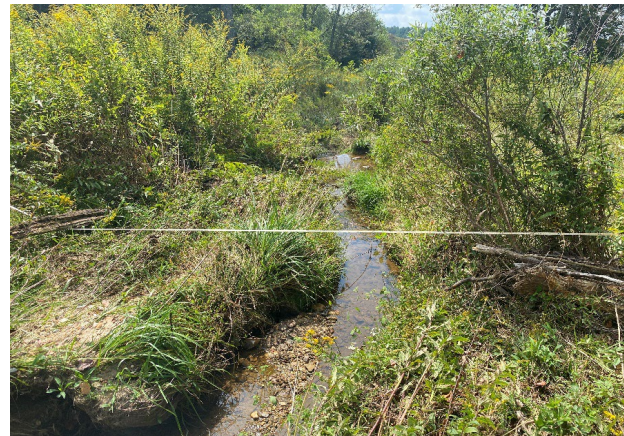
Cross Section 12 - UT2

5.4	x-section area (ft.sq.)
5.8	width (ft)
0.9	mean depth (ft)
1.8	max depth (ft)
7.3	wetted perimeter (ft)
0.7	hydraulic radius (ft)
6.2	width-depth ratio
34.1	W flood prone area (ft)
5.9	entrenchment ratio
1.0	low bank height ratio

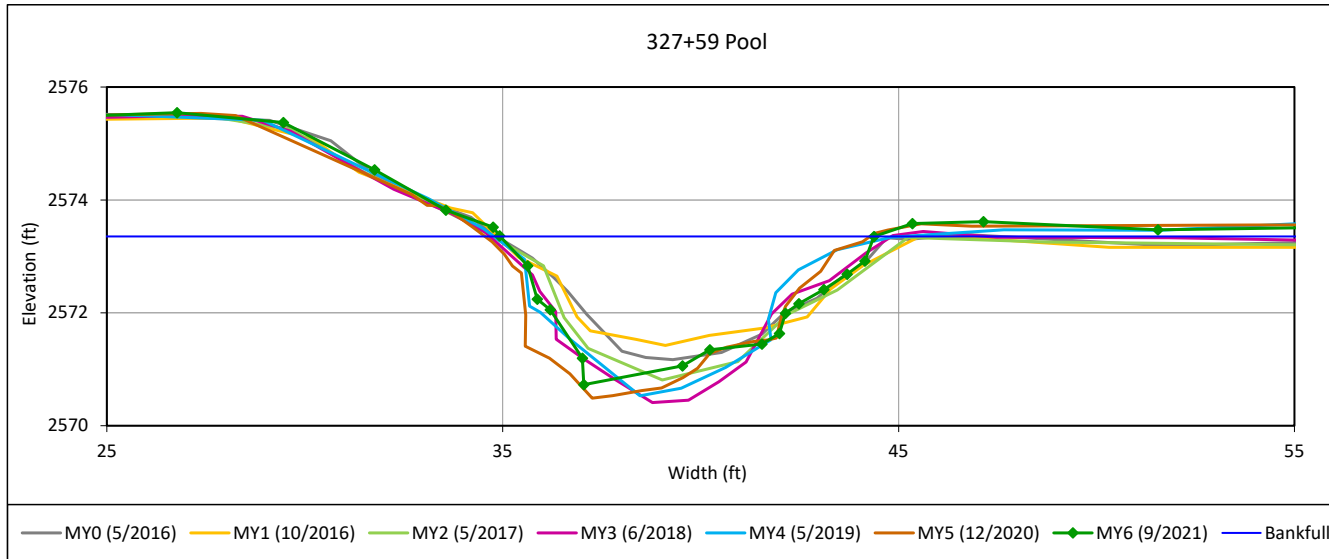
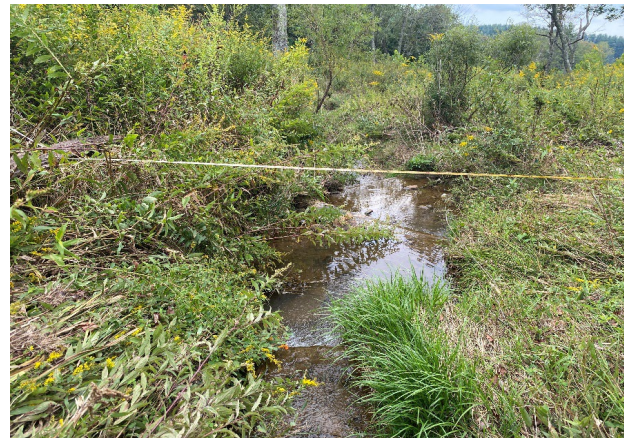
Cross Section 13 - UT2

15.4	x-section area (ft.sq.)
9.4	width (ft)
1.6	mean depth (ft)
2.6	max depth (ft)
11.7	wetted perimeter (ft)
1.3	hydraulic radius (ft)
5.8	width-depth ratio

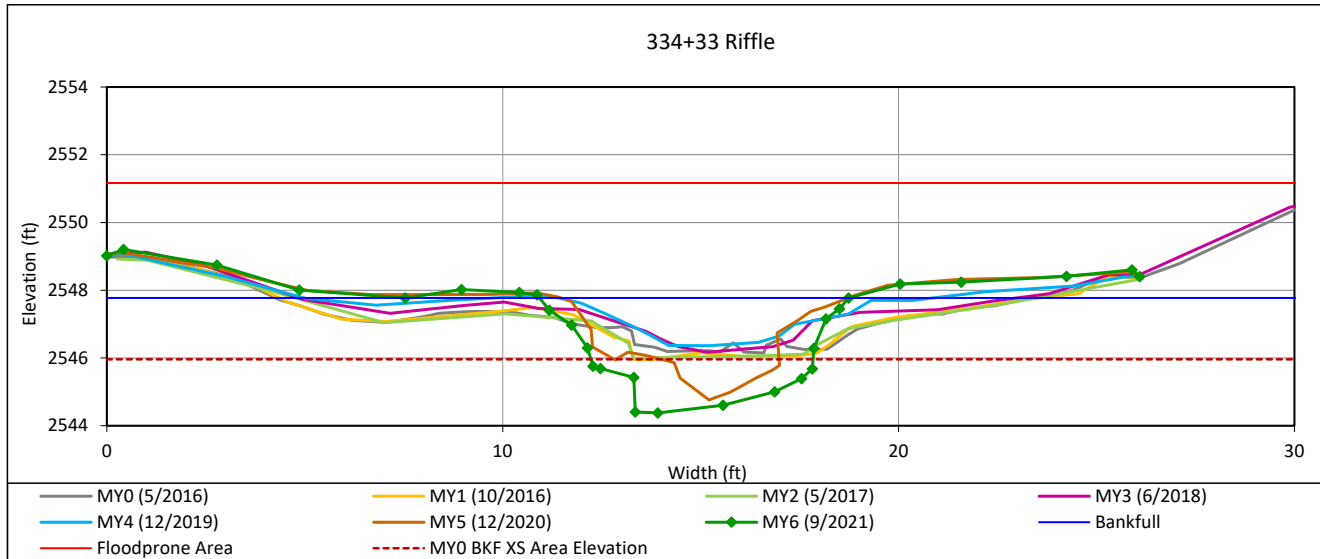
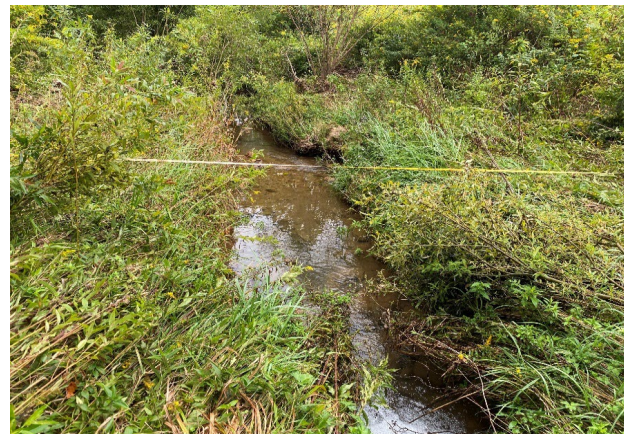
Cross Section 14 - UT2

17.6	x-section area (ft.sq.)
7.8	width (ft)
2.3	mean depth (ft)
3.4	max depth (ft)
11.7	wetted perimeter (ft)
1.5	hydraulic radius (ft)
3.5	width-depth ratio
26.0	W flood prone area (ft)
3.3	entrenchment ratio
2.1	low bank height ratio

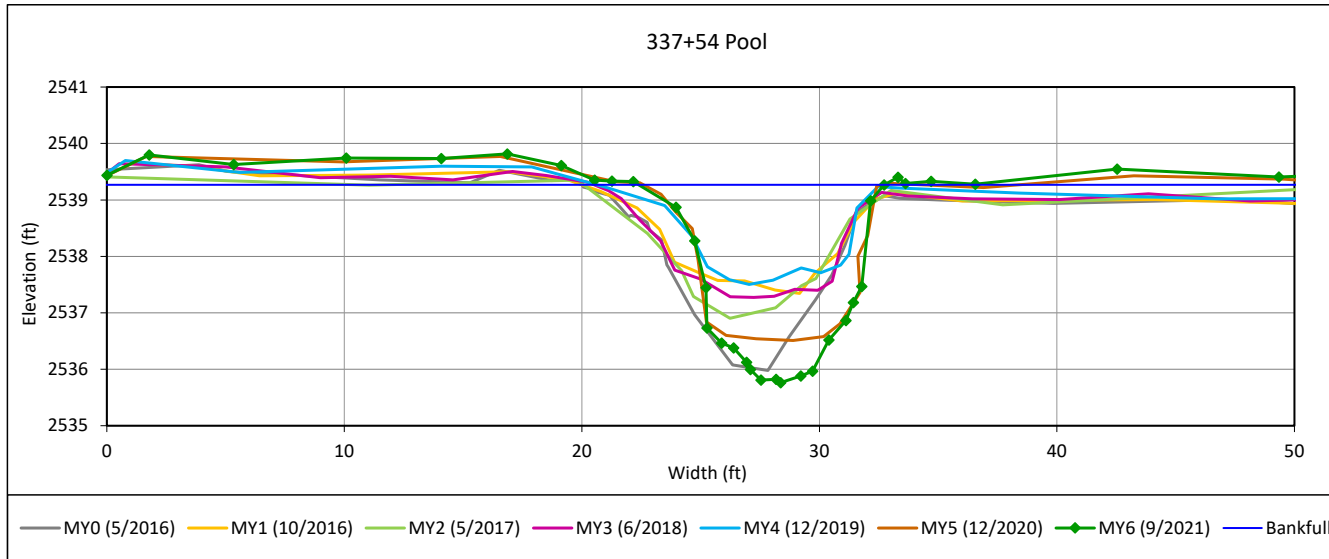
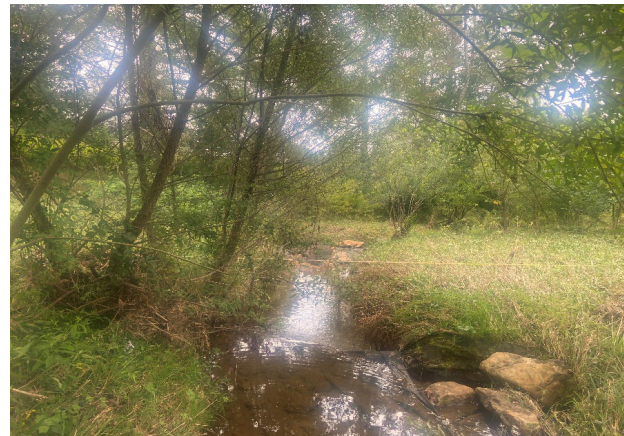
Cross Section 15 - UT2

21.6	x-section area (ft.sq.)
10.3	width (ft)
2.1	mean depth (ft)
3.5	max depth (ft)
13.7	wetted perimeter (ft)
1.6	hydraulic radius (ft)
4.9	width-depth ratio
