MONITORING YEAR 7 ANNUAL/CLOSEOUT REPORT

LITTLE PINE III STREAM AND WETLAND RESTORATION PROJECT

Alleghany County, NC
NCDEQ Contract 6844
DMS Project Number 94903
DWR # 14-0041
USACE Action ID 2012-01299

Data Collection Period: August - December 2022
Draft Submission Date: January 26, 2023
Final Submission Date: February 23, 2023

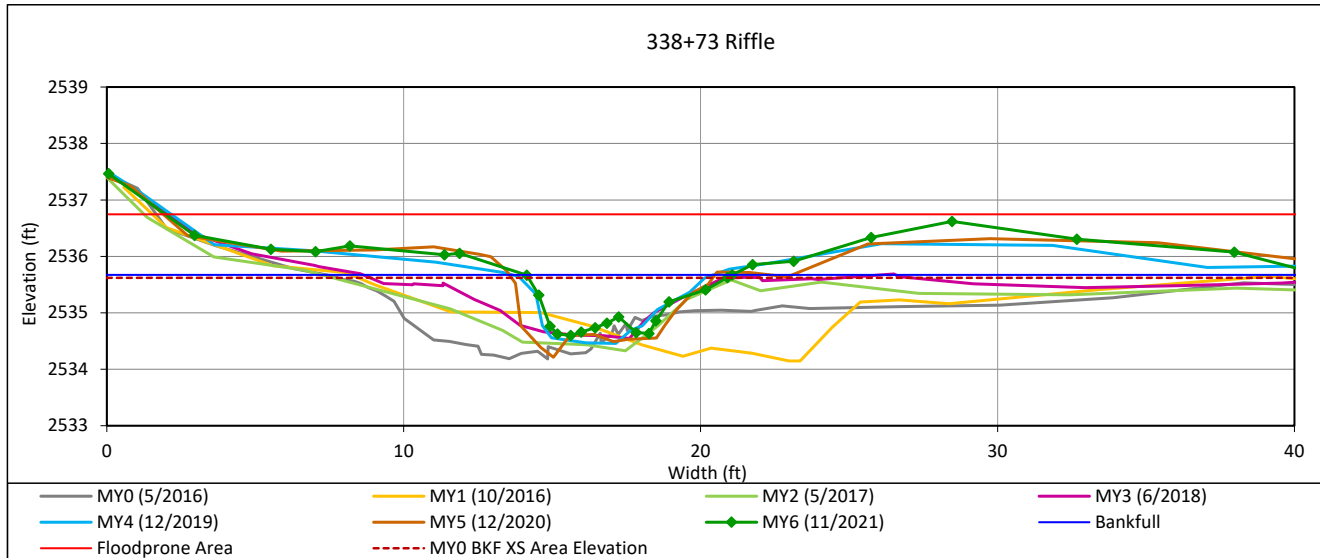
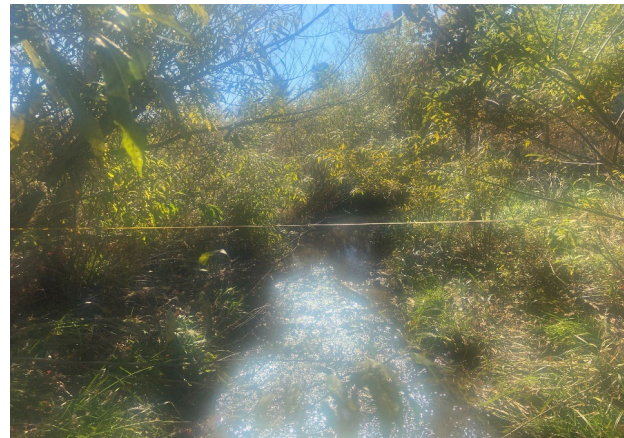
Cross Section 16 - UT2

4.6	x-section area (ft.sq.)
6.9	width (ft)
0.7	mean depth (ft)
1.1	max depth (ft)
7.8	wetted perimeter (ft)
0.6	hydraulic radius (ft)
10.5	width-depth ratio
40.6	W flood prone area (ft)
5.9	entrenchment ratio
1.1	low bank height ratio

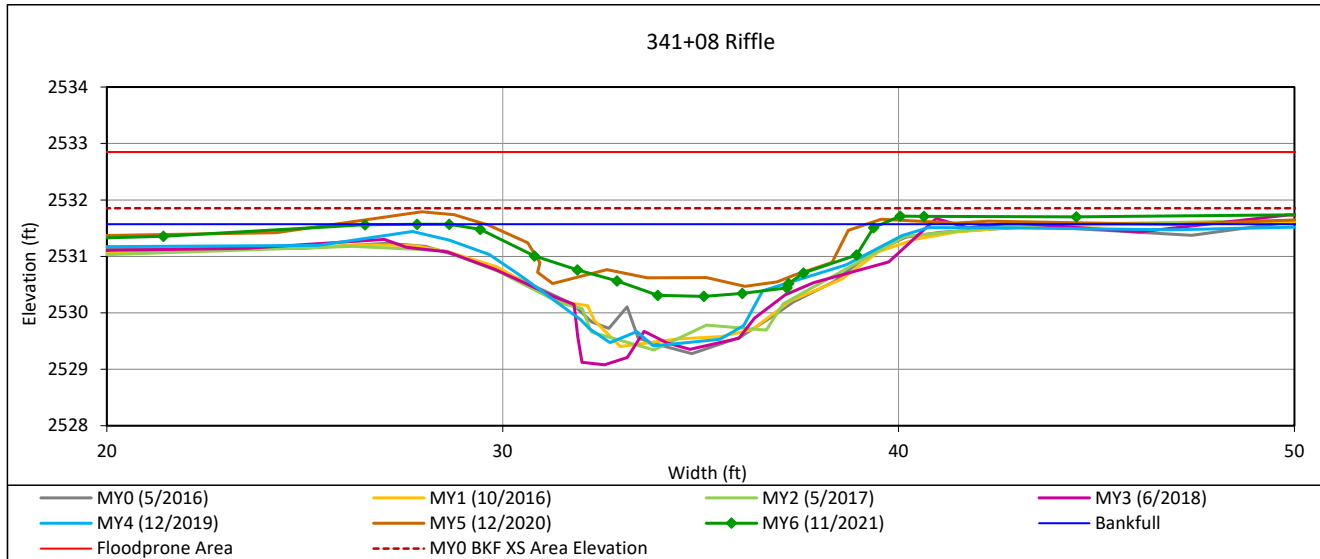
Cross Section 17 - UT2

8.8	x-section area (ft.sq.)
10.9	width (ft)
0.8	mean depth (ft)
1.3	max depth (ft)
11.4	wetted perimeter (ft)
0.8	hydraulic radius (ft)
13.5	width-depth ratio
71.0	W flood prone area (ft)
6.5	entrenchment ratio
0.8	low bank height ratio

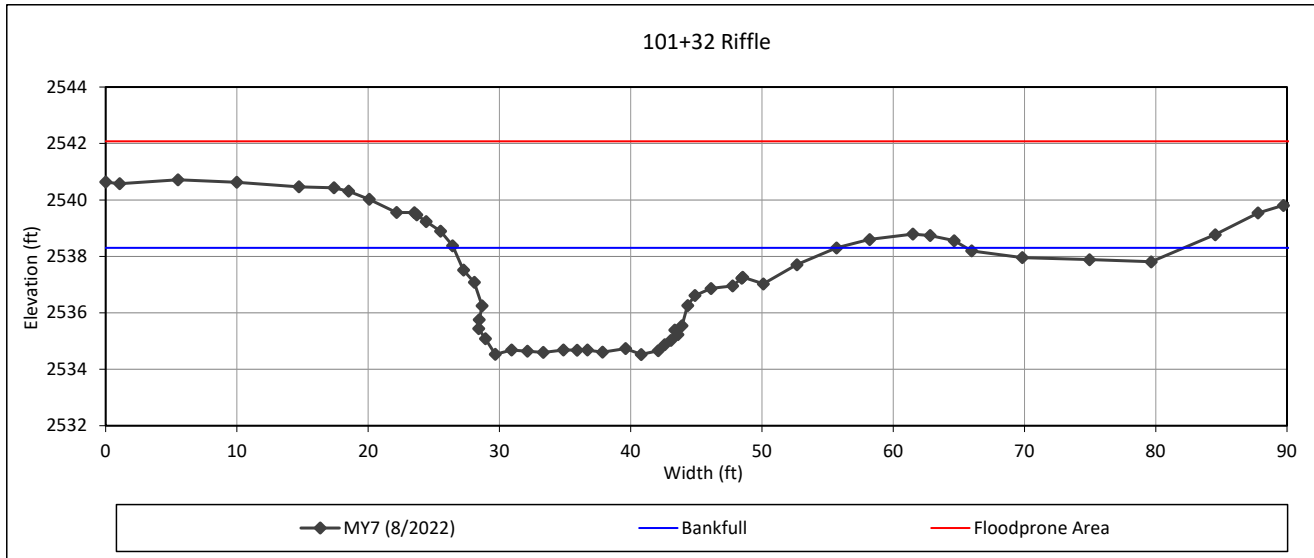
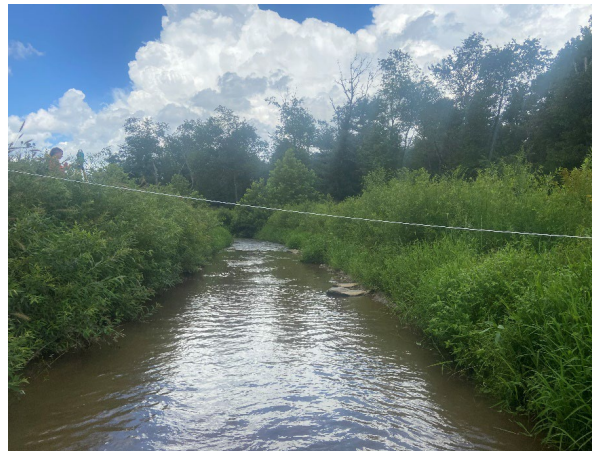
Cross Section R1 - Little Pine Reach 1

69.3	x-section area (ft.sq.)
29.2	width (ft)
2.4	mean depth (ft)
3.8	max depth (ft)
32.9	wetted perimeter (ft)
2.1	hydraulic radius (ft)
12.3	width-depth ratio
91.3	W flood prone area (ft)
3.1	entrenchment ratio
1.0	low bank height ratio

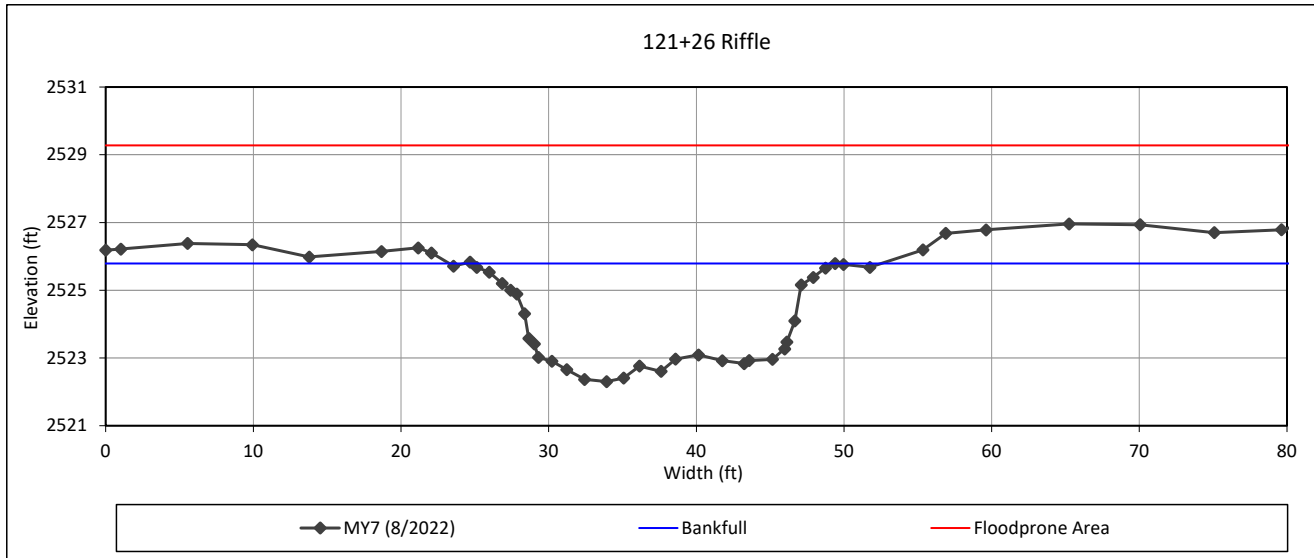
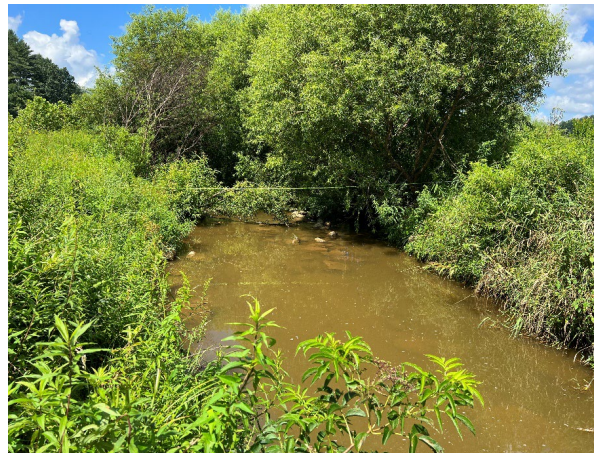
Cross Section R2 - Little Pine Reach 2a

57.0	x-section area (ft.sq.)
24.6	width (ft)
2.3	mean depth (ft)
3.5	max depth (ft)
27.2	wetted perimeter (ft)
2.1	hydraulic radius (ft)
10.6	width-depth ratio
80.6	W flood prone area (ft)
3.3	entrenchment ratio
1.0	low bank height ratio

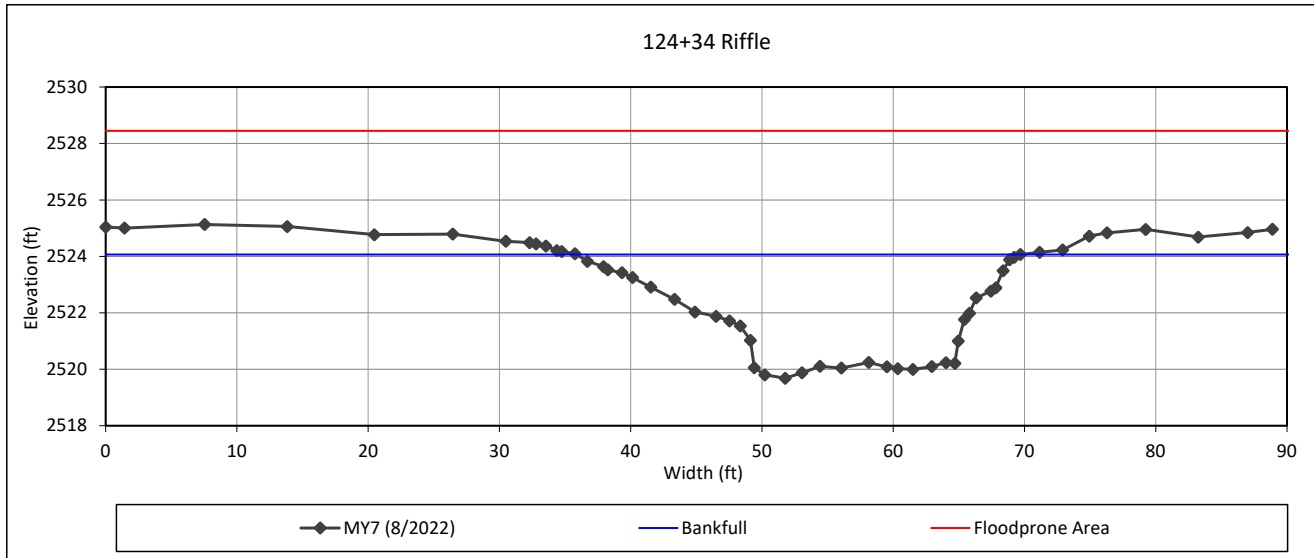
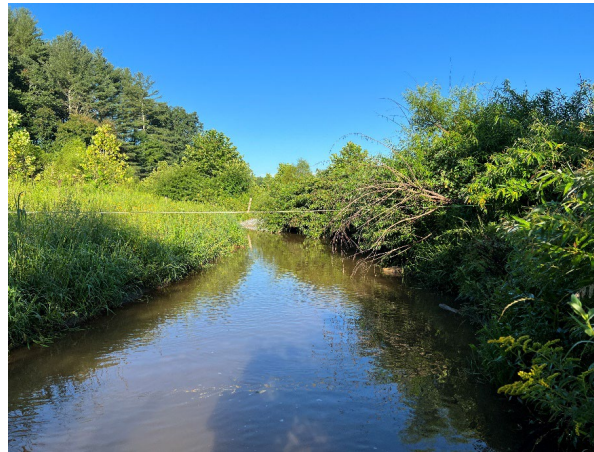
Cross Section R3 - Little Pine Reach 2a

88.0	x-section area (ft.sq.)
33.8	width (ft)
2.6	mean depth (ft)
4.4	max depth (ft)
36.9	wetted perimeter (ft)
2.4	hydraulic radius (ft)
13.0	width-depth ratio
88.9	W flood prone area (ft)
2.6	entrenchment ratio
1.0	low bank height ratio

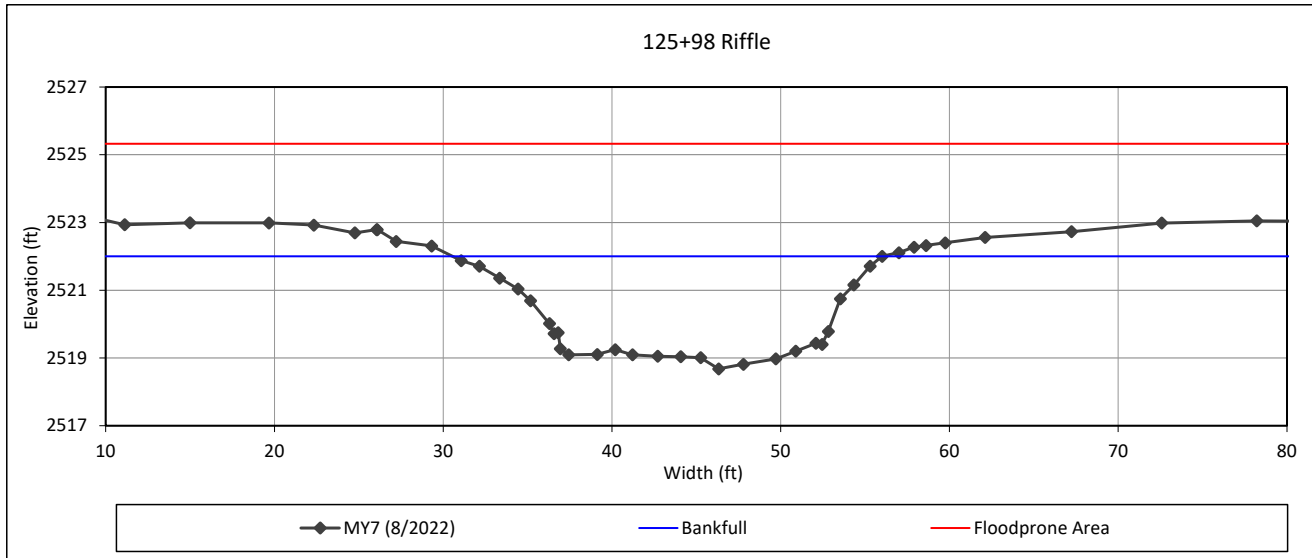
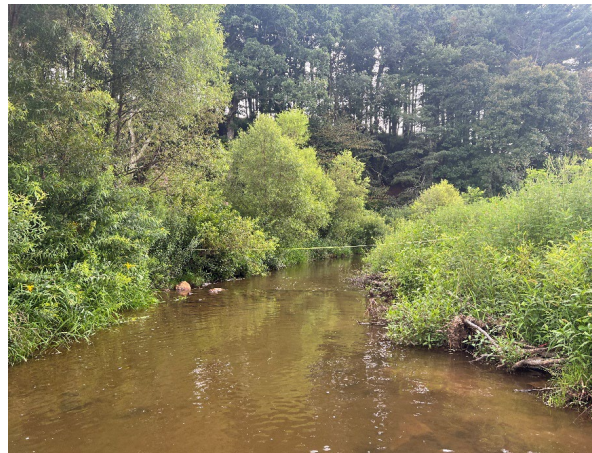
Cross Section R4 - Little Pine Reach 2b

55.3	x-section area (ft.sq.)
25.5	width (ft)
2.2	mean depth (ft)
3.3	max depth (ft)
27.5	wetted perimeter (ft)
2.0	hydraulic radius (ft)
11.7	width-depth ratio
86.9	W flood prone area (ft)
3.4	entrenchment ratio
1.0	low bank height ratio

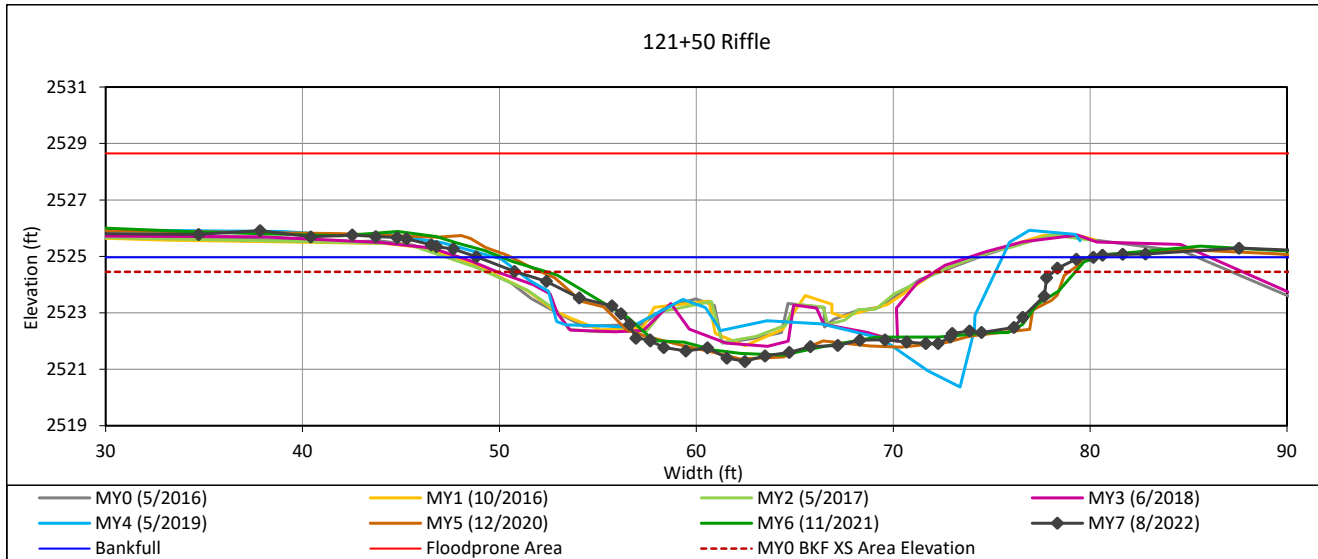
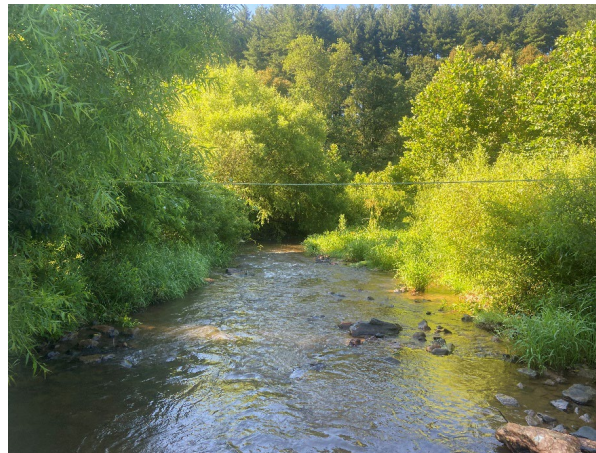
Cross Section 5- Little Pine Reach 2a

71.8	x-section area (ft.sq.)
31.3	width (ft)
2.3	mean depth (ft)
3.7	max depth (ft)
33.4	wetted perimeter (ft)
2.2	hydraulic radius (ft)
13.6	width-depth ratio
71.5	W flood prone area (ft)
2.3	entrenchment ratio
1.2	low bank height ratio

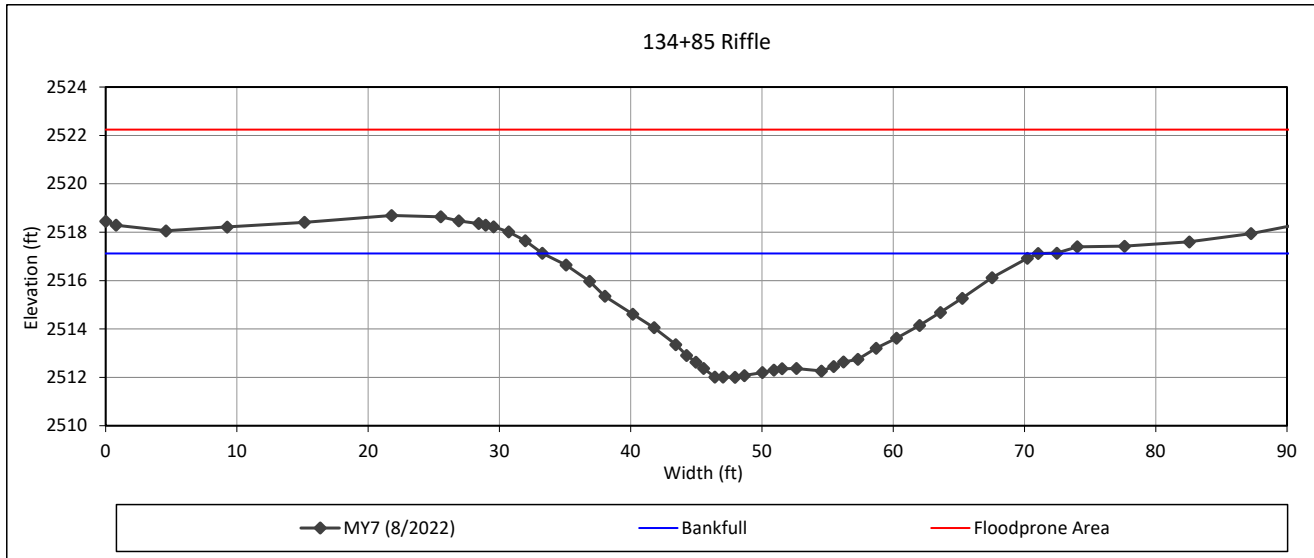
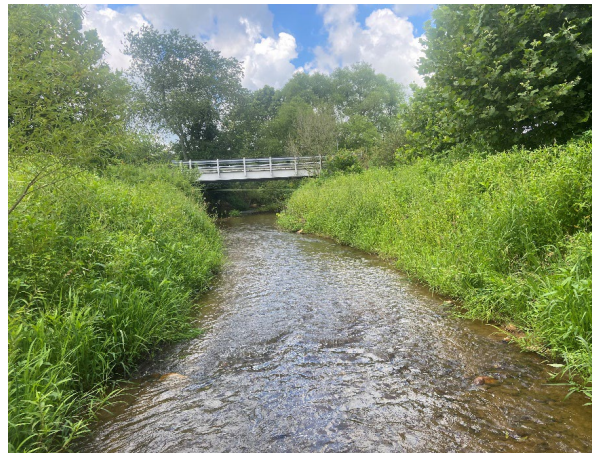
Cross Section R6 - Little Pine Reach 2b

114.2	x-section area (ft.sq.)
37.7	width (ft)
3.0	mean depth (ft)
5.1	max depth (ft)
39.5	wetted perimeter (ft)
2.9	hydraulic radius (ft)
12.5	width-depth ratio
91.7	W flood prone area (ft)
2.4	entrenchment ratio
1.0	low bank height ratio

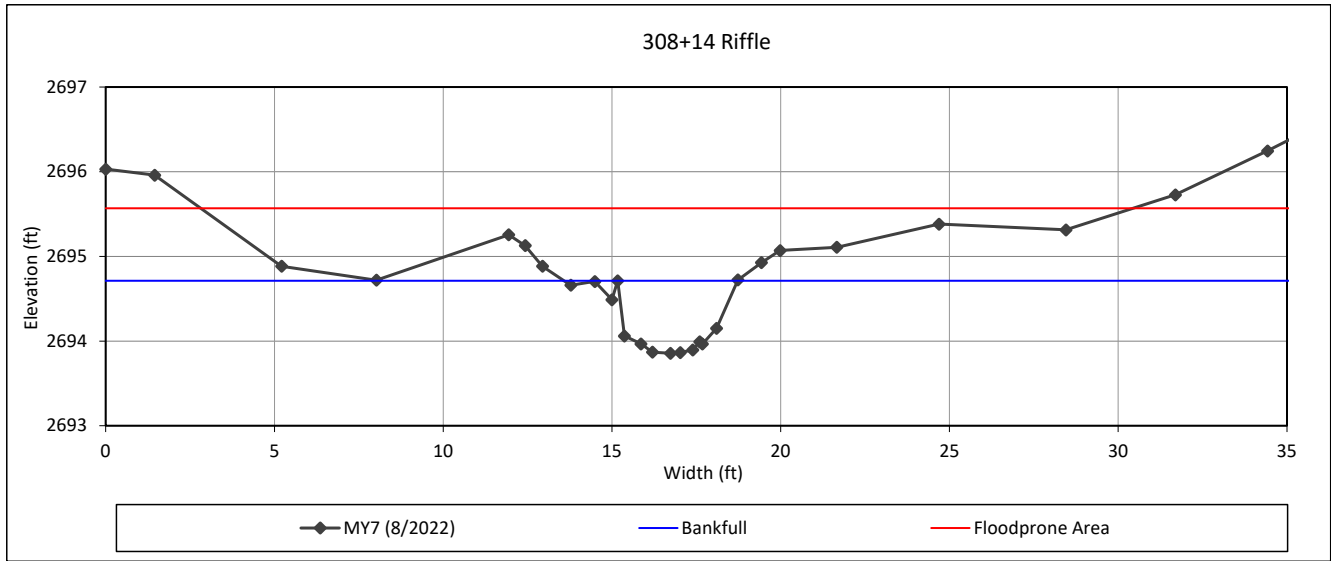
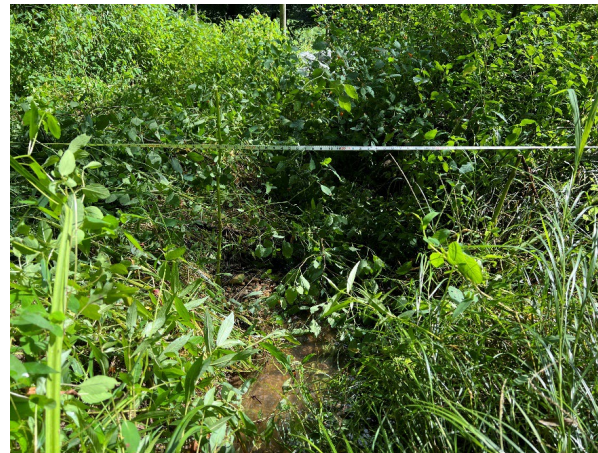
Cross Section R7 - UT2 Reach 1 Upper

2.4	x-section area (ft.sq.)
3.5	width (ft)
0.7	mean depth (ft)
0.9	max depth (ft)
4.3	wetted perimeter (ft)
0.5	hydraulic radius (ft)
5.4	width-depth ratio
27.9	W flood prone area (ft)
7.9	entrenchment ratio
1.0	low bank height ratio

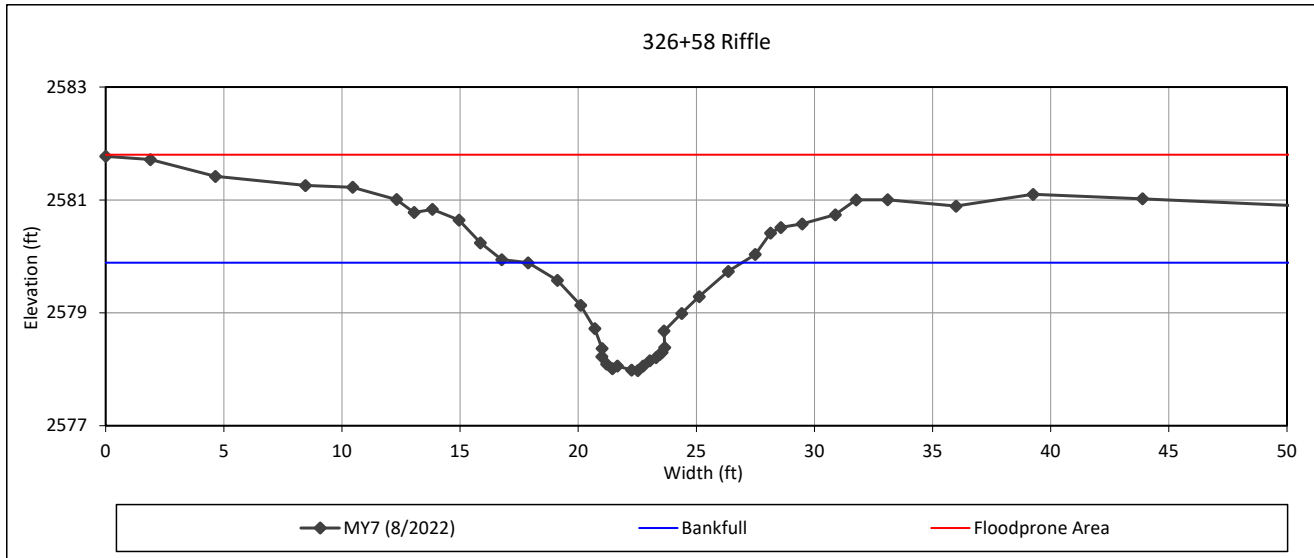
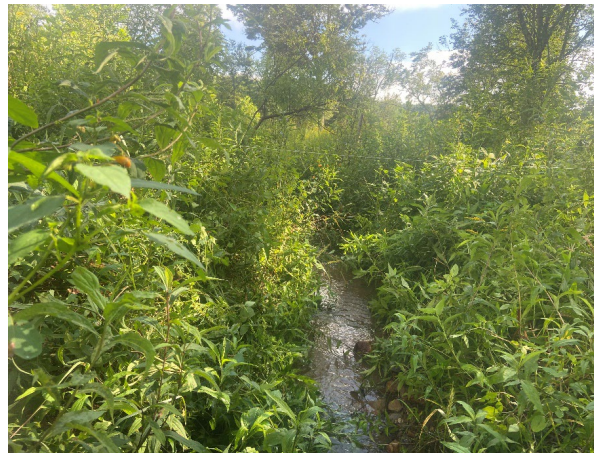
Cross Section R8 - UT2 Reach 1 Lower

8.3	x-section area (ft.sq.)
9.1	width (ft)
0.9	mean depth (ft)
1.9	max depth (ft)
10.3	wetted perimeter (ft)
0.8	hydraulic radius (ft)
9.9	width-depth ratio
62.4	W flood prone area (ft)
6.9	entrenchment ratio
1.0	low bank height ratio
