MONITORING YEAR 5 ANNUAL REPORT

LITTLE PINE III STREAM AND WETLAND RESTORATION PROJECT

Alleghany County, NC

DMS Project Number 94903

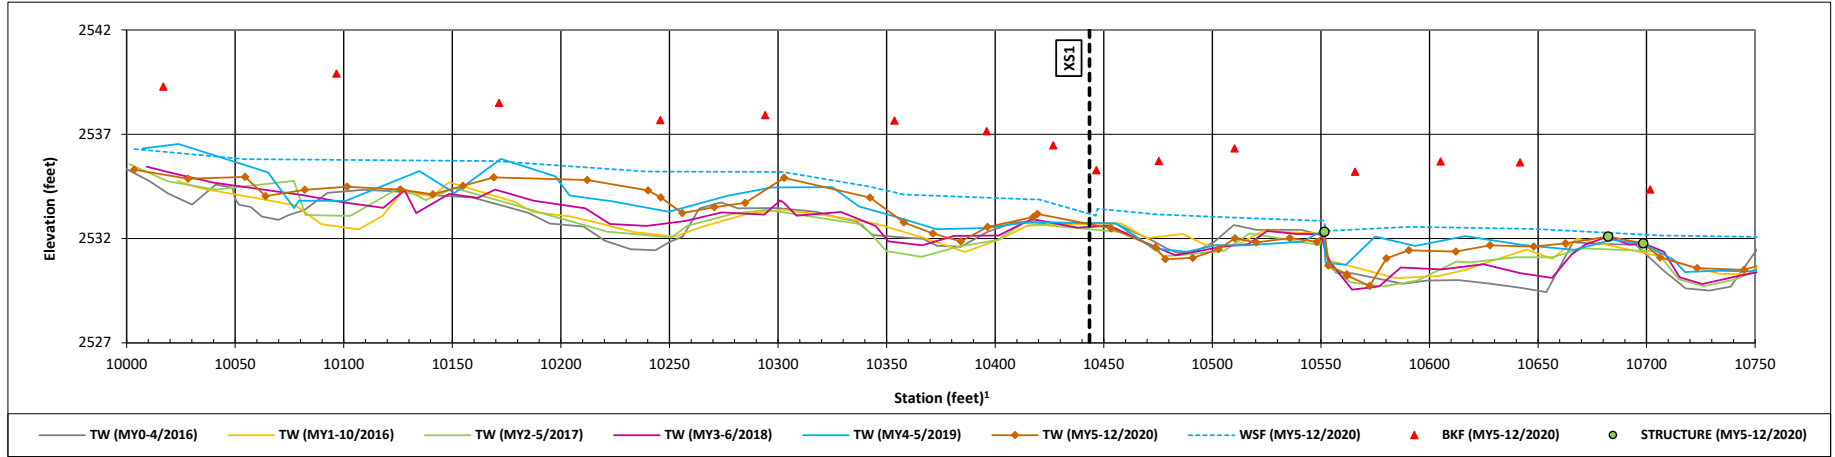
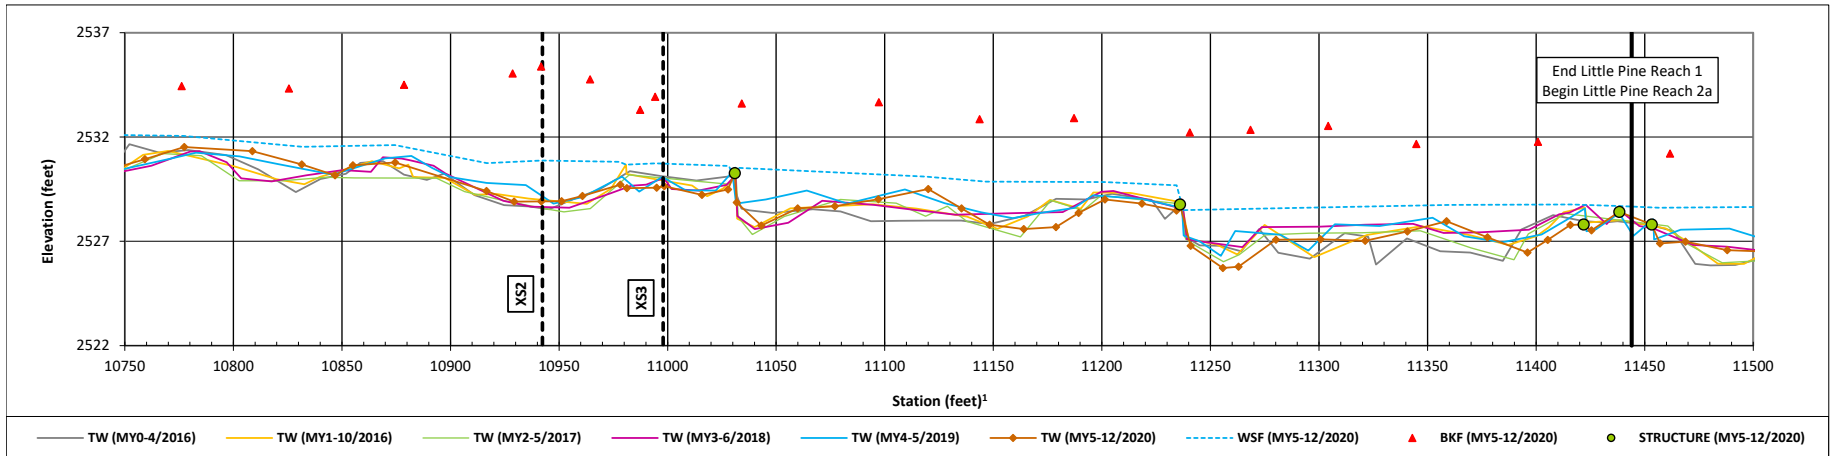
Little Pine Reach 1 (STA 100+00 - 114+44)

² Stream repairs completed in fall 2020 on Little Pine Creek Reach 1 (STA 100+43 to 101+75) and Reach 2a (STA 121+25 to 122+50).

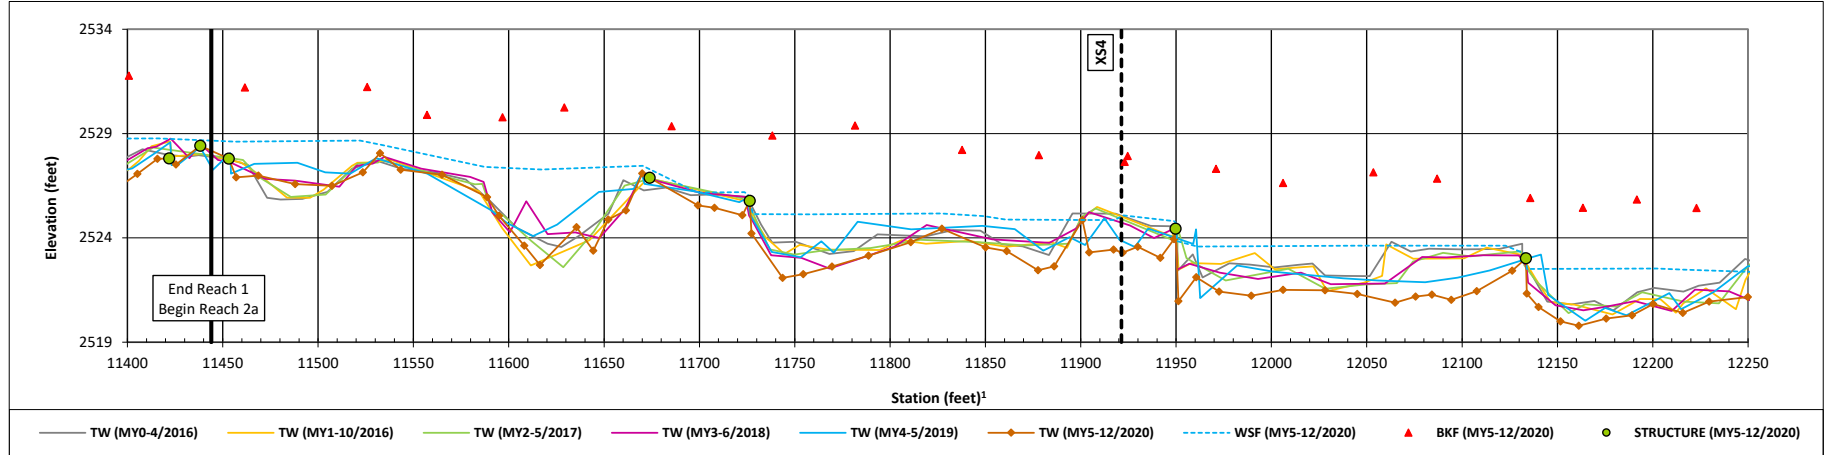
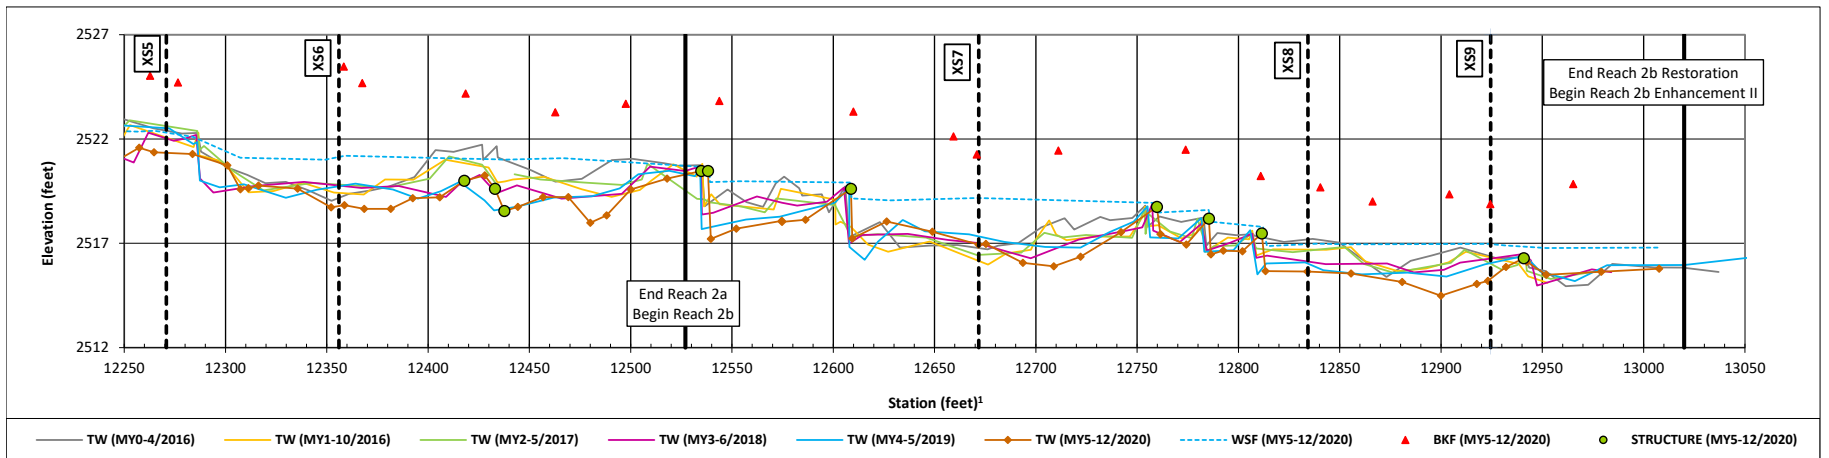
Little Pine Reach 2a (114+44-125+27) and Reach 2b (125+27-130+20)

² Stream repairs completed in fall 2020 on Little Pine Creek Reach 1 (STA 100+43 to 101+75) and Reach 2a (STA 121+25 to 122+50).

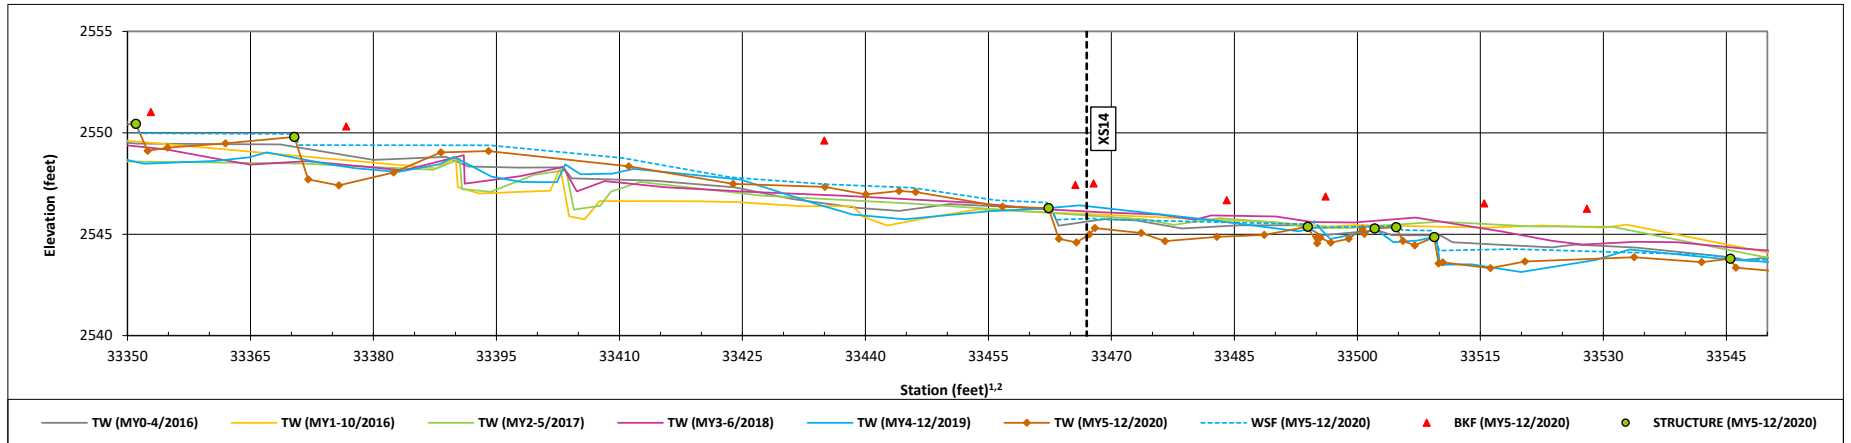
UT2 Reach 2 (STA 330+00 - 343+18)

² Stream repairs completed in September 2019 on UT2 Reach 2 STA 332+25 to 339+15.

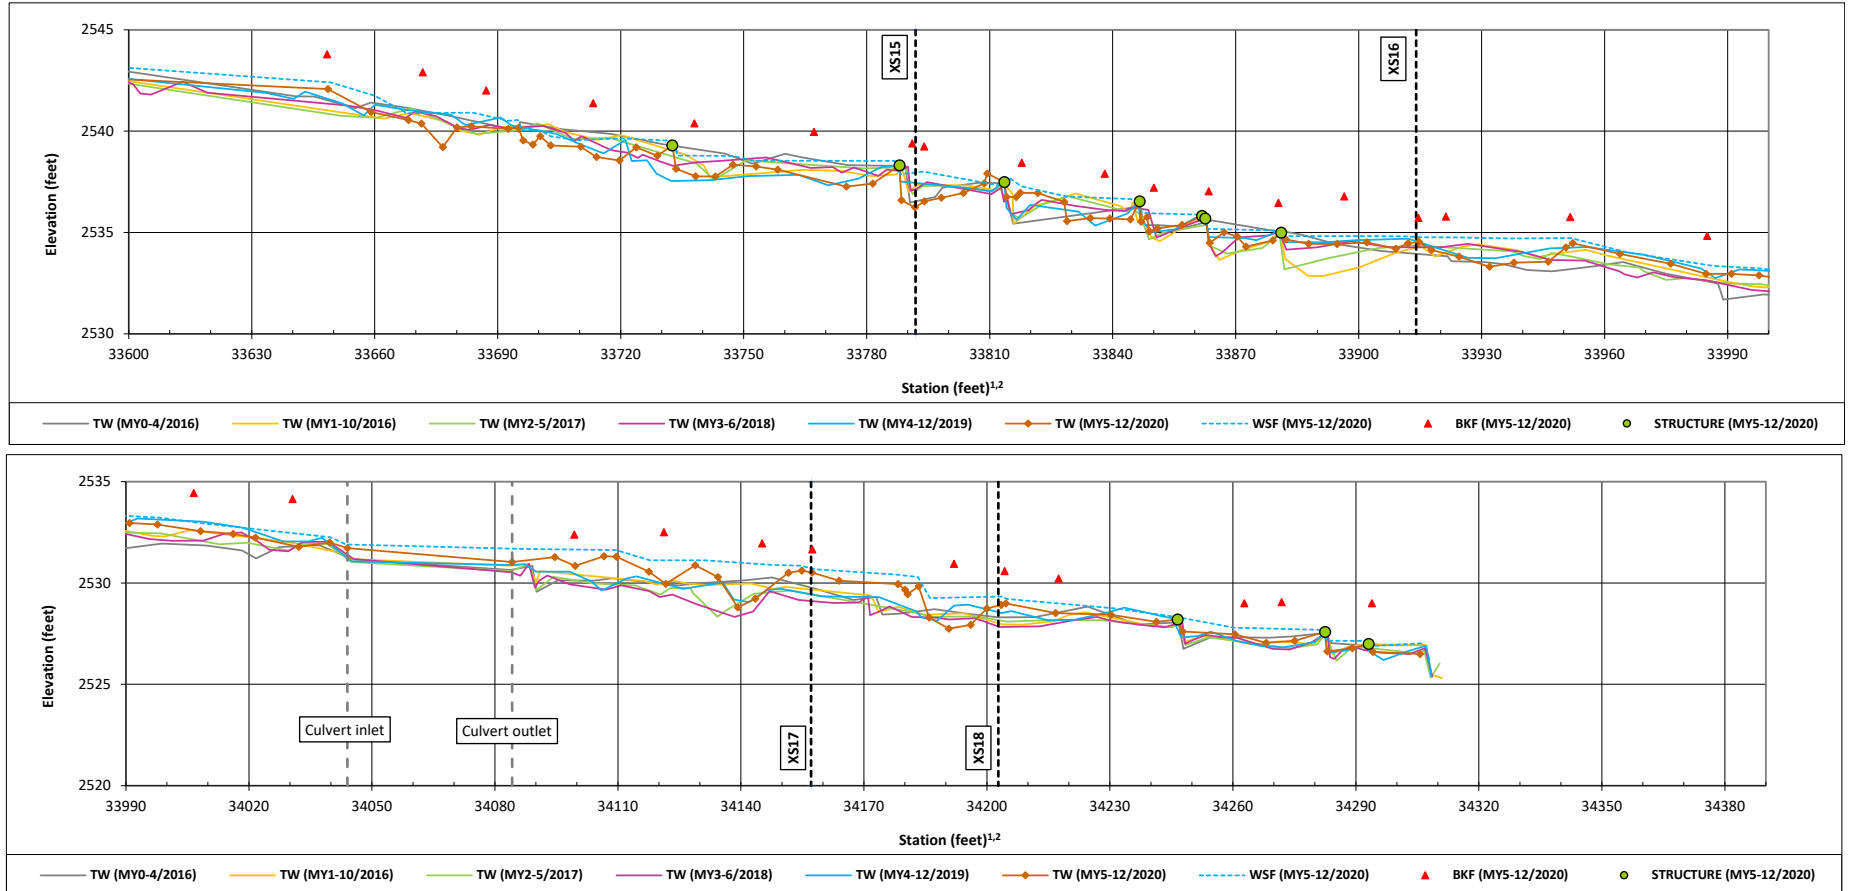
UT2 Reach 2 (STA 330+00 - 343+18)

² Stream repairs completed in September 2019 on UT2 Reach 2 STA 332+25 to 339+15.

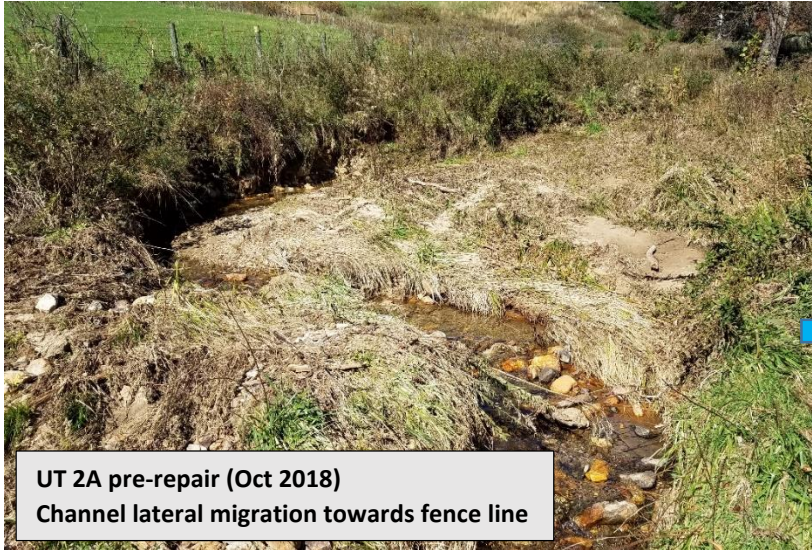
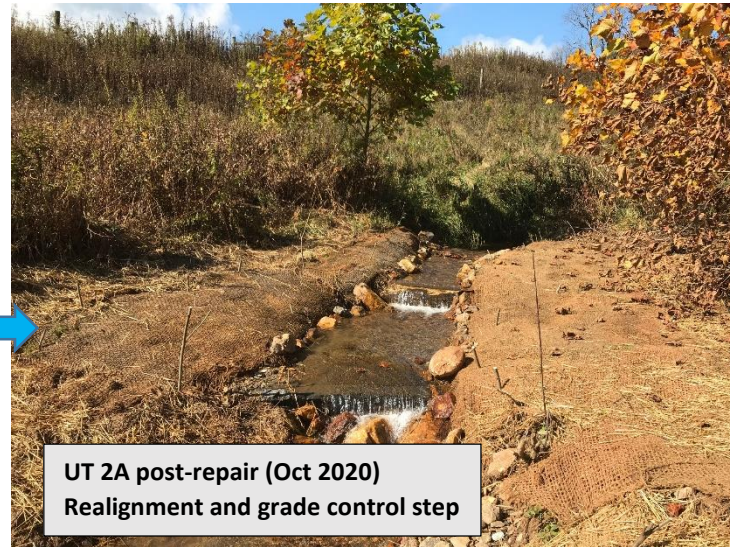
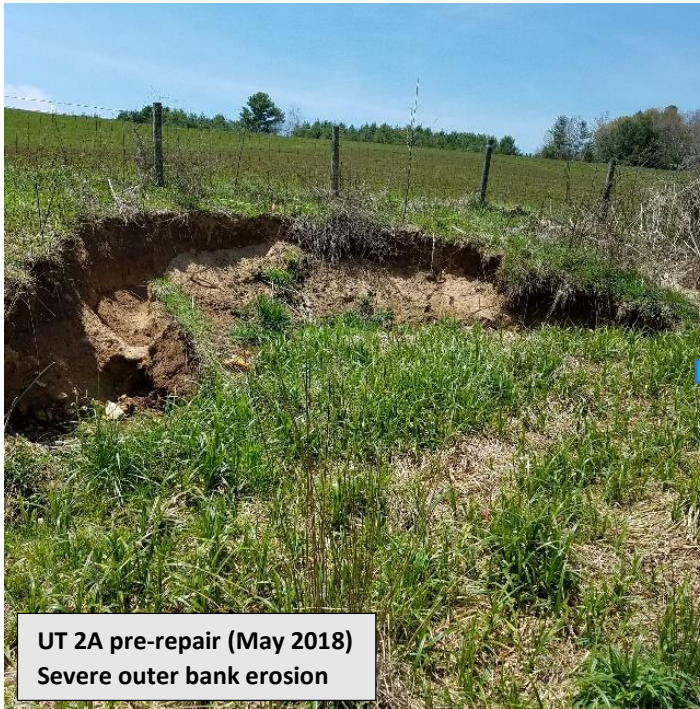
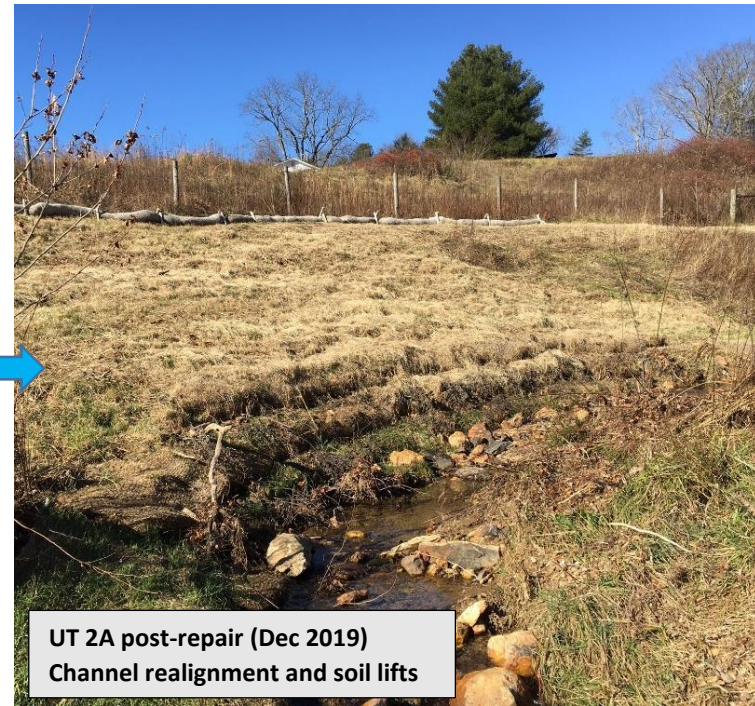
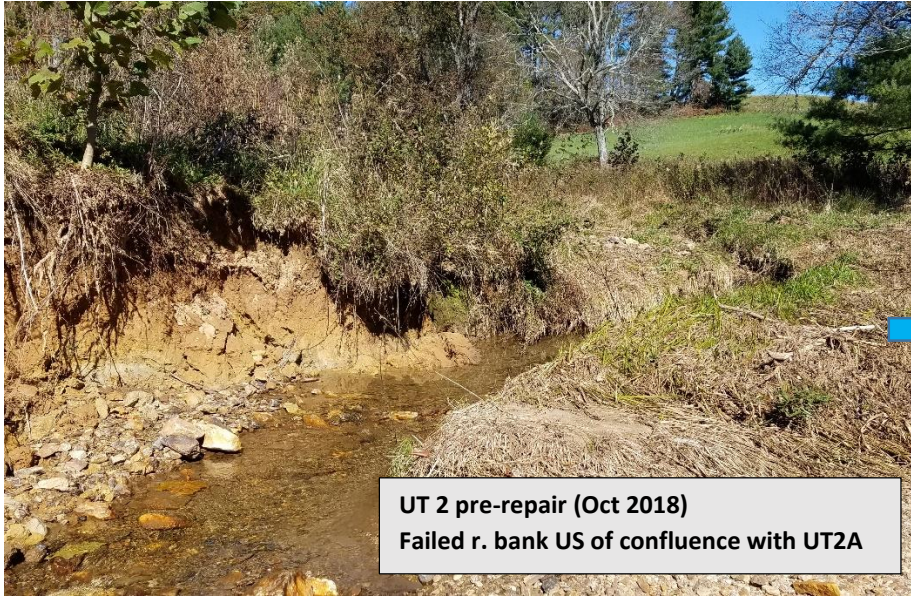
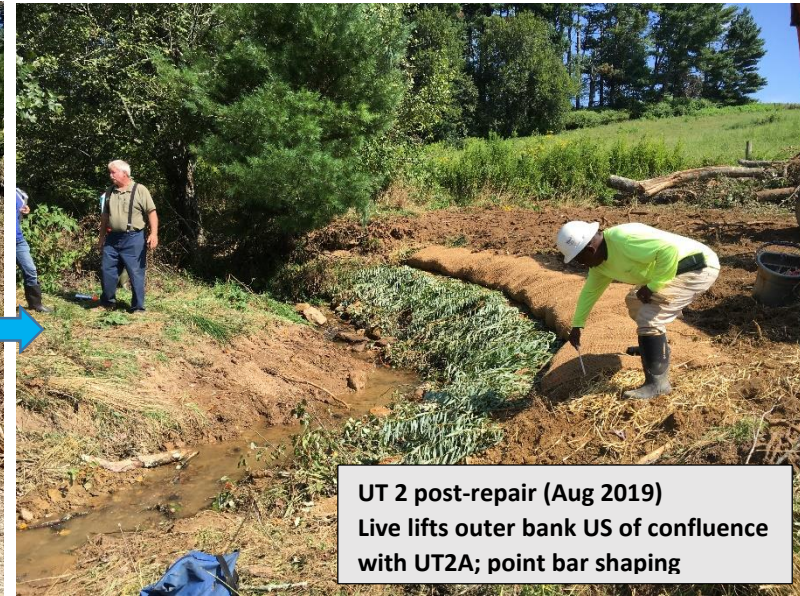
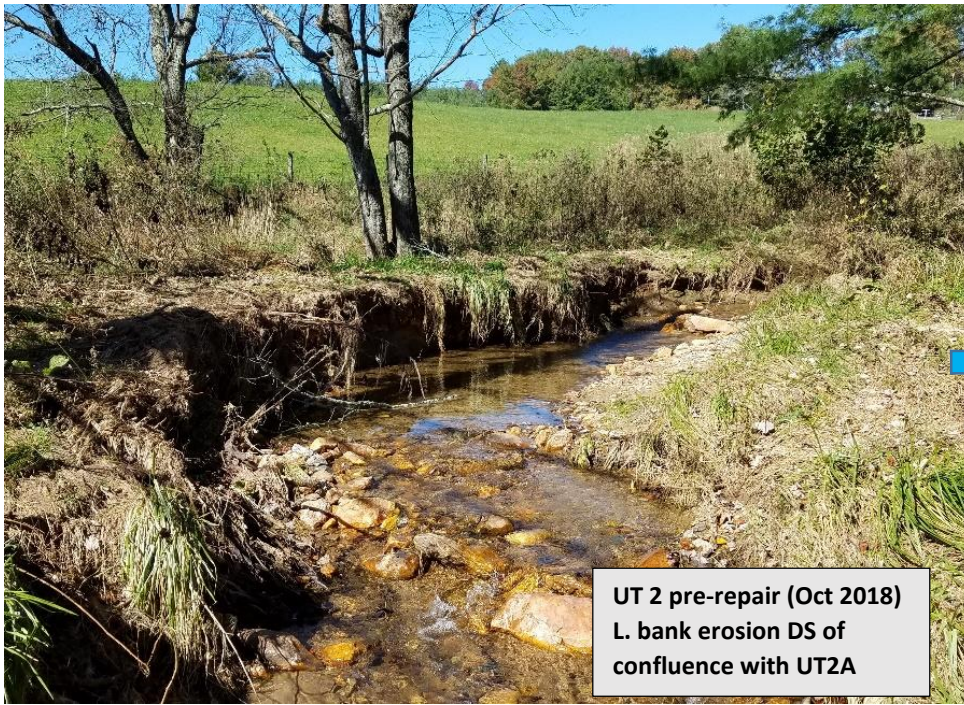
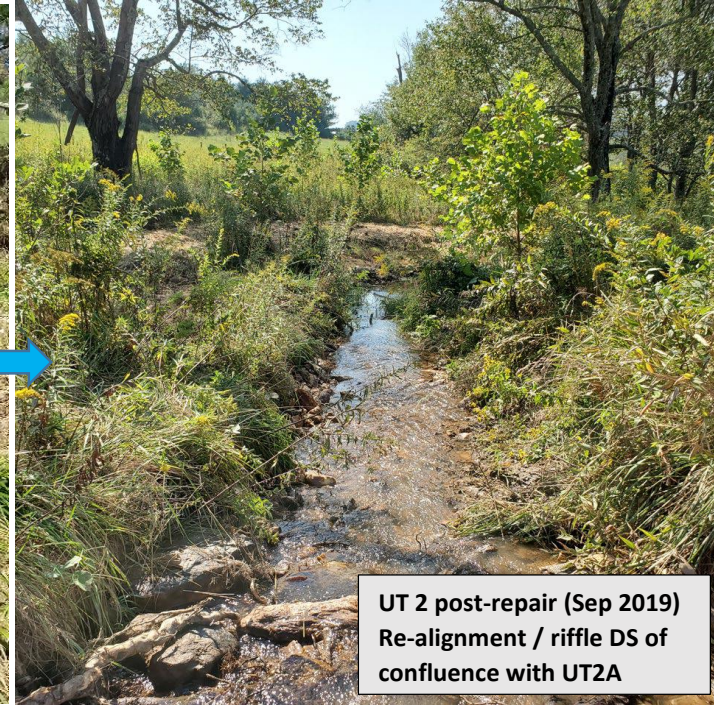
Phase 1 Stream Repair Photos – UT2 and UT2A

There have been 2 recent repair events. The attached aerial map and design plan views show the repair stations and areas for each repair event. Phase 1 repairs were conducted in Fall 2019 and addressed severe tributary erosion along portions of UT2 and UT2A. Phase II repairs were conducted in Fall 2020 and addressed areas of erosion and structural failures at 2 sections along Little Pine Creek, as well as a series of small head cuts along UT1. Both repair events were designed by Water and Land Solutions (WLS) and built by Backwater Environmental. The bulk of the repairs involved soil lifts with toe wood for bank protection, stone and log steps for grade control, and minor stream realignment. Before and after photos are shown for each phase and area.
