# MONITORING YEAR 6 ANNUAL REPORT

## LITTLE PINE III STREAM AND WETLAND RESTORATION PROJECT

Alleghany County, NC

DMS Project Number 94903

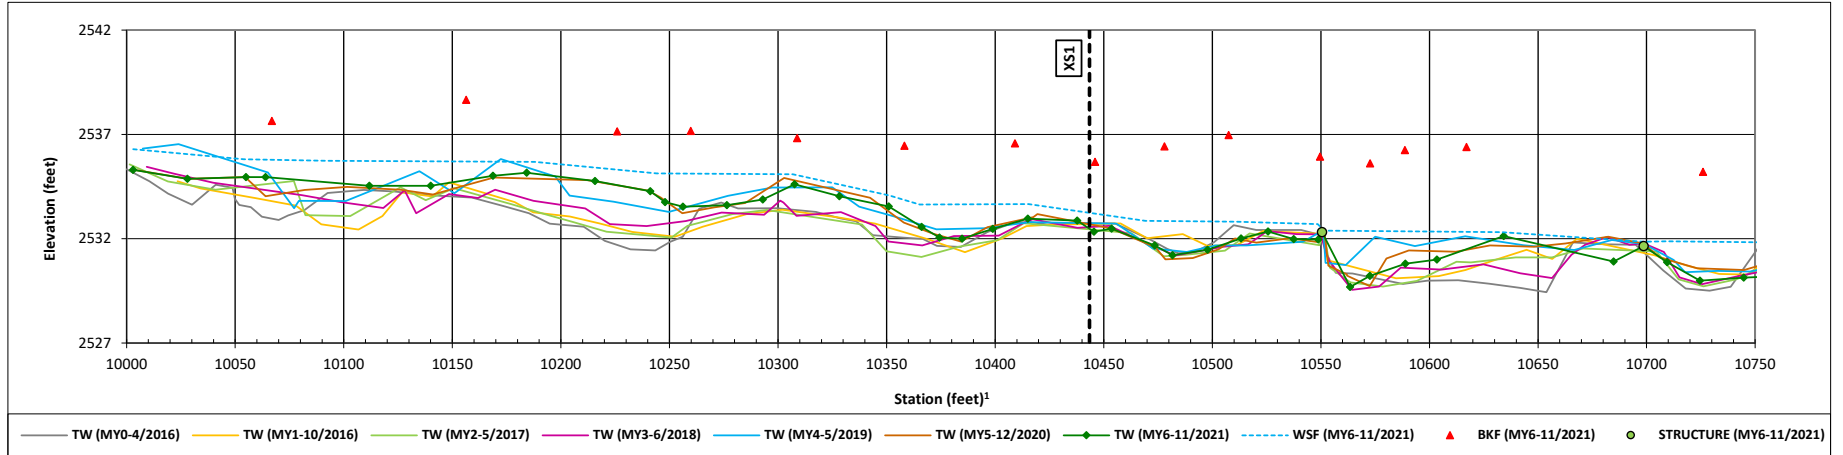
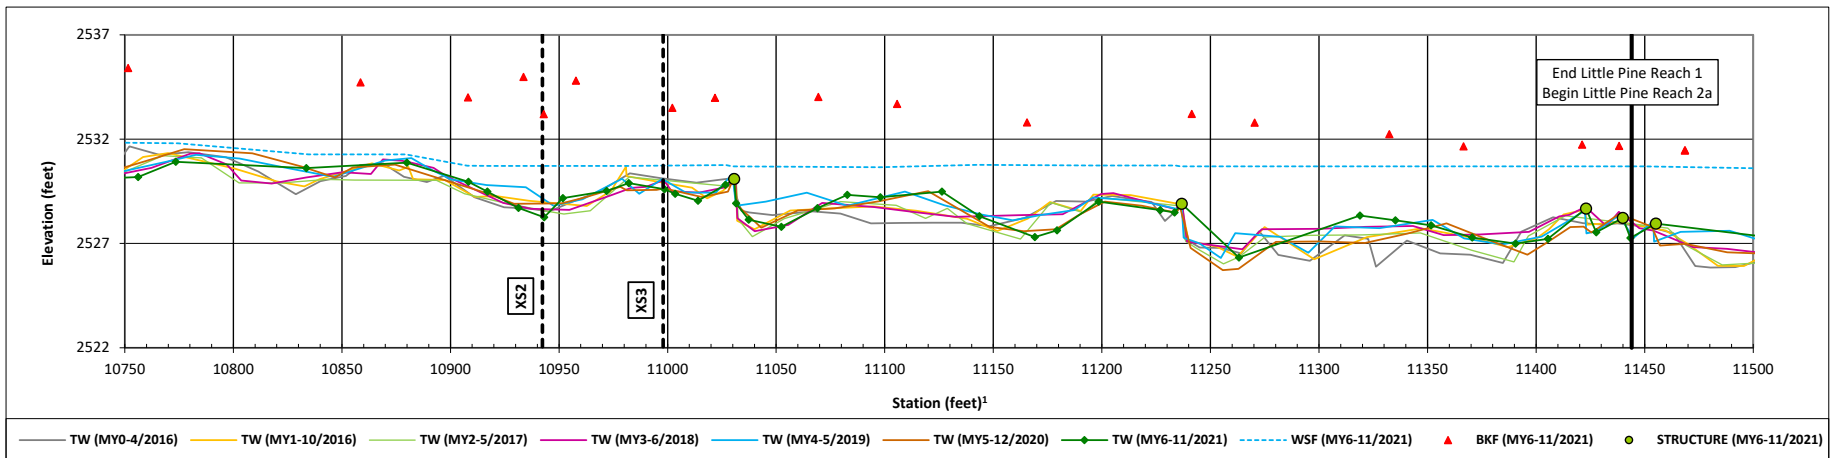
**Little Pine Reach 1 (STA 100+00 - 114+44)**

<sup>2</sup> Stream repairs completed in fall 2020 on Little Pine Creek Reach 1 (STA 100+43 to 101+75) and Reach 2a (STA 121+25 to 122+50).

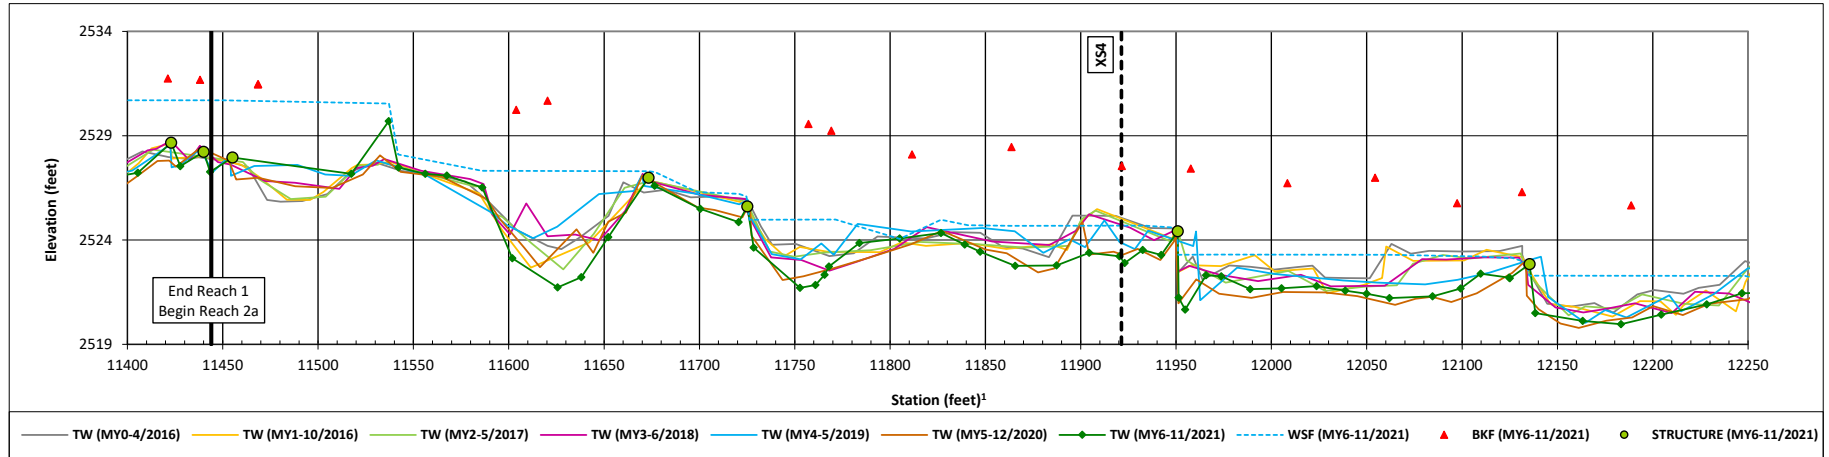
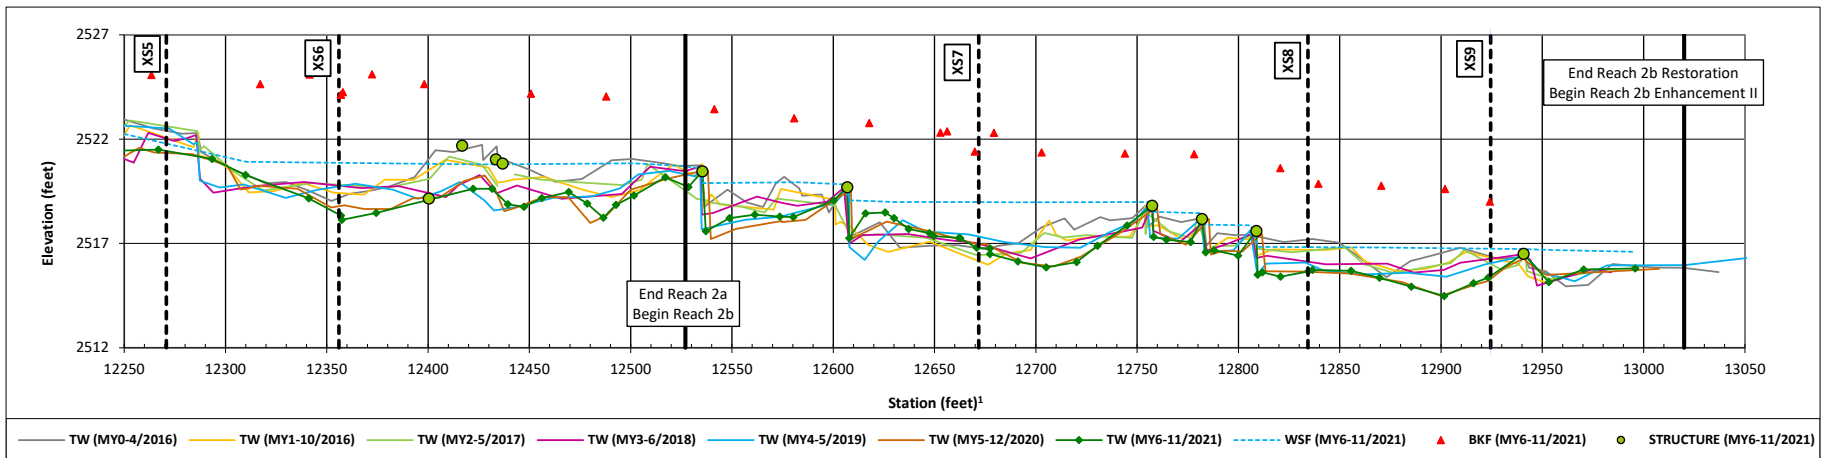
#### Little Pine Reach 2a (114+44-125+27) and Reach 2b (125+27-130+20)

<sup>2</sup> Stream repairs completed in fall 2020 on Little Pine Creek Reach 1 (STA 100+43 to 101+75) and Reach 2a (STA 121+25 to 122+50).

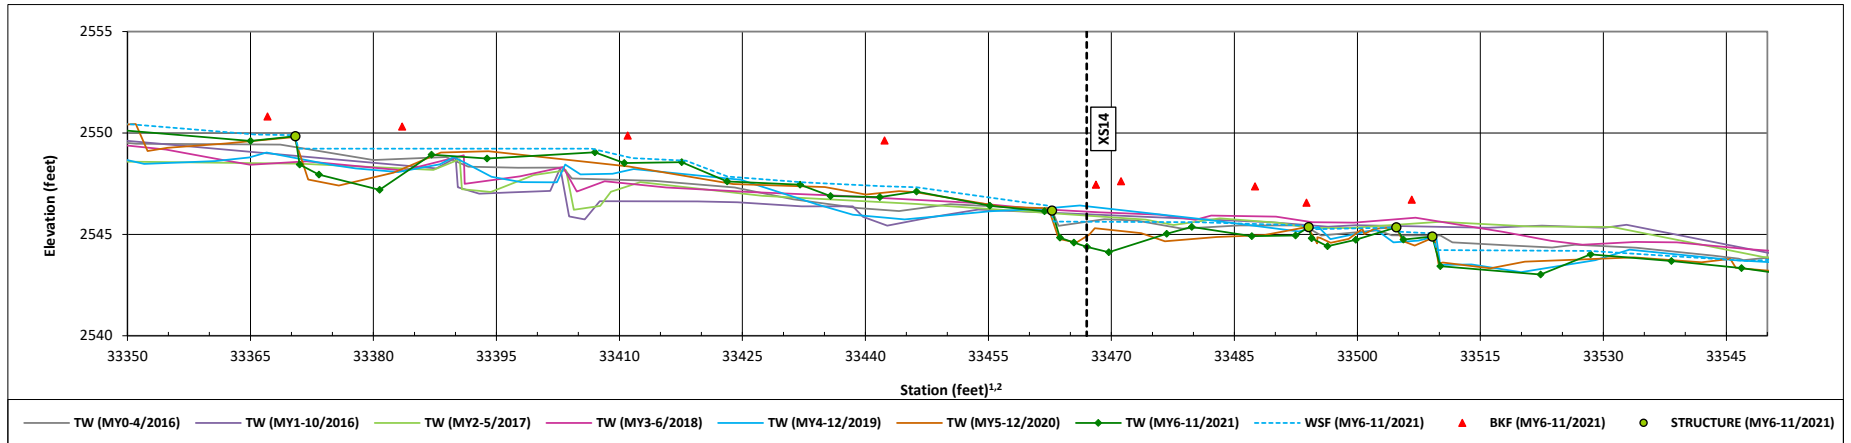
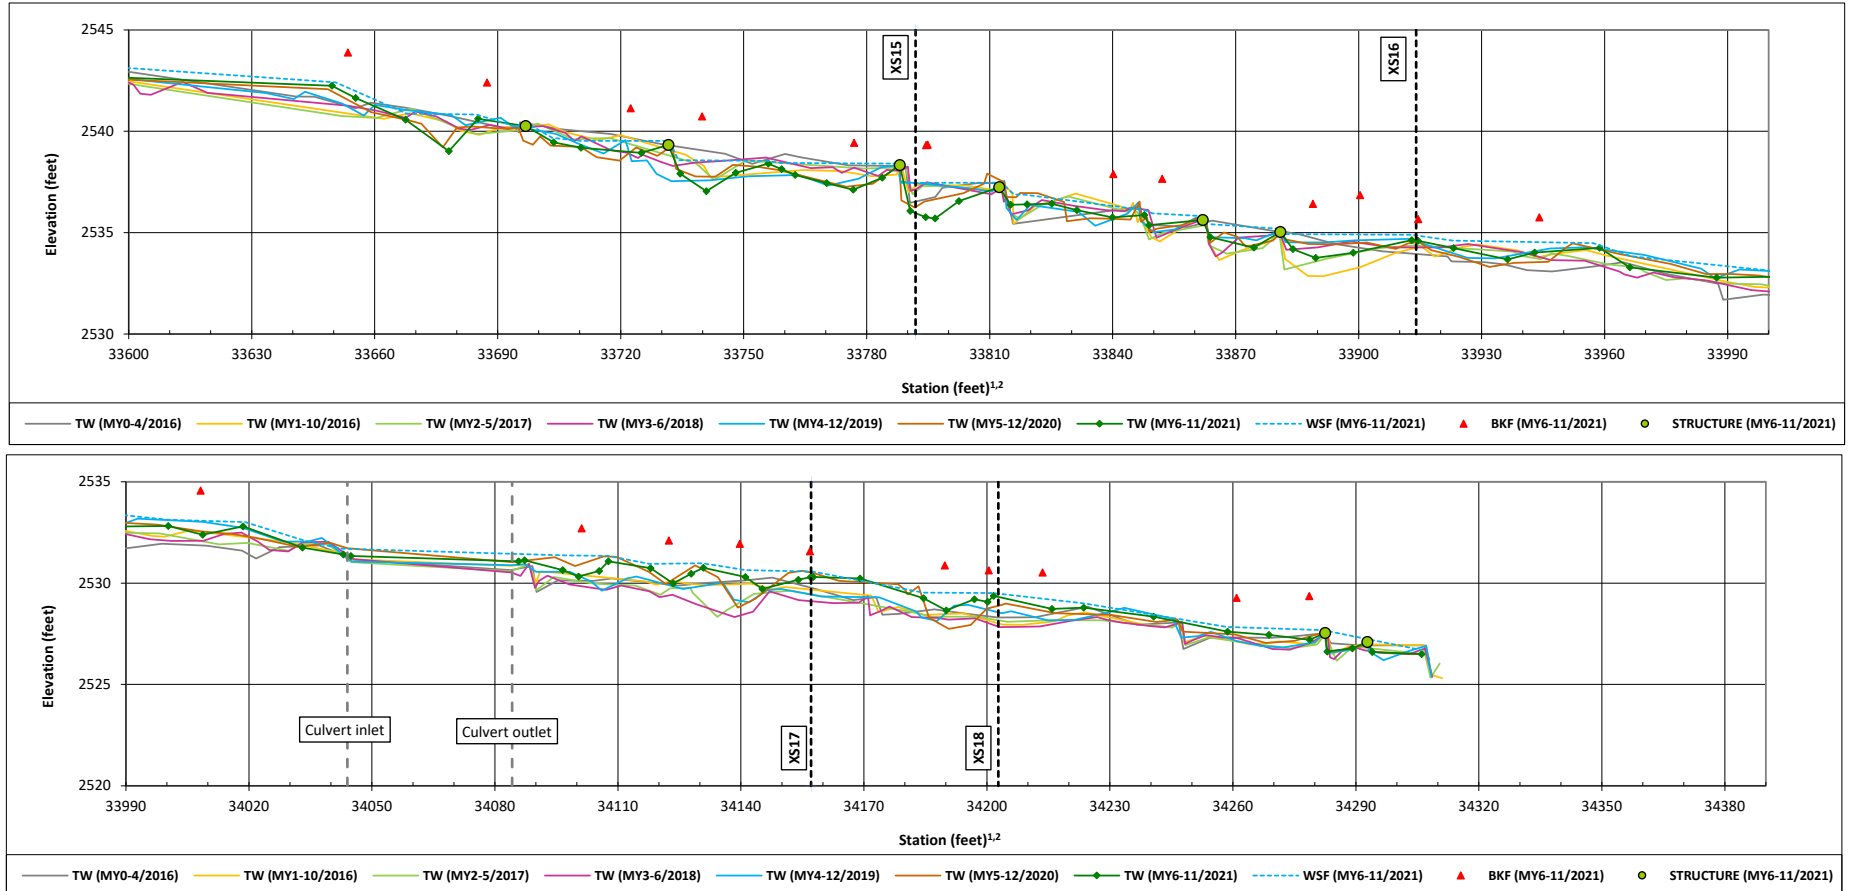
#### UT2 Reach 2 (STA 330+00 - 343+18)

<sup>2</sup> Stream repairs completed in September 2019 on UT2 Reach 2 STA 332+25 to 339+15.

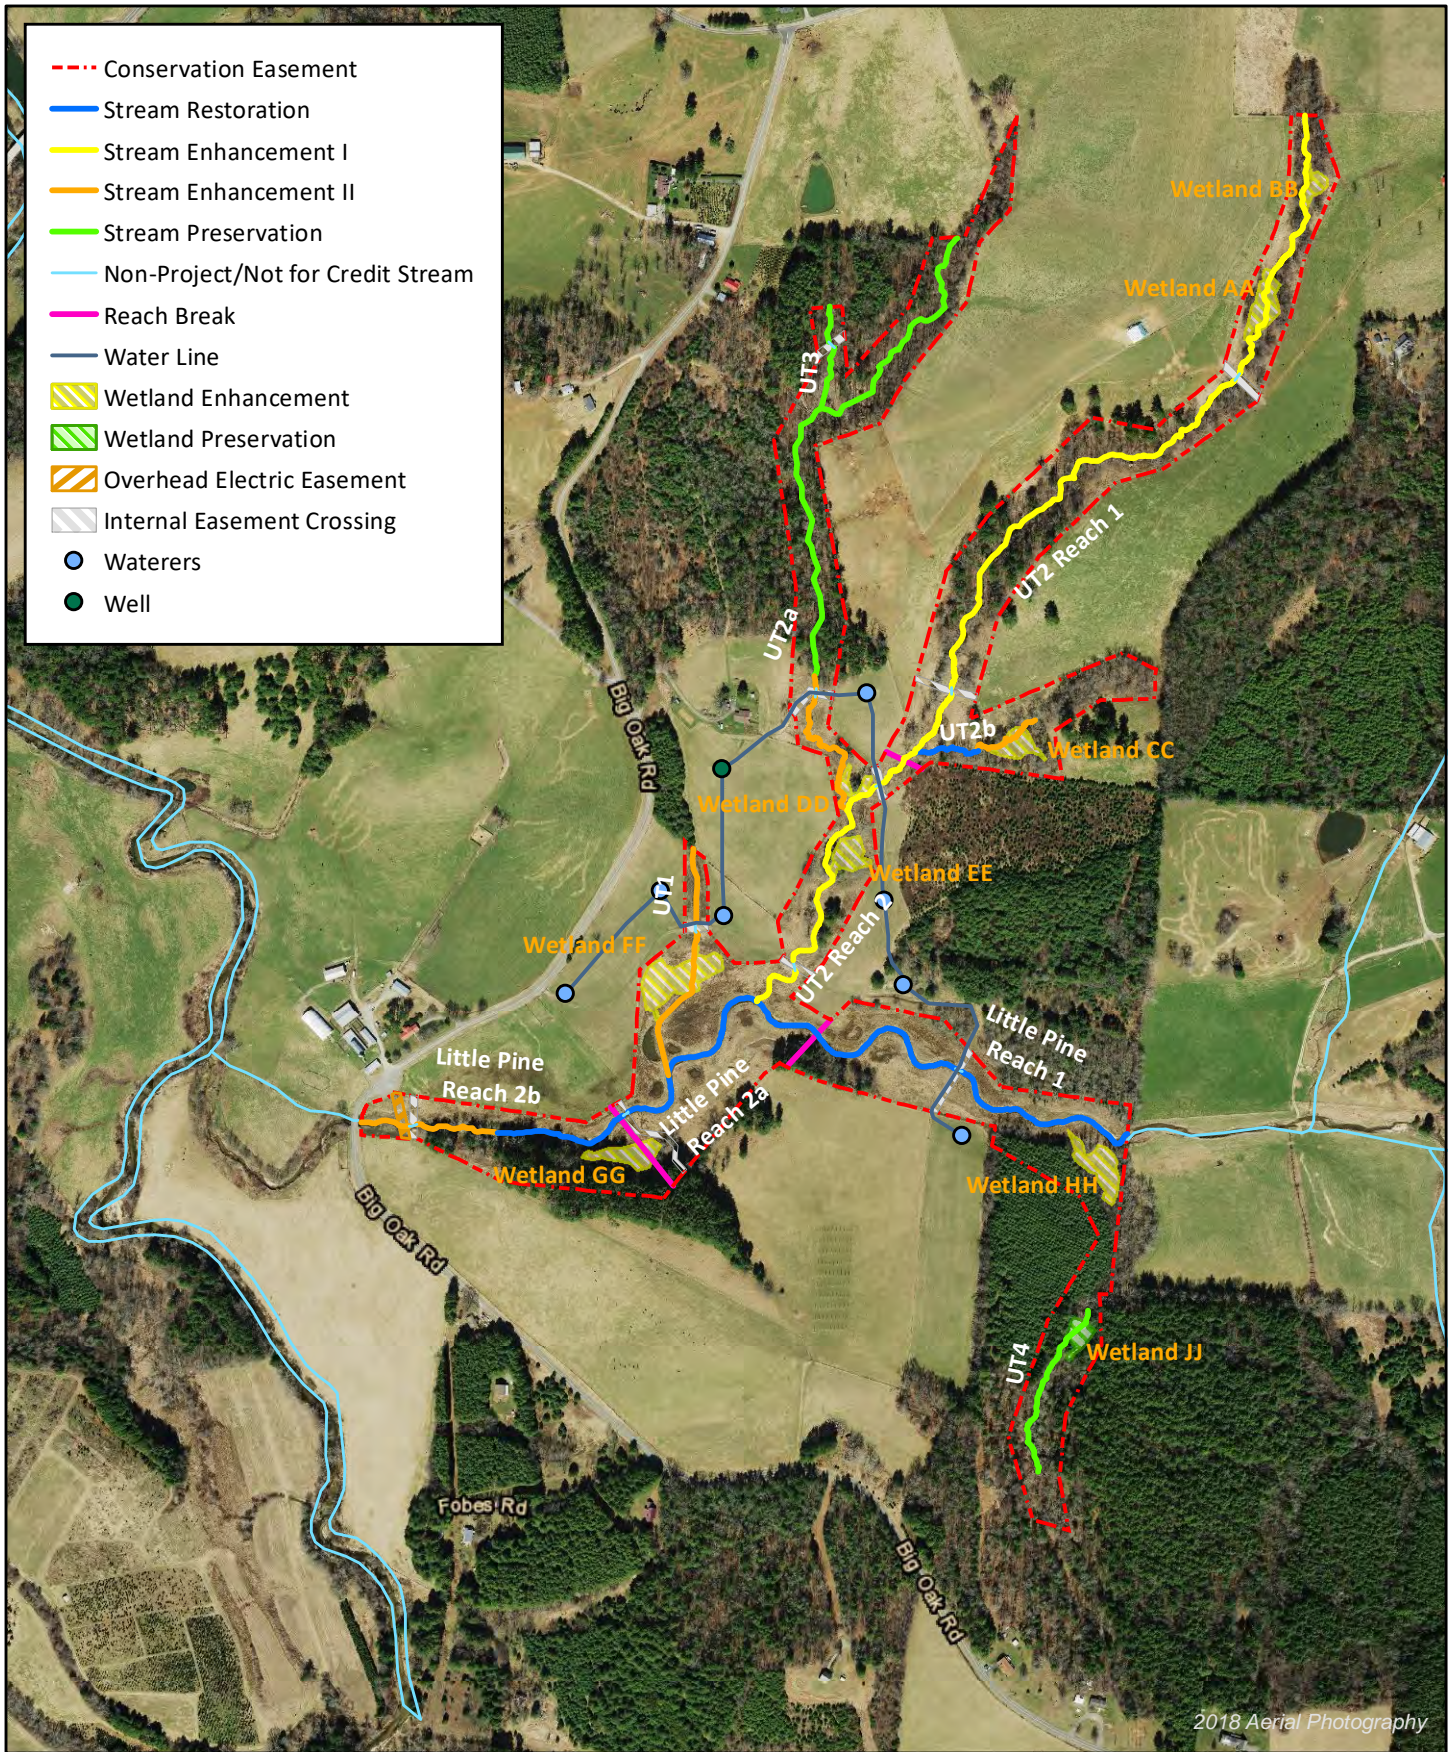
Figure 2 Project Component/Asset Map  
 Little Pine III Stream & Wetland Restoration Project  
 DMS Project No. 94903  
 Monitoring Year 5 - 2020

- Project areas were observed outside of the repair areas including walking UT2 upstream direction to the UT2 Reach 1-upper culvert and just beyond, and a preservation portion of UT2a. The main concerns were the conditions and functionality of the culverts on UT2 Reach 1-upper (UT2R1-U), and UT2 Reach 1-lower (UT2R1-L)

UT2R1-L showed recent impacts of overtopping that had scraped away the top dressing material for a large portion of the middle of the crossing. This loss of rock was not noted previously on field walks or in the MY5/2020 report and apparently the result of recent winter storms. The area just upstream from this culvert was a constructed pool that had filled in pretty quickly following project completion in 2015-2016 and well-known; while the culvert is allowing water passage, there is substantial deposition upstream from the culvert along the original pool that has caused incremental lateral migration of the stream towards the right side (facing downstream) over the monitoring period such that water flow is elbowing to the left at the culvert opening to get through.

It was noted by IRT that both UT2R1-L and UT2R1-U seem undersized and not passing sediments effectively to the point where they are not functioning as intended, and need either maintenance/repair or replaced entirely. A conclusion on the solutions to the issues at these two culverts remains to be seen; further evaluation/ calculations would need to be performed. DMS is evaluating further, pursuing alternatives, and will communicate statuses in the next monitoring report.

- Erin noted a head cut along UT2b the CCPV sheet that has appeared as a new feature on the MY5 (2019) CCPV that was not mapped in MY4. The group did not have time to observe but DMS agreed to evaluate and follow up appropriately.

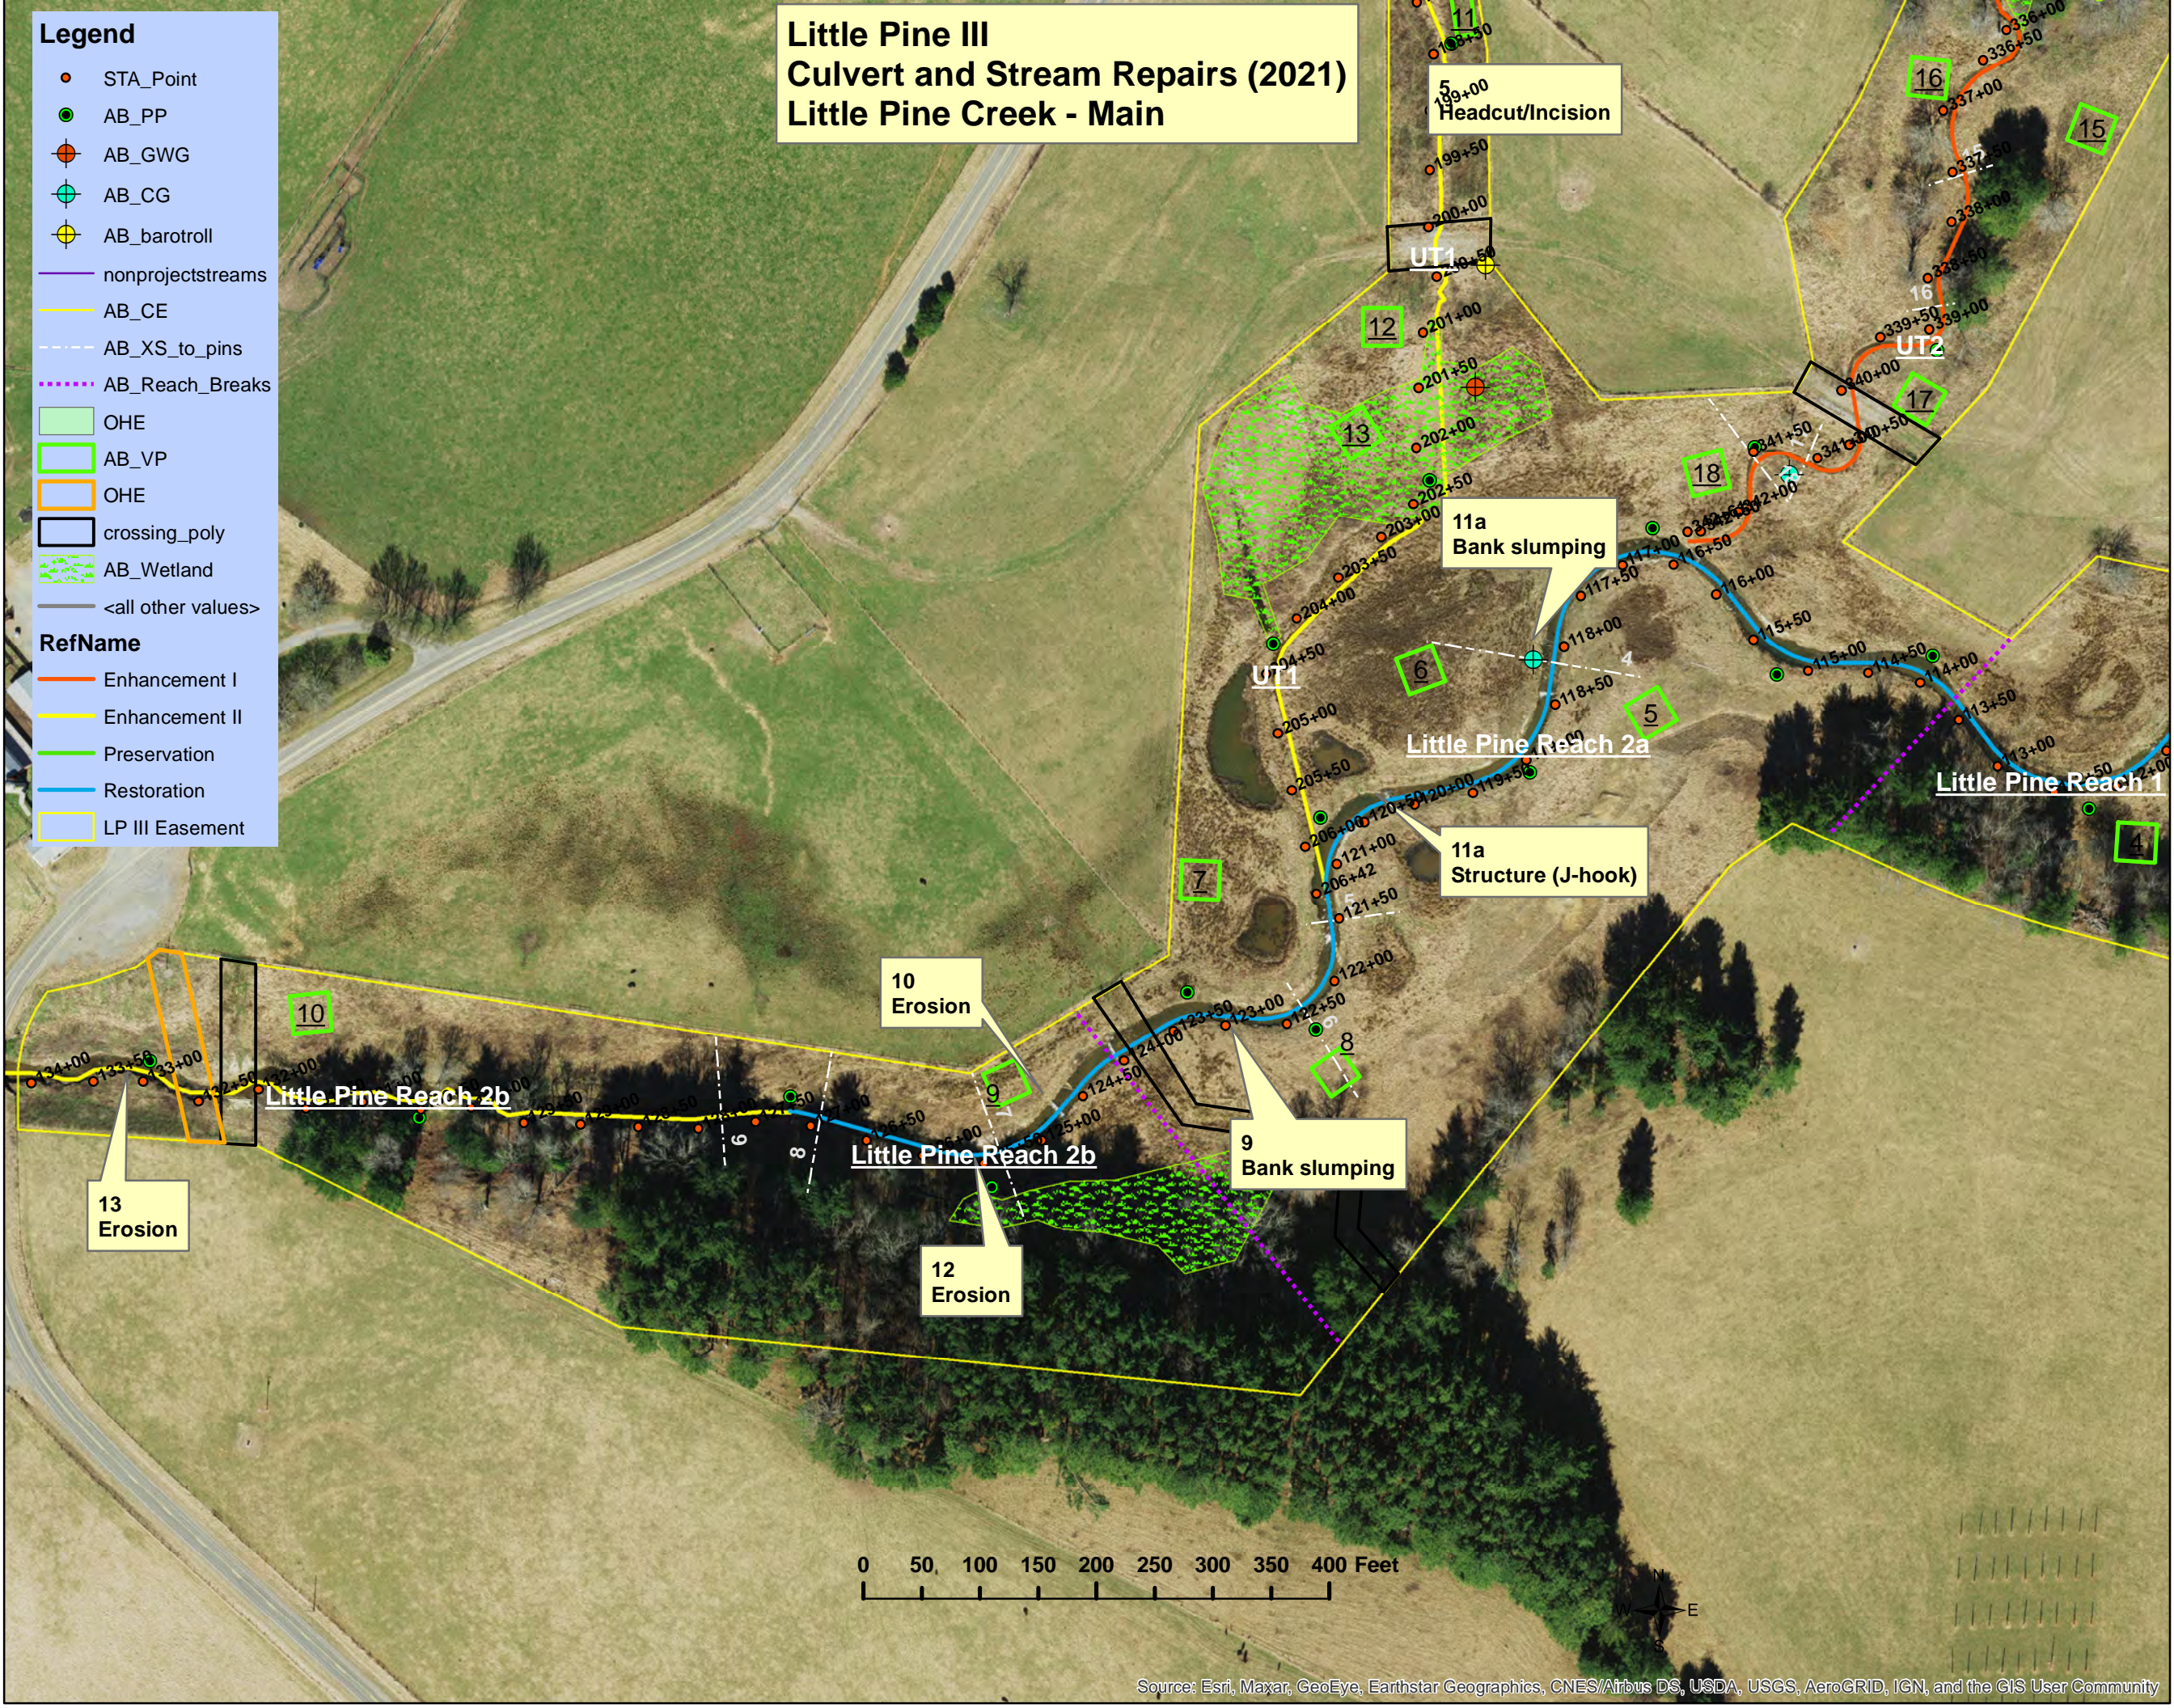
**Little Pine III  
Culvert and Stream Repairs (2021)  
Little Pine Creek - Main**

Bank slumping along Little Pine Creek  
**Little Pine Creek Repair Area:  
DMS Locations #10**

EPR proposes that areas suffering from bank erosion/slumping will be repaired and stabilized by a combination of grading and bioengineering with any seeps or overland flow being addressed with a stabilized outlet structure.

These banks will be repaired and stabilized utilizing a combination of large stone and bioengineering. Geolifts utilizing live cuttings with a stone toe will be constructed in combination with the placement of some larger stone where needed.

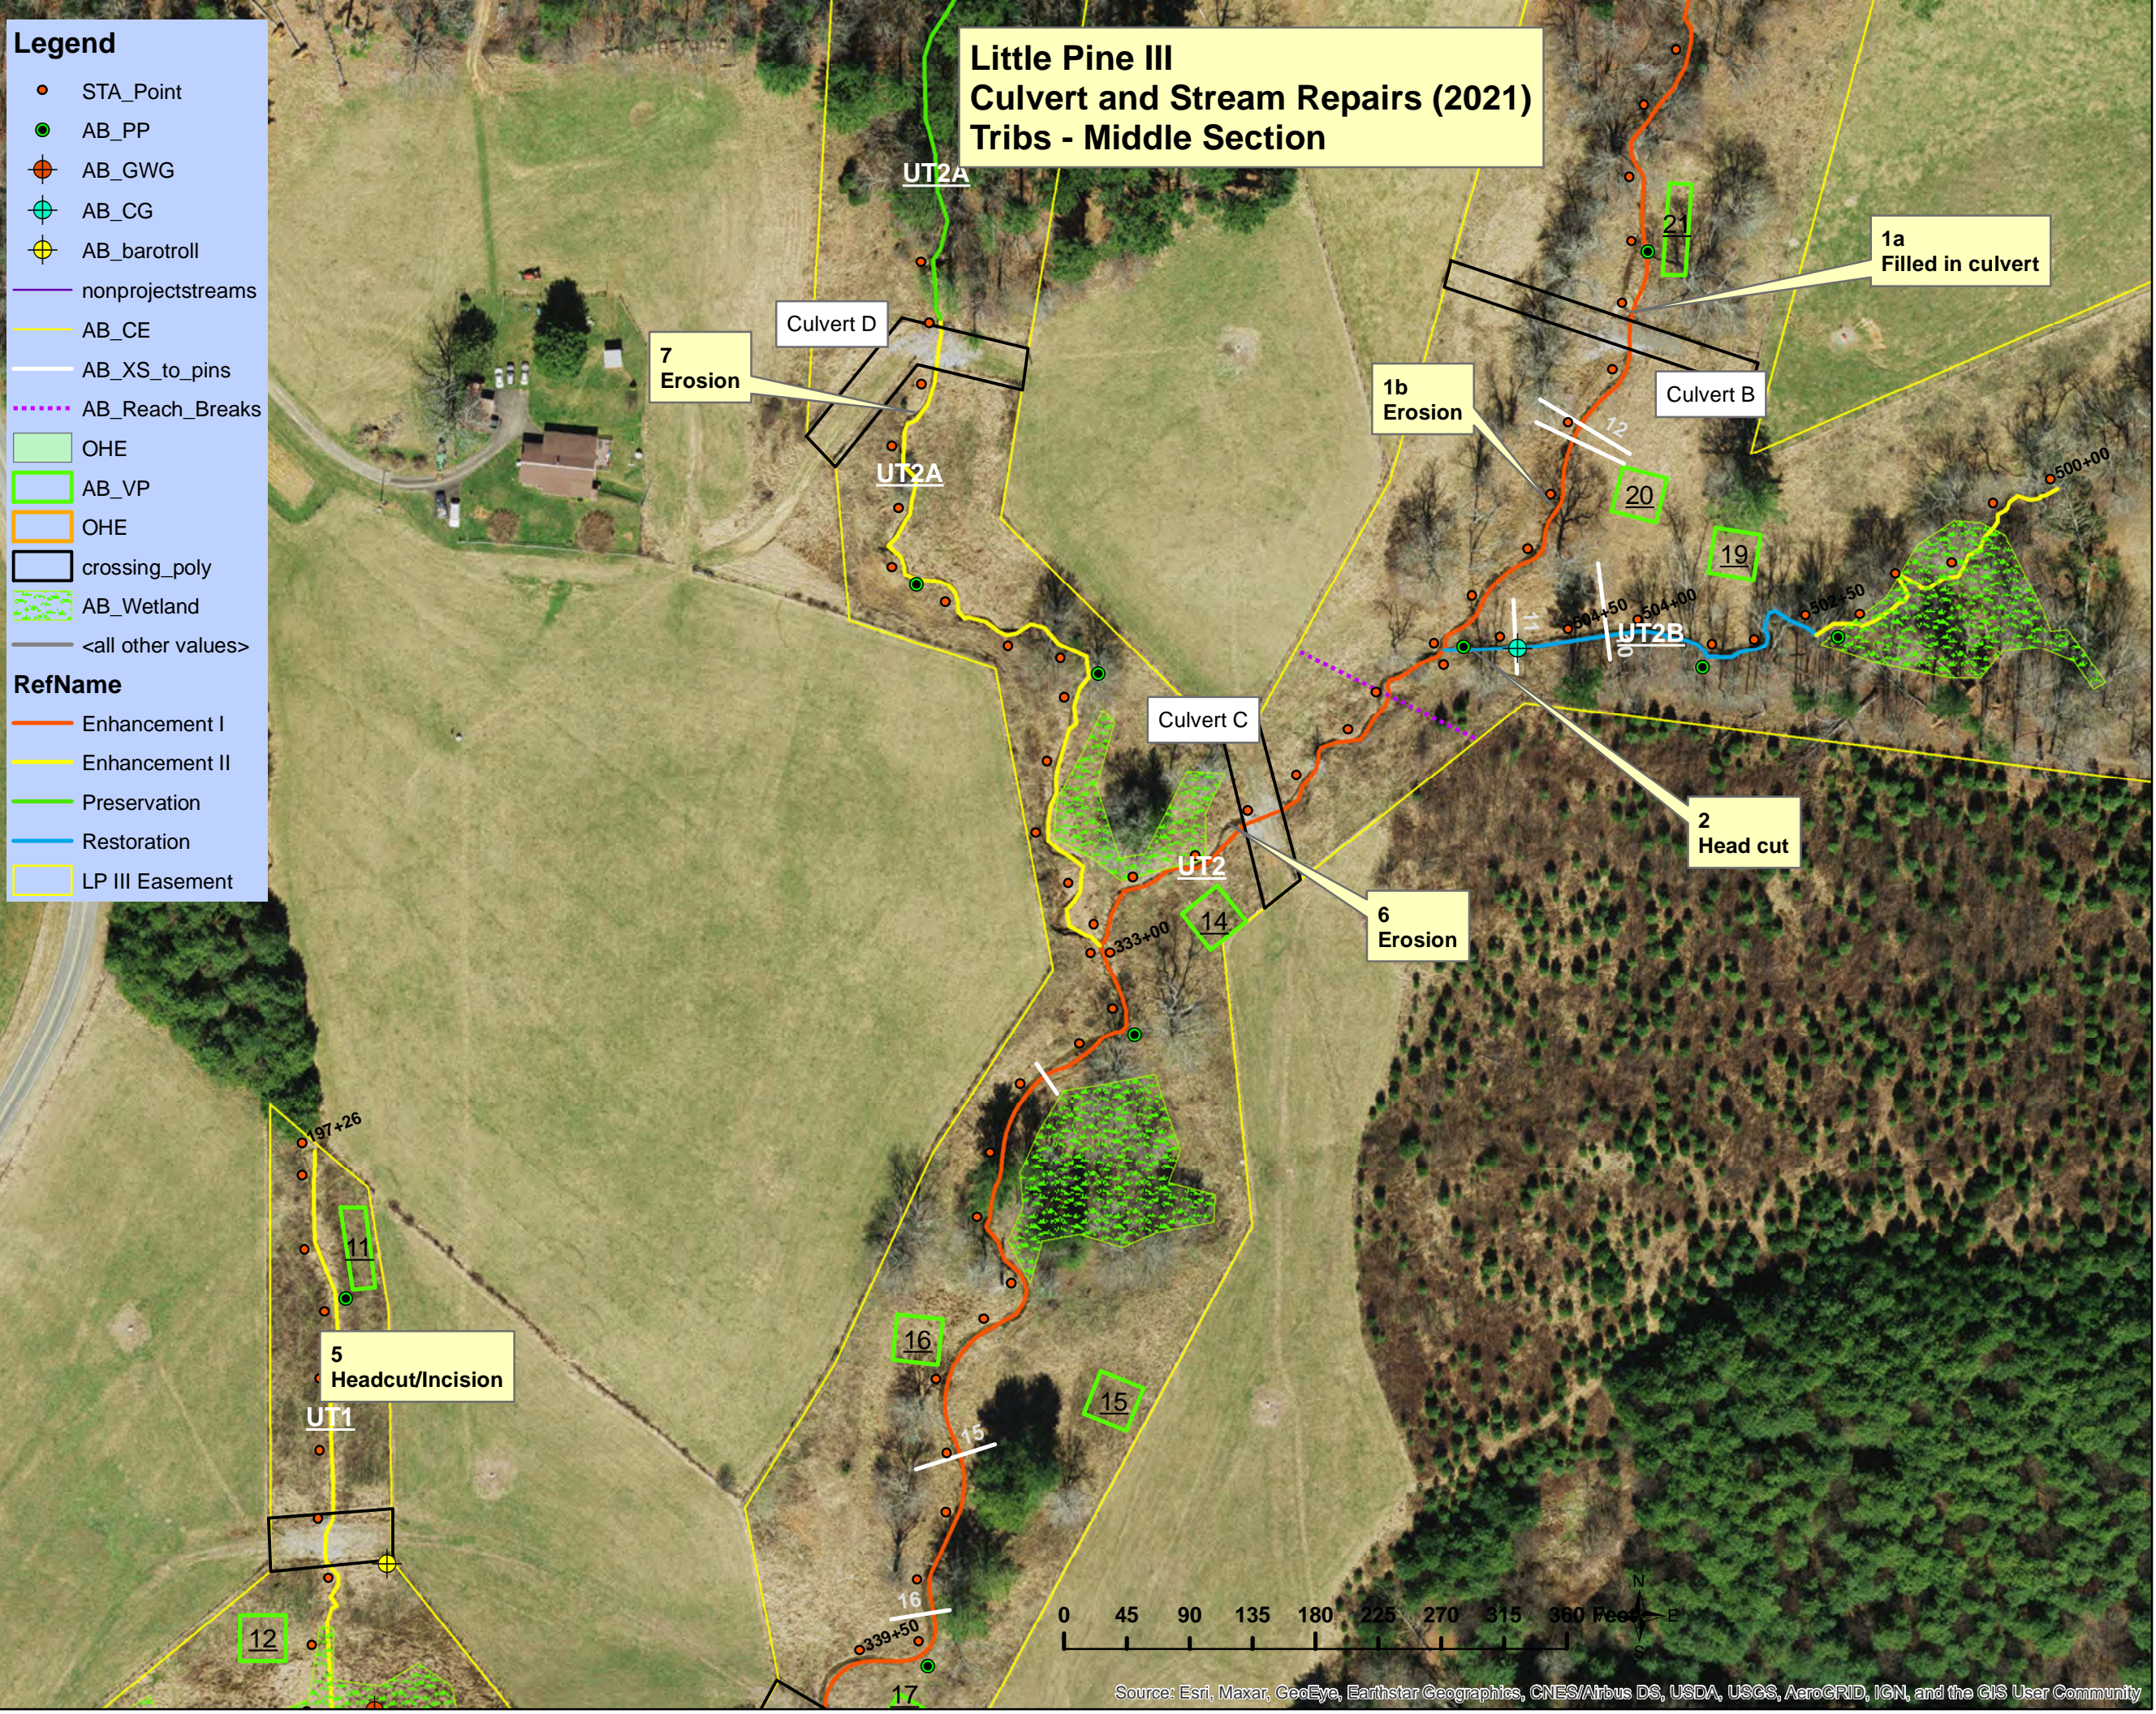
**Little Pine III  
Culvert and Stream Repairs (2021)  
Trib - Middle Section**

This repair area consists of existing culverts at stream crossings at locations #1 and #3. Both culverts appear to be undersized and are frequently inundated with sediment. The crossings have also been overtopped on several occasions.

These repair areas consist of bed and bank instability. Banks are eroding and several existing grade control structures are piping.

Based on hydraulic analysis of the culverts, both culverts are undersized for the 25-year storm. Replacement of the 30-inch culverts with 48-inch culverts will convey the 25-year discharge without overtopping the road. EPR will work with DMS to determine if installing a larger culvert or replacing the culvert crossing with a ford crossing is the best course of action. Bed and bank stabilization upstream and downstream of both crossings will be incorporated as needed and include grade control structures to step down the channel if required. Cross fencing will be repaired. Upstream of location #1 at approximate station 310+10 the streambed will be stabilized using in-stream structures and the banks will be graded, matted, seeded, mulched, and live staked.

EPR proposes to stabilize the bed instability by repairing or replacing the existing grade control structures. Structures will be repaired by excavating upstream and installing new filter fabric and bankfull to prevent piping or by rebuilding structures utilizing existing materials as much as possible. Banks will be graded to slopes of 3:1 or flatter, seeded, mulched, matted and live staked.
