Little River Farm Site – Stream Enhancement, Restoration, and Preservation Project Final Year 1 Monitoring Report (2010) Montgomery County, North Carolina

EEP Contract Number 000623

Data Collection Period: Nov. 2010

Submission Date: December 2010

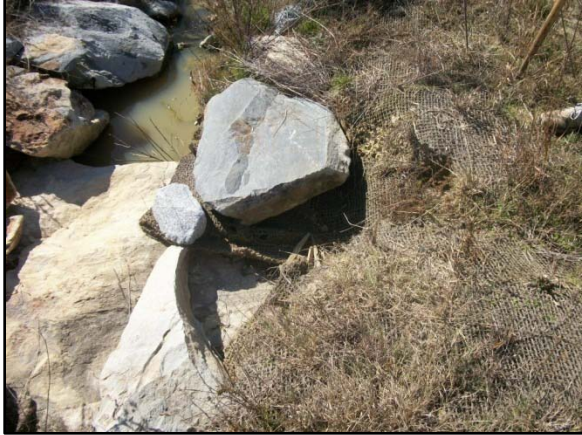
The constructed sections of stream channel are functioning as designed. There were no observed vertical bed adjustments within the pools and only a minor adjustment in Riffle X1. During the field review, all rock step pool structures on UT4 were noted as stable. However, at Station 13+50, a boulder that ties the structure into the stream bank has shifted and is exposing a small area of bank at the tie-in point. This change in position allows for erosion to occur around the structure and will therefore be repaired.

Structural Problem Area-1
Shifted Bank Armor of Boulder Step
Station – 13+50
