# Little River Farm Site – Stream Enhancement, Restoration, and Preservation Project Final Year 2 Monitoring Report (2011) Montgomery County, North Carolina

EEP Contract Number 000623

Data Collection Period: November – December 2011

Submission Date: March 2012

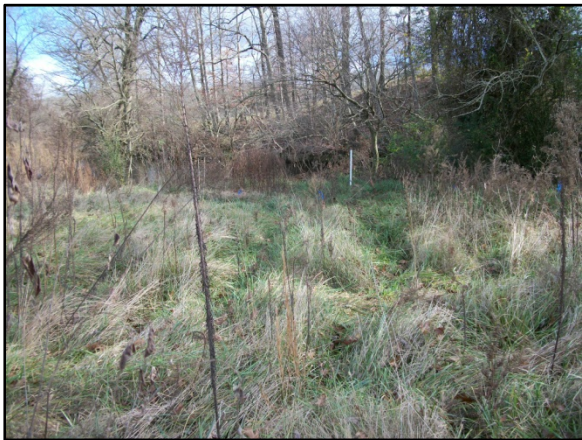
**VP-3**

Vegetation plot counts were conducted from November to December 2011. During this assessment, individual planted saplings were noted to be hand-cut in Vegetation Plots 3 and 4. Observations indicate the cutting was in the area adjacent to the fence line associated with the affected vegetation plots. Neither incident should result in a significant loss of vegetation within the project area; however, these areas will be monitored to ensure their recovery and success.

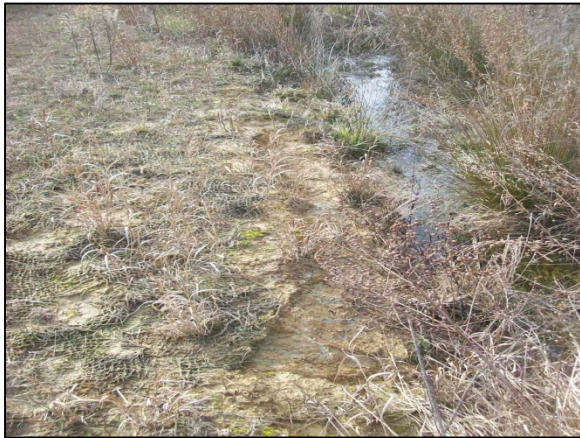
**C.6-3 Station 11+75 – 11+90**

No invasive species were observed within the project site during the field assessment. See Table C.6 in Appendix C for problem area categories, locations, descriptions, causes, and photo log.
